To refurbish or replace steel water pipelines, that is the question

S. Creig-Smith

Advanced Engineering and Testing Services, MATTEK, CSIR, Private Bag X28, Auckland Park 2006, South Africa

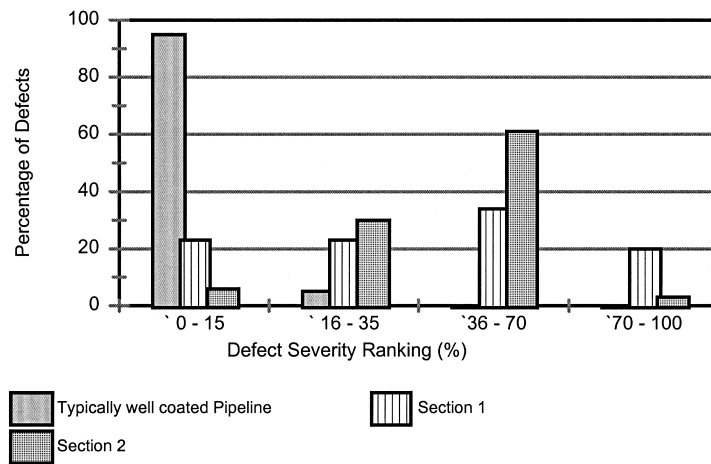
Fig. 1. Severity distributions of Sections 1 and 2, shown in comparison to the severity distribution of a relatively well coated pipeline.

During the DCVG survey of Section 1 a total of 30 defects over a distance of 567 m were located and ranked. A total of 33 defects over a distance of 263 m were located in Section 2. Table 1 shows the defect size/severity distribution of these defects. The results presented above in Table 1 are plotted graphically below in Fig. 1 in comparison to a typical distribution of a pipeline coating in relatively good condition. It is evident from Fig. 1 that the severity distributions of both Sections 1 and 2 deviate substantially from that of a typically well-coated pipeline.

The DCVG survey results showed that a relatively large number of defects per meter were found (one defect every 8 m for Section 2 and every 19 m for Section 1). This in conjunction with the comparison to the defect distribution data of a relatively well-coated pipeline, is indicative of an external coating in poor condition. The excavation and examination of 11 defects further confirmed this finding.
