SURFACE CONTACT FATIGUE FAILURES IN GEARS

P. J. L. FERNANDES and C. McDULING

Advanced Engineering and Testing Services, CSIR, Private Bag X28, Auckland Park 2006, South Africa

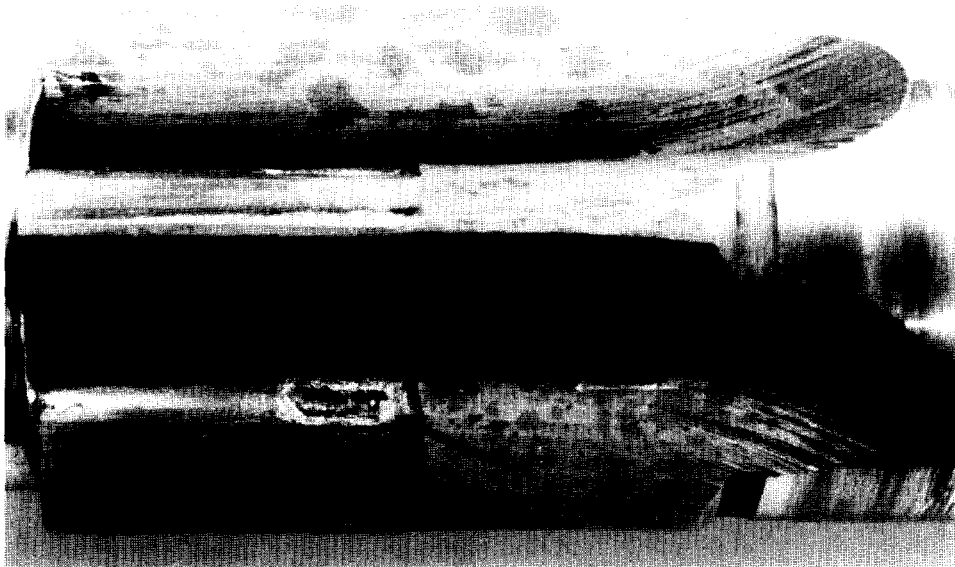
Another region in which contact fatigue damage is frequently encountered is at the lowest point of single tooth contact, i.e. the point at which contact is made with the tip of the matching tooth [3]. Since the contact area in this case is very small, high stresses are generated, even under normal loads. Moreover, the lowest point of single tooth contact is always in the dedendum of the matching tooth, and sliding speeds, both in approach and recess, are at a maximum. The negative sliding conditions in these regions, together with the high stresses and high sliding speeds, lead to rapid initiation of damage. Figure 5 shows the driving gear of a 1.5 ton lever hoist in which severe pitting in the dedendum has occurred at the point of single tooth contact [6]. The extent of damage observed occurred after only 500 cycles under test conditions.

Fig. 5. Severe pitting in the dedendum of the driving gear of a lever hoist. Pitting initiated at the lowest point of single tooth contact.

effectively by ensuring that correct lubrication conditions are maintained. Furthermore, it has been shown that sliding–rolling damage can be minimized by achieving a surface hardness on the matching bodies greater than HRC 60 [4]. Retained austenite, at levels of 10–20%, in the case-hardened layer also minimizes the extent of contact fatigue since this microstructural constituent deforms plastically to form larger contact areas, and hence lower contact stresses. However, austenite reduces the fatigue strength of the material, and can therefore introduce other deleterious effects.

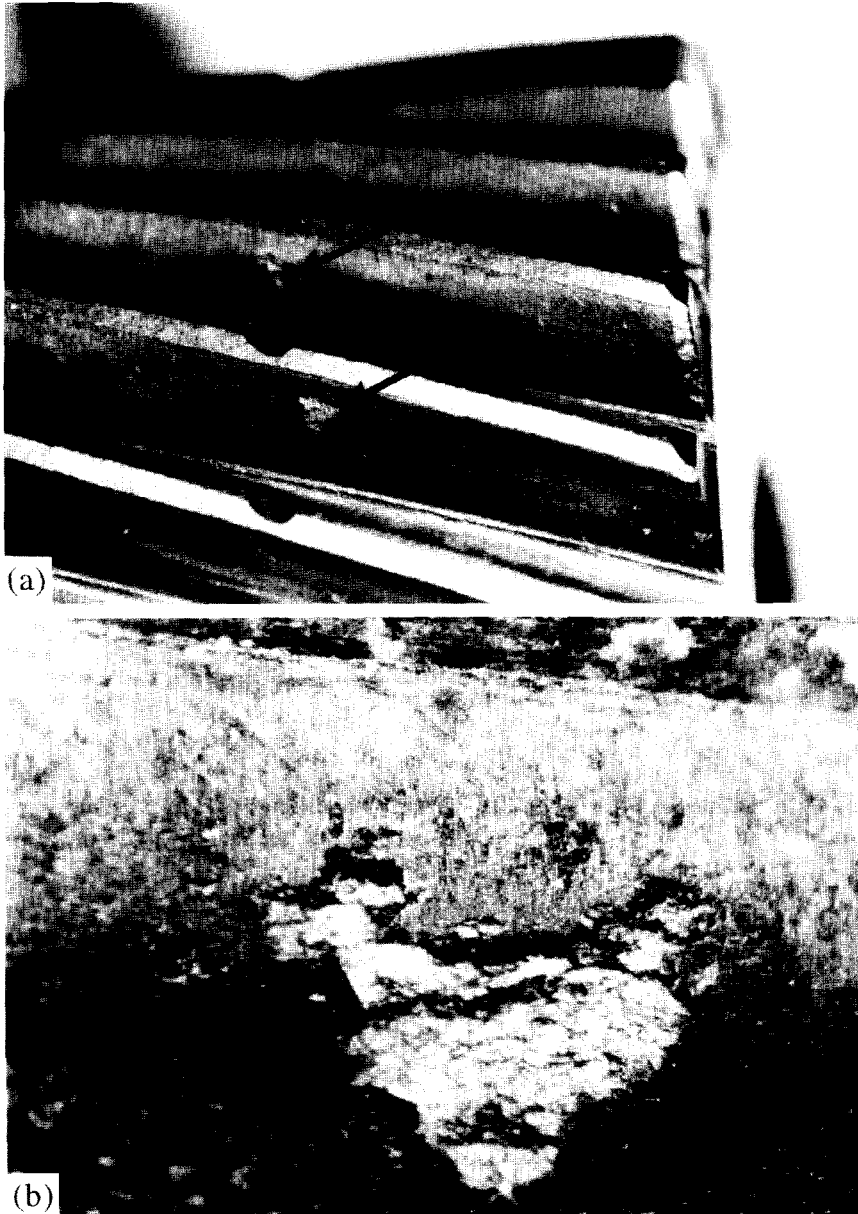
Firstly, spalling may occur as a continuation of pitting resulting from rolling or sliding–rolling contact fatigue. In some instances, the cracks initiated by these mechanisms will propagate into the material, and ultimately result in the loss of large pieces of metal from the contact surface. An example of this is given in Fig. 6, which shows severe spalling which occurred as a result of rolling contact fatigue pitting along the pitch-line of a helical gear. In some cases, pitting will start at one point, and progress outwards and upwards along the tooth profile to form what is known as the “cyclone” effect [3]. This is clearly shown in Fig. 7 for the case of a small helical gear from an automatic gearbox [8].

Fig. 7. (a) Active flank of a helical gear showing the "cyclone" effect, and (b) high-magnification photograph of the same area showing how pitting has extended upwards and outwards.
