# SIMRAC

## Final Project Report

**Title:** DETERMINE THE NEED TO RESEARCH THE TIME-RELATED STABILITY DECAY OF BORD AND PILLAR SYSTEMS

**Project No:** COL 439

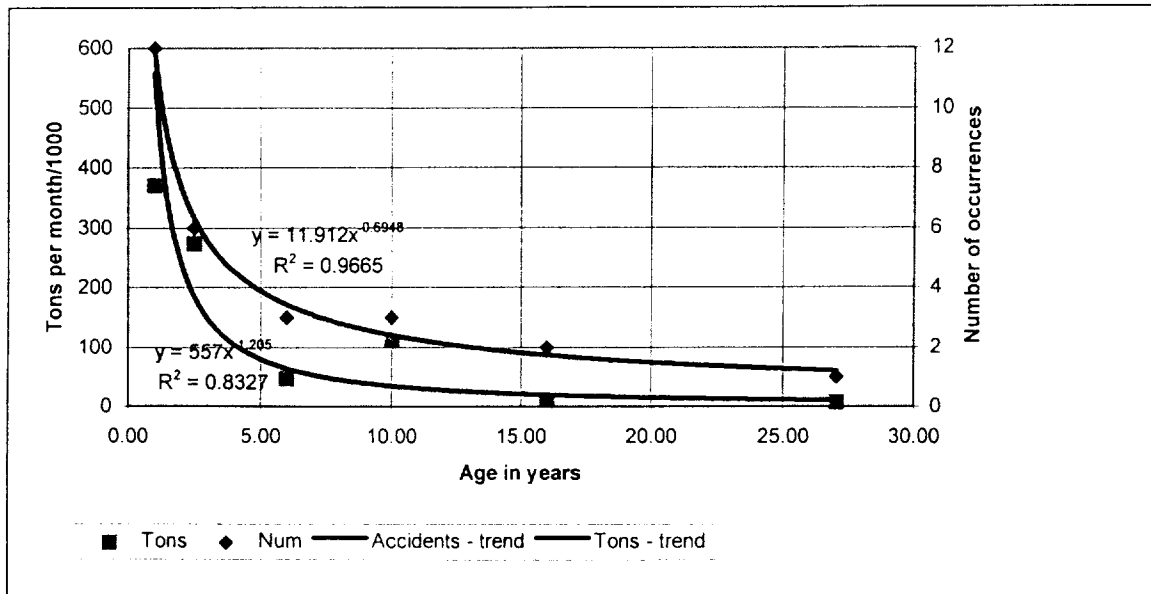
The statistics in table 1 are presented graphically in figure 1. The results suggest that the frequency of occurrences are not directly related to the age of the pillars. It rather indicates that pillars are being extracted in areas where the age of the pillars are less than four years and

**Figure 1 Graph showing statistics of age of workings against number of accidents and tonnage produced in panels where fall of ground accidents occurred**

very frequently less than one year. The percentage of occurrences in areas where the age is less than 4 years equals to 60 % with the tonnage produced in the period before the accidents occurred amounted to 78 % of the relevant tonnages. This was also found to be the case where pillar extraction was being done during the investigation period, where more than 60% of the tonnage was being mined from panels younger than four years.

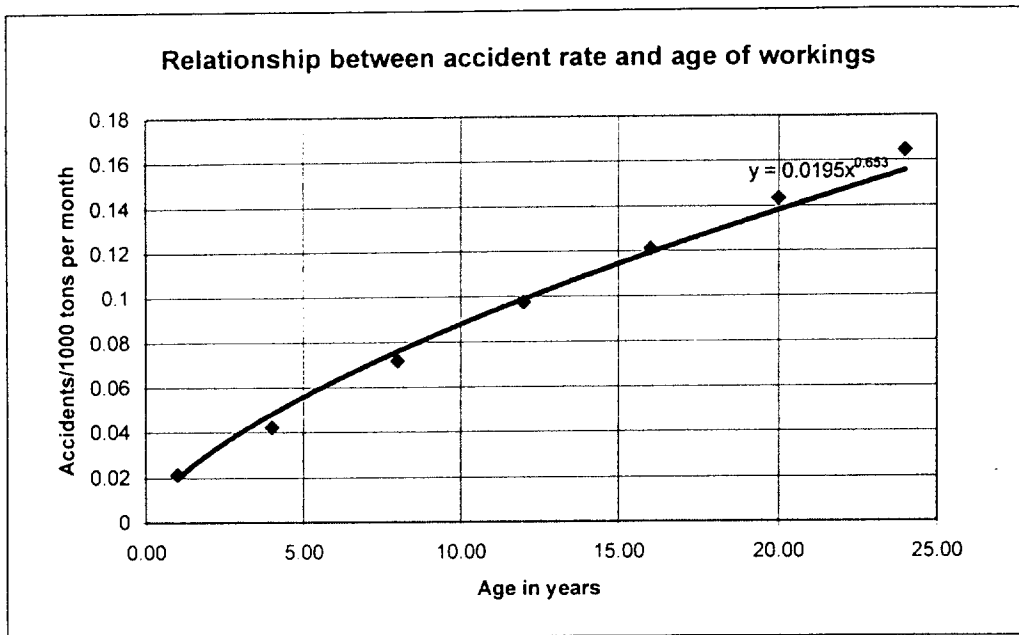
Statistically the sample is not large enough and the tonnages too erratic, due the physical mining conditions at different mines, to try and relate the occurrence of individual accidents to age or production rates. As a result, the relationship between the trend lines shown in figure 1 were used to calculate the accident rate per ton produced, shown in figure 2. It can be seen that there is an increasing trend in accidents per ton mined as the age of the pillars increases.

**Figure 2 Graph showing trend of accident rate against age of workings in pillar extraction panels where fall of ground accidents occurred**

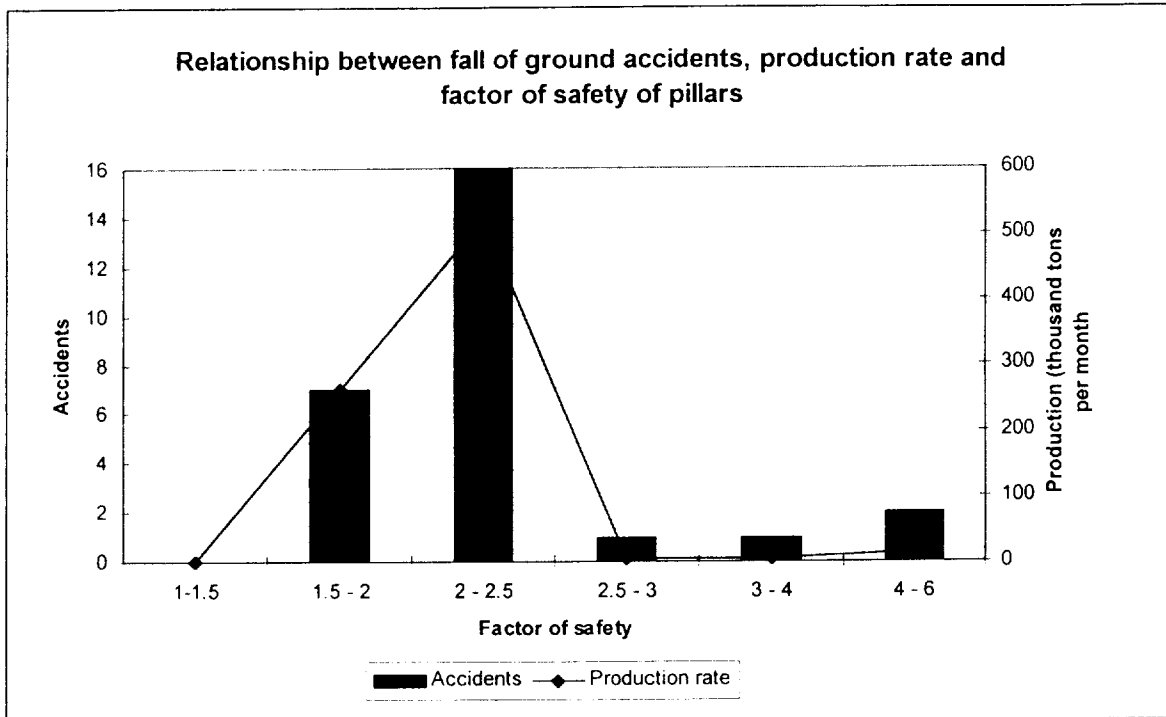
The statistics presented in table 2 are shown graphically in figure 3. It can be seen that the accident frequency does not relate to the factor of safety, but rather to the tons produced. The results rather indicate that most of the tonnage from the pillar extraction panels was mined at factors of safety of between 1,5 and 2,5 which is also the range within which most of the accidents took place. Approximately 85% of the accidents took place at safety factors between 1,5 and 2,5 whilst 97% of the tonnage was produced in this range. Owing to the low number of data points and the different mining conditions, ie low seam and high seam mining, no further analysis of the effect of the factor of safety was carried out.

**Figure 3 Relationship between fall of ground accidents, production and factor of safety in panels where accidents were recorded**

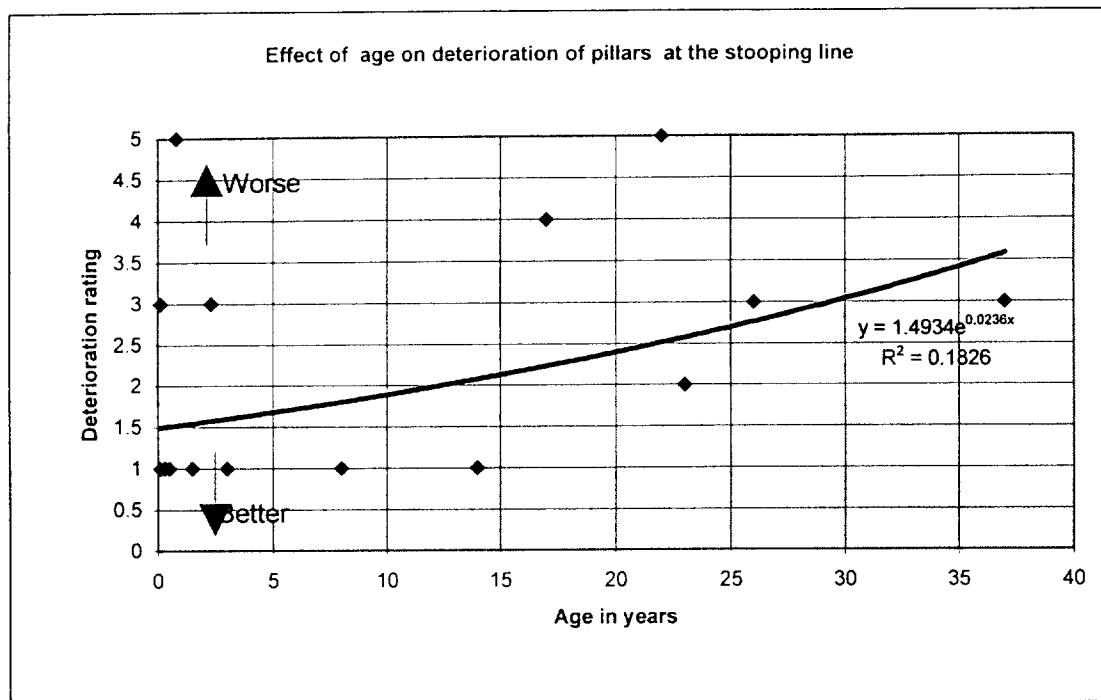
condition at the stooping line. There is a wide scatter of results, but a fitted linear trend line indicates an upward trend (poorer conditions) with age. It can be concluded that age only has a slight influence on the pillar rating away from the goaf line. Near the goaf line the older

pillars appears to be scaling slightly more than newer pillars with the same safety factors.

Figure 4 Effect of age on pillar conditions at the stooping line

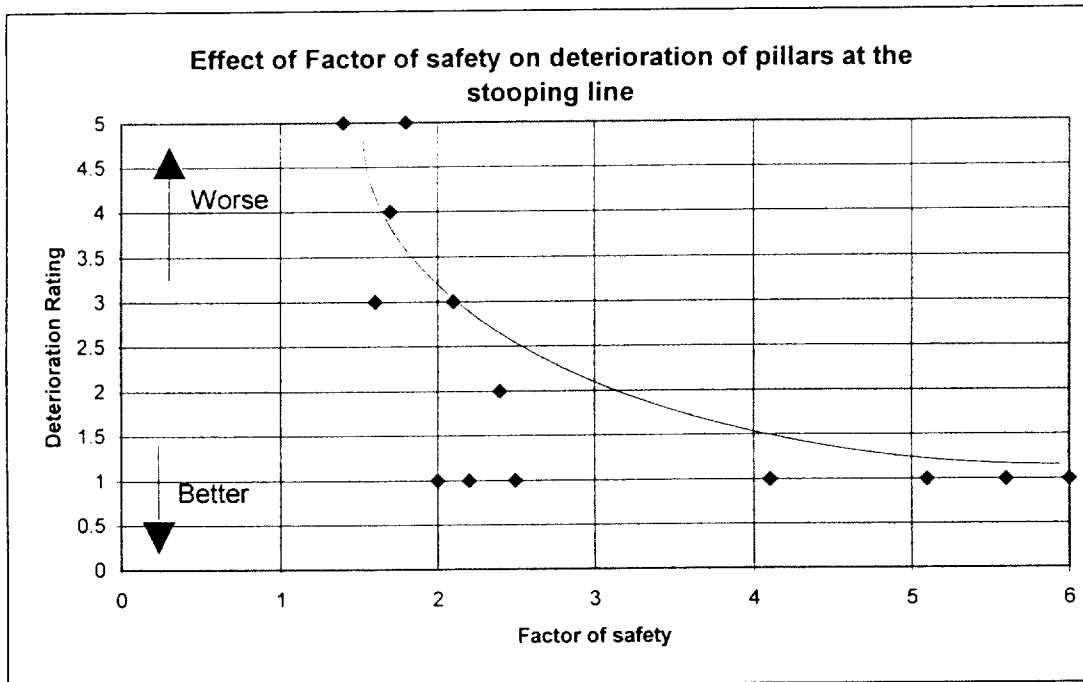
As far as the effect of the safety factor is concerned, the row of pillars next to the stooping line is severely effected when the safety factors are low, as shown in figure 5.

There are two panels of specific interest. Panel number 5 where the age was less than one year and the safety factor is around 1.8. all the pillars deteriorated dramatically as the goaf line moved forward. Close to the barrier pillar the scaling was less severe but towards the

Figure 5 Effect of factor of safety on pillar conditions at stooping line

centre and specifically where there was an apex the scaling of the pillars was very severe. This scaling reduced drastically from the second line of pillars. It in fact became almost zero. The roof conditions remained stable.

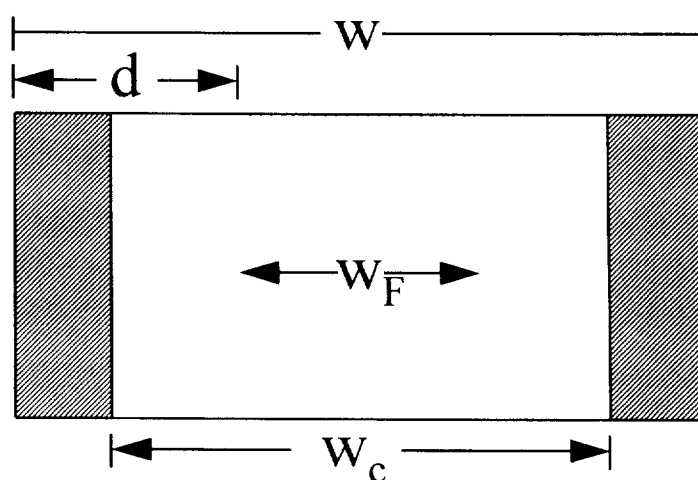
Figure 6. Required Amount of Scaling

Given that  $k$  is 7,2 MPa and that pillar failure will occur when the safety factor is 0,5 the original dimensions were used in equation (1). For Section A1 scaling of 4,166 m from the pillar was required. Assuming a linear rate of scaling of 0,069 m/yr, based on the increase in bord width during the period 1982 to 1996, pillar failure could occur in approximately 60 years from the time of the formation of pillars, as this was 19 years ago failure would be anticipated in about 40 years time.

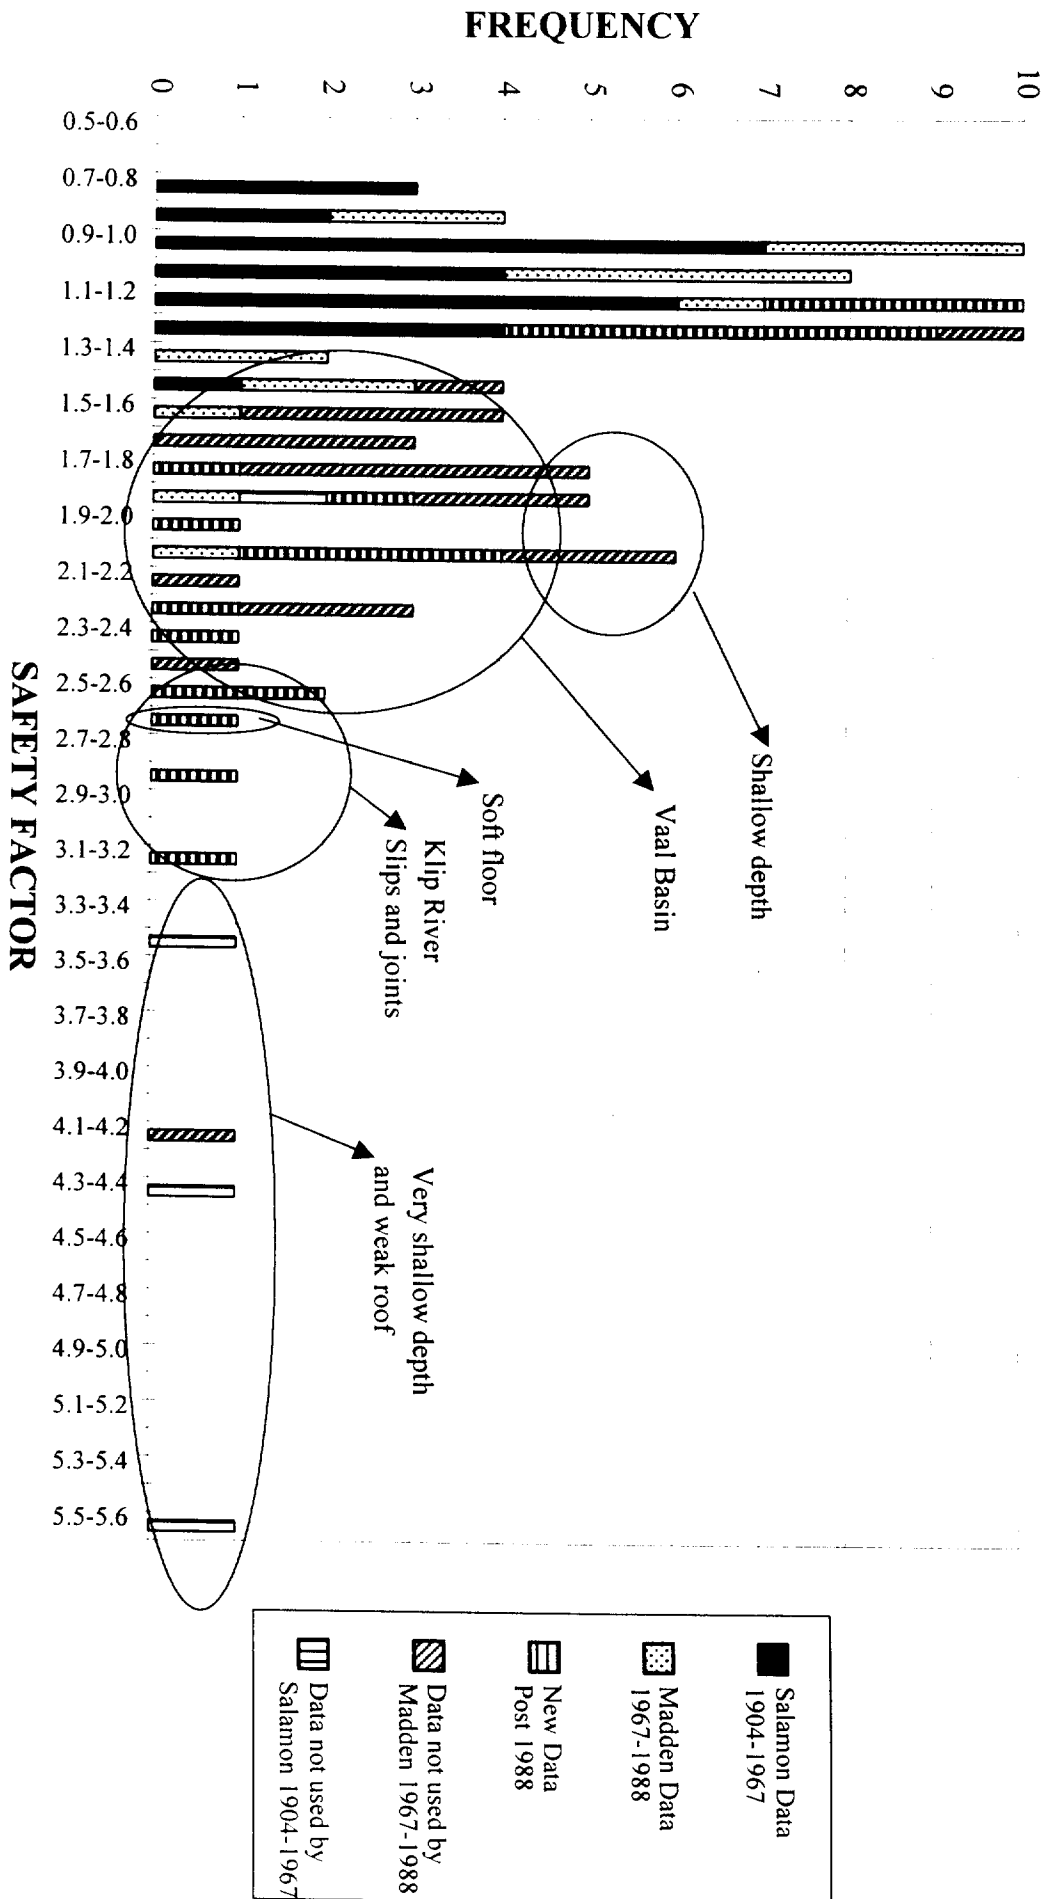
Figure 1. Frequency of Pillar Collapses versus the Design Safety Factor  
 Note: Broad Categories of Possible Reasons for Collapse

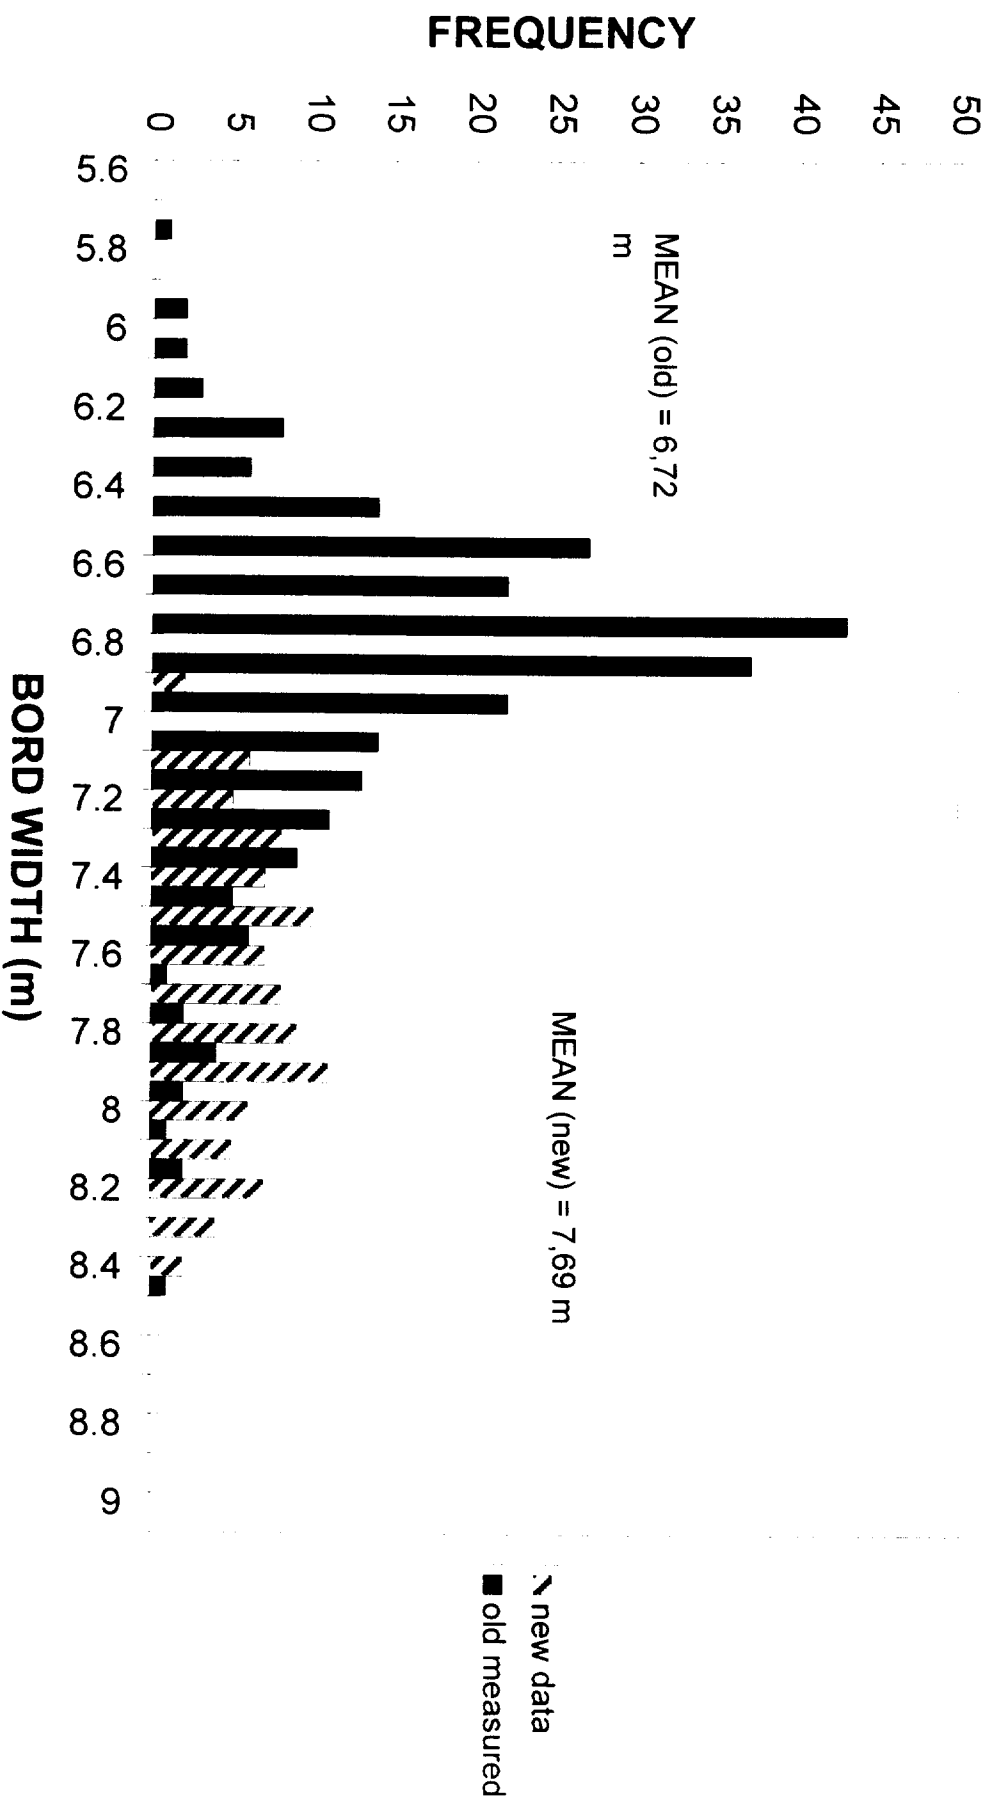
Figure 2. Frequency of Bord Width Measured in Section A1 (Drill and Blast old) 1987 and 1996

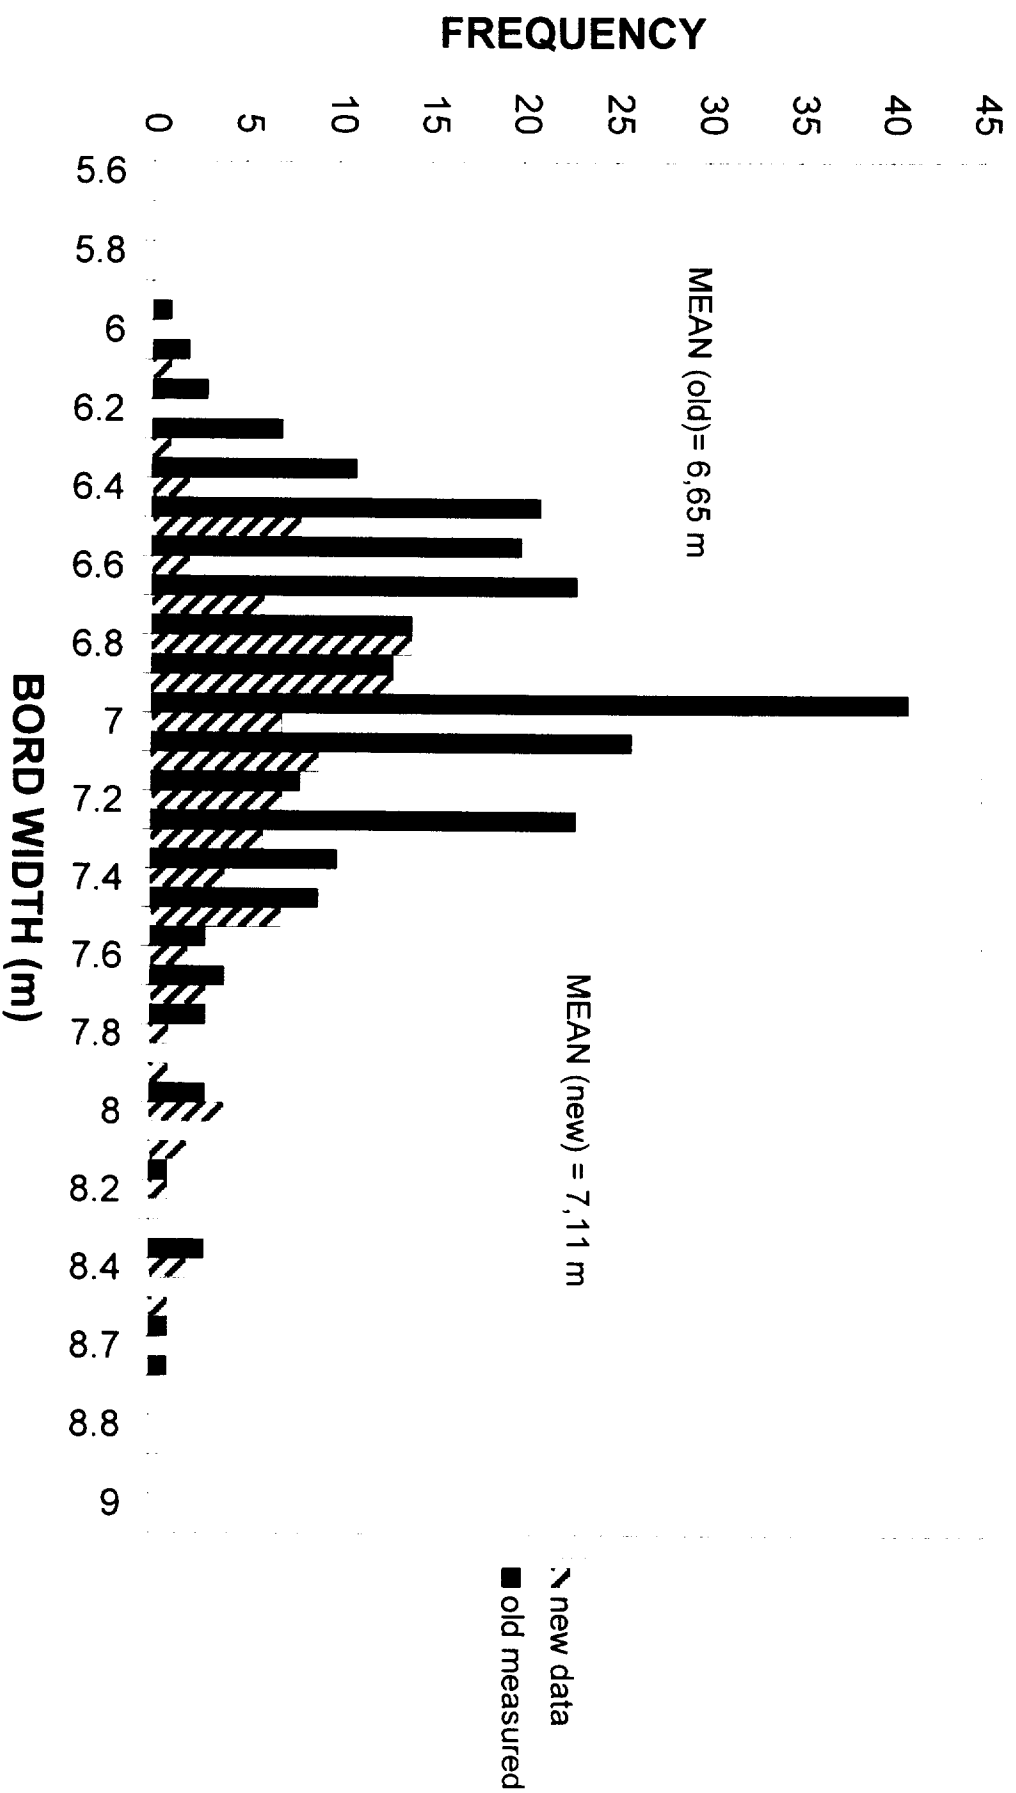
Figure 3. Frequency of Bord Width Measured in Section A12 (CM old) 1987 and 1996

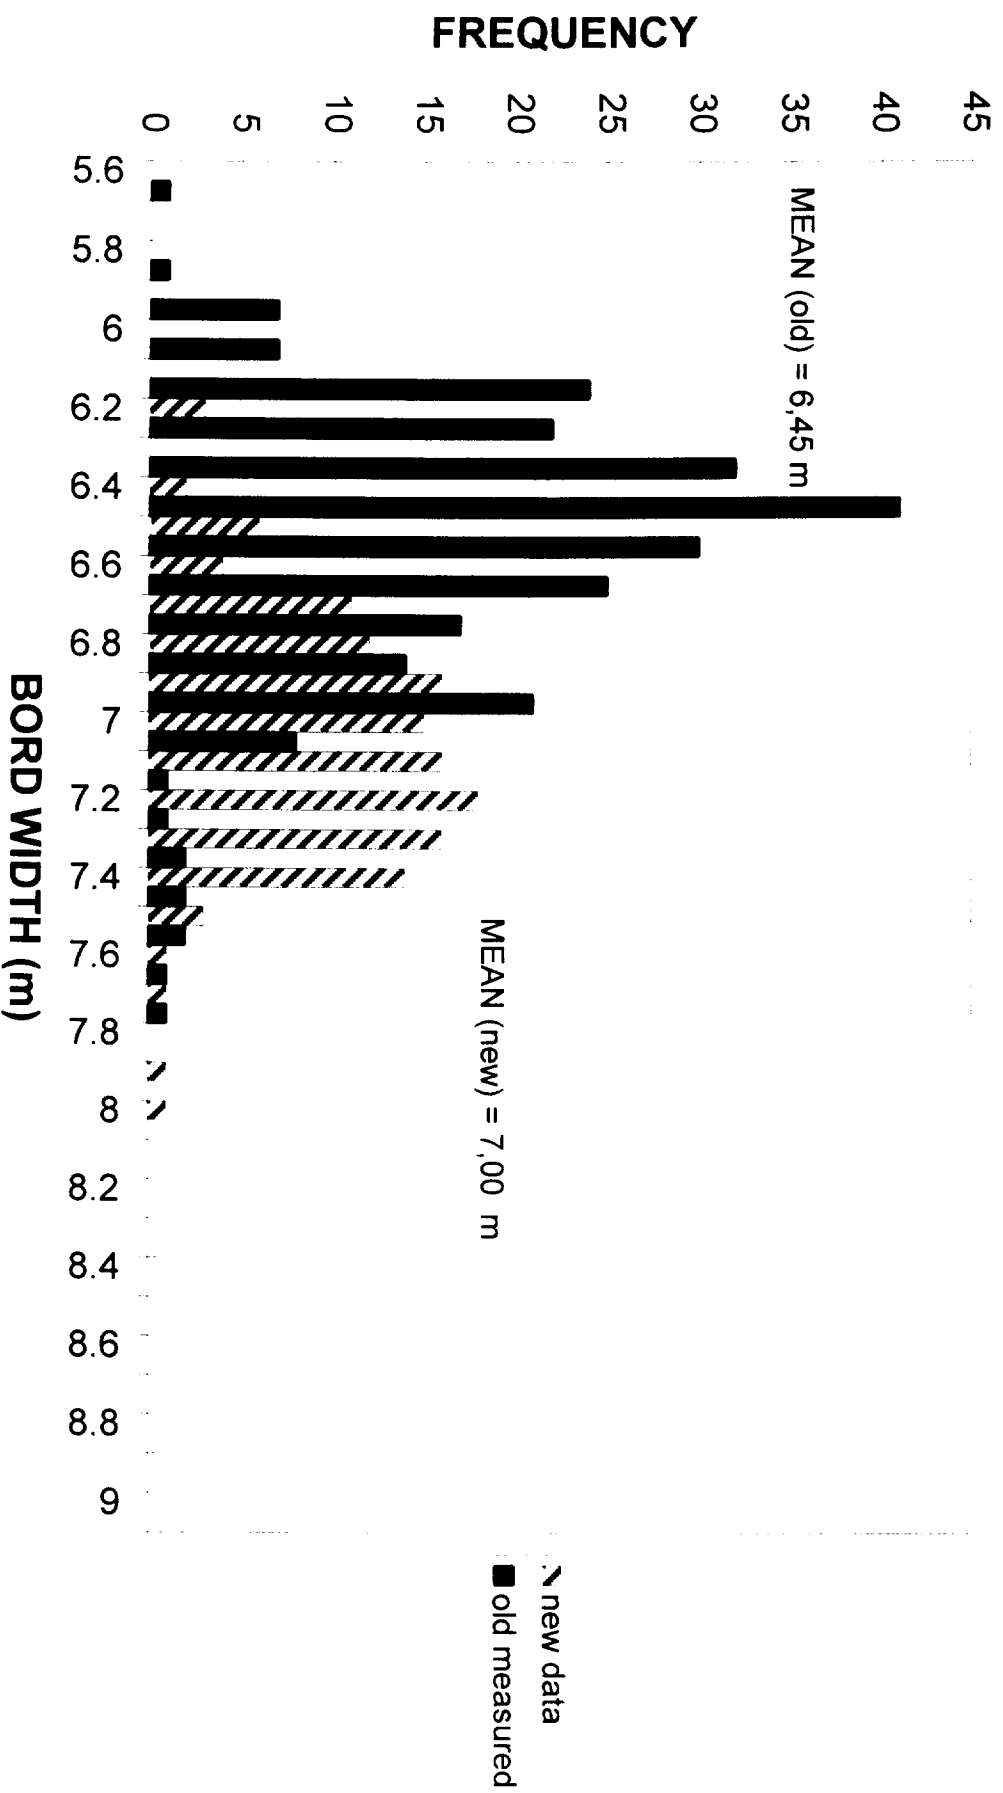
Figure 4. Frequency of Bord Width Measured in Section F17 (Drill and Blast old) 1987 and 1996

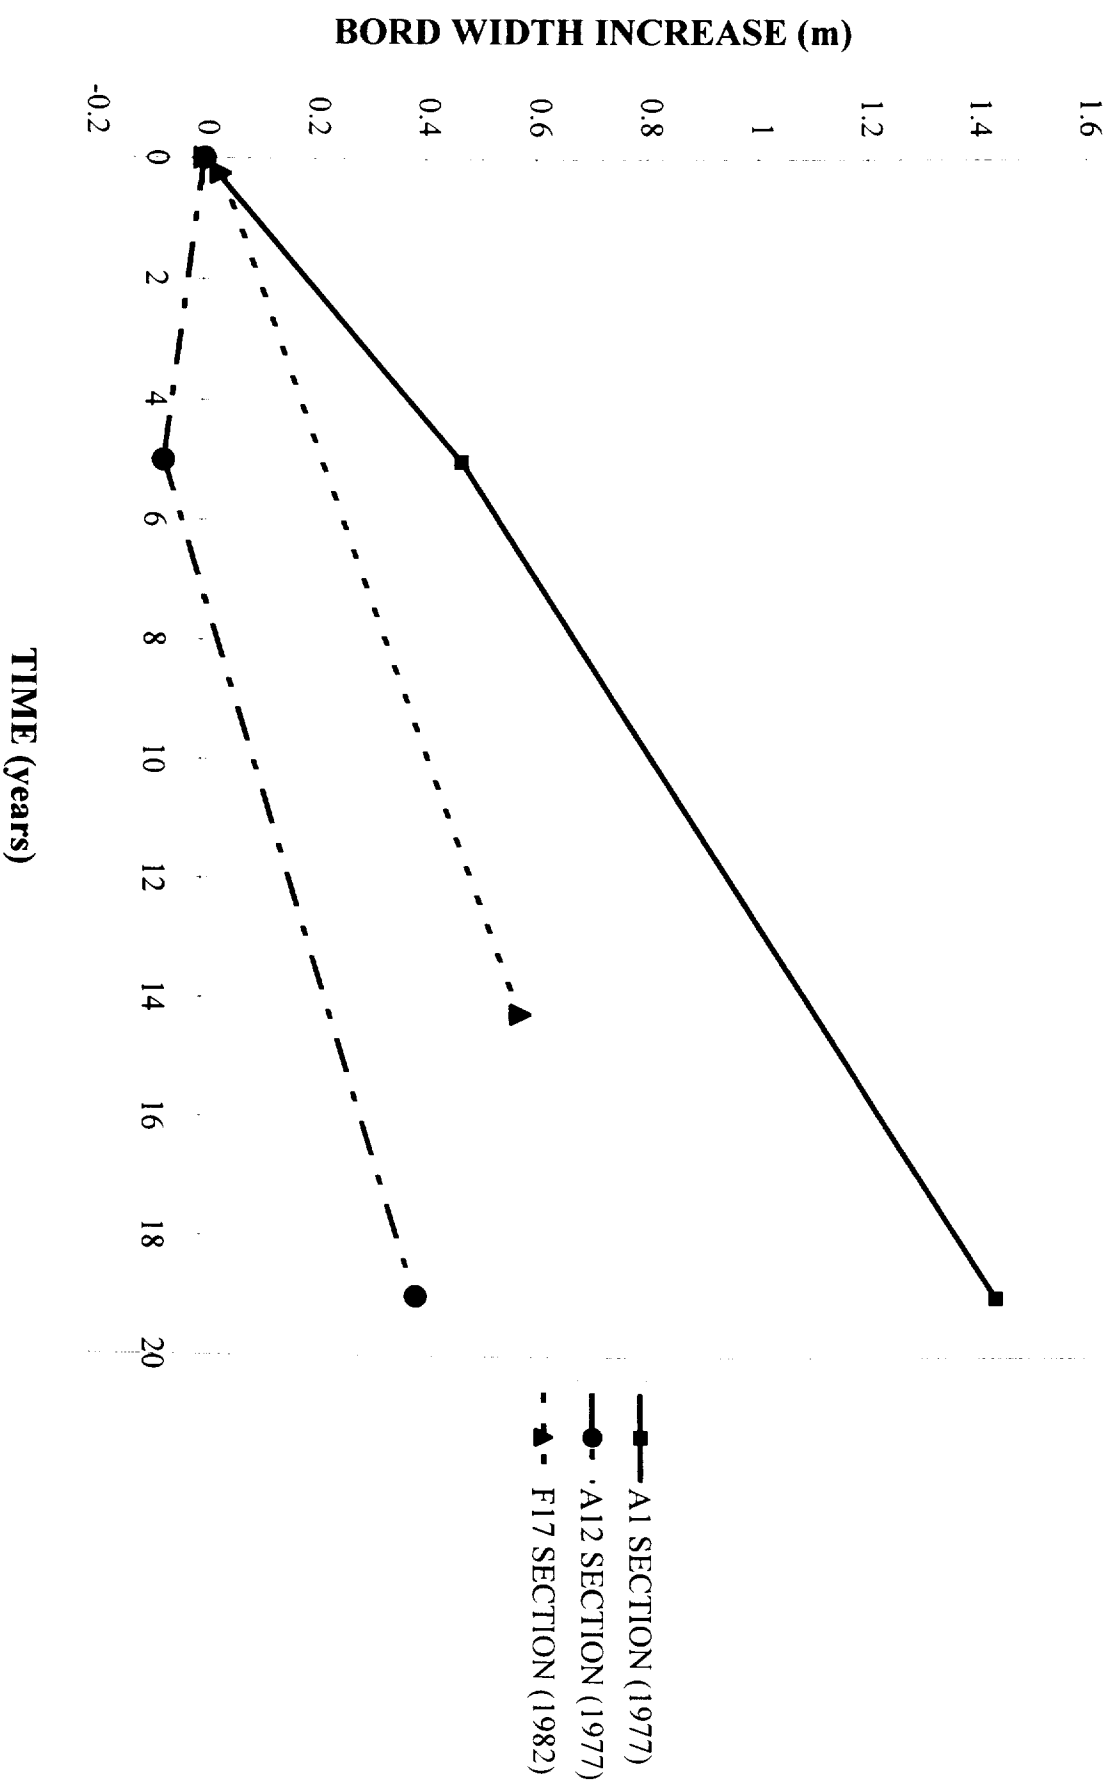
Figure 5. Bord Width Measurements of 1996, 1987 and at the time of Mining Normalized to the same time Since Mining

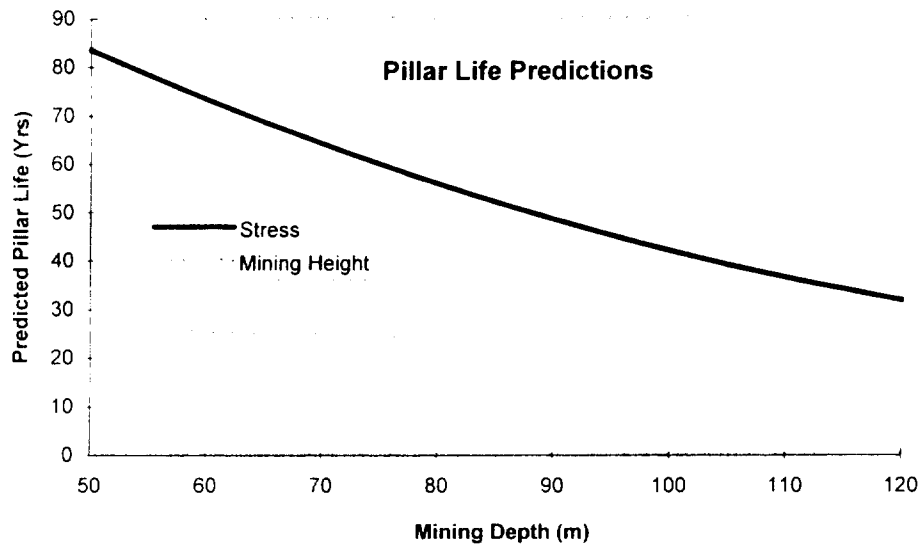
**Conclusion 2 : There have been attempts to predict pillar life. The existing methods are both crude and suspect, but it has at least been shown that the possibility to enter this field exists. It is not impossible to do this work.**

Figure 1. Comparison of two methods to predict the life of pillar mining systems
