Engineering Failure Analysis 8 (2001) 145–156

## Pump impeller failures — a compendium of case studies

A. van Bennekom<sup>a,\*</sup>, F. Berndt<sup>b</sup>, M.N. Rassool<sup>a</sup>

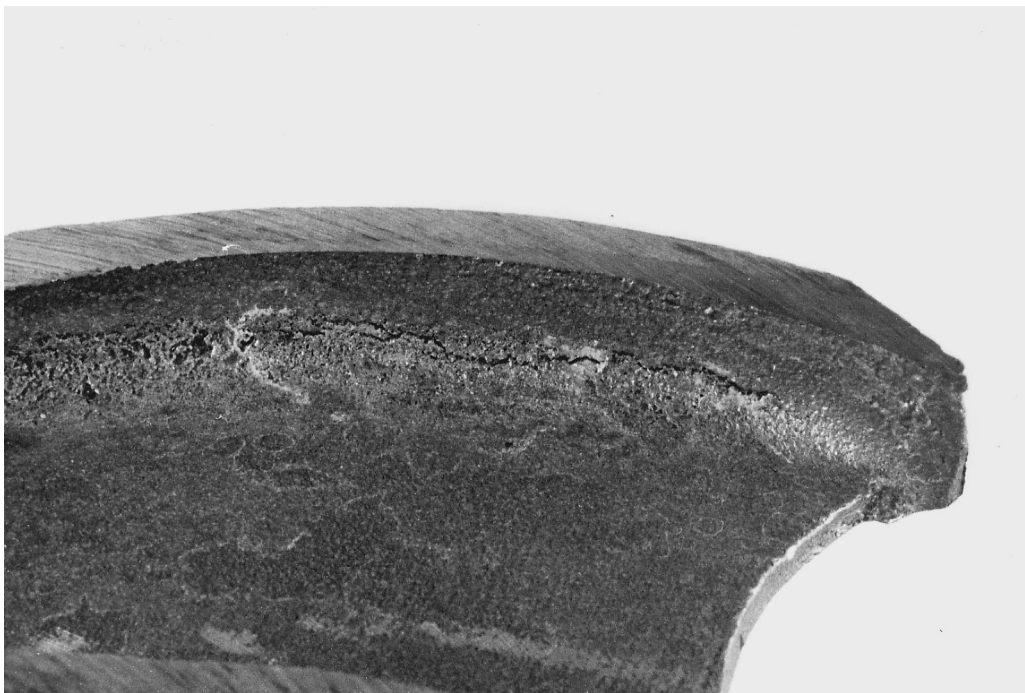
This CF-8M (cast equivalent of type 316 stainless steel) impeller, which was used to pump a nickel sulphate solution, fragmented after only a few hours in service. The failure of this impeller resulted in a significant financial loss due to subsequent damage and loss of production. On removal of the impeller, it was noted that some 'pitting' and slight cracking was evident along the interface between the web and flange of the impeller (see Fig. 1). The plant personnel assumed the failure to be due to pitting corrosion in the nickel sulphate solution, but this was obviously not the case since the previous impeller, which was also made from CF-8M stainless steel, operated for several years without pitting being observed. Also, pitting would not be expected to occur this rapidly.

Fig. 1. 'Pitting' and cracking at the junction between web and flange of a cast 316 type stainless steel impeller.

It can thus be seen that this failure was due to insufficient feeding of the casting with molten metal during the solidification process. This failure could have been avoided if additional runners and risers

had been used in the casting. It is also evident that a lack of quality control at the foundry that cast this impeller allowed the impeller to be dispatched and subsequently be installed in the pump where it failed.

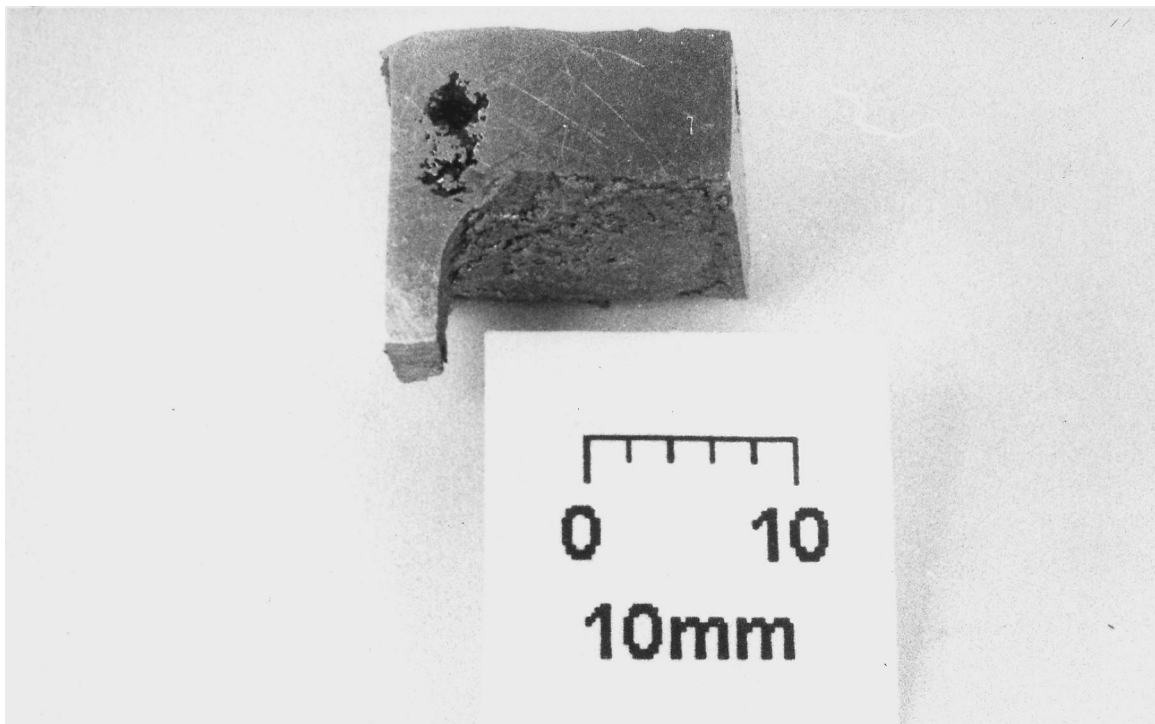
When a portion of the impeller, which was sectioned through the cracked and pitted region, was prepared for metallographic examination by grinding and polishing a transverse section, extensive porosity was observed. The extent and location of this porosity is evident in the photograph in Fig. 2. From the location and morphology of the porosity it is clear that this defect has been caused by shrinkage porosity during solidification of the casting. Unfortunately, this defect is located in the most highly stressed portion of the impeller and it is thus not surprising that the impeller fragmented after only a short time in service.

When a metal solidifies from the molten state, in a casting for instance, the volume of the metal decreases and unless steps are taken to ensure that this shrinkage is compensated for by feeding the casting with more liquid metal, shrinkage porosity will result. The resultant shrinkage porosity is usually located at the last region to solidify and appears as an irregularly shaped cavity within the casting.

Fig. 2. Porosity on a cross section from the cracked region of Fig. 1.

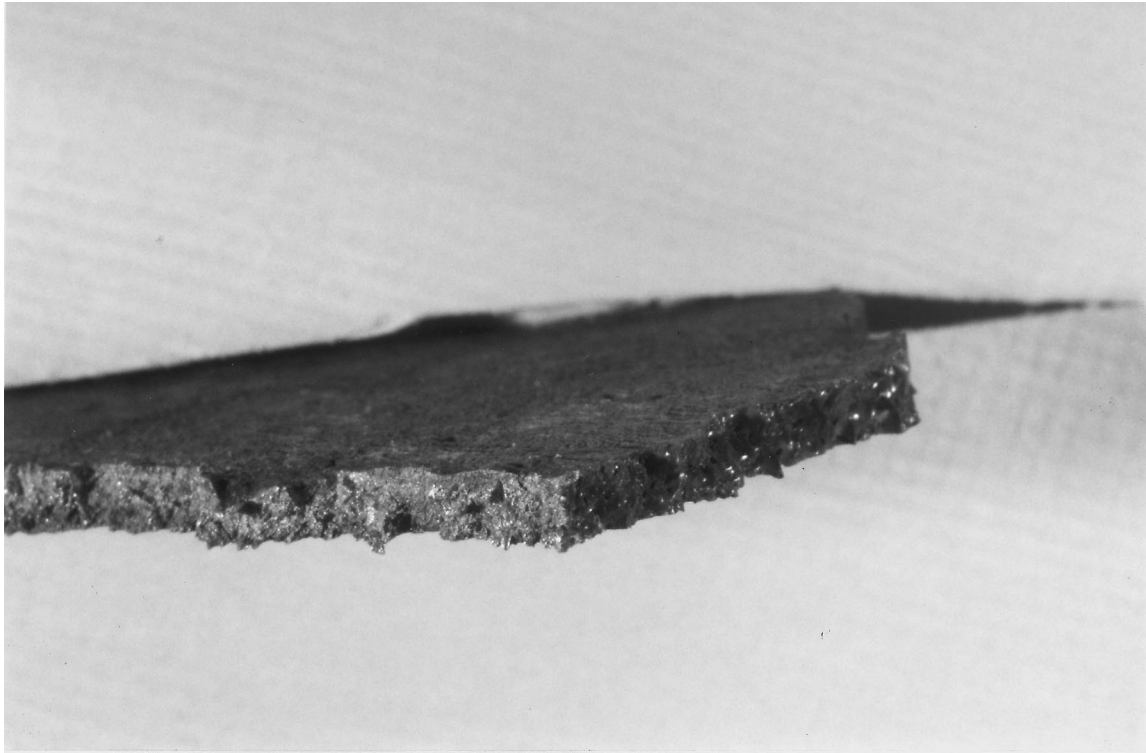
A bronze impeller was installed in a pump, but on start-up a significant amount of vibration was observed followed by fragmentation of the impeller a few minutes later. When the fragments of the impeller were examined, a blue oxide layer was observed on some of the fracture surfaces, showing that the impeller in question had failed due to the presence of a pre-existing crack.

The presence of this blue oxide layer on the fracture surface shows that the crack must have formed during solidification of the casting since a glossy blue oxide of this type only forms at high temperatures (see Fig. 4). The intriguing part about this failure is that the defect, which measures at least 6 cm in length, was not detected by either the manufacturer or the technicians who installed the impeller. This failure thus shows us that pump impellers should be visually examined for defects before they are installed into a pump.

Fig. 4. Blue oxide layer on the fracture surface of a bronze impeller.

that the failures have very little to do with the operational conditions of the pump. Apart from performing a visual examination of the impeller before installation and ensuring that the supplier adheres to stringent quality control checks, there is very little that a pump operator can do to avoid failure as a result of the presence of metallurgical defects.

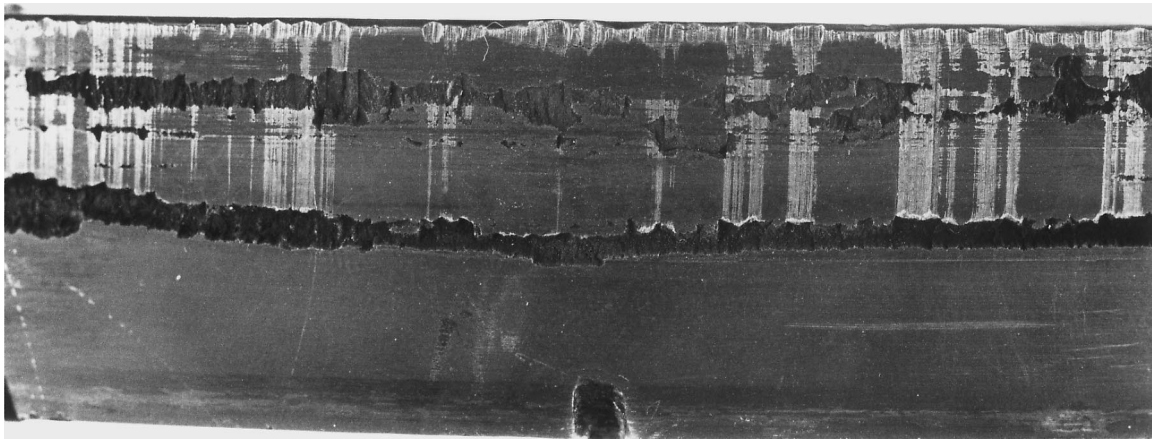
This case study is concerned with the failure of a stellite coating on an impeller wear ring. The problem manifested itself when severe vibration was detected on a pump in which a new stainless steel impeller had just been installed. This vibration was found to become steadily worse until the pump was stopped. The impeller was removed to determine the cause of the vibration. On removal of the impeller, it was noted that the wear ring had suffered from extensive galling damage (see Fig. 5). Examination of the wear ring showed that it had been stellite-coated. The reason for coating the wear ring with a stellite coating is to prevent or minimise the amount of galling damage that would usually occur between two stainless steel surfaces. As a general rule the coating that is used should be at least 50–60 Brinell hardness units higher than the hardness of the stainless steel.

Fig. 5. Galling damage to a stellite-coated wear ring.

dependent on the operating stresses and type of coating, disbonding and spalling of the coating will occur resulting in the damage observed in Fig. 5.

The specification of a Ni based, self-fluxing type of coating applied by powder flame spraying followed by fusing is correct, but it can be seen that some of the spraying parameters were not optimised resulting in an inferior coating. Once again, there is nothing that the operator of the pump could have done to prevent failure of this type other than to insist that proper quality control measures are implemented by the supplier of the pump components.

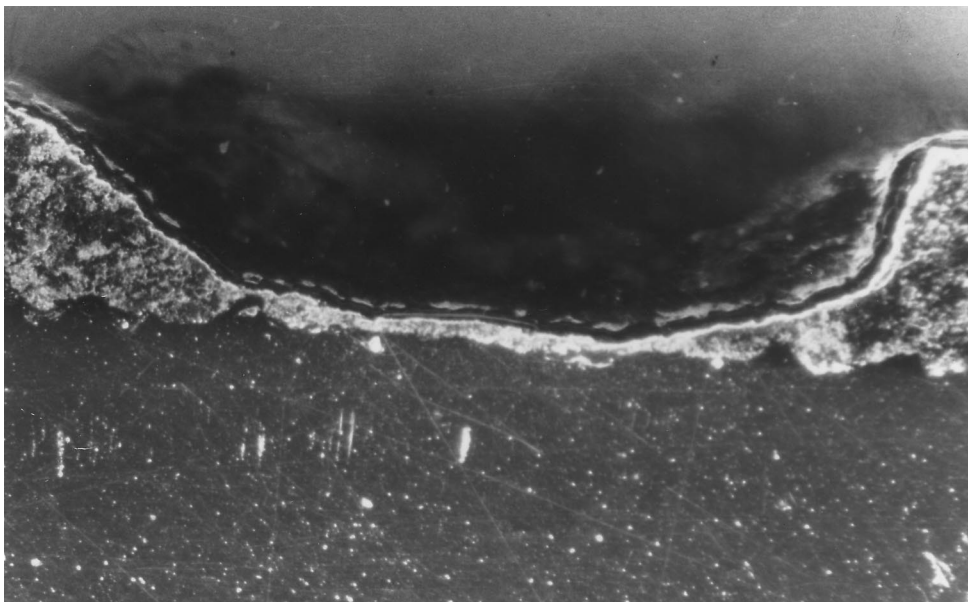
After visual examination of the failed wear ring, it was thought that the stellite coating had spalled off the stainless steel substrate due to inadequate surface preparation prior to thermal spraying of the stellite coating. When the wear ring was sectioned, and prepared for metallographic examination, it was noted that the interface between the coating and the stainless steel substrate was intact and that failure had

occurred within the coating. A micrograph showing that failure occurred within the coating and that some stellite is still adherent to the substrate at the point of coating failure is presented in Fig. 6. It is also clear from this micrograph that the stellite coating contains a large amount of porosity and oxide inclusions. When the amount of porosity and oxide inclusions reaches a certain critical value, which is

Fig. 6. Failure of stellite coating in wear ring of Fig. 5 revealed by metallographic sectioning.

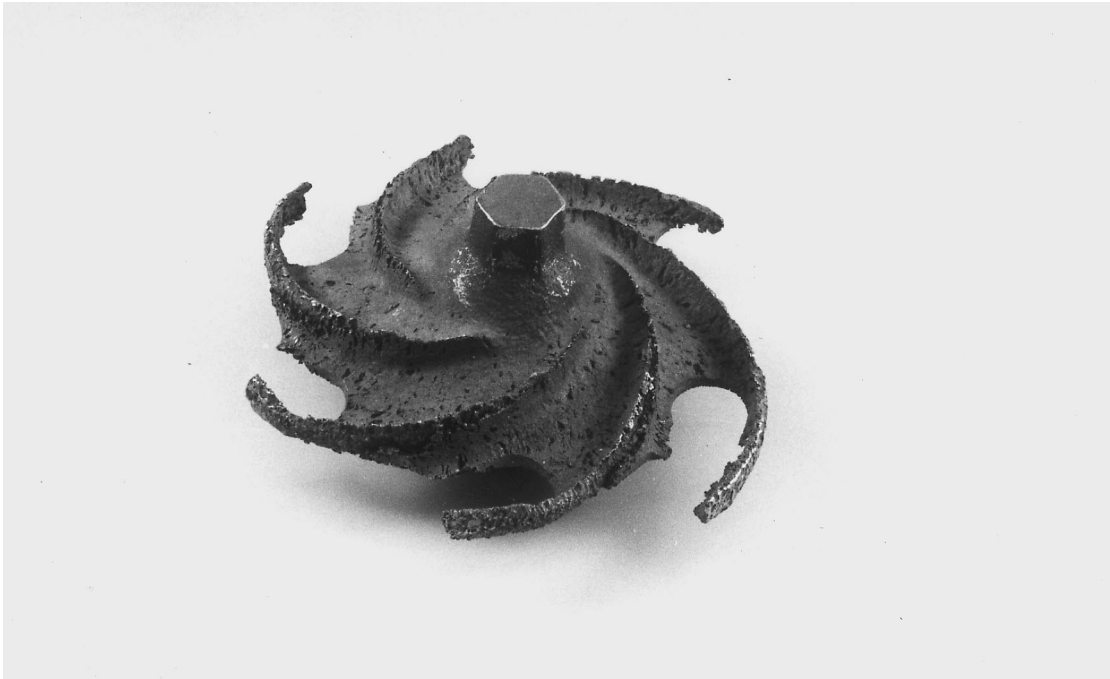
The following case study relates to the failure of a type CF-8M pump impeller by the mechanism of cavitation (see Fig. 7). This impeller was used to pump an acidic (pH 2–3) nickel sulphate solution at a flow rate of between 1300 and 2000 l/min. The acid solution which was at a temperature of 20–30°C, contained some precipitated crystals and had a general composition of: 6–10 g/l H<sub>2</sub>SO<sub>4</sub>, 500 g/l (NH<sub>4</sub>)<sub>2</sub>SO<sub>4</sub>, 0.1–0.2 g/l Ni, 0.1–0.2 g/l Co, 0.1–0.2 g/l (Fe + Mn), 50–70 ppm Cl<sup>-</sup> and 2–5 g/l Na.

Fig. 7. Cavitation failure of cast 316 type stainless steel impeller.

- choice of materials
- hard-facing the surface of impellers to resist the effects of implosions
- using rubber or other linings to reflect shock waves without resulting in severe damage
- design to increase the pressure of the system or decrease the turbulence
- using inhibitors to increase vapour pressure of the liquid.

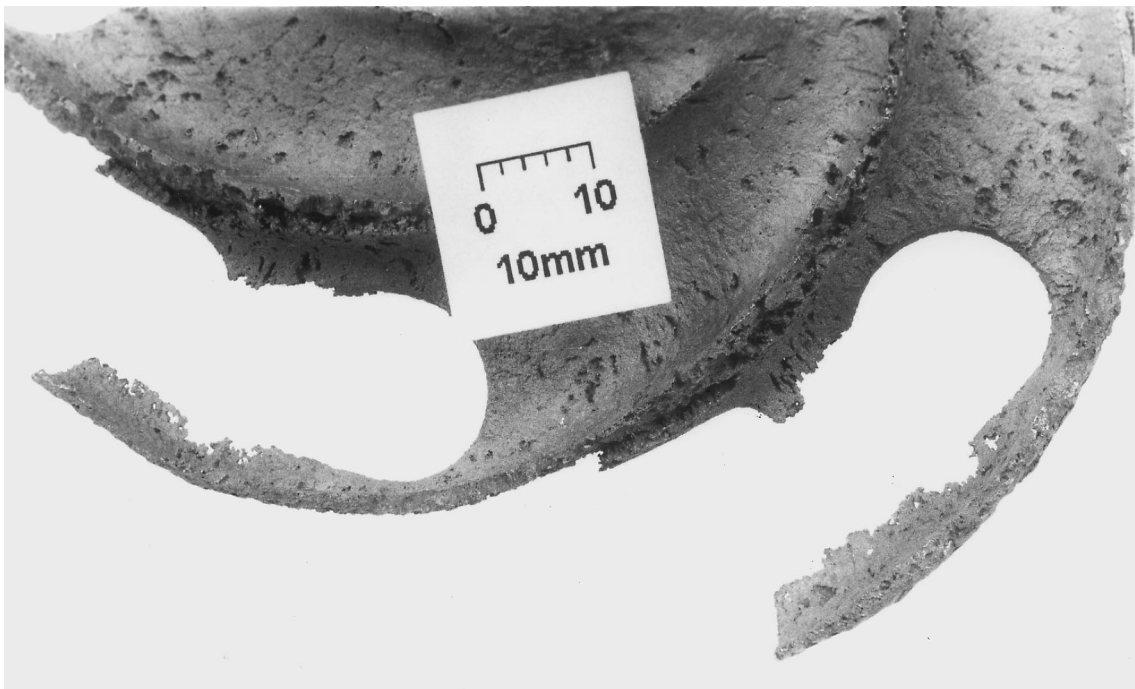
Examination of the impeller showed it to be extensively pitted, with the pitting damage being more severe at some locations than at others, (see Fig. 8). The distribution and appearance of the pits showed that failure was most likely due to cavitation.

Fig. 8. Close-up of impeller of Fig. 7.

When an impeller operates in a corrosive environment, damage as a result of cavitation may be confirmed by the lack of corrosion products on the component's surface since these are removed by the cavitation process. Cavitation is also affected by the amount of entrained air and the presence of solid particles that can act as nucleation sites for cavity formation. In this case no corrosion products were observed on the surface of the impeller, again confirming that cavitation was the cause of failure.

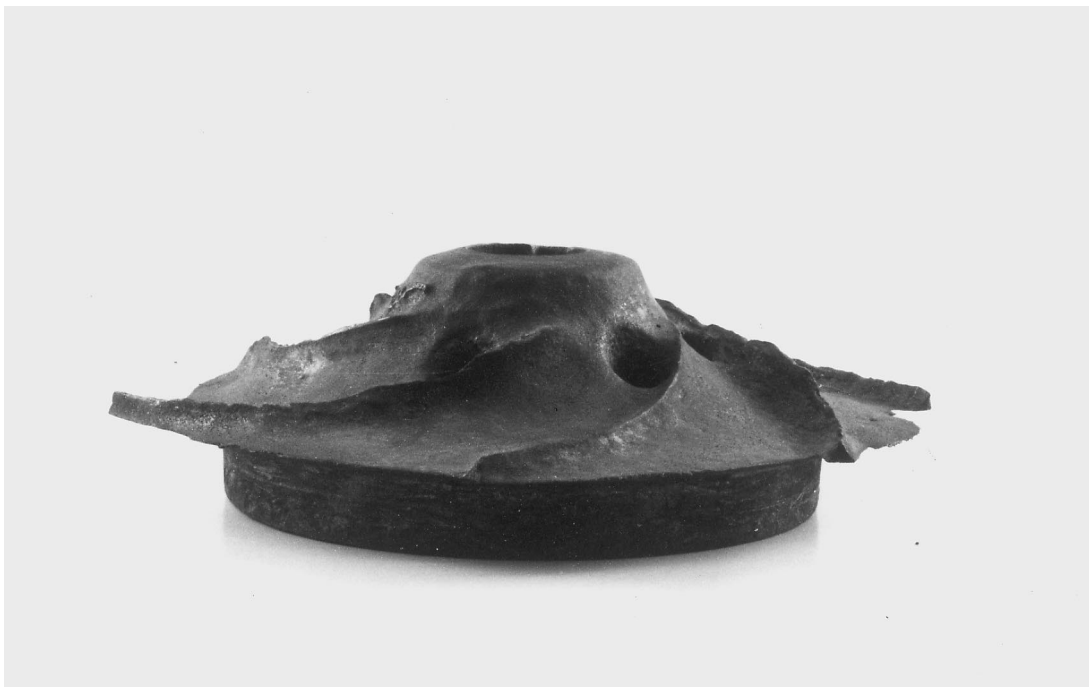
General corrosion of pump components, especially impellers, usually occurs when the incorrect materials have been chosen for the specific application or when the service conditions in which the pump operates have changed. As the name would imply, general corrosion is the name given to the uniform removal of metal from the surface of a metallic component over a period of time. Since the corrosion is uniform, damage of this type manifests itself over a period of time and is usually detected by a gradual decline in pump efficiency. A photograph of a cast-iron pump impeller which has been removed from service due to general corrosion is presented in Fig. 9. It is clear from this photograph that the impeller has become significantly thinned due to general corrosion and that the pump efficiency would also have been unacceptable. This impeller was used to pump relatively low pH waters. Had a stainless steel or bronze impeller been used, no corrosion problems would have been experienced. It should also be noted that recent advances in coating technology have resulted in the formulation of several coatings that can be used to protect pump components by forming a physical barrier between the metal components and the media being pumped.

Fig. 9. General corrosion of a cast-iron impeller.

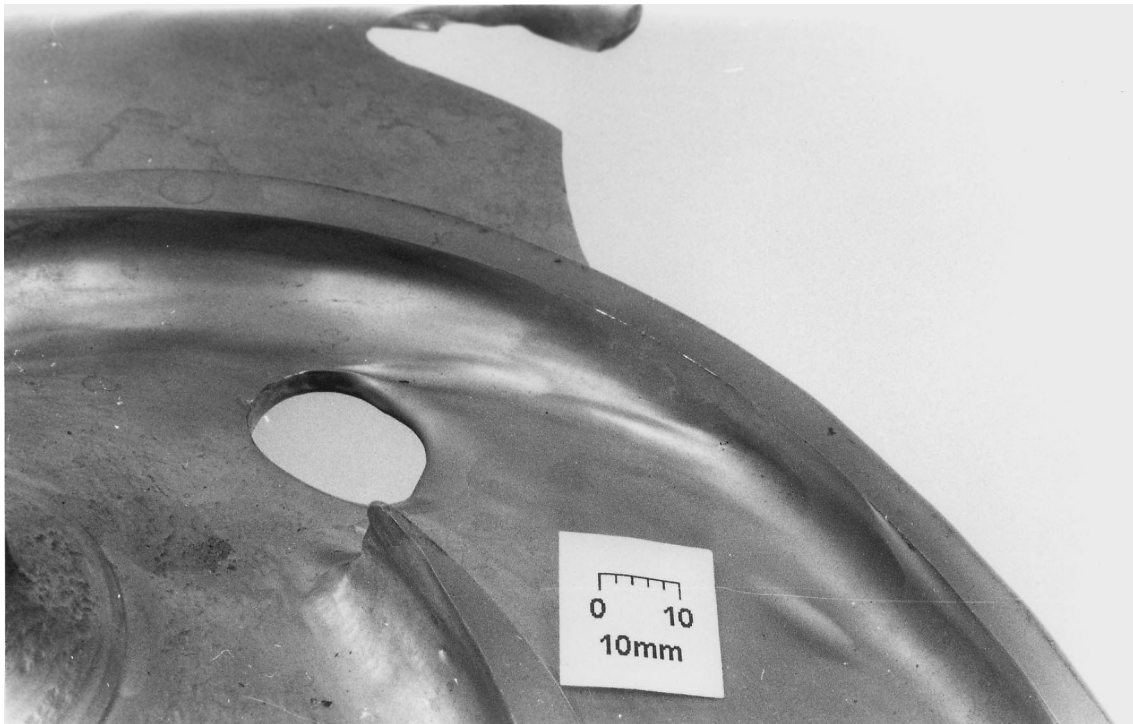
Fig. 10. Erosion–corrosion grooves and depressions on an impeller surface.

Variation in the rate of erosion with the concentration of solids in a slurry appears to follow a definite pattern. This is a linear increase in the rate of material damage with increasing concentration of solids up to a certain level, followed by a much slower rate of increase at higher concentration. Erosion–corrosion is characterised by the presence of grooves, as illustrated in Fig. 10, and holes on the surface of the metal, which usually exhibit a directional pattern.
