EXAMINATION OF A FAILED FIFTH WHEEL COUPLING

P. J. L. FERNANDES

Abstract—Examination of a fifth wheel coupling which had failed in service showed that it had been modified and that the operating handle had been moved from its original design position. This modification completely eliminated the safety device designed to prevent inadvertent opening of the coupling locking mechanism. No alternative safety device was employed to ensure the safety of the modified design. Furthermore, the rubbing plate on the pup-trailer was significantly smaller than that on the fifth wheel, with the result that the load transfer conditions were not optimal. This may have resulted in excessive damage to the wearing components such as the locking jaw, the locking bar and the king pin. © 1998 Elsevier Science Ltd. All rights reserved.

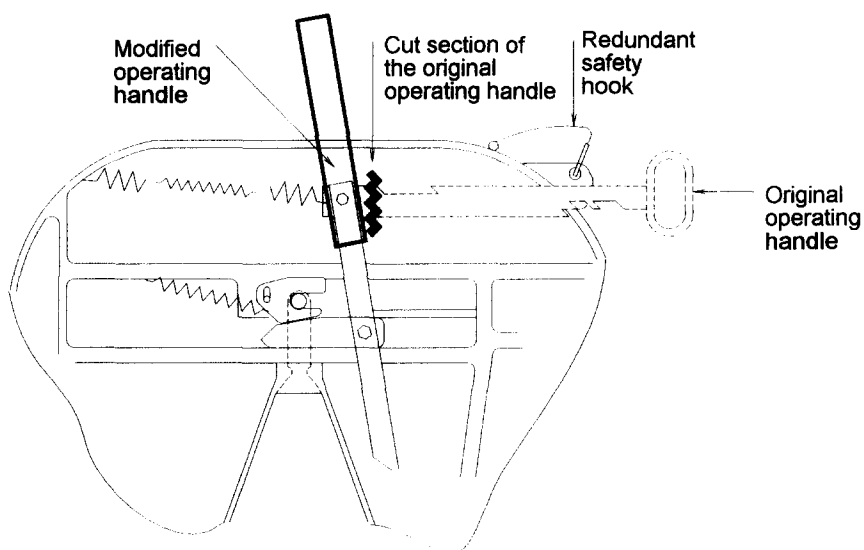
Modified design

and the permissible weight of the articulated unit was 32,000 kg. The diameter of the wheel was approximately 600 mm. Examination of the modified fifth wheel showed that a modification had been made to the operating handle and lever arrangement which controls the locking mechanism. This is shown schematically in Fig. 4. The operating handle which should protrude through the slot in the casing of the fifth wheel (labelled in Fig. 4) had been cut and was instead welded onto and in line with the lever arm.

Furthermore, it is also evident that in the modified condition there was no locking mechanism to prevent the operating handle-lever arm combination from moving and possibly opening the lock jaw during operation. Thus, the spring loaded safety device which had been rendered useless by the modification had not been substituted by a device performing an equivalent function in the modified design. The importance of this safety device was discussed in detail in the previous section, and, as such, this modification can be expected to seriously reduce the safety and integrity of the coupling system.

Fig. 4. A schematic illustration of the modified fifth wheel. The modified operating handle is shown in heavy lines, and the zig-zag line shows where the original operating handle was cut.

The modification made to the operating handle–lever arm arrangement eliminated the spring loaded safety device designed to prevent inadvertent opening of the coupling locking mechanism and no alternative safety device was employed to ensure the safety of the modified design. Furthermore, the area of the rubbing plate on the pup-trailer was significantly smaller than that on the fifth wheel, with the result that abnormally high stresses would be imposed on the locking mechanism. Finally, excessive damage of some wearing components had taken place, and this damage could be due to non-optimum design conditions. As such, the uncoupling of the fifth wheel during operation is believed to be a direct result of the modified configuration of the locking mechanism of the fifth wheel.

This failure illustrates the inherent danger in modifying established and proven designs of safety-critical components. Such modifications should be avoided as far as possible. However, where changes to existing designs are required, a thorough understanding of the component, its mechanics and especially its safety features is essential. Any modifications must be carefully analysed and the safety of the modified design verified.
