TYPE I PITTING OF COPPER TUBES FROM A WATER DISTRIBUTION SYSTEM

PAULO J. L. FERNANDES

Advanced Engineering and Testing Services, MATTEK, CSIR, Private Bag X28, Auckland Park, 2006, South Africa

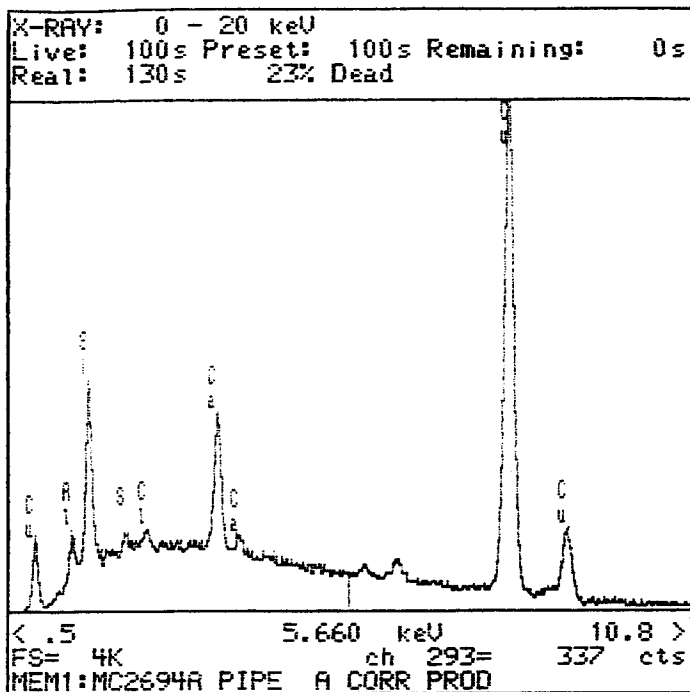
Samples of the tubes were examined in a scanning electron microscope (SEM) equipped with an energy dispersive spectroscopy of X-rays (EDS) facility. The results of the EDS analysis of the greenish-white scale found on the internal surfaces of the tubes are shown in Fig. 4. The large copper

peak originates from the base metal. The large silicon and calcium peaks, and the smaller aluminium peak are due to the presence of these elements in the scale. These elements are readily oxidised and are therefore frequently detected in scale deposits. A minor chloride peak was also detected. This ion is usually associated with pitting attack but the quantity of chloride in this case does not appear to be large.

Fig. 4. The EDS results of the greenish-white deposits found on the internal surfaces of the tubes.
