Safety in Mines Research Advisory Committee

DRAFT FINAL REPORT

**Improvement of worker safety through
the investigation of the site response
to rockbursts**

Research agency : CSIR: Division of Mining Technology

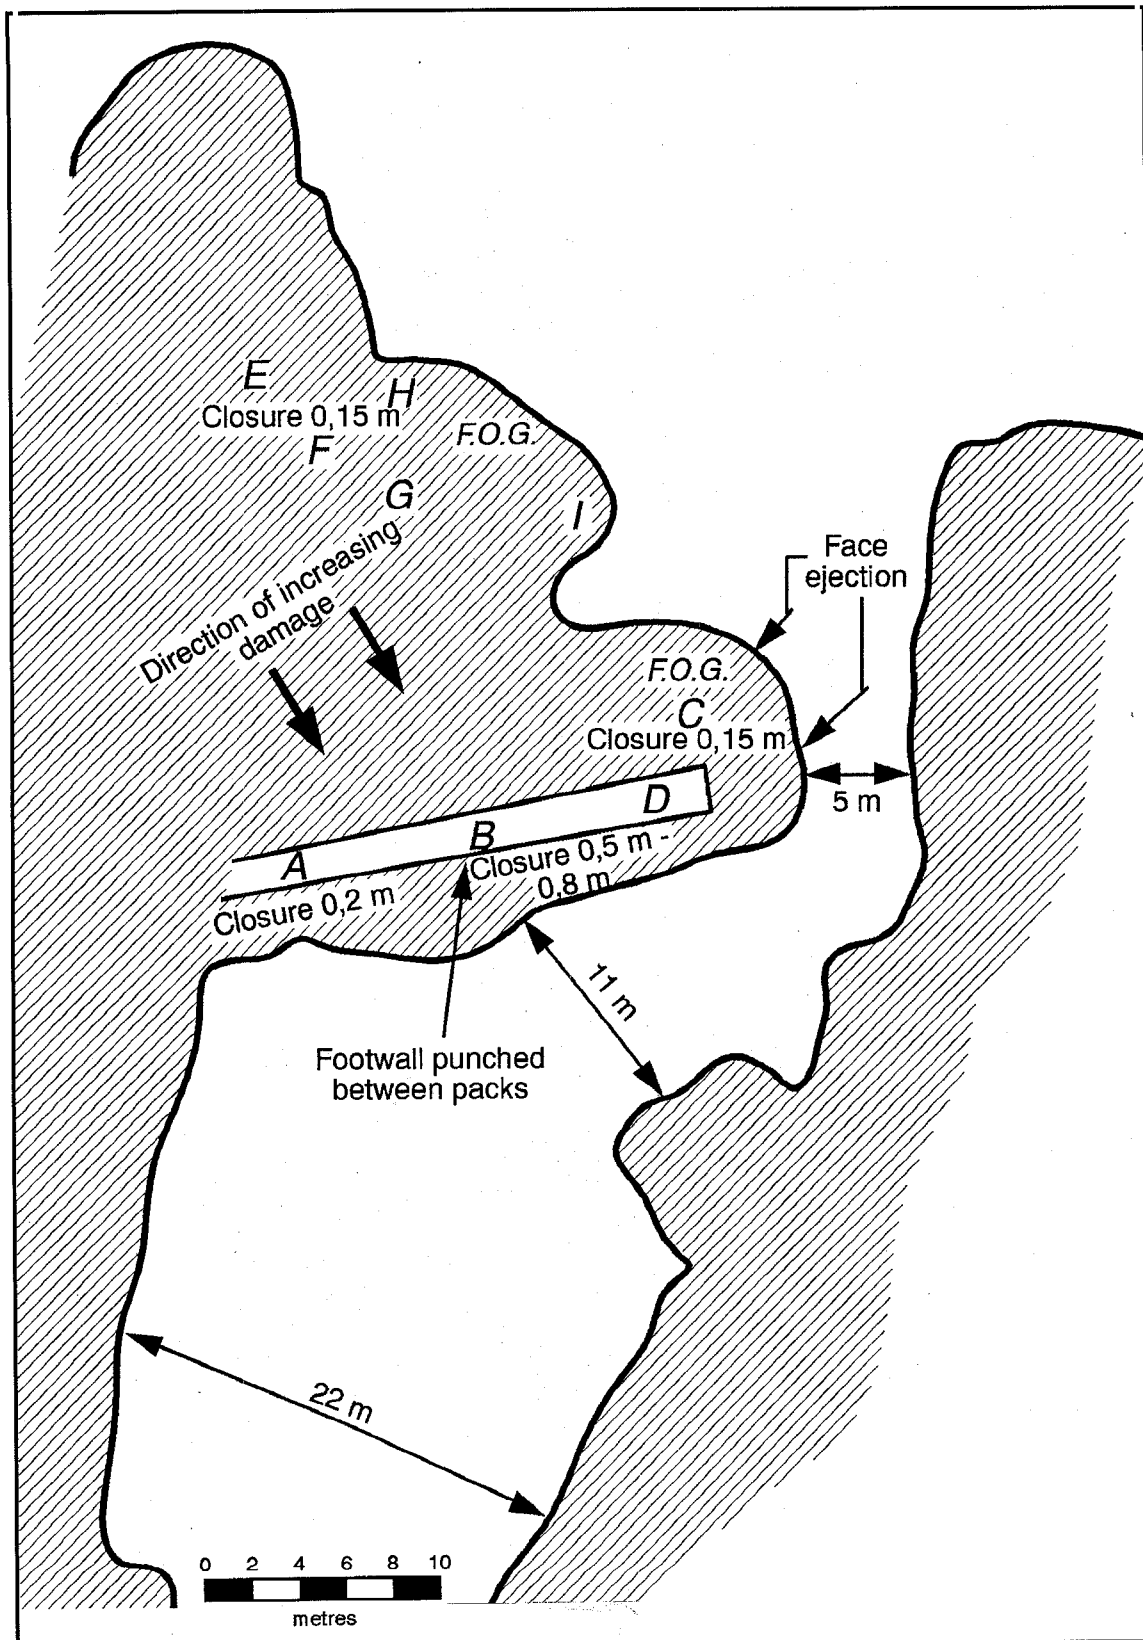
Figure B.3 Plan of the panels damaged by the rockburst, indicating rockburst damage and estimates of co-seismic closure.

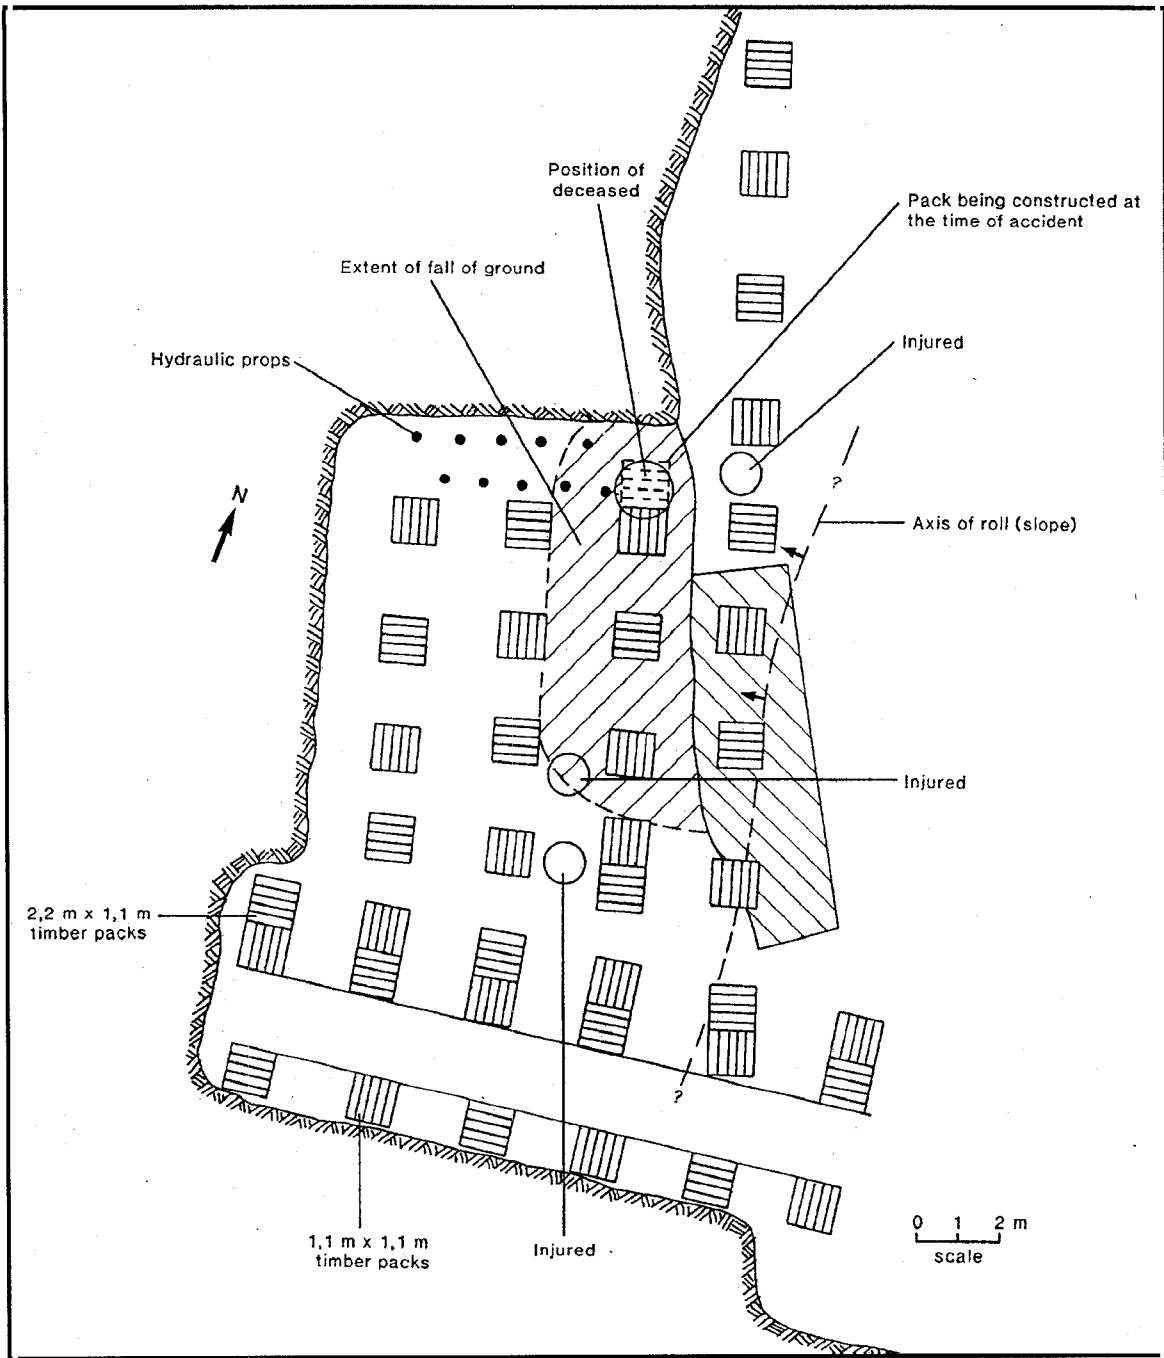
Figure B.6 Plan showing the support installed in the 21-3E VCR 1W Up-dip working place at the time of the rockburst, and the extent of the fall of ground.

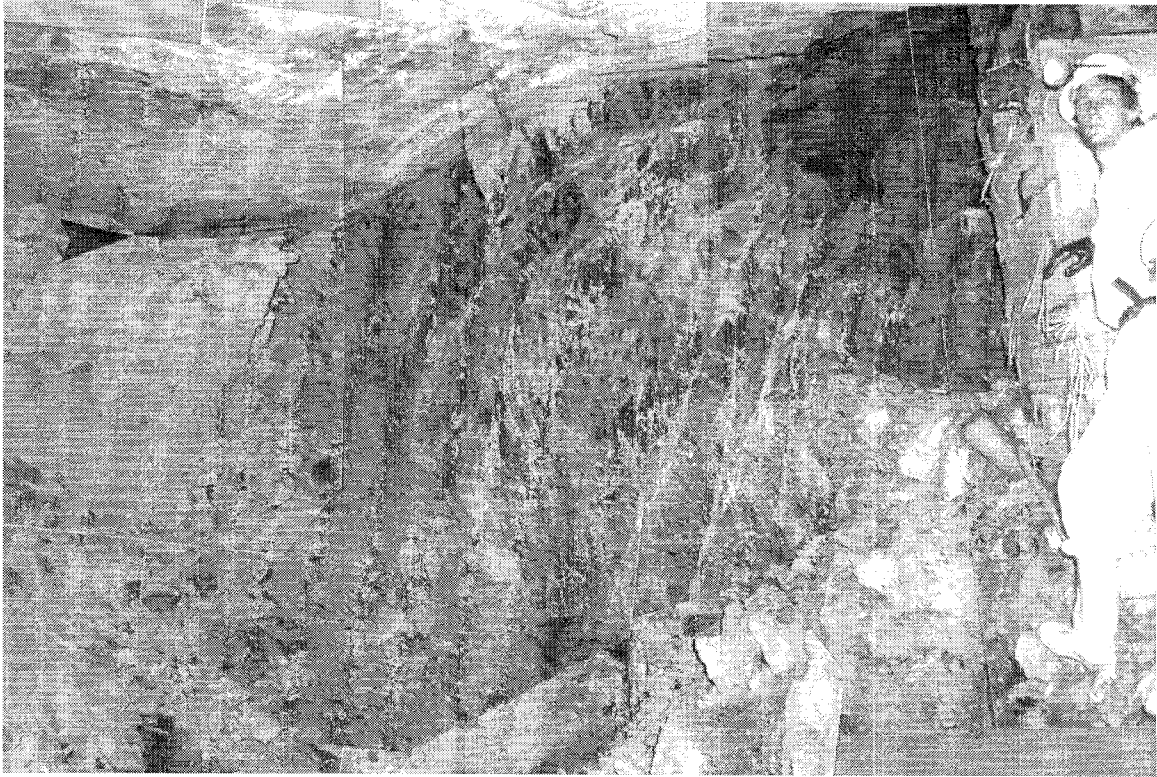
Figure B.9 Photo-mosaic showing the up-dip face where the fatalities occurred, viewed from position H (Figure B.8) and looking up-dip. The timber packs on the right are situated to the east of the roll. The corresponding section is shown in Figure B.7. The hangingwall fragmented during the rockburst. Most of the fallen rock was sub-sequently removed. Note the numerous fractures and joints in the face, and the smooth surface marking the parting above the collapsed brow.

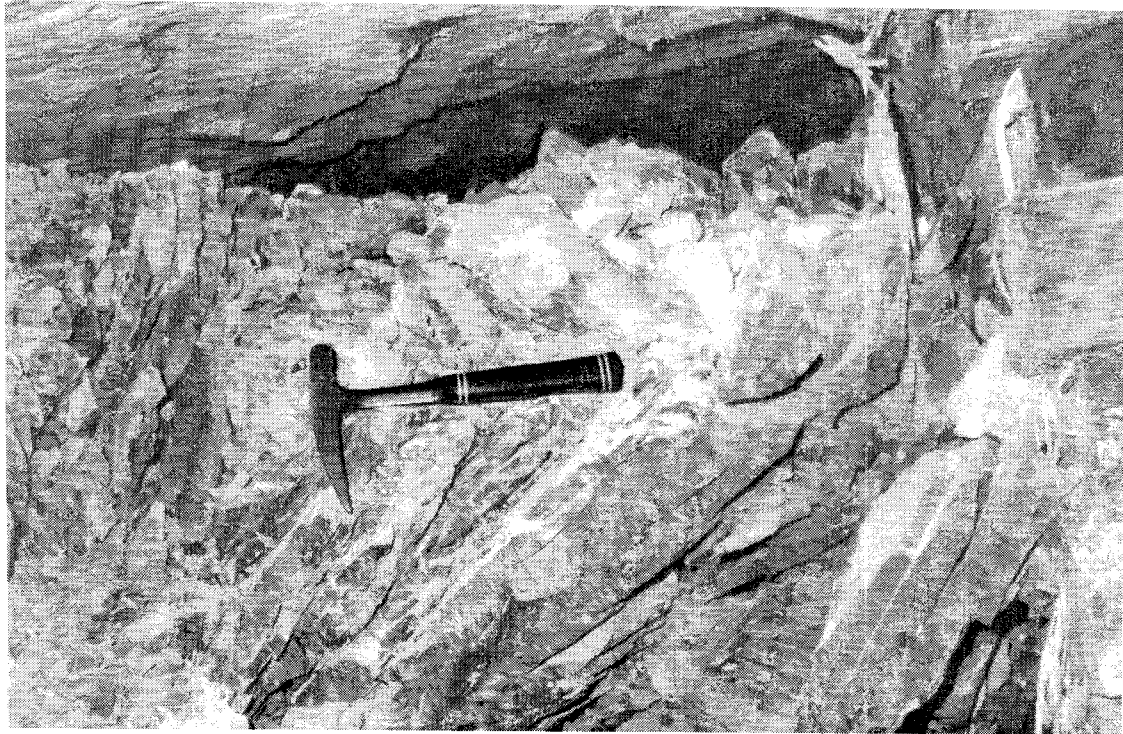
Figure B.10 Rock ejected from the footwall and face between F and G (see Figure B.8) into the space between the original face position and the first dip line of packs. The photograph is taken looking up-dip with the face to the left. Note the intact hangingwall.

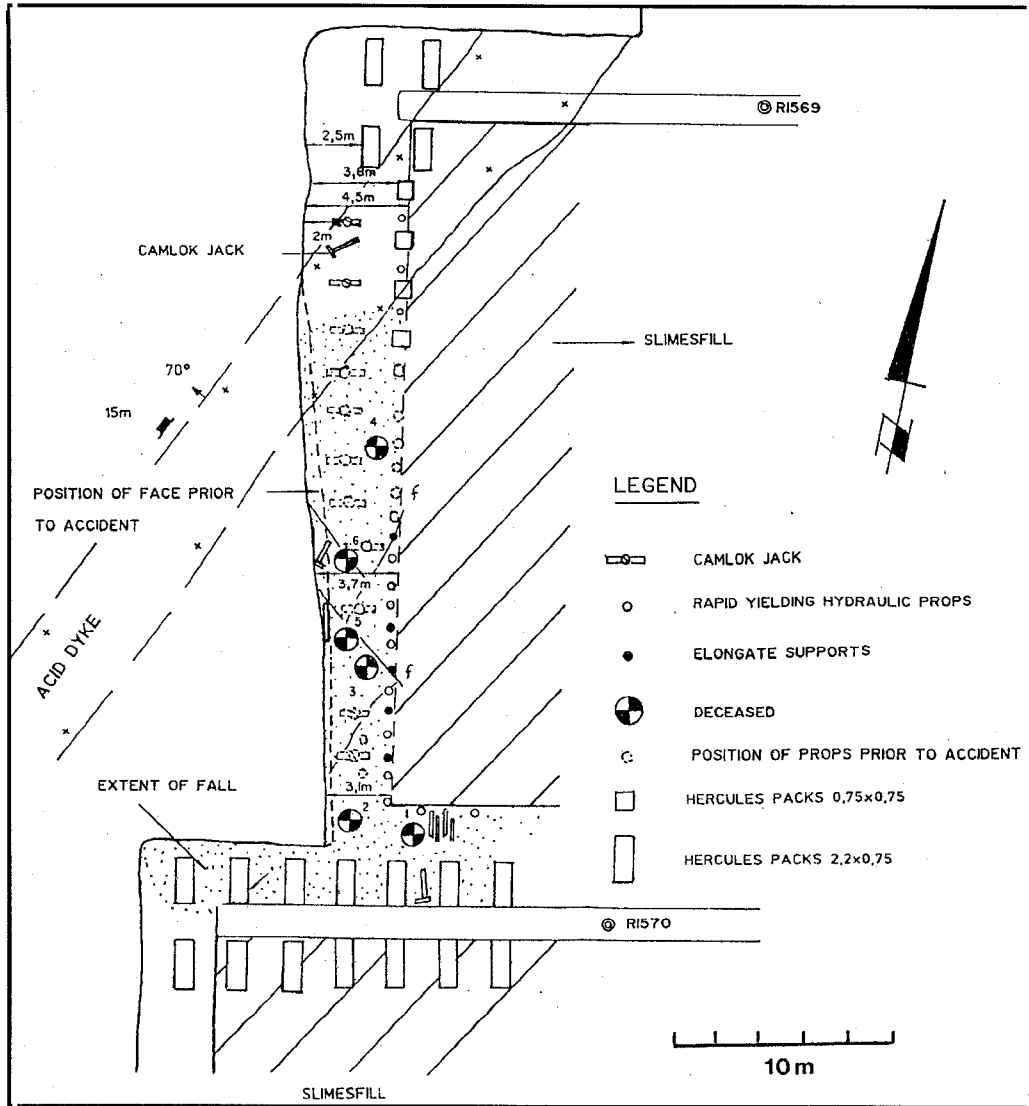
Figure B.15 Plan showing the support in the 113-36 West 3 Carbon Leader panel and the extent of the fall of ground during the rockburst of 3 November 1994.

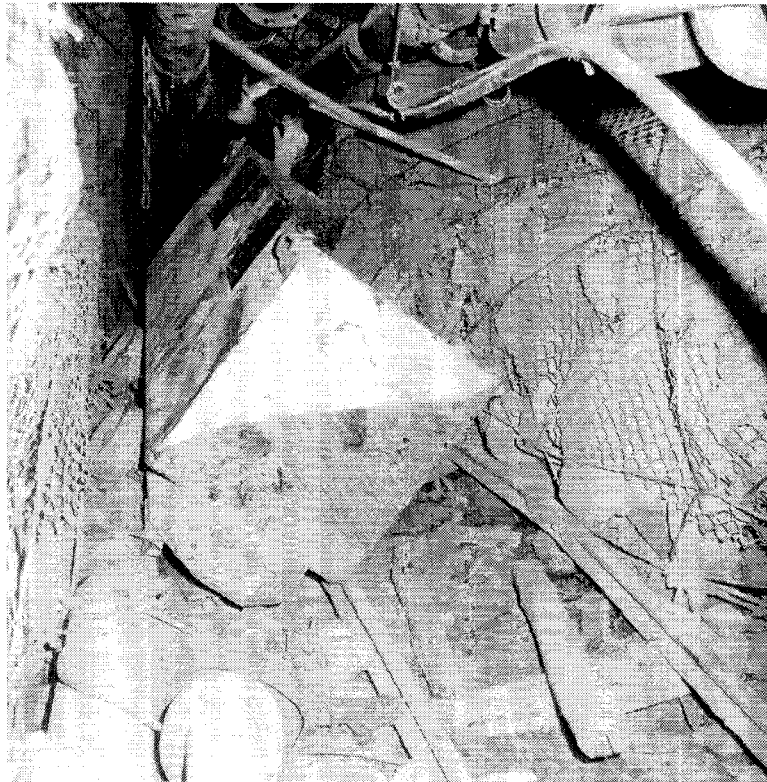
Figure B.19 View north along 24-26 haulages east showing severe damage and deformation of the eastern sidewall of the tunnel. Note displacement of tracks (bottom right) and material rail car.

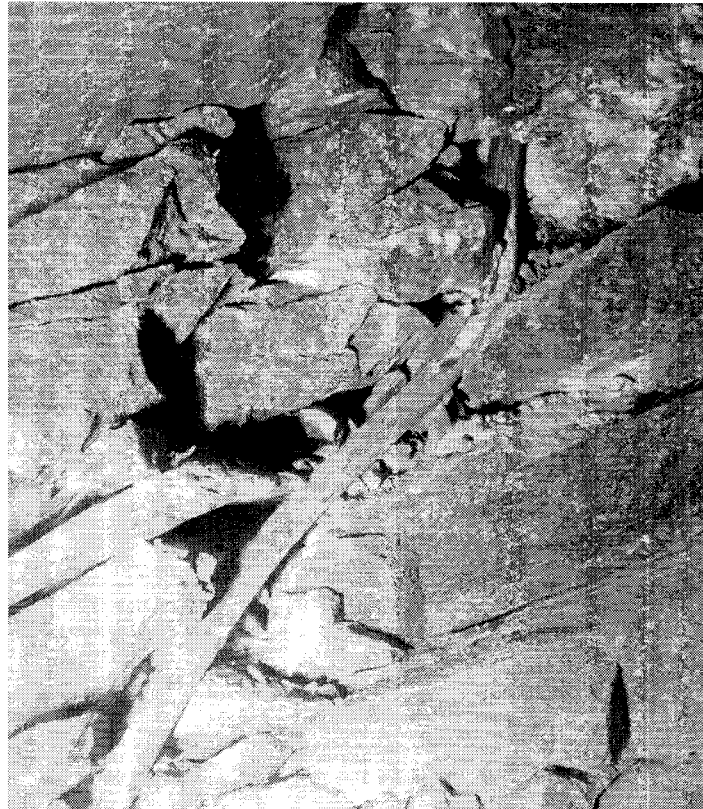
Figure B.20 Shear deformation of smooth bar rock bolt in upper east sidewall of 24-26 haulages east.

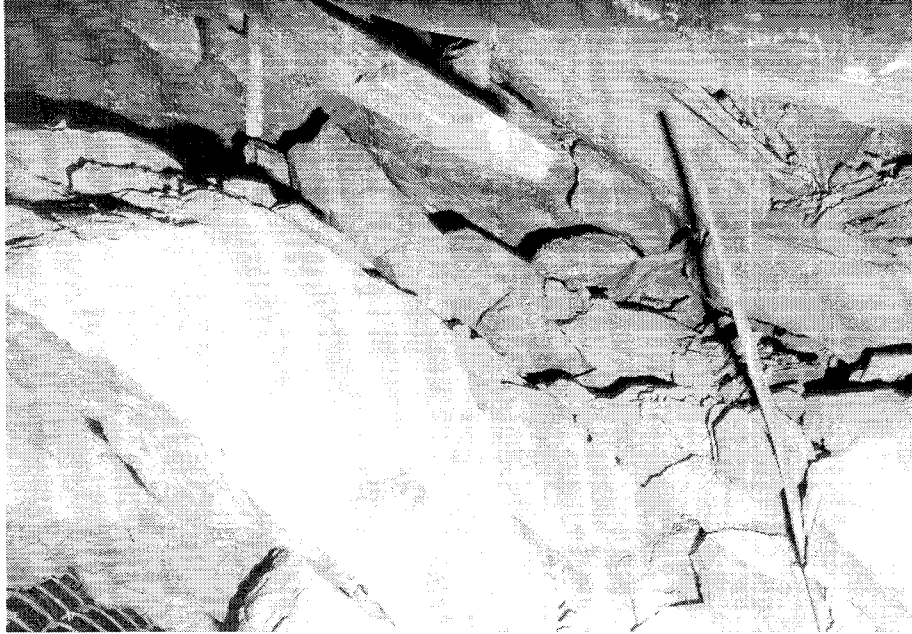
Figure B.21 Tensile failure of a smooth bar rock bolt in the immediate hangingwall of the 24-26 haulage east.

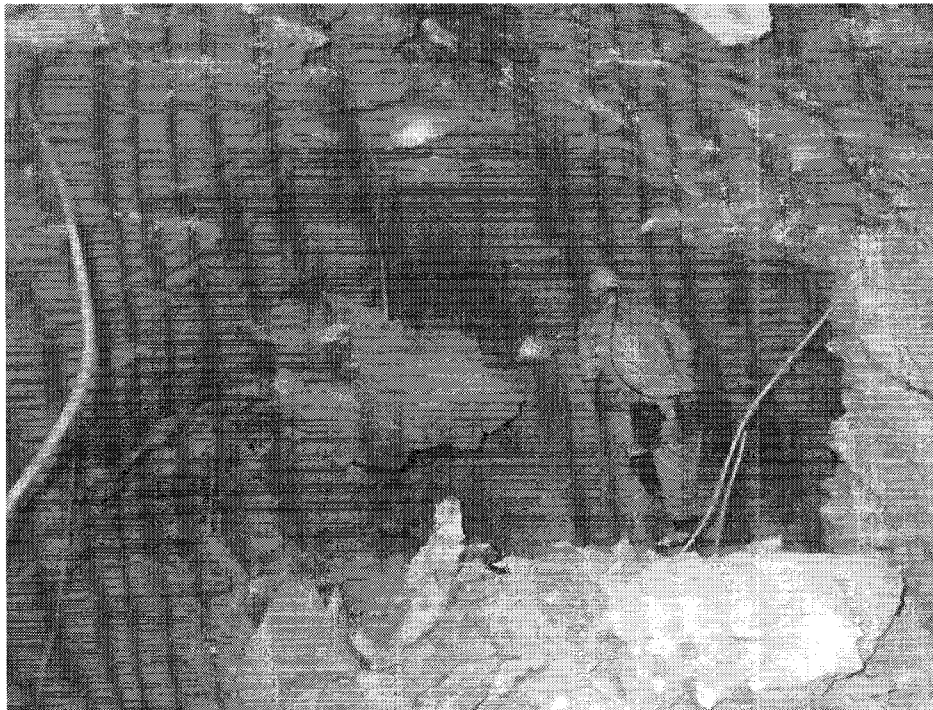
Figure B.22 View south along 24-26 haulages east showing collapse of hangingwall over an estimated height of 1,5 m to 2,0 m.

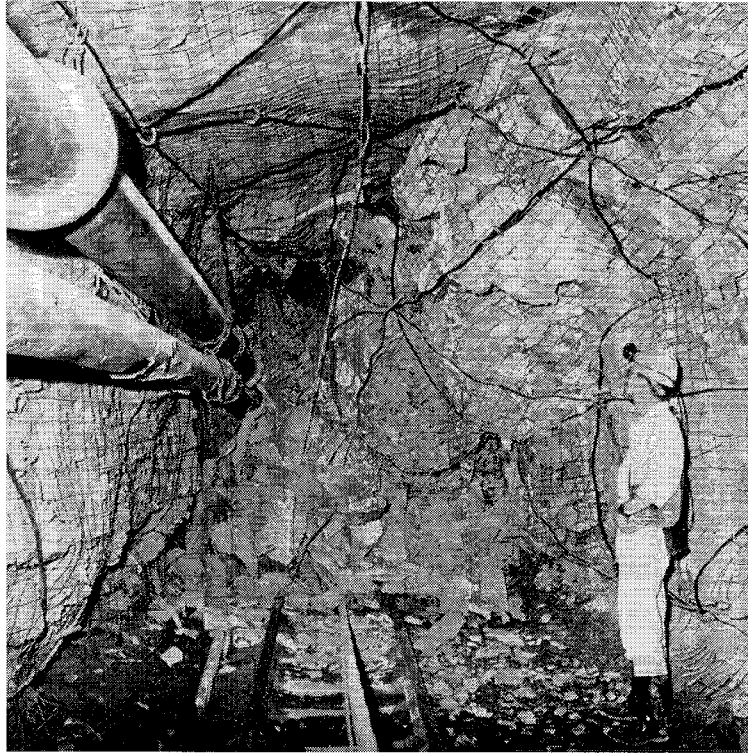
Figure B.30 Damage to 34K footwall drive at Site B showing complete closure of the tunnel.

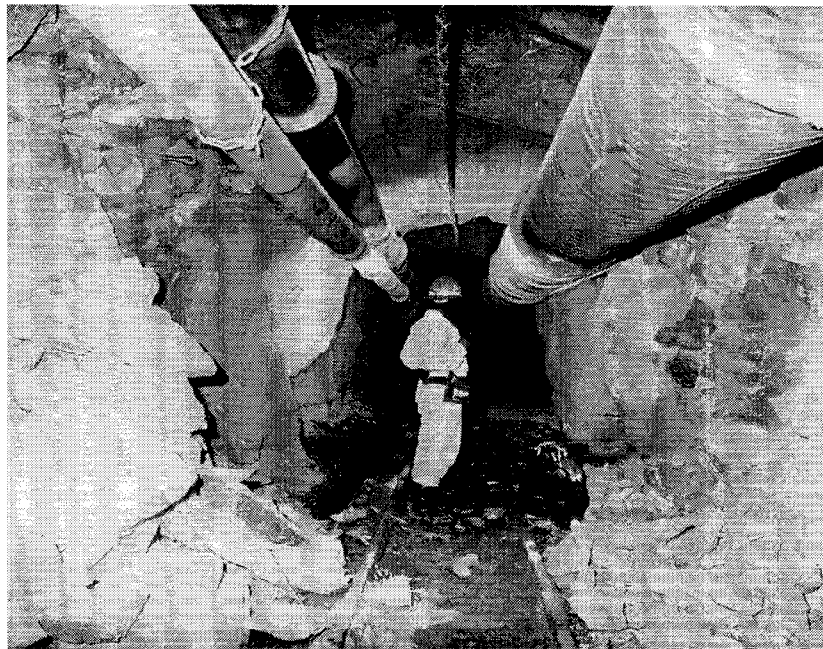
Figure B.31 A haulage on 34 level showing the effect of the support system on damage. The section of the tunnel in the foreground was supported only by grouted rebars, and significant damage was sustained. The support system in the section of the tunnel beyond the miner consisted of grouted rebars, mesh, lacing and shotcrete. Damage was negligible.

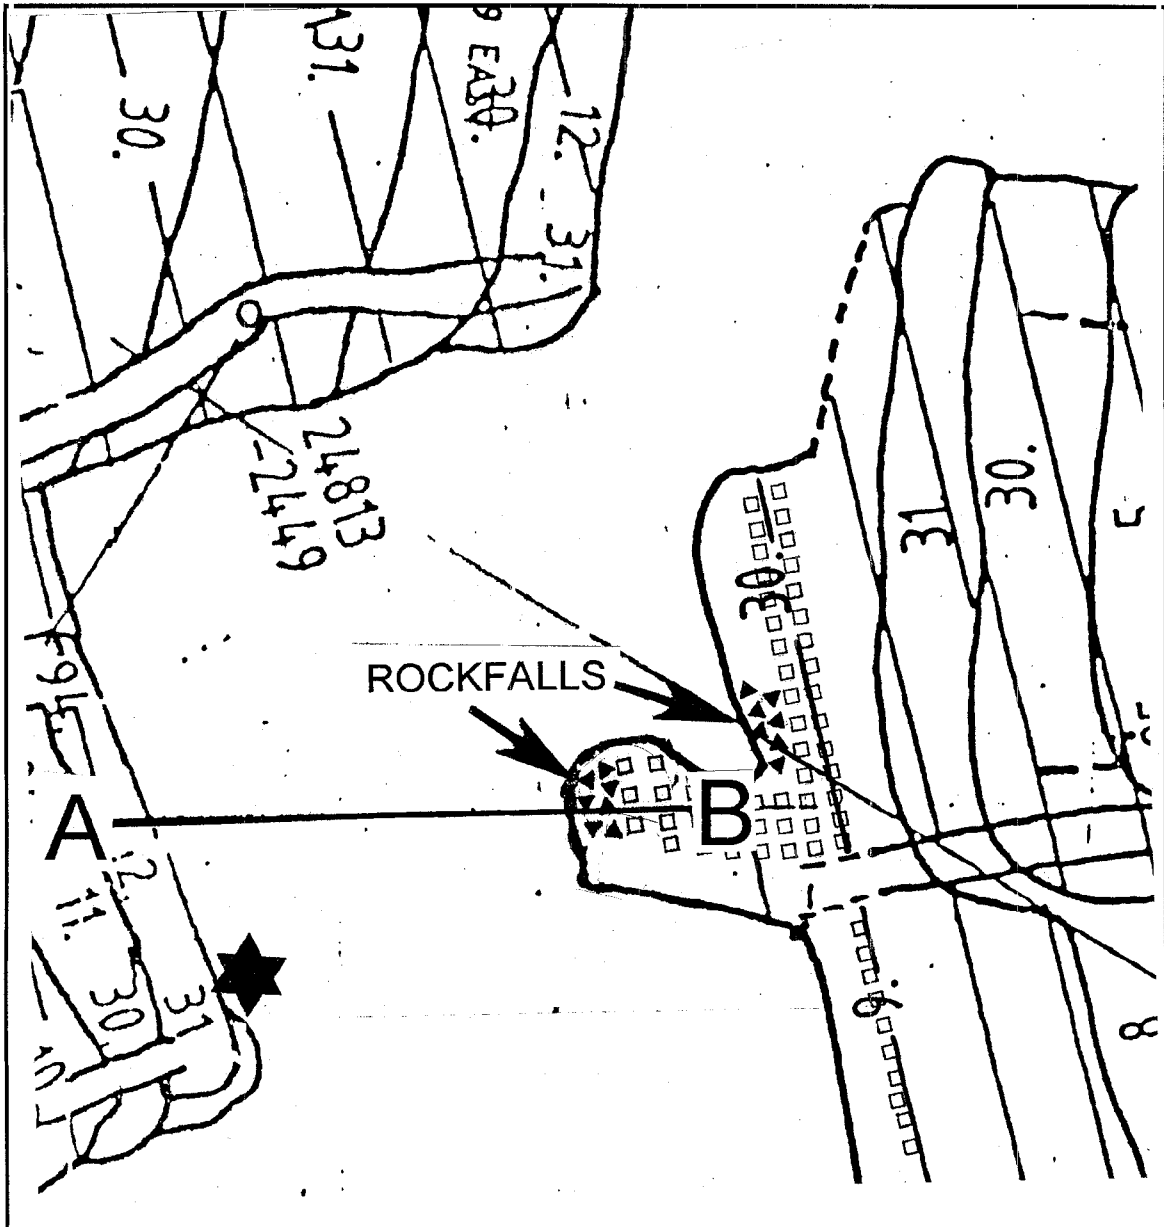
Figure B.34 Plan showing the extent of the damage to the 84-61 West 4 VCR panel caused by the rockburst of 18 September 1995. Open squares show the approximate position of packs. AB is the section line along which Figure B.36 is drawn. Scale 1:500

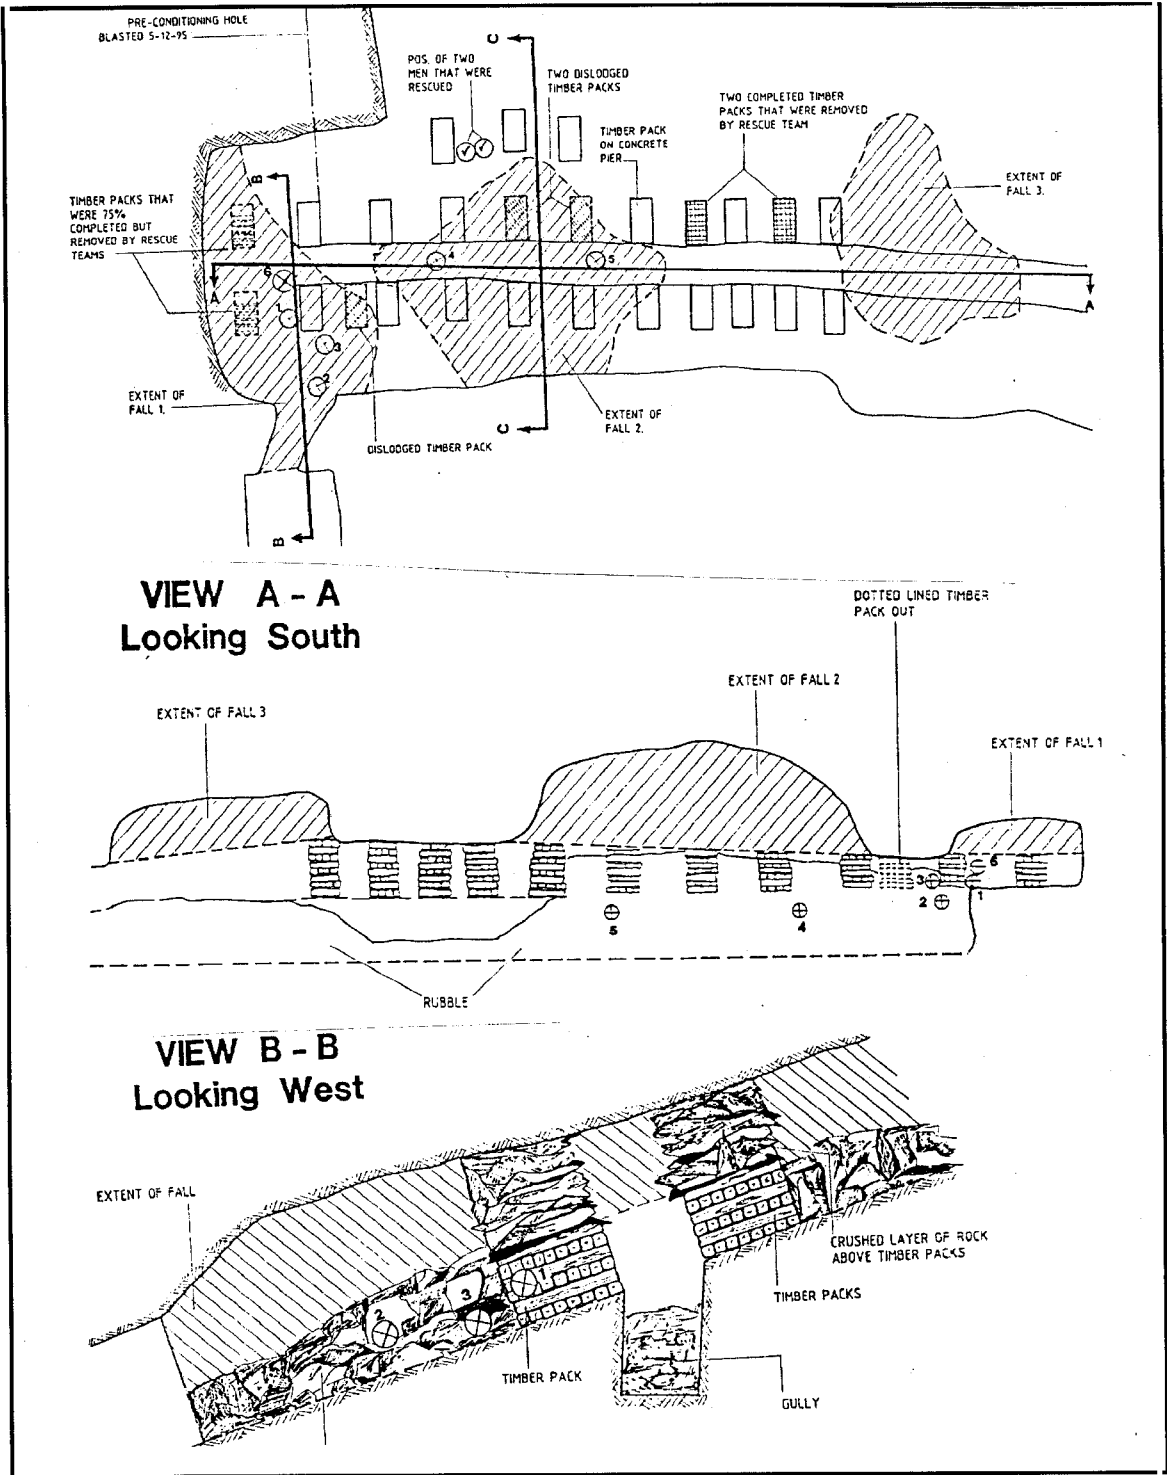
Figure B.43 Plan and sections showing the damage caused by the rockburst on 30 January 1996 to the panel 2 strike gully in the 17-24W stabilizing pillar, Blyvooruitzicht Gold Mine: Prepared by L. Schultz and H. Redelinghuys, Blyvooruitzicht Gold Mine.

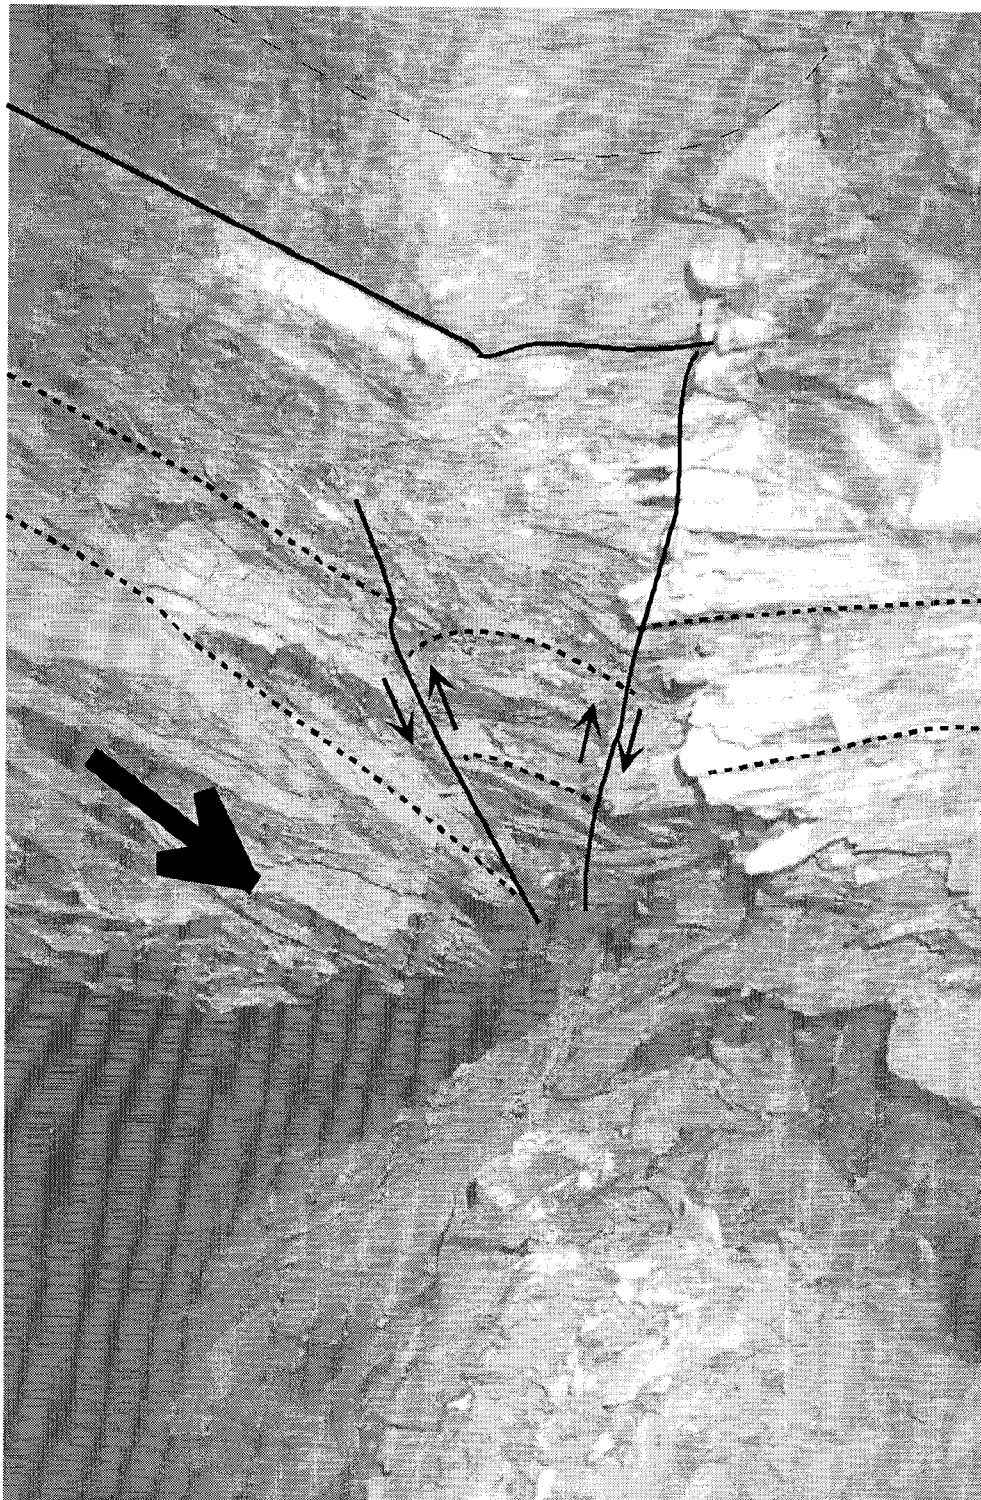
Figure B.44 (a) Photograph showing a rockburst damage to a Carbon Leader Reef gully.

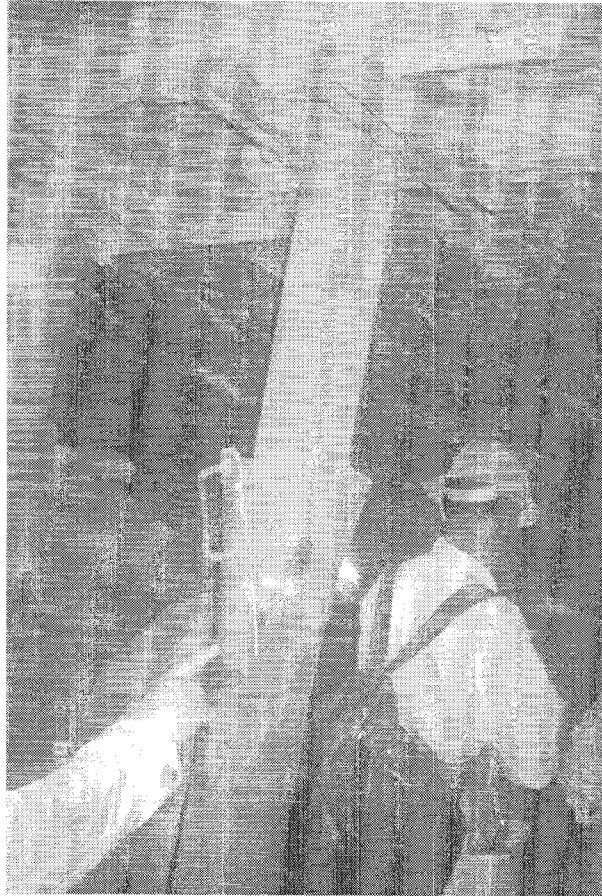
Figure B.51 A rocprop observed in the 2W panel of the 34-19 Carbon Leader stope showing a barrel that had split as a result of closure.

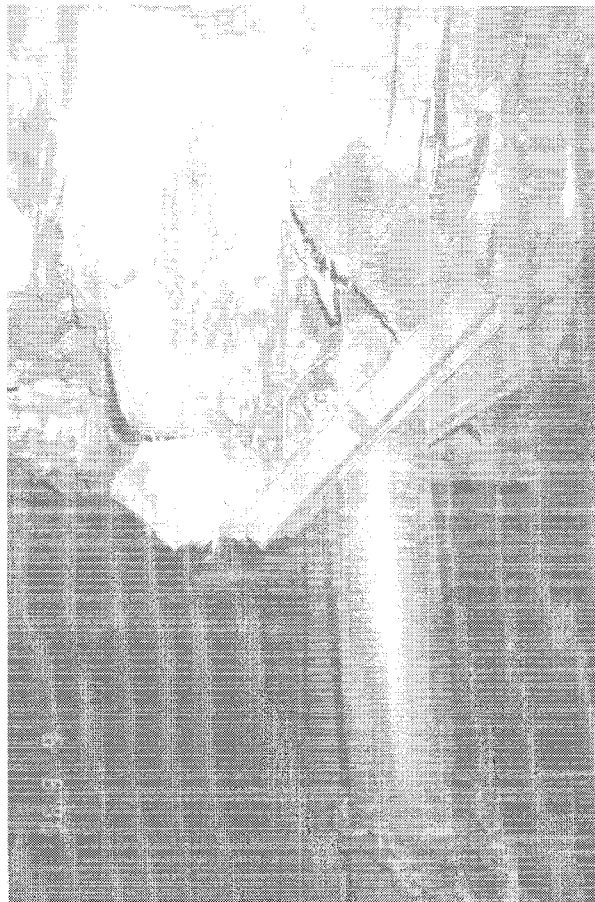
Figure B.52 A Rocprop showing a headboard that had failed so that the prop was exerting a point load on the hangingwall.

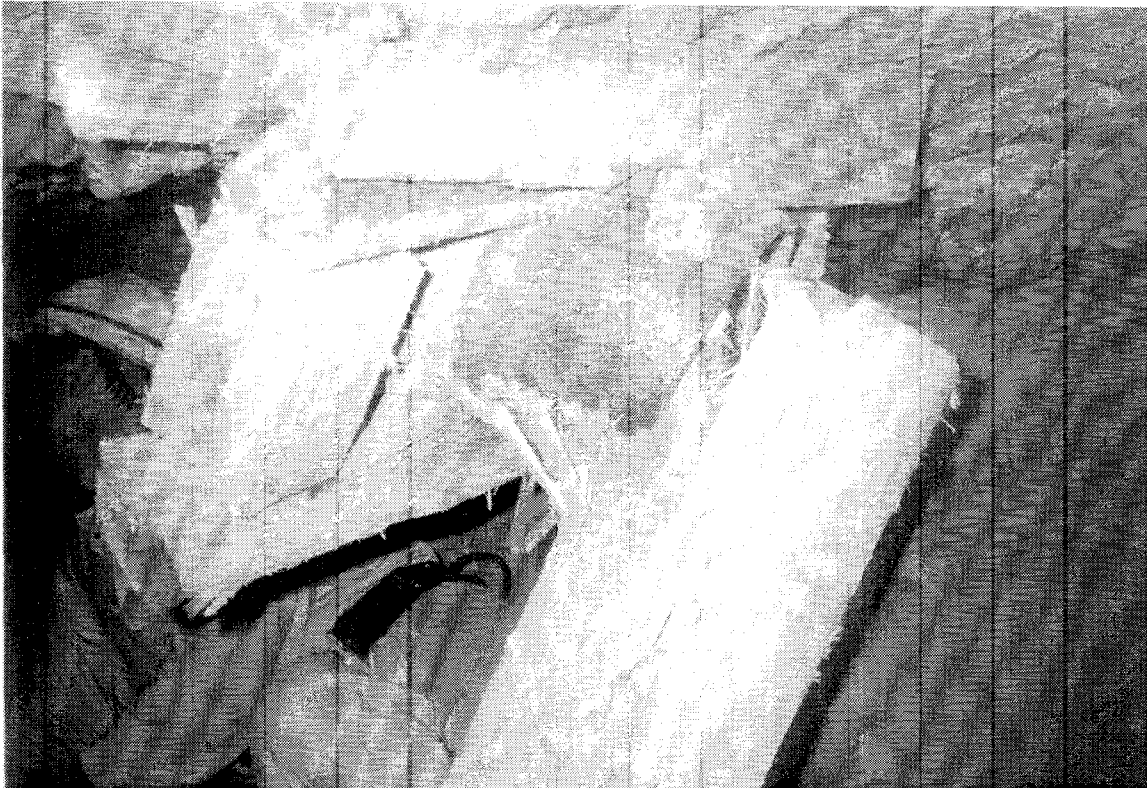
Figure B.54 Tilting of the headboard and cap of a Madoda prop.

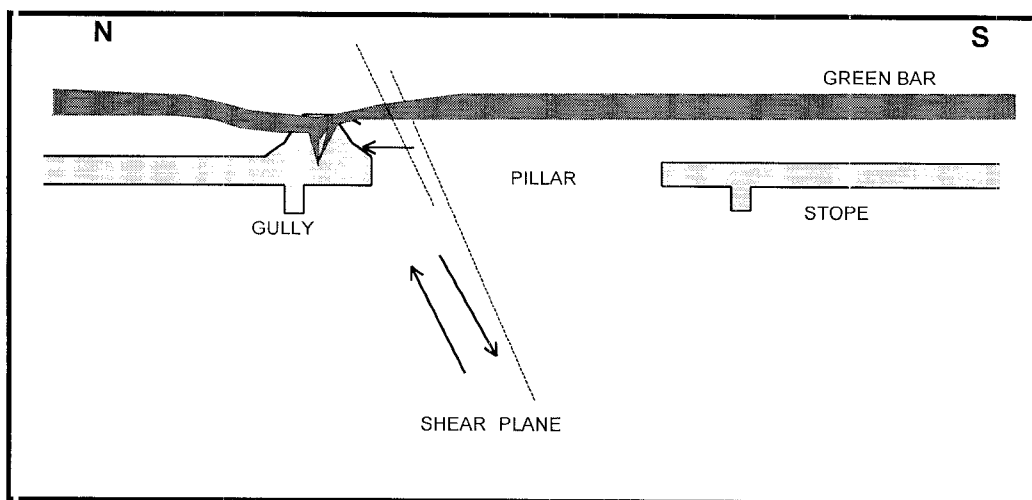
Figure B.66 Section of a stope and stabilising pillar that failed. Horizontal dilation of the rock in the vicinity of the shear plane cause buckling and collapse of hangingwall above the gully.

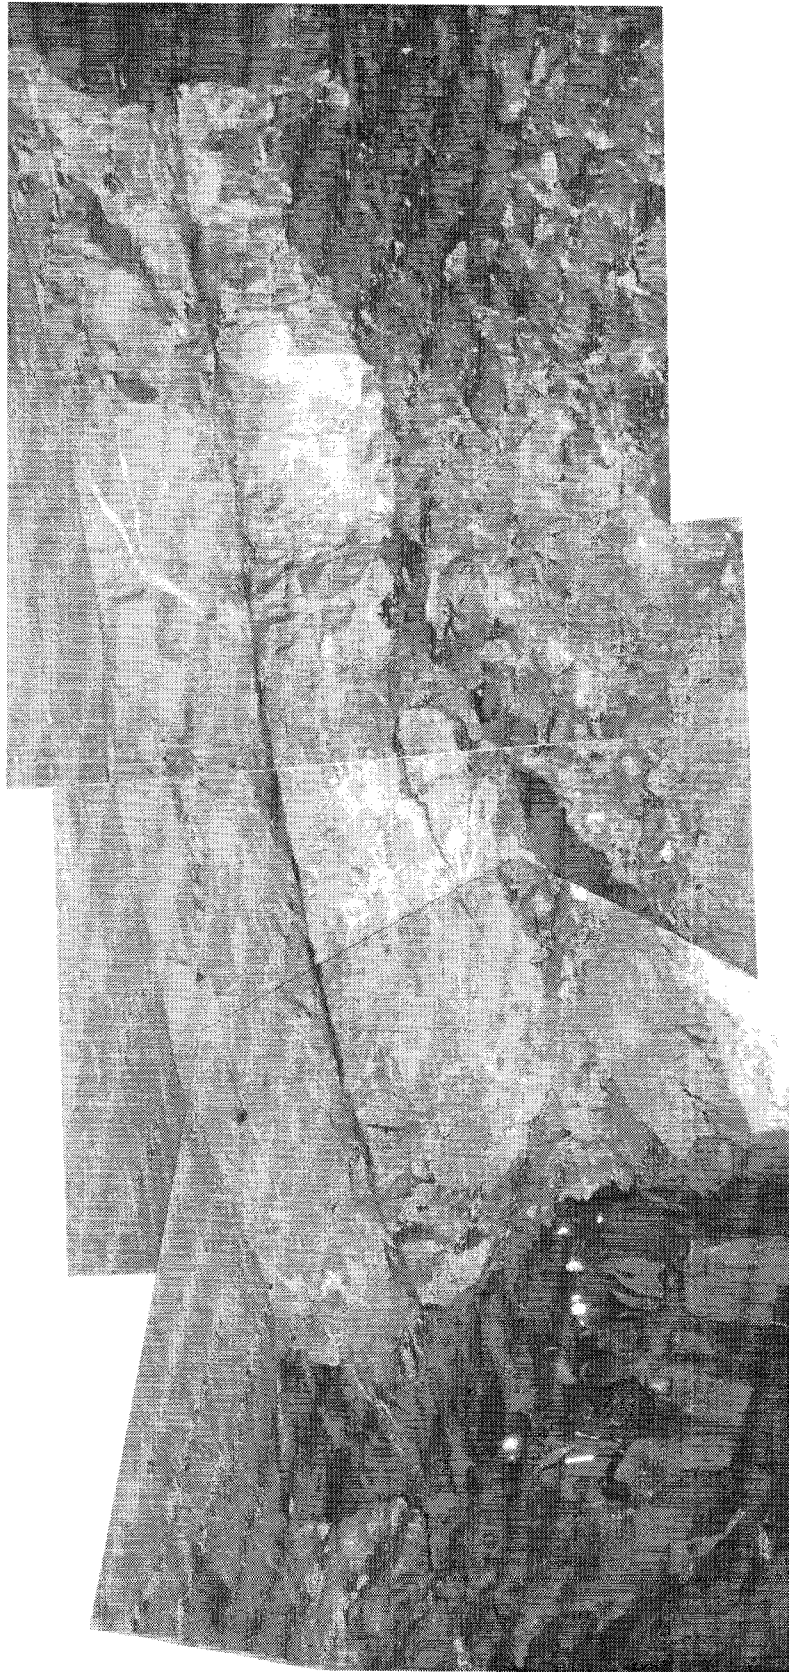
Figure B.69 View towards the west of the fall of ground in the 3W strike gully, 36-35 C/L west mini-longwall, West Driefontein No. 6 shaft.

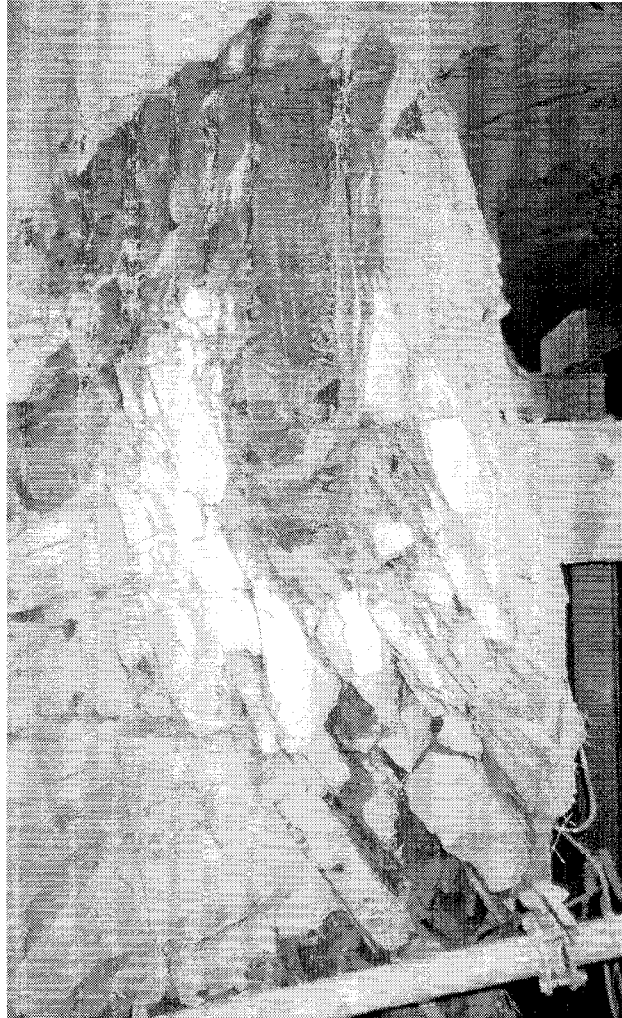
Figure B.72 View of south sidewall of 38 level pump chamber showing distribution of fracturing within the sidewall rock mass at the junction of the pump chamber and dam access excavations.

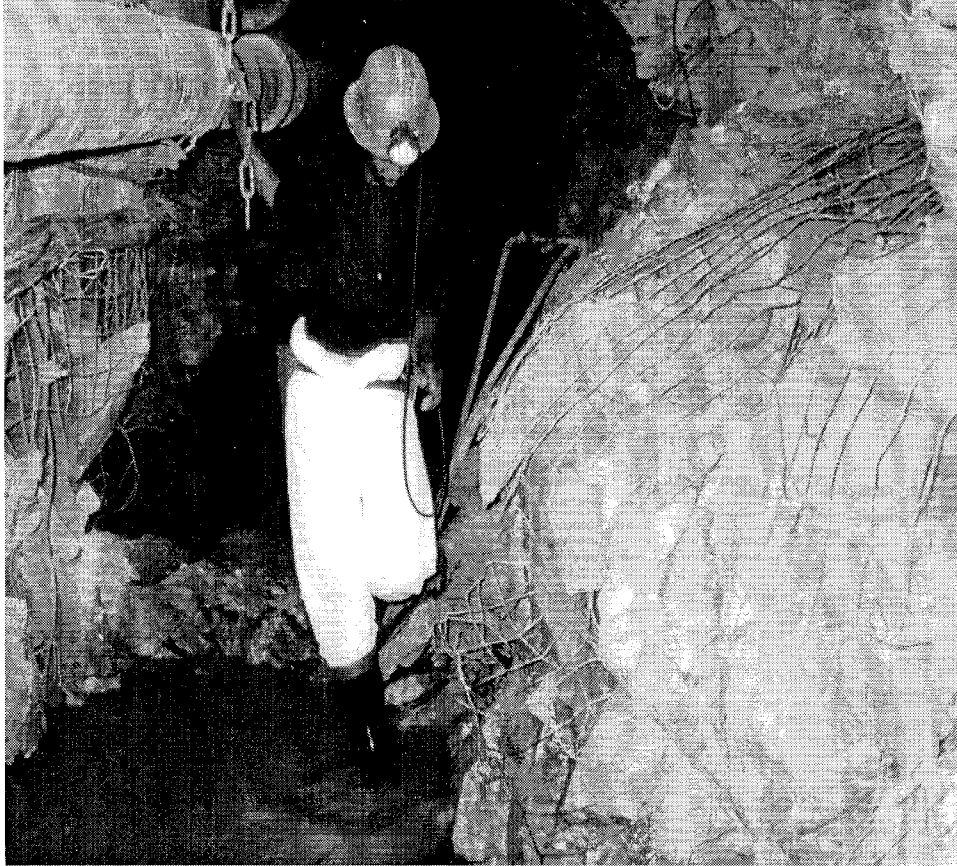
Figure B.73 View west along 38 level deep footwall drive showing large scale bulking of the rock mass, particularly of the lower north sidewall.
