Identifying structural damage with ground penetrating radar

by Michael van Schoor and Stoffel Fourie, CSIR

Ground penetrating radar (GPR) and electrical resistance tomography (ERT) surveys were conducted in an urban environment in an attempt to identify the cause of severe structural damage to a historically significant residential property in Johannesburg, South Africa.

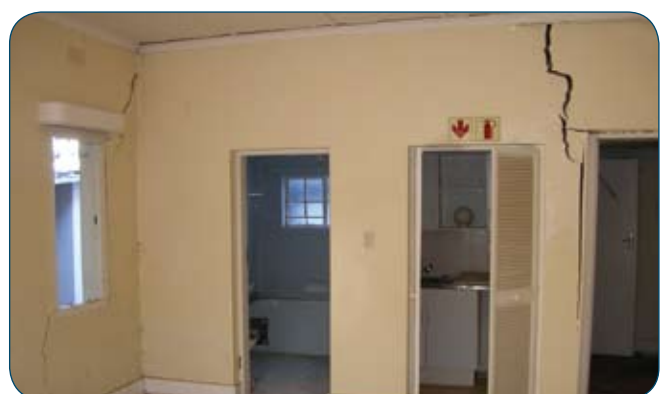
The CSIR's Applied Geosciences Group was presented with a fairly unusual problem: owner and editor of DeKat magazine, Elzilda Becker, was an interested buyer of an upmarket residential property located in 13th Avenue, Houghton, Johannesburg (see Fig. 1). The property also has historic significance in that former president Nelson Mandela lived in the house for some time after his release from prison in 1994. The house also appears on a list of 200 historic sites published by the Nelson Mandela Foundation. In recent years, the house developed severe cracks and signs of subsidence became apparent (Fig. 2).

The uncertainty around the exact cause and extent of the observed damage was an obvious concern to all interested parties during the property sale negotiations. Long term leaking of subsurface water and drain pipes were cited as a probable cause for the observed structural damage.

Fig. 2: Some evidence of the structural damage that can be observed at the 13th Avenue property.

ERT succeeded in mapping what is interpreted to be an unnatural cavity – probably caused by rapid subsurface

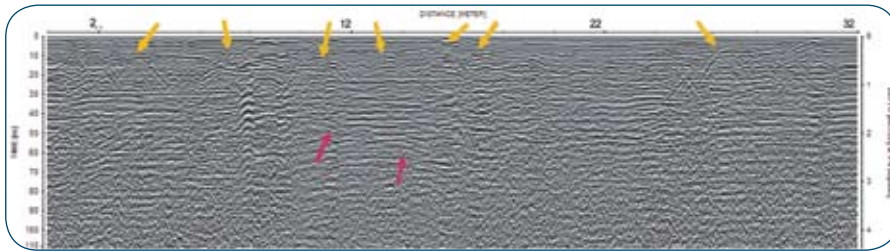
The radargram acquired along the main profile is presented in Fig. 4. Various utility responses can be observed in the upper near-surface (orange arrows). At greater depths, between approximately 2 m and 3 m, anomalies characterised by broad hyperbolic reflection patterns (magenta arrows) can be seen. Unfortunately the radargrams are characterised by poor signal-to-noise beyond about 70 ns (3 m depth at an assumed radar velocity of 0,08 m/ns). These radar results, however, do not provide sufficient proof to make interpretations about possible subsurface cavities or other subsurface features that may have resulted in the structural damage to the building.

Fig. 4: Output radargram acquired along the southern side of the house. The orange arrows indicate utility responses; the magenta arrows show broad hyperbolic reflectors at depths of 2 - 3 m.

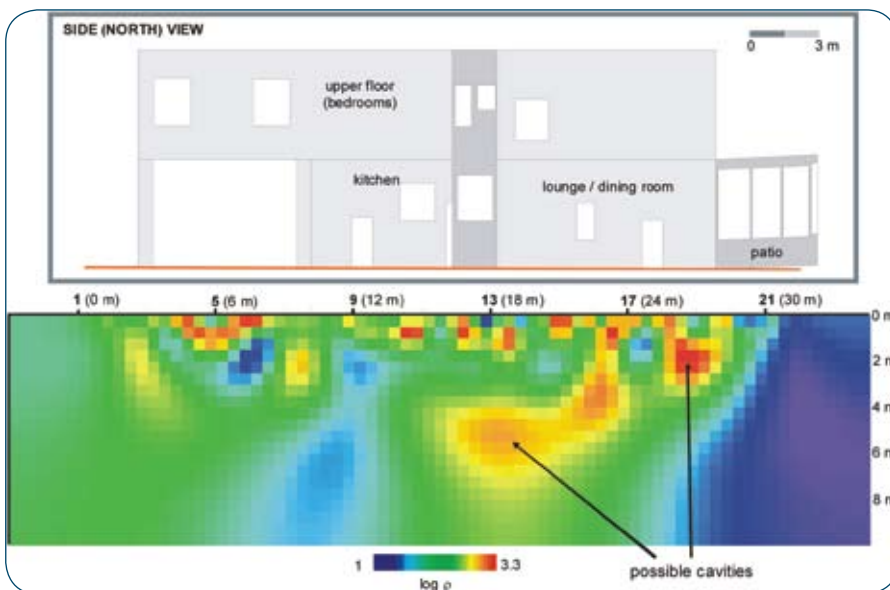
The corresponding ERT result however clearly reveals the presence of prominent high resistivity zones that may be attributed to air filled cavities. Note that even though the image pixel values in such ERT sections are not absolute, the high relative contrast observed here is consistent with the expected response of such cavities.

Fig. 5: ERT output image shows in relation to a schematic side view of the house. Electrode numbers are shown in bold and the relative in-line position in brackets. The most prominent high-resistivity anomaly occurs directly below the section of the house showing the most structural damage.

The deepest, most prominent apparent cavity also occurs just to the east of the previously mentioned broad hyperbolic GPR reflectors. However, the correlation between the observed ERT and GPR anomalies is not clear.

The resistivity anomalies occurring in the upper near surface (0-1,5 m) can mostly be attributed to known utilities and infrastructure features such as foundation structures. The reason for the sudden change in background resistivity towards the end of the profile between electrodes 21 and 22 is thought to be an inversion artefact associated with the local boundary between high-

sensitivity and low-sensitivity grid elements resulting from the restricted measurement scheme.
