# FORENSIC INVESTIGATION INTO THE PERFORMANCE OF HOT-MIX ASPHALT

E. DENNEMAN<sup>1</sup> and E.S. SADZIK<sup>2</sup>

<sup>1</sup>CSIR, Built Environment, PO Box 395, Pretoria, 0001, SOUTH AFRICA

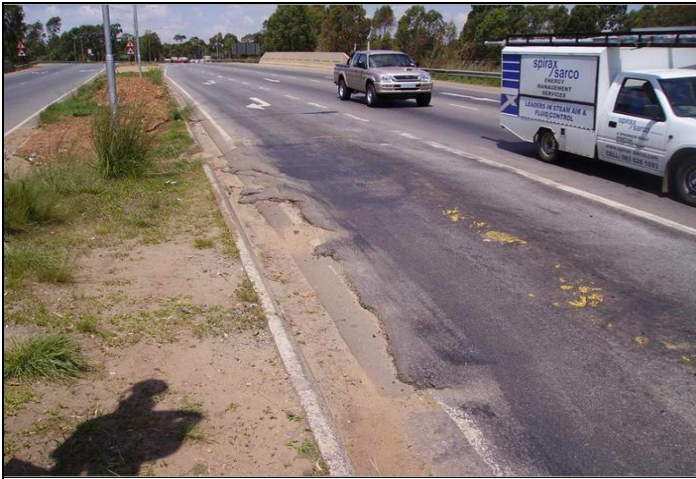
The primary problem with the 25 mm continuously graded medium asphalt (ACM) overlay placed at the intersections of section P2 is extreme permanent deformation (see Figure 2).

**Figure 2: Permanent deformation at intersection road P2**

Despite the poor resistance to permanent deformation of the new mix, most of the permanent deformation seems to have taken place in the older asphalt layer that was not removed before the new overlay was placed.

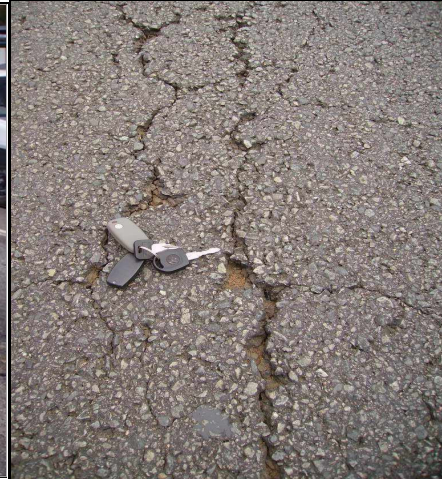
Sections P3 and P4 are situated on the opposite directions of a dual carriageway. The overlay placed on section P3 consists of a 4 mm Stress Absorbing Membrane Interlayer (SAMI), a 30 mm ACM middle layer and a 30 mm Bitumen Rubber Continuously-graded Asphalt (BRCA) top layer. The structure of the section P4 overlay is similar to that of P3, except that the top layer consists of an SMA instead of the BRCA layer. The primary form of distress found at both sections is cracking of the surfacing. Figure 3 shows an example of the cracking observed in the BRCA of section P3. The distress in the SMA of section P4 is of a similar nature. At the good performing section G1, no distress was reported, apart from a slight degree of binder dryness of the binder.

**Figure 3: Cracked BRCA surfacing section P3**

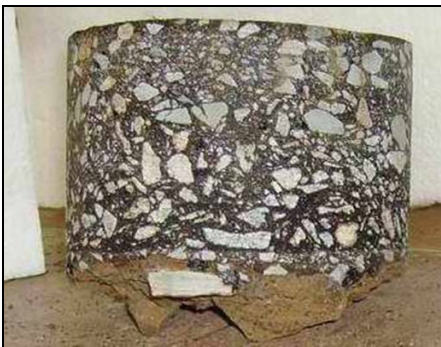
Figures 5 and 6 show pictures of the cores taken from the severely deformed P2 section. The core shown in Figure 5 was taken from the wheel path, where the HMA material is approximately 60 mm thick. The core in Figure 6 taken from the area between the wheel paths is approximately 100 mm thick, giving an indication of the extent by which migration of material has taken place. On both cores, the 25 mm new ACM overlay placed during the 1999 rehabilitation can still be discerned. It seems that most of the displaced material is part of the underlying old ACM layer of unknown composition that deformed after it had been overlaid.

The void content of the material taken from HMA overlay in the wheel track is 0.9 per cent on average. At void content of less than 2.0 per cent the aggregate may start floating in the binder when the binder expands at high temperatures. The lack of resistance against permanent deformation of the mix is also apparent from the low dynamic creep modulus obtained. The average dynamic creep modulus for the tested samples was 4.3 MPa, with results below 10 MPa considered to be indicative of limited resistance against permanent deformation.

**Figure 5: Core from outside wheel path of section P2**

**Figure 6: Core taken from the wheel path of section P2**
