The environmental effect of SO₂-bearing atmosphere on the creep fatigue failure of aluminide-coated MM-002 nickel-base superalloy at 870 °C

High-temperature low-cycle fatigue (HTLCF) failure mechanisms of aluminide-coated MAR-M002 nickel-base superalloy in air, argon and Ar + 5% SO₂ atmospheres were investigated at 870 °C. The loading conditions were constant and consisted of creep tension and plastic compression according to the creep plasticity mode of the strain-range partitioning method. The resultant failure mechanisms were investigated using scanning electron microscopy, energy dispersive spectroscopy and X-ray diffraction analysis. The results obtained indicated that the combination of environmental effect and cyclic loading resulted in an early failure of the coating. This failure acted as the incubation and initiation stages for the HTLCF failure of the coated alloy. However, it was found that under an SO₂-containing environment, an accelerated and premature failure was obtained compared to that obtained in argon and air environments. Hence, it is evident that although the aluminide coating provides relatively adequate resistance towards oxidation environment, this protec

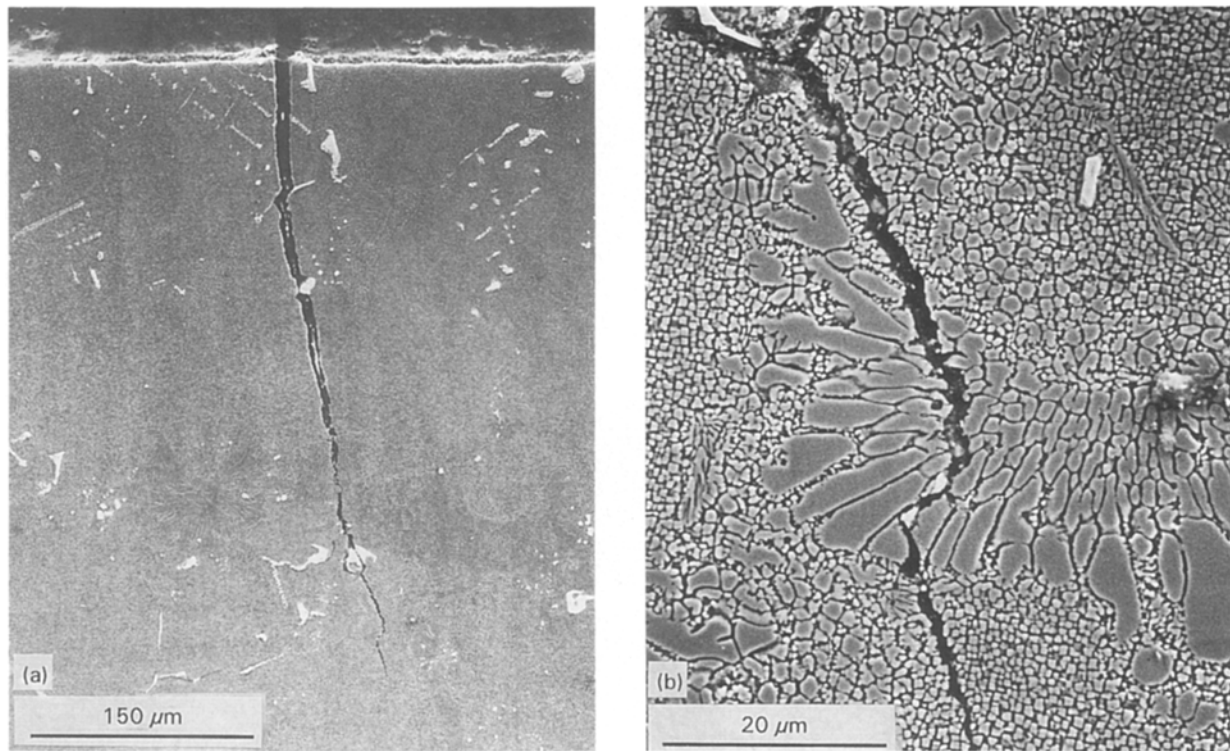
Figure 2 Cross-section of a fatigue specimen after HTLCF failure in an argon atmosphere; (a) a general view, (b) a close-up view of the crack tip.

HTLCF tests performed on several coated specimens at $870^\circ C$ in an inert argon atmosphere showed an average life of 877 cycles. Analysis of the fatigue specimen that had failed after HTLCF in argon atmosphere disclosed circumferential cracking of the coating on the external surface close to the fracture surface, which was due to pure mechanical failure of the coating. Metallographic examination of a cross-section close to the fracture indicates that the mode of crack propagation was transdendritic (Fig. 2a). The fatigue crack propagation was relatively "straight" and has initiated from the region where the coating was mechanically cracked. A high magnification of the crack tip (Fig. 2b) shows that there was no evidence

of environmental interaction along the crack edge and tip. Chemical analysis along the crack edge (Table II) shows negligible variation in the chemical composition near the crack edge and base material, hence indicating no environmental interaction.

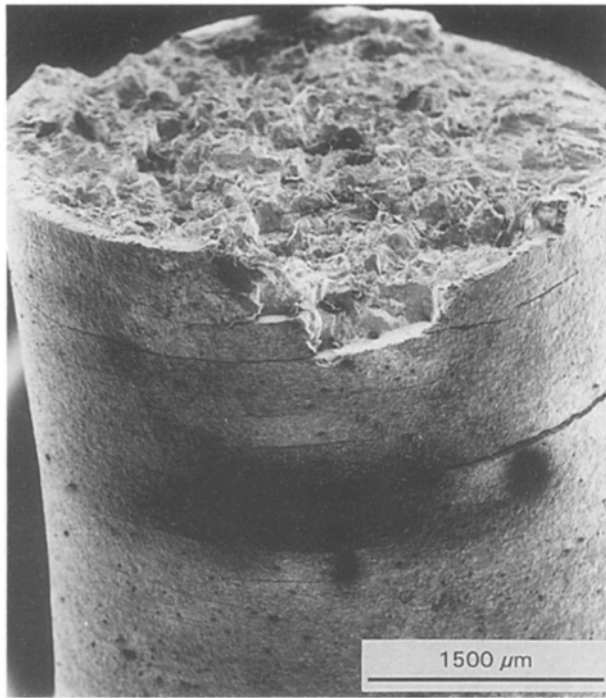
In the air environment, the average HTLCE life of several coated specimens at $870^\circ C$ was 670 cycles. Investigation of the fracture surface showed evidence of oxidation (Fig. 3). Circumferential cracking of the coating close to the fracture was evident as in the specimen that had failed in the argon atmosphere. This may indicate that the initial cracking of the coating was due mainly to mechanical loading and not environmental interaction.

Figure 3 The fracture surface obtained after HTLCF failure in an air atmosphere at 870 °C.

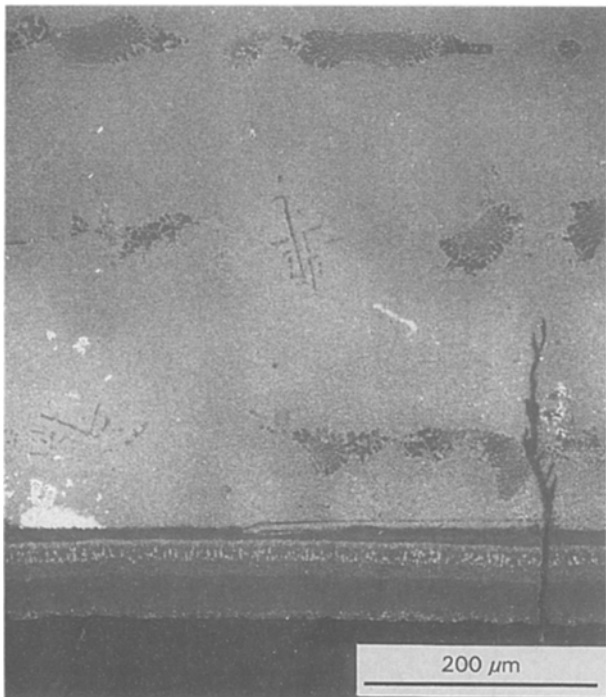
Metallographic examination of a cross-section close to the fracture revealed several cracks in the coating (Fig. 4). All cracks were initiated at the cracks in the coating and the mode of propagation was transdendritic. The cracks tended to branch during the propagation stage. Close-up examination of a crack (Fig. 5) revealed porous oxides rich in the reactive elements, such as aluminium and chromium, close to the crack edge. Adjacent to the porous oxide layer is a uniphase layer in which growth and coarsening of the γ' has occurred. The chemical composition of the uniphase layer complies more closely with bulk material with exception of a high concentration of chromium.

Figure 4 Cracks observed in a longitudinal cross-section after HTLCF in air.

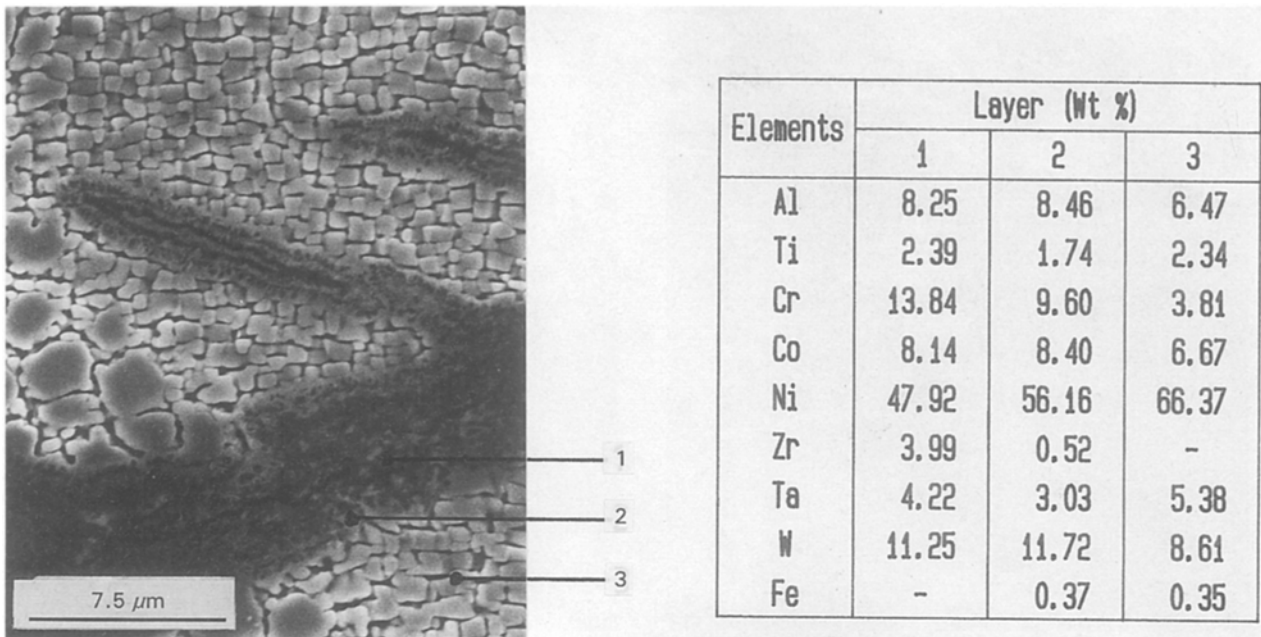
Figure 5 Spot chemical analysis of the layers along the crack edge after HTLCF failure in an air atmosphere.

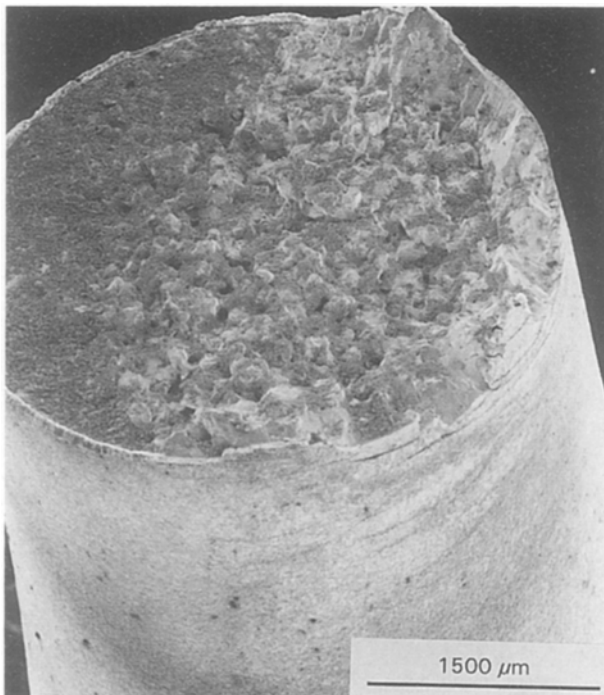
Catastrophic HTLCF failure was observed in the Ar + 5% SO_2 environment with the average number of cycles to failure being less than 50 cycles. The fracture surface was covered with dark sulphide phases (Fig. 6). There were two distinct areas, namely the smooth region where crack propagation occurred and the coarse region where final failure resulted. The concentration of sulphide phases was much higher in the smooth region than in the coarse region. This may indicate a severe sulphidation attack in the initial stage of the crack propagation. The average sulphur content on the fracture surface was found to be approximately 5.7 wt %. Circumferential cracking of the coating was observed as in the fatigue specimens that had failed in air and argon atmospheres, thus emphasizing that the fatigue failure under the tested condition was always initiated by the failure of the coating.

Figure 6 The fracture surface obtained after HTLCF failure in an Ar + 5% SO₂ atmosphere.

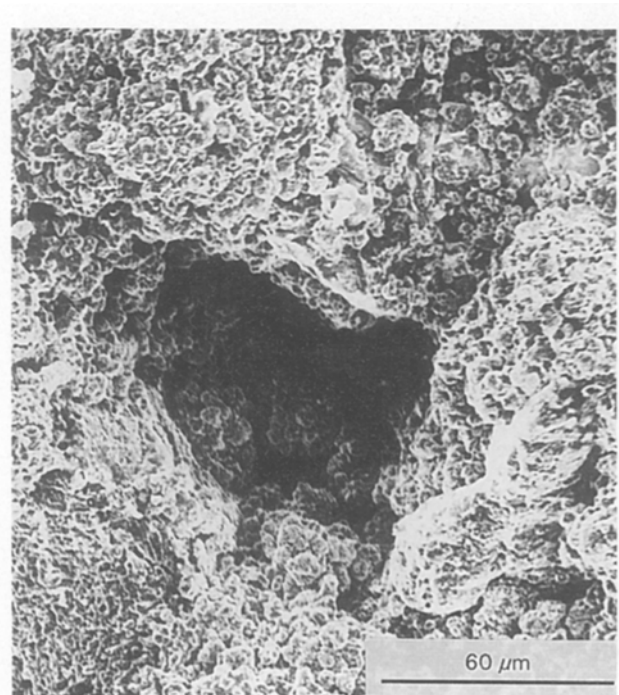
Severe sulphidation attack was observed on the coating (Fig. 7) near the fracture surface. Metallographic examination of cross-sectional samples shows extensive damage to the coating (Fig. 8a) and even peeling of the coating near the fracture surface (Fig. 8b). Examination of a crack through the coating indicates that the crack was well developed in the coating but there was some resistance to the sulphidation attack and crack propagation in the interdiffusion zone (Fig. 9). This observation was in agreement with that made by Fryxell and Leese [12] on the role of the interdiffusion zone in hot-corrosion environments of aluminide coatings.

Figure 7 Localized corrosion attack of the coating after HTLCF failure in Ar + 5% SO₂.

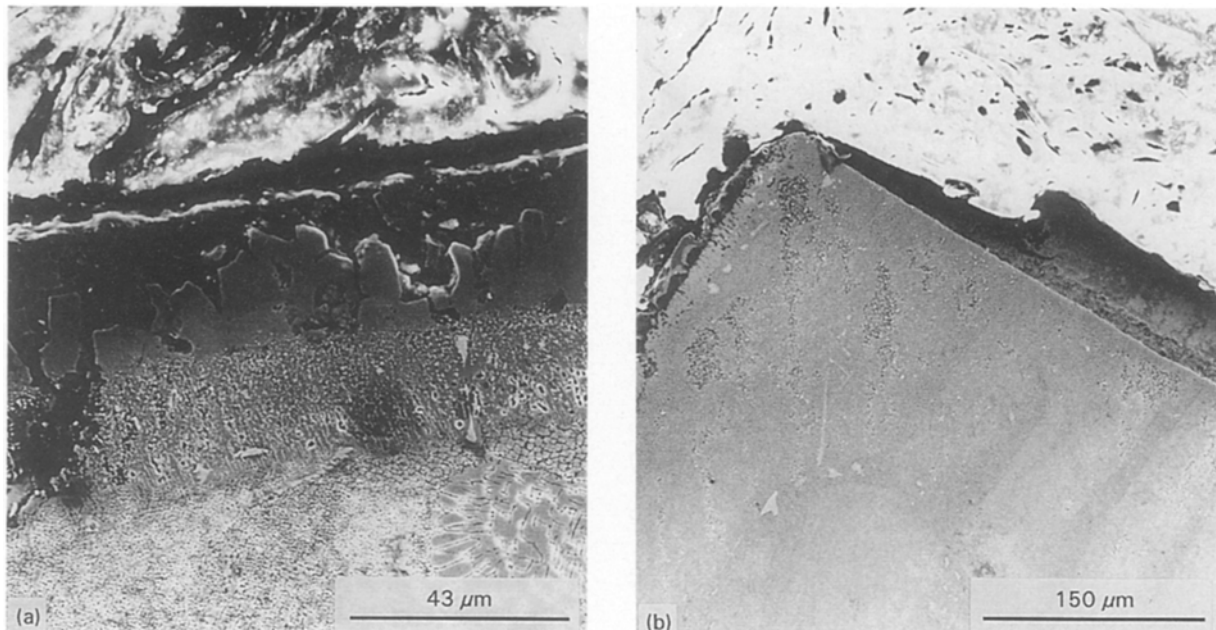
Figure 8 Damage to the coating after HTLCF in Ar + 5% SO₂; (a) general appearance, (b) region where peeling of the coating occurred.

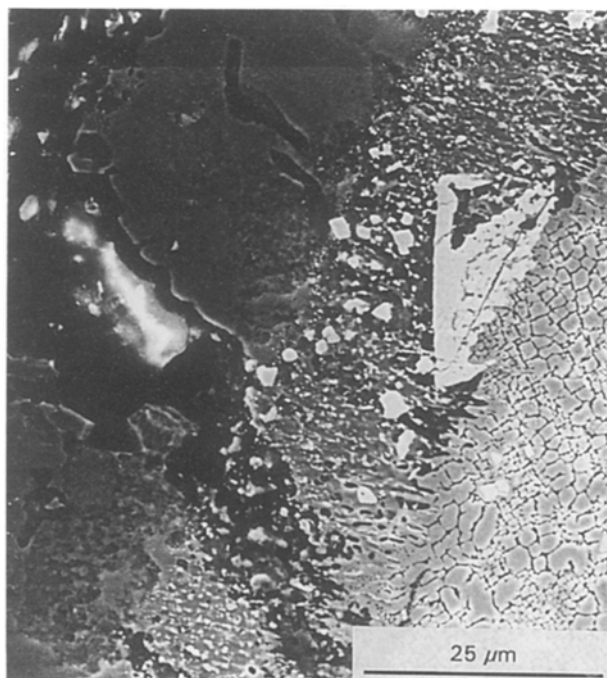
Figure 9 Cracking through the coating after HTLCF in an Ar + 5% SO₂ environment.

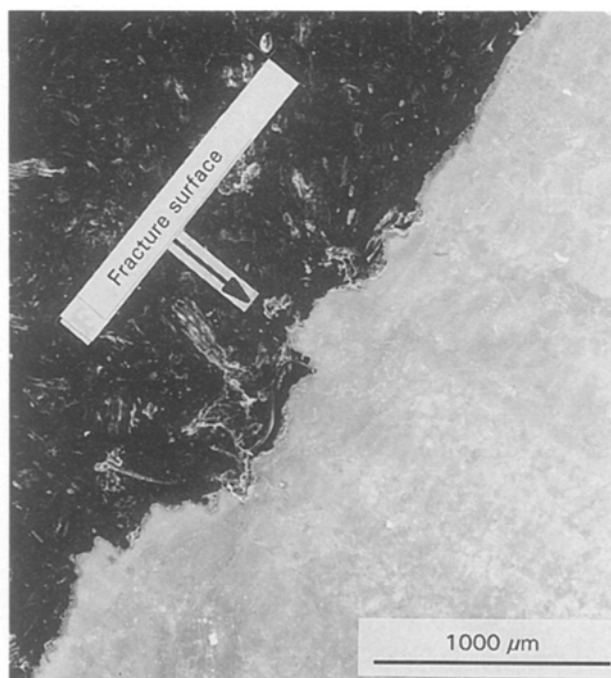
A general view of the longitudinal cross-section of the fracture surface (Fig. 10) showed that the fatigue crack was initiated where the coating was damaged and peeling off. The crack propagation was perpendicular to plane of loading and direction of solidification. The secondary cracks tended to nucleate at the interdendritic segregation zone suggesting that the mode of crack propagation was a mixed trans-interdendritic one. Coalescence and coarsening of the γ' phase was observed adjacent to the fracture surface and secondary crack edges. In order to evaluate the nature of the layers along the crack edge, EDS analysis was performed in the different regions (Fig. 11). A sulphur content of 8.25 wt % was found in the crack manifesting the presence of sulphide phases. There was rich presence of reactive elements aluminium, chromium, and hafnium in the crack indicating the presence of the sulphide phases of these elements and also the oxide phases as a result of the SO_2 breakdown. The presence of sulphur in the second and third layers analysed indicate the penetration of the sulphidation attack.

Figure 10 Cross-section showing the intersection between the longitudinal cross-section and fracture surface after HTLCF failure in Ar + 5% SO₂.
