RML NO.	5/89
	PRINCIPAL AUTHOR	P A TURNER
	DATE	FEBRUARY 1989
	TASK NO.	GR6P

ROCK MECHANICS LABORATORY

TECHNICAL NOTE

TITLE : THE INFLUENCE OF LEAD LENGTH ON THE FRACTURES ASSOCIATED WITH LEADING CORNERS AND SIDINGS

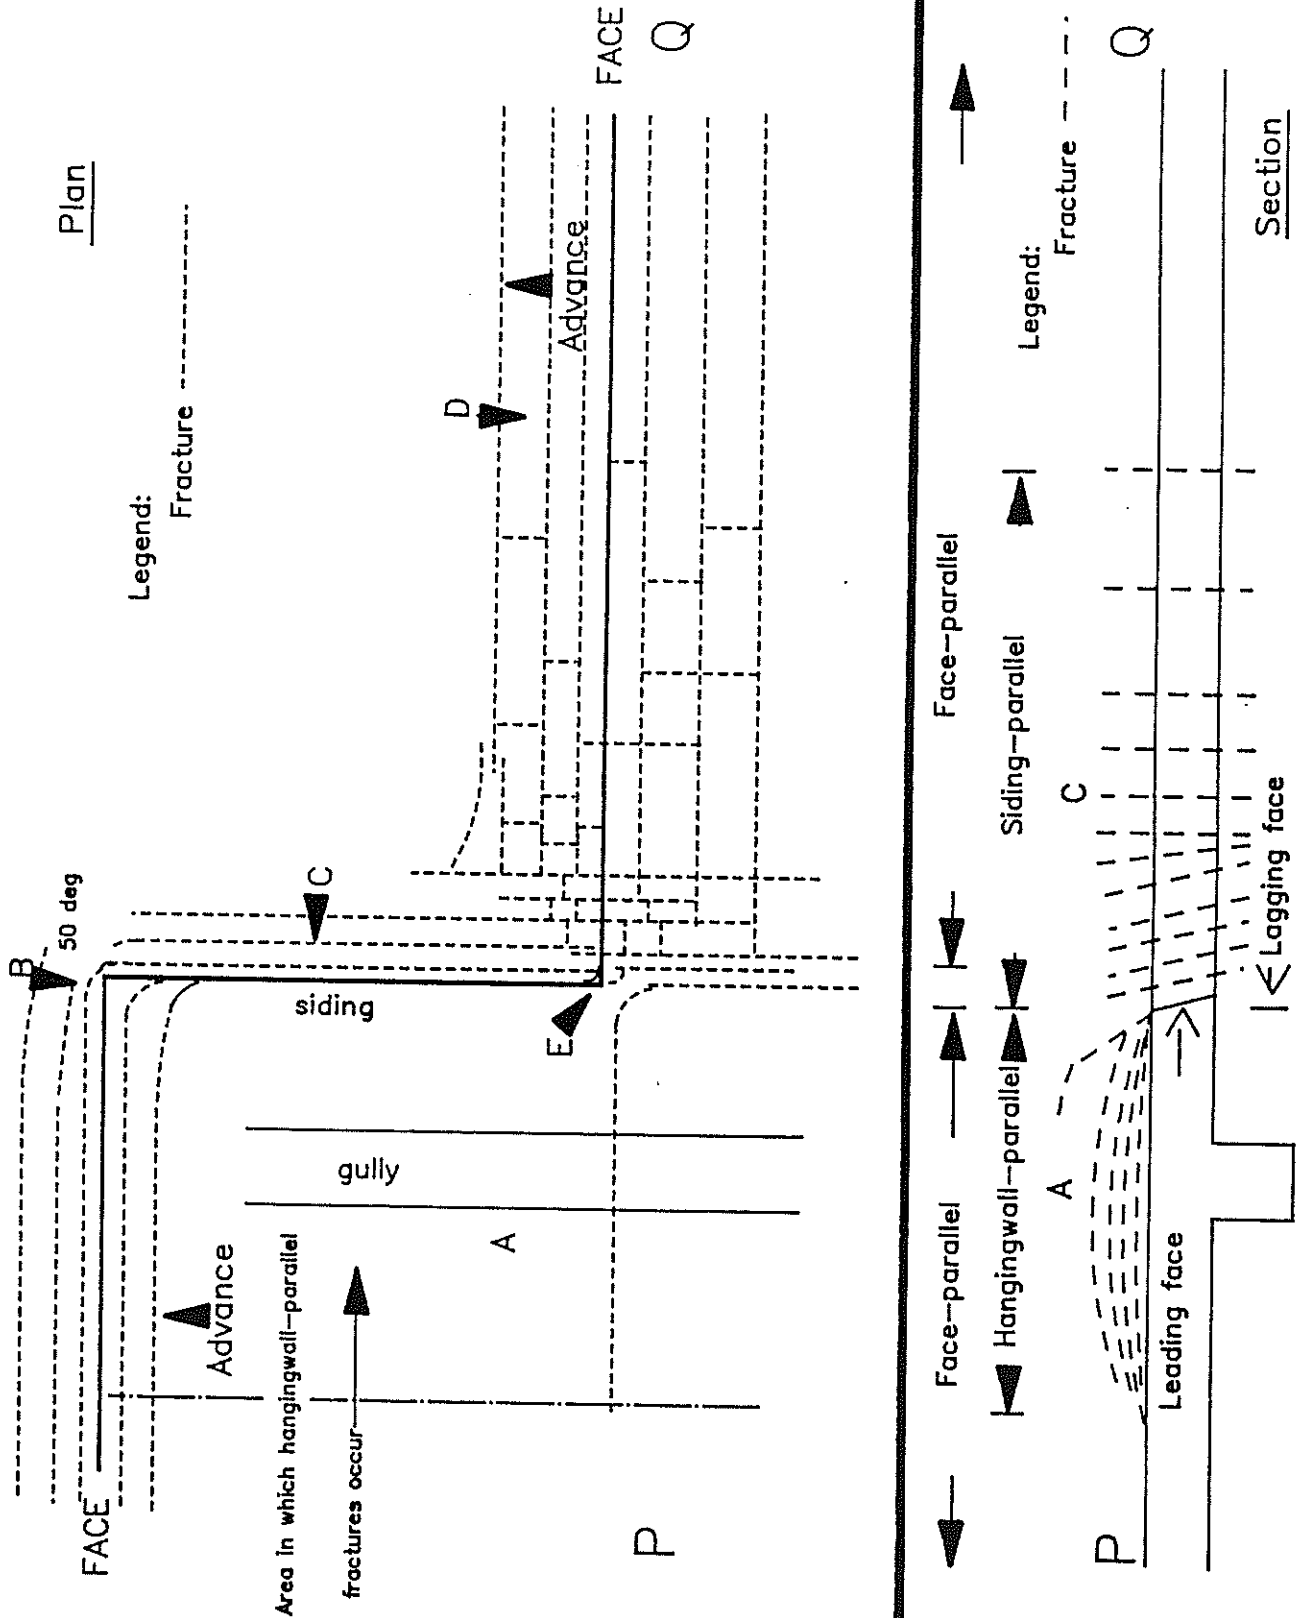
Five fracture geometries have been recognized as being likely to influence hangingwall stability immediately up and down dip of the sidings between leading and lagging panels. These are (Figure 1):

- (A) hangingwall-parallel fractures formed over the leading corner of the stope. These are formed within the face-parallel slabs which were developed ahead of the leading face
- (B) the strike curvature and flattening of dip of face-parallel fractures formed ahead of and round the leading corner of the stope. Fractures formed some distance ahead of the face curve over several metres. Fractures formed close to the face curve over 1-2 m.
- (C) siding-parallel fractures formed up dip of the siding
- (D) face-parallel fractures formed ahead of the lagging face
- (E) fractures with strike curvature formed ahead of the lagging face in the corner at siding/lagging face intersection.

Figure 1. Fractures associated with inter-panel leads.

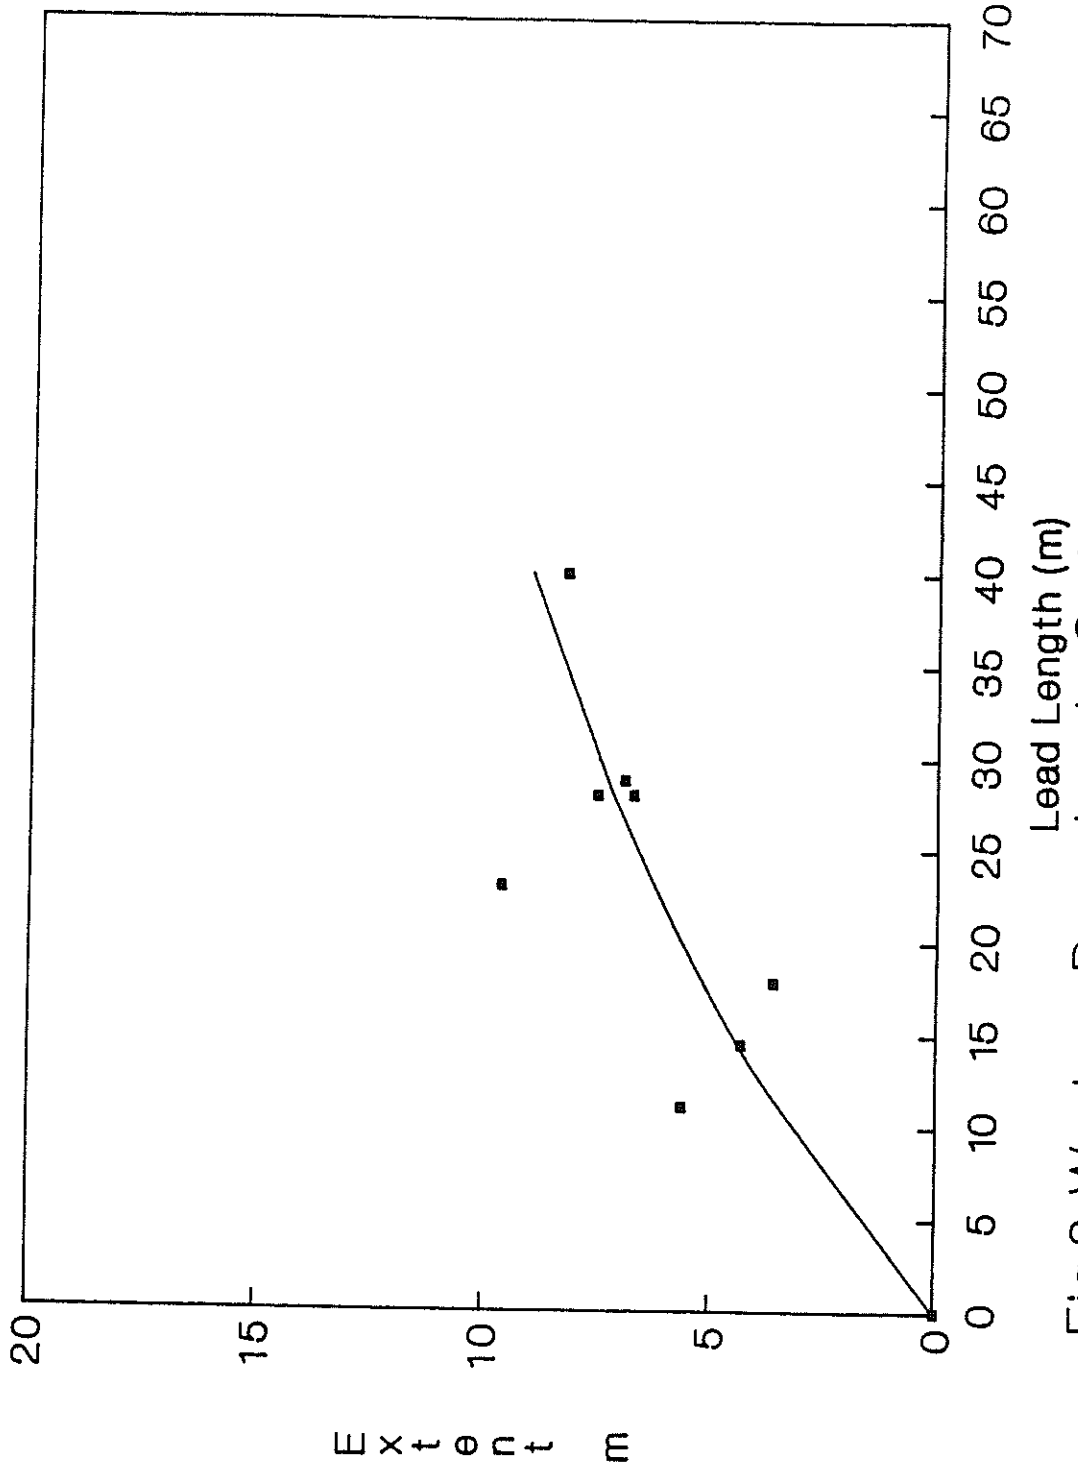
Fig.2 Western Deep Levels Carbon Leader Reef

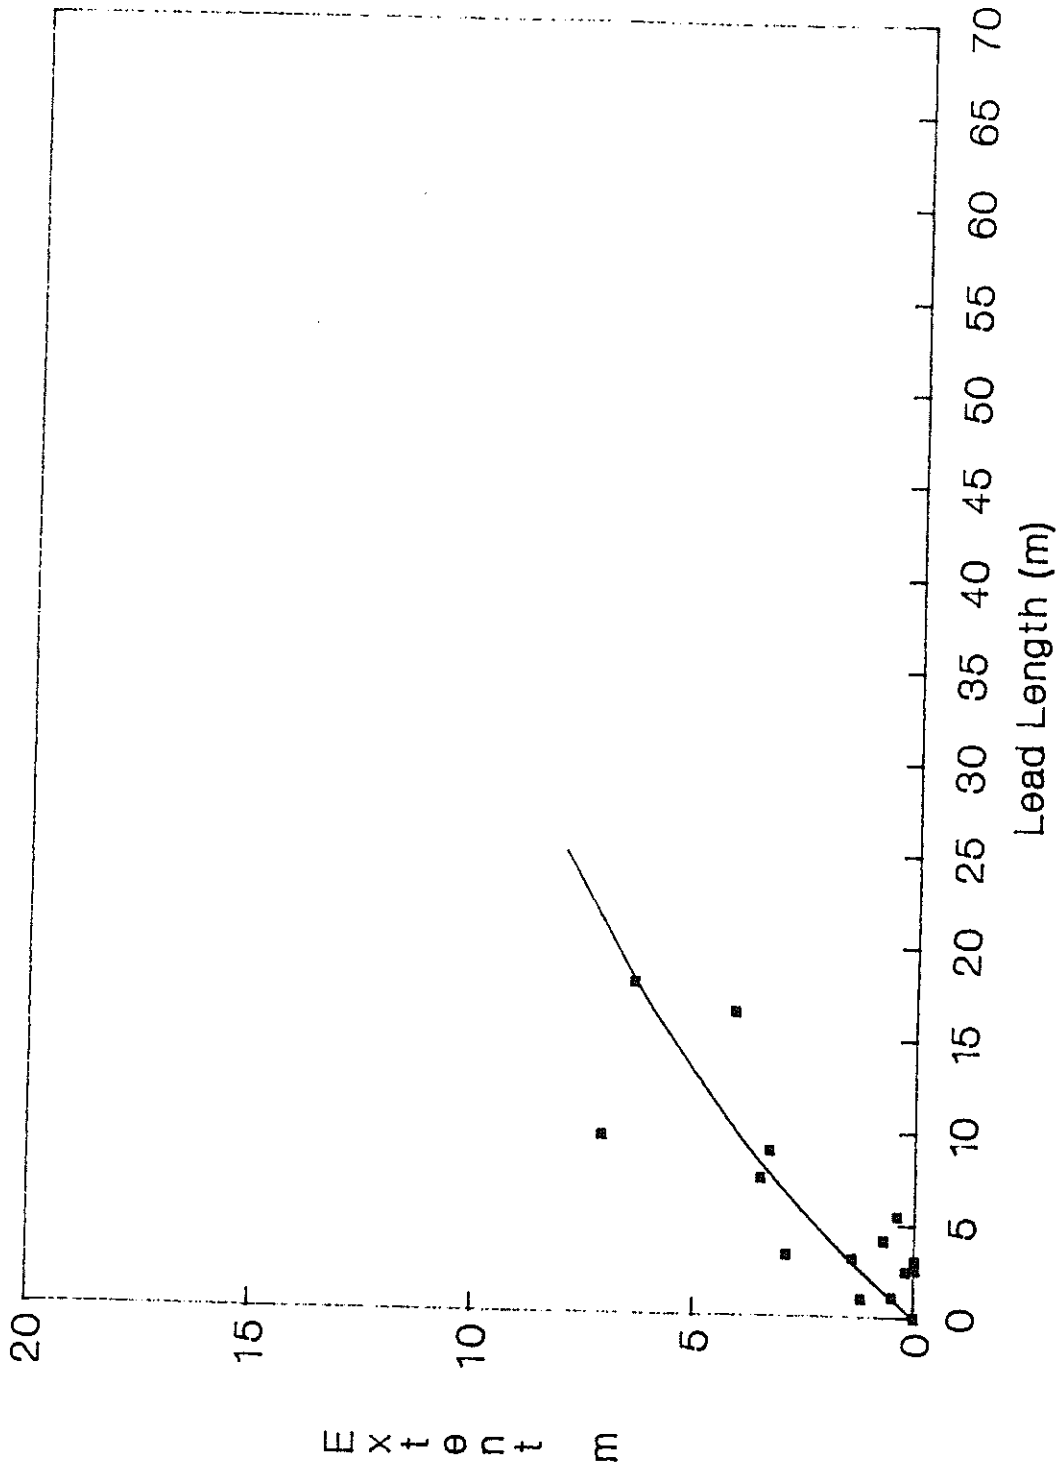
Fig.3 Doornfontein Carbon Leader Reef (>2200m)

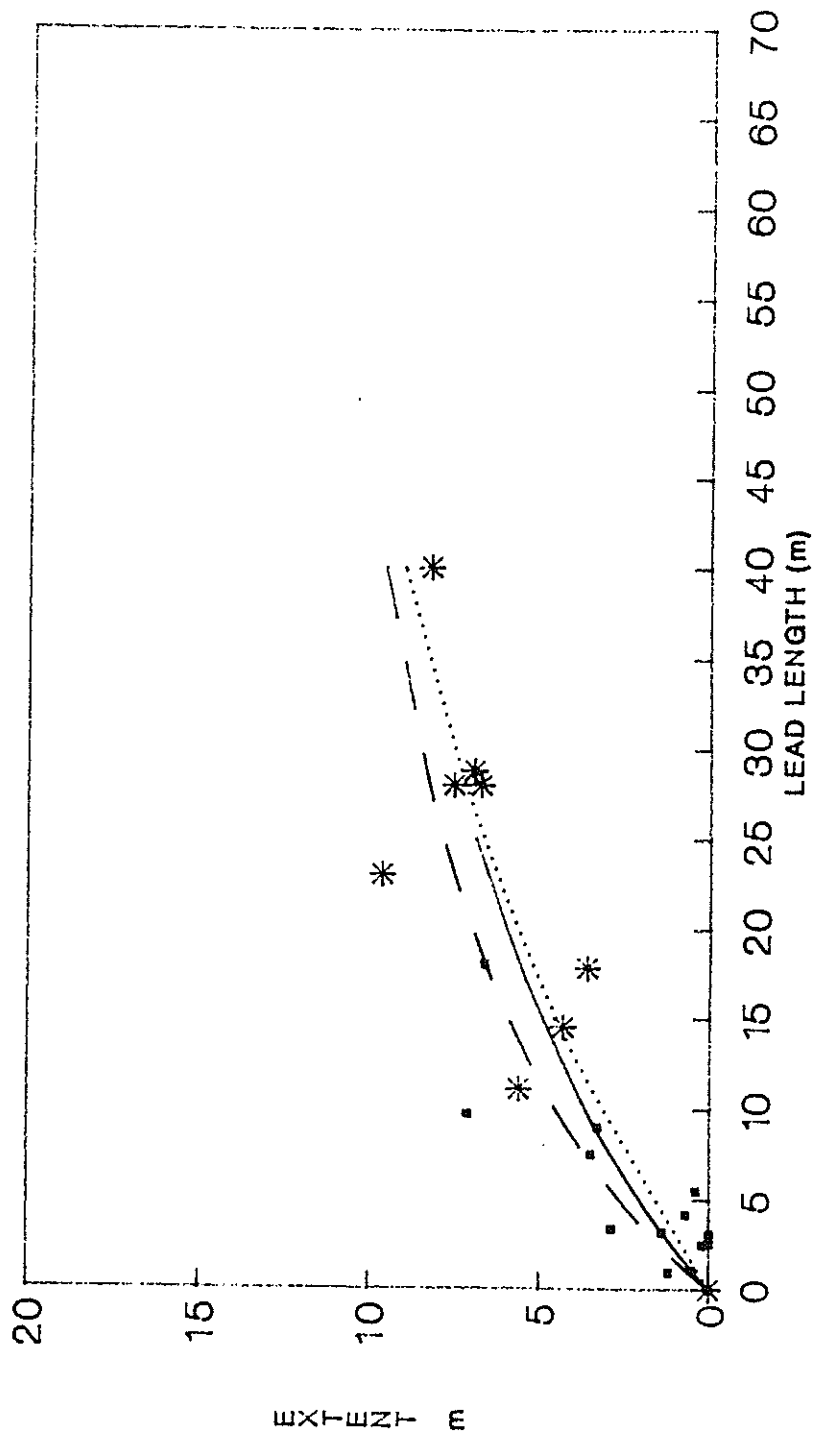
Fig.4 W.D.Levels and Doornfontein Carbon Leader

Figure 4 is a plot of the data and curves for the Western Deep Levels and Doornfontein data together with a composite curve for these Carbon Leader mines. Comparison between the individual curves in Figure 4 suggests that they do not differ significantly despite a depth difference of about 1 000 m between the stopes examined. Both mines are operating with large longwalls in which large stope spans will have resulted in total closure. However because of the stabilizing pillars on WDL the energy release rates would be similar in the panels investigated on the two mines thus explaining the minimal difference in results.

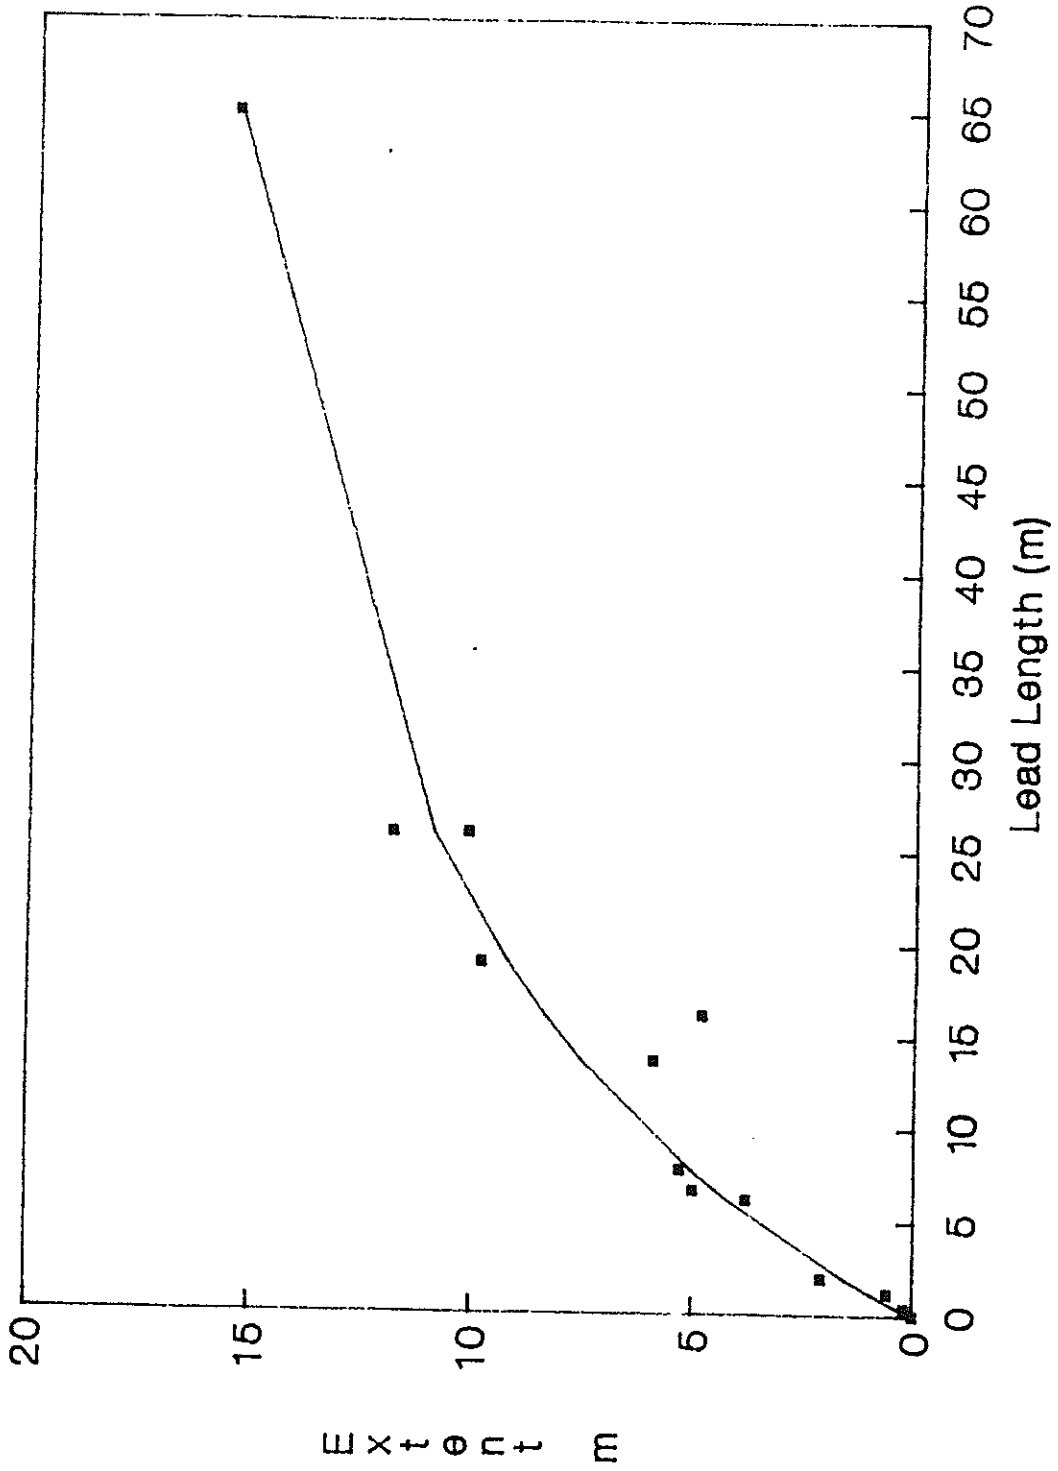
Fig.5 Haartebeesfontein and Buffelsfontein Vaal Reef

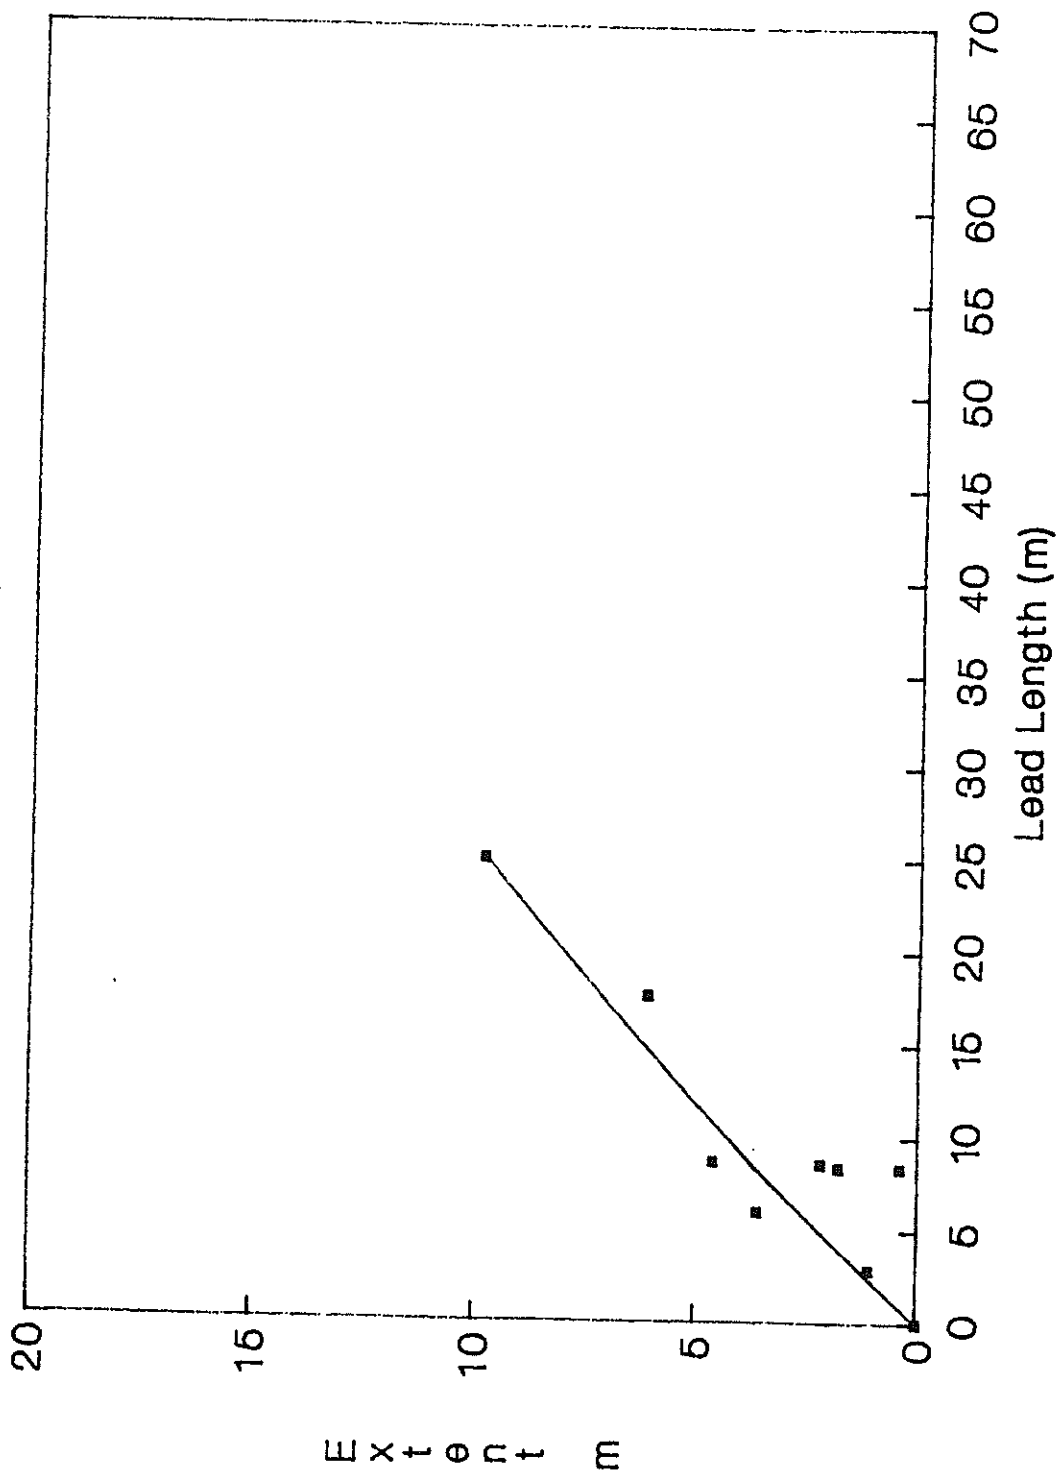
Fig.6 Pres Steyn Basal Reef (>2200m)

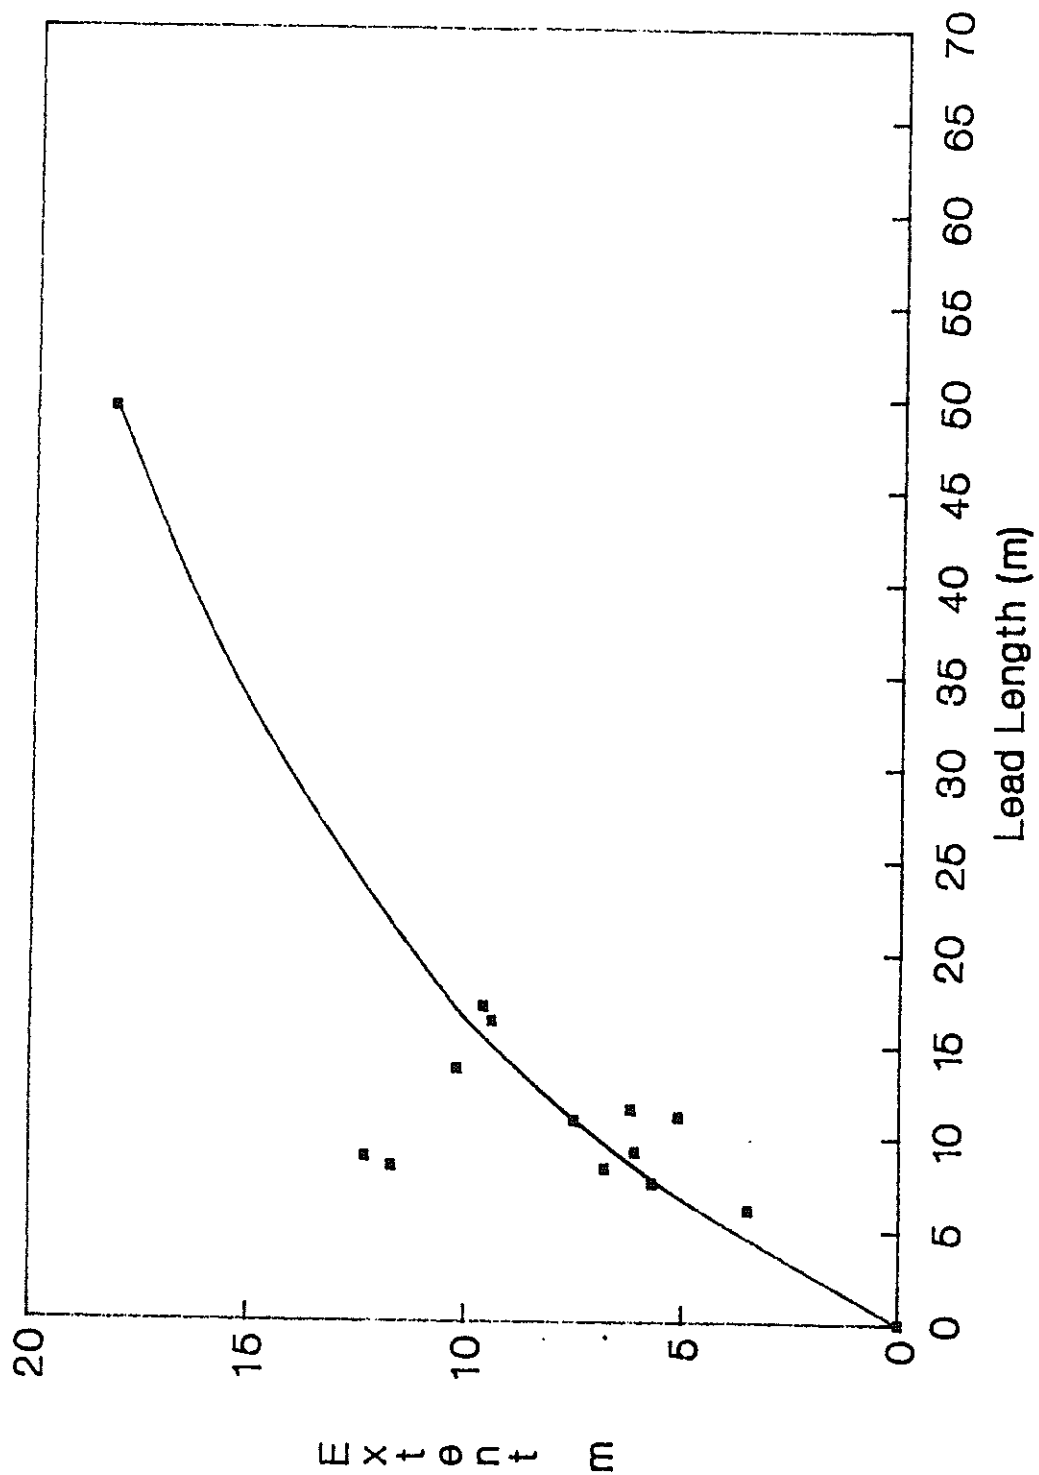
Figure 7. Harmony Basal Reef.

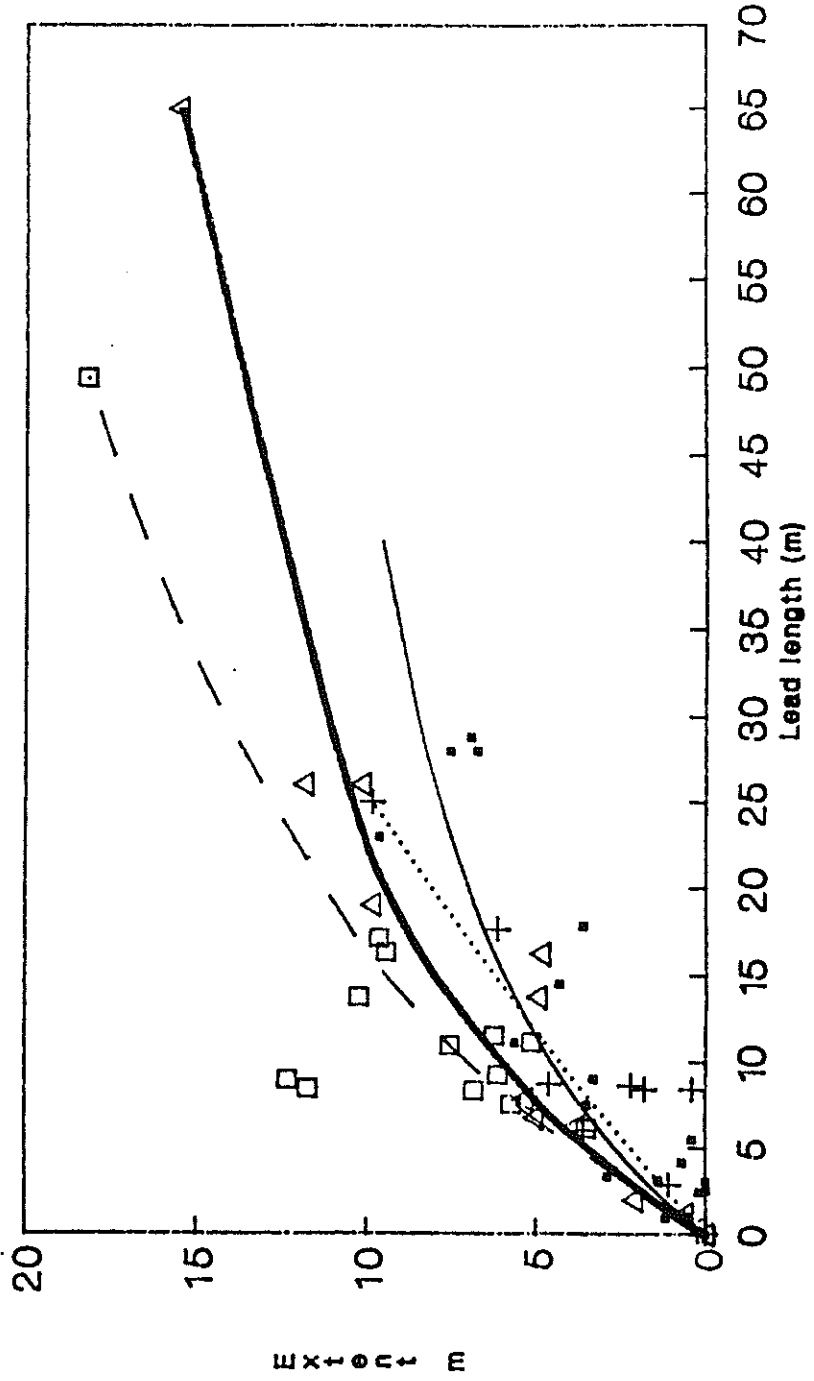
Figure 8 Carbon Leader, Vaal reef and Basal reef

It is evident from Figure 8 that the extent of siding-parallel fracturing is different in the four different geological settings summarized by the regression curves. At 30 m lead length the extent of fracturing ranges between 7 m on the Carbon Leader, through 10 m for the Vaal Reef and Basal Reef on President Steyn, to 13 m for the Basal Reef on Harmony.

The source of this difference seems likely to be a combination of difference in ERR and the thickness of the hangingwall beds which ranges from about 0,5 m on Harmony through 0,8 - 1 m on President Steyn and on the Vaal Reef to about 1,5 - 2 m on Western Deep Levels where all the longer lead length data for the Carbon Leader were collected. It has been shown that geological joint spacing (Ladeira and Price, 1981), and hence the susceptibility to fracturing of strata, is approximately proportional to bed thickness up to a bed thickness of 1-2 m. Since the extent of siding-parallel fracturing was measured to the point where siding-parallel fractures were 1 m or less apart, it would be expected that this cut off point would be reached furthest into the lagging panel for the thinnest hangingwall bedding and vice versa.

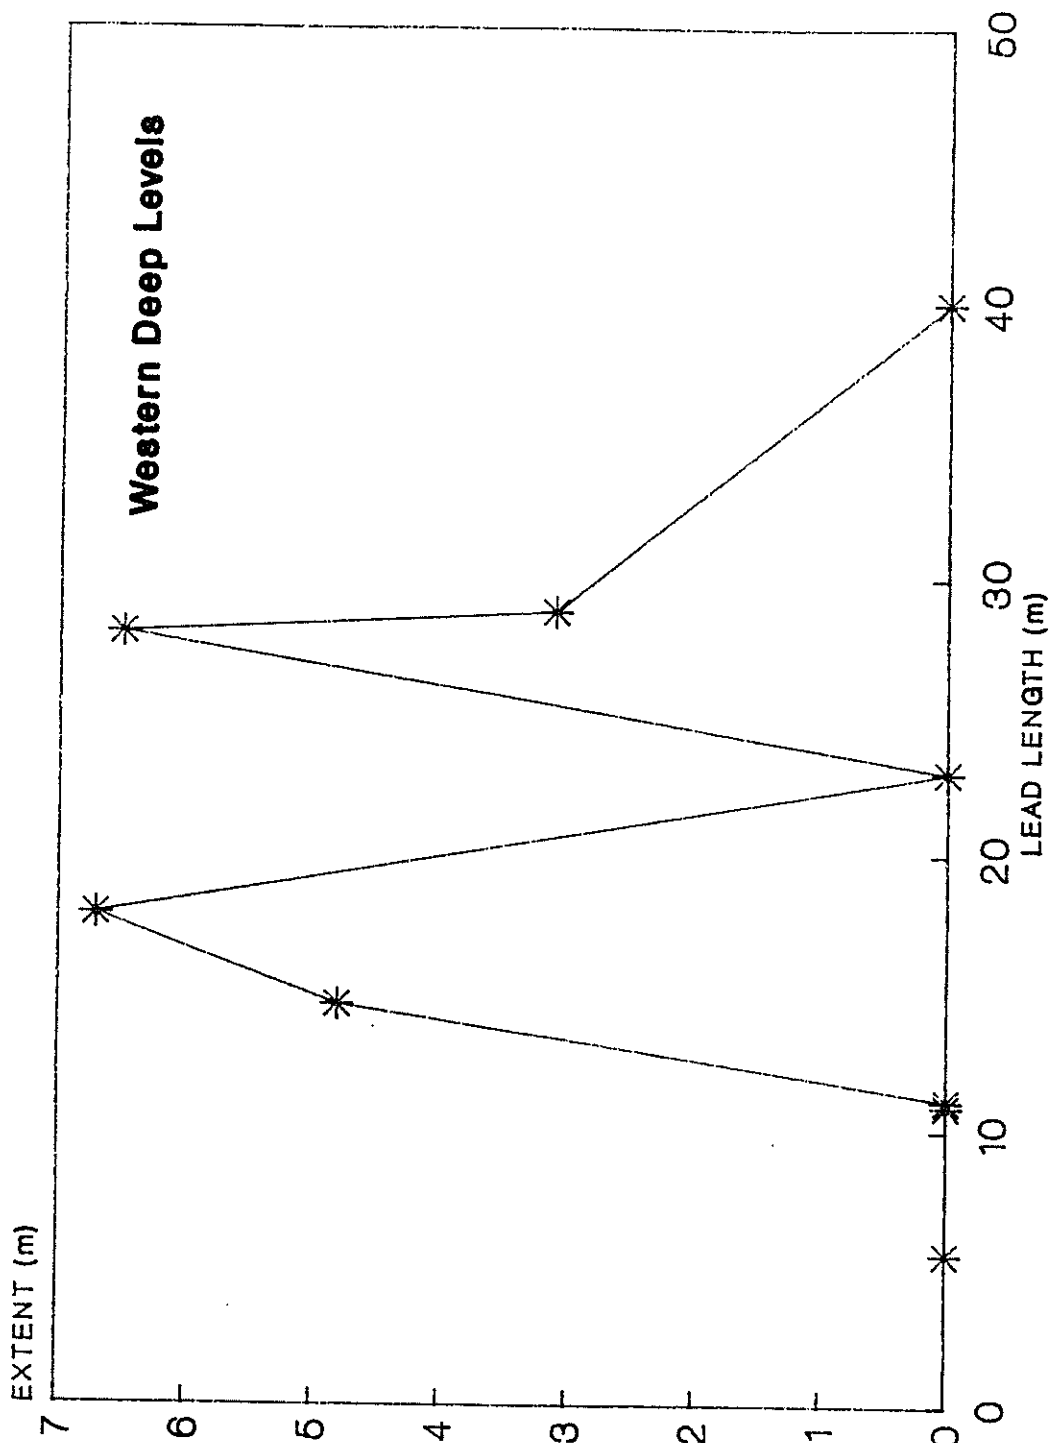
The term exclusive siding-parallel fracturing is used to denote the zones adjacent to the sidings in which the prior formation of siding-parallel fracturing effectively stopped the formation of face-parallel fracturing ahead of the lagging face. Examination of Figures 9 - 11 reveals that the extent, or even existence, of such exclusive siding-parallel fracture zones bears no apparent relationship to the length of the interpanel lead. The most that can be deduced is that, for the Carbon Leader, Vaal and Basal reefs (on President Steyn), exclusive siding-parallel fracture zones occur in 30 to 50 per cent of cases and may extend as far as 6 m into the lagging panel. On Harmony no exclusive siding-parallel fracture zones were observed.

Figure 9 Exclusive sidng-parallel fracture, Carbon Leader

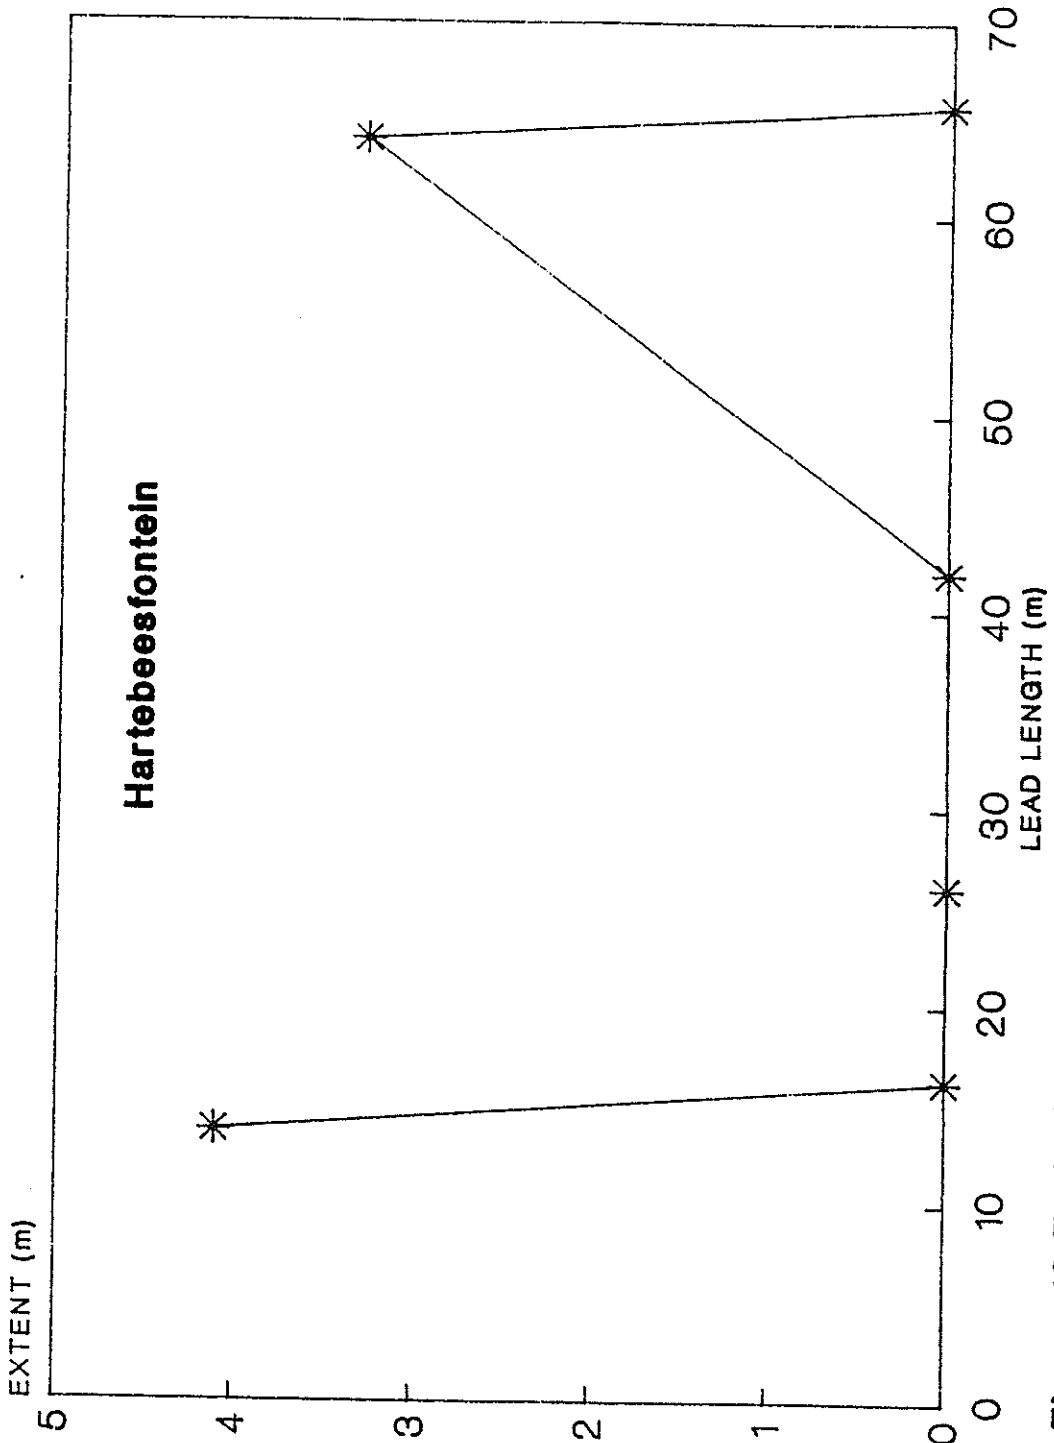
Figure 10 Exclusive sliding-parallel fractures, Vaal reef

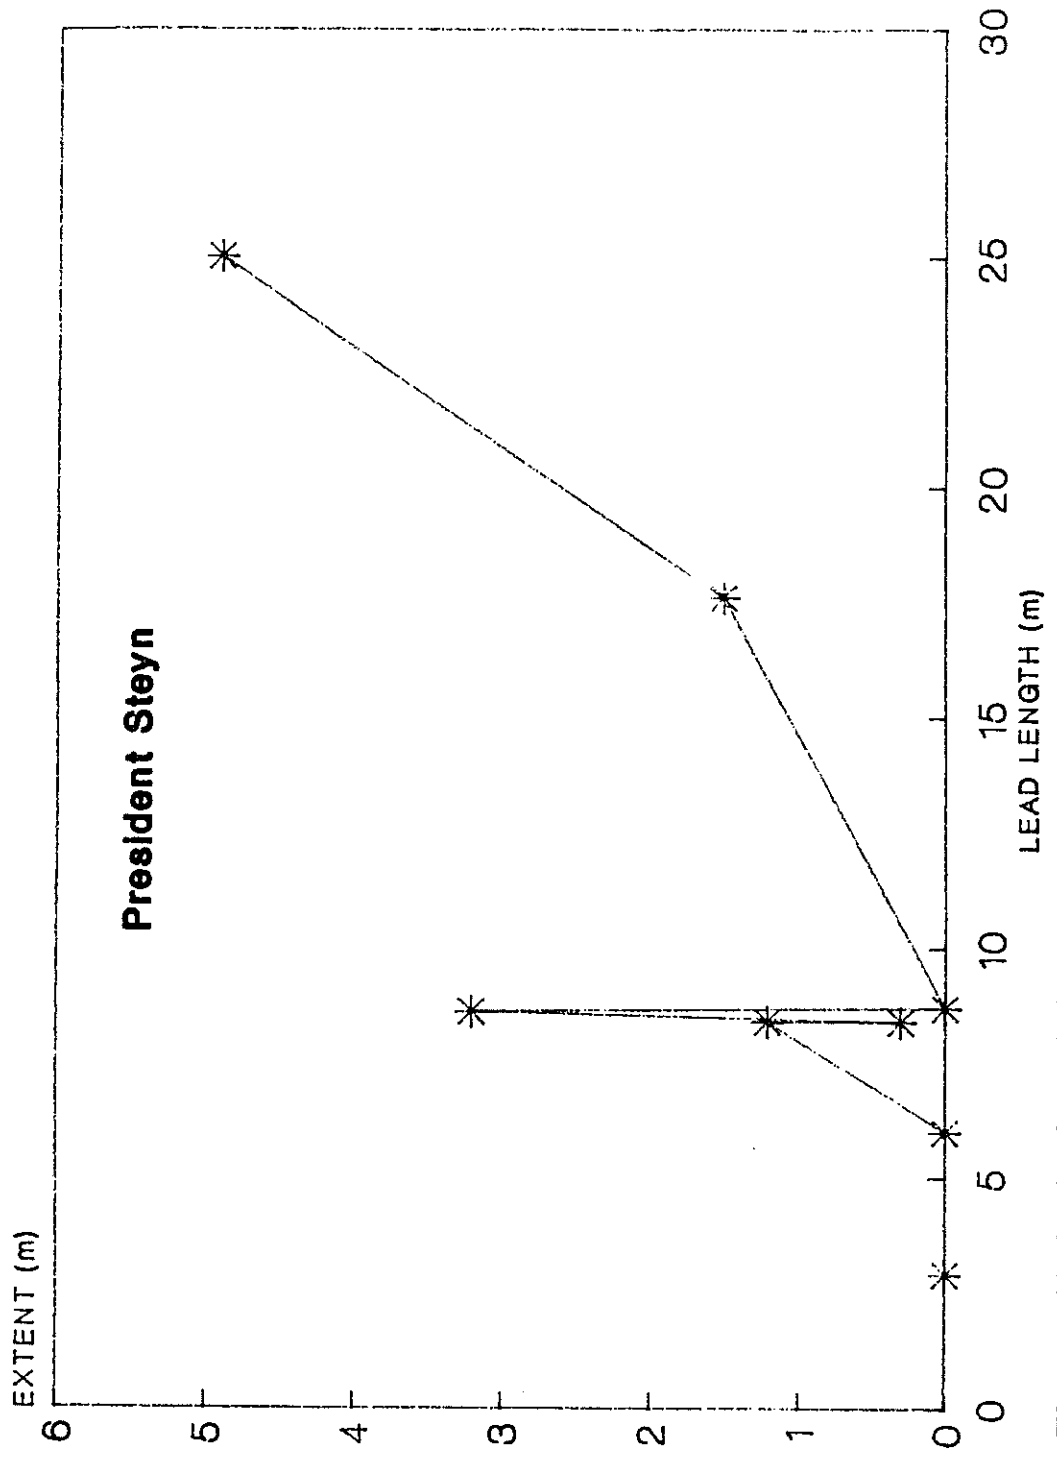
Figure 11 Exclusive sliding-parallel fractures, Basal reef
