TITLE Mining of the 94 East faces, TauTona

CLIENT AngloGold. Mr. A Naismith

DATE 19th December 2001

CSIR REPORT NUMBER 2002-0035

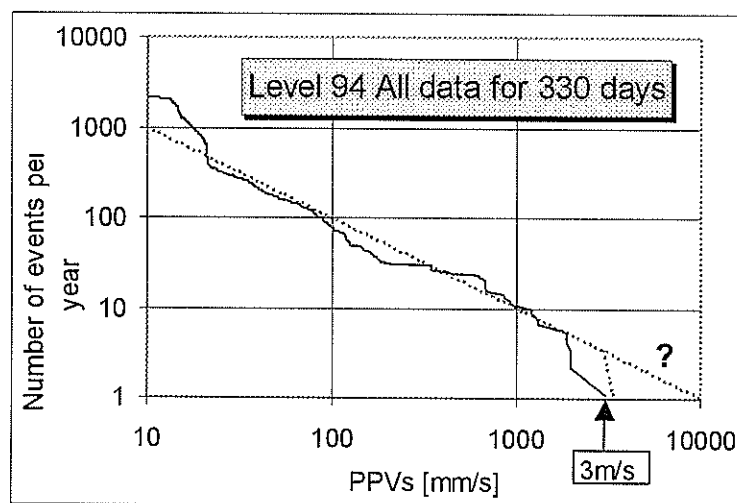
Peak velocities were measured in 94E panels between November 2000 and August 2001 as part of SIMRAC project GAP709. 10 events produced strong ground motion in excess of 1 m/s during the 330 days of recording. Figure 2 shows the rate at which peak velocities were measured to have exceeded values ranging from 10 mm/s to 3 m/s. Although there was a sharp change in slope suggesting that the maximum PPV might be 3 m/s, the data alone cannot be used to exclude the possibility of exceeding 3 m/s at some stage.

Figure 2. Incidence of strong ground motion recorded by Peak Velocity Detectors in 94E, all data. From GAP709 final report (in preparation).

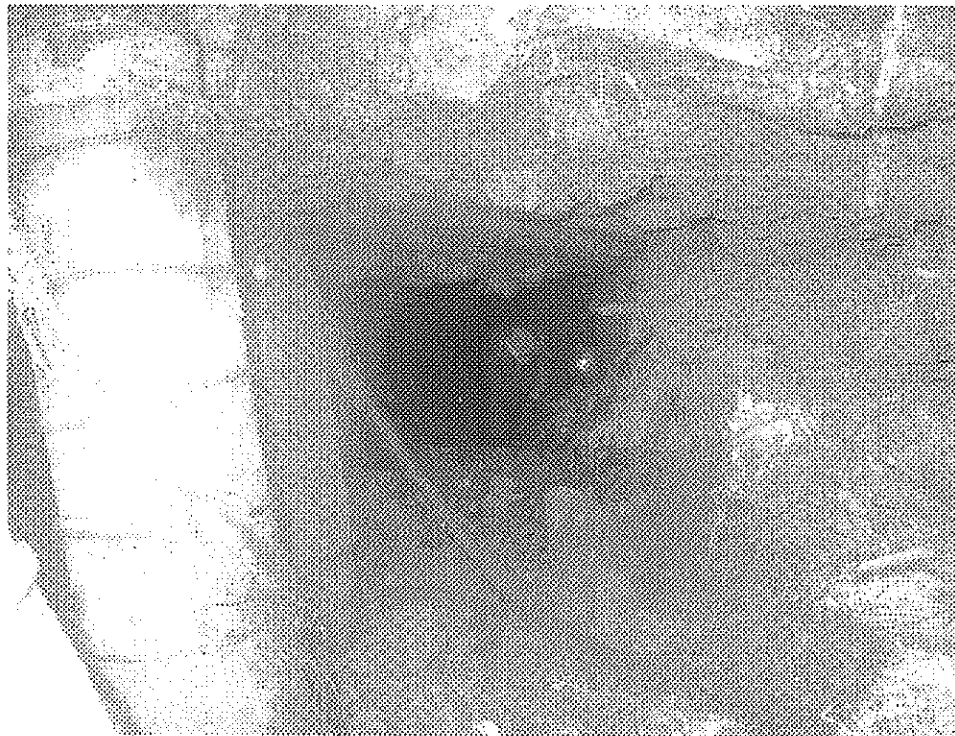
From the observed damage it was clear that the event caused rapid bulking of the footwall under high acceleration. In places, the remaining stope width was less than ± 70 cm. If persons were in the panels at the time of the event it could have resulted in injury or death.

The intense support at the face and the clamping effect of the backfill were very effective in limited the degree of hanging-wall fall-outs. A small reason for the damage to the footwall was that the footwall is not barred. The fundamental processes of the footwall rubbelsation are not understood.

Figure 3. Photograph taken in panel 94E1 looking down towards a person in the bottom strike gully. Note the rubble on the footwall derived from rubbelised footwall rocks. .

3. **Increased the stoping width from the current 0.9 m to 1.3 m.** From the observed damage it was clear that the event caused rapid bulking of the footwall under high acceleration. In order to reduce this damaging effect on persons being projected onto the hanging wall, it is recommended that the stoping width be increased from the current 0.9 m to 1.3 m. This increase will not compromise the existing support system. The high closure rate should provide sufficient stress on the elongates even though they will be longer. . By providing more space between

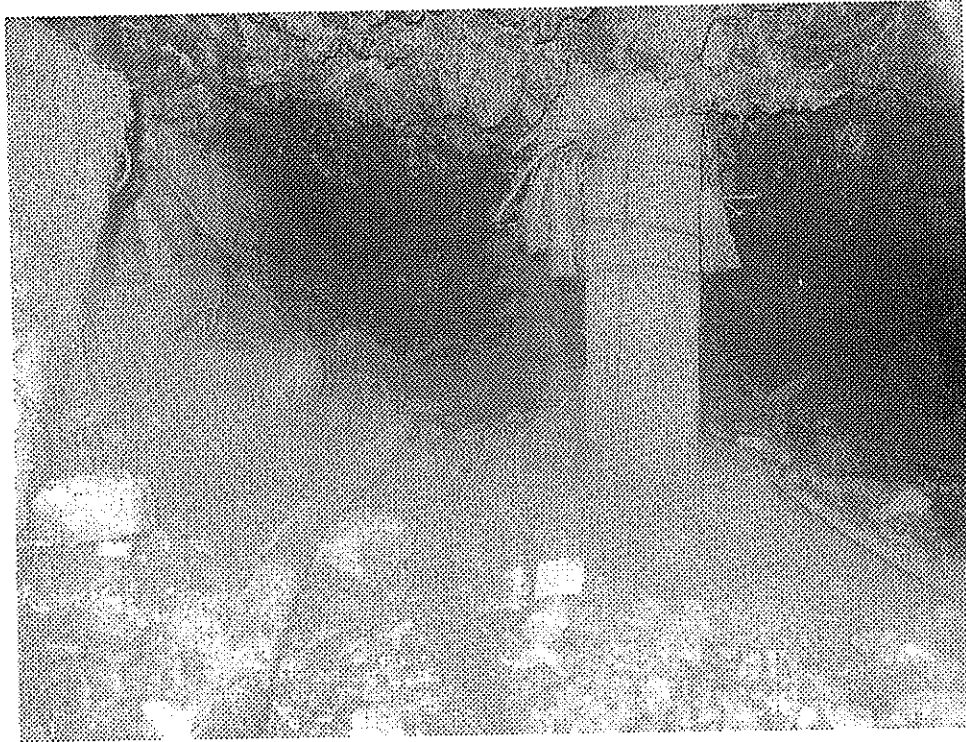
Figure 4. Photograph taken in the lower portion of panel 94E1 looking updip. The closure shown on the elongate showed that it performed well. Note again the rubble on the footwall rocks.
