FORENSIC STUDY INTO THE CAUSES OF PREMATURE FAILURES IN ASPHALT PAVEMENTS IN TANZANIA

ABSTRACT

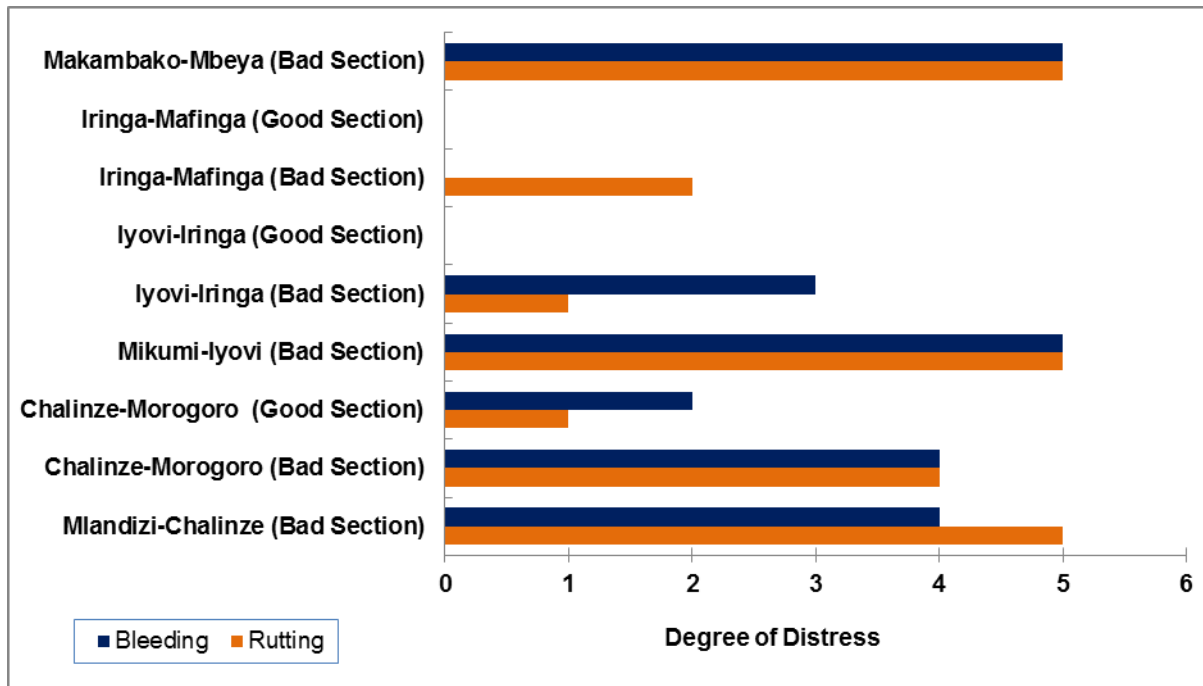
The degree and extent of visible distresses were recorded and evaluated in accordance with guidelines as set out in TMH 9 (1992). Figure 1 presents the degree of rutting and bleeding. The degree of zero (0) means no distress, whereas five (5) indicates a severe distress condition. There were apparently no distresses observed on the good sections of Iyovi-Iringa and Iringa-Mafinga. These results are incomplete as the visual inspection results of Nelson Mandela and Chalinze-Kitumbi sections were not available for reporting. Of significance is the fact that the three overlay rehabilitated road sections (Mlandizi-Chalinze, Mikumi-Iyovi and Makambako-Mbeya) showed more severe rutting and bleeding

than all other sections. Severe shoving was also associated with the rutting observed in these sections.

Figure 1: Observed critical distresses for nine road sections –TMH 9 criteria

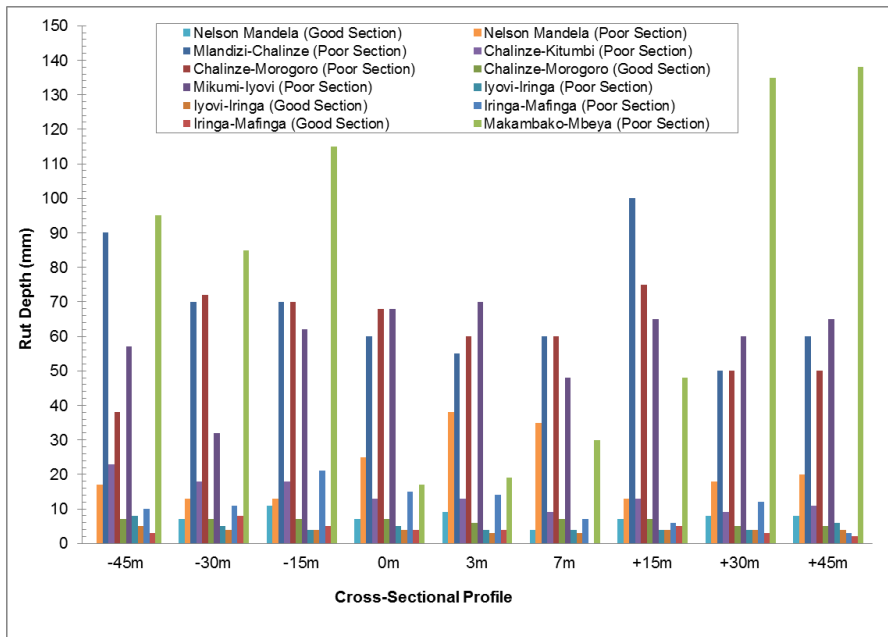
Figure 2 and Figure 3 show the maximum rut depth for the outer and inner wheel tracks, respectively. It is important to note that the rut depths presented in these graphs are the total rut depth for both densification and shoving. Generally, the measurements for the outer wheel tracks were found to be higher than those of the inner wheel tracks.

Figure 2: Maximum rut depth for outer wheel track

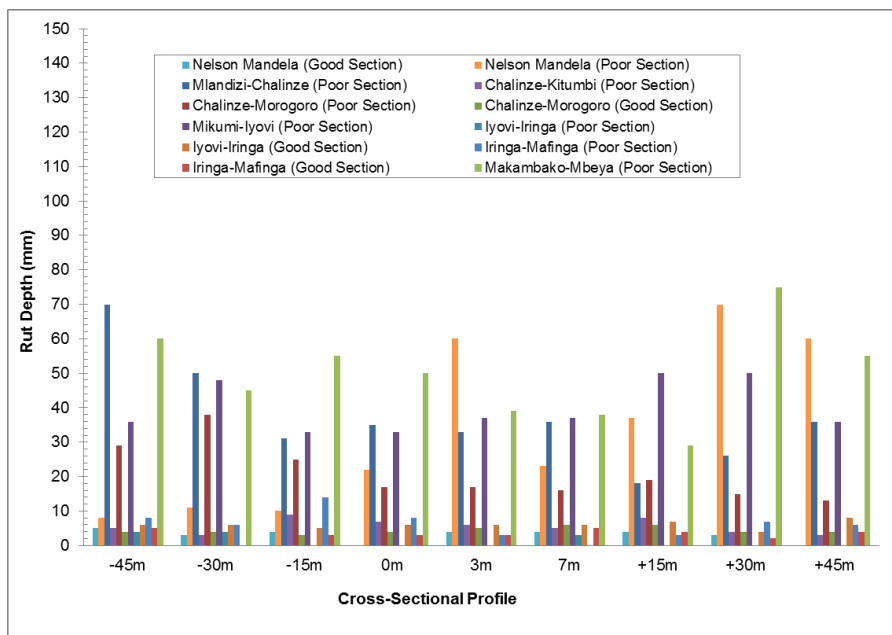
Figure 3: Maximum rut depth for inner wheel track

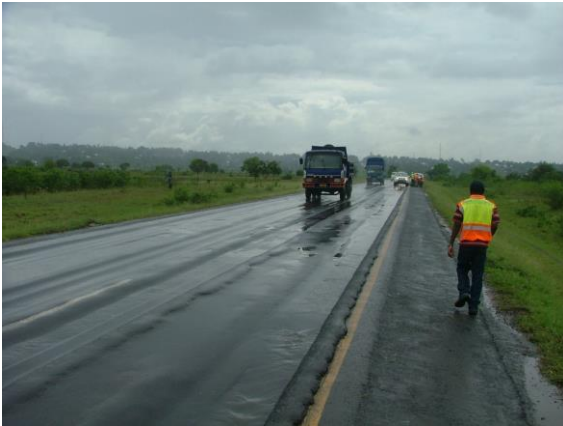
Figure 4 shows detailed results of rut depth measurements for the Mlandizi-Chalinze, Chalinze-Morogoro, Mikumi-Iyovi, and Makambako-Mbeya road sections. A common feature for these sections was that after rain, water stays in the wheel tracks, resulting in ponding and aquaplaning. In addition, bleeding was accompanying rutting on some sections. The maximum rut depth in the outer wheel track was about 140 mm, and the maximum rut depth in the inner wheel track was about 70 mm. Figure 5 shows test pits indicating that rutting on the Mlandizi-Chalinze, Mikumi-Iyovi, and Makambako-Mbeya road sections was restricted to the asphalt layers of the pavement whereas rutting on the Iringa-Mafinga road section can be attributed to both underlying and the asphalt concrete layers.

(a) Severe rutting on Mlandizi-Chalinze road section

Name of Road section	Condition of Section	Critical Distress	Cause and Mechanism	Rehabilitation Option
Mlandizi-Chalinze	Poor, rehabilitated road section	Rutting/shoving	Unstable asphalt mix (poor mix design) for the heavy truck traffic and axle loads on T1. Occurred over long sections in this road possibly due to high axle loads (from heavy trucks) causing densification, or shear failure (plastic flow) in the asphalt layers.	Overlay, mill out and replace (full depth-asphalt, full lane width) the unstable mix with a high stability mix (> 100 mm asphalt binder/base course, 40 mm - 50 mm wearing course). Use strong stone skeleton mixes (e.g. Dense graded mixes) with or without modified binders for wearing course, and a high stiffness mixes (with or without modified binder, EVA, SBS) for base/binder course. Use high quality, angular and rough textured crushed stones in the mix.
Chalinze-Morogoro	Poor, rehabilitated road section	Rutting/shoving	Unstable asphalt mix (poor mix design) for the heavy truck traffic and axle loads on T1. Occurred over long sections in this road possibly due to high axle loads (from heavy trucks) causing densification, or shear failure (plastic flow) in the asphalt layers.	Overlay, mill out and replace (full depth-asphalt, full lane width) the unstable mix with a high stability mix (> 100 mm asphalt binder/base course, 40 mm - 50 mm wearing course). Use strong stone skeleton mixes (e.g. Dense graded mixes) with or without modified binders for wearing course, and a high stiffness mixes (with or without modified binder, EVA, SBS) for base/binder course. Use high quality, angular and rough textured crushed stones in the mix.

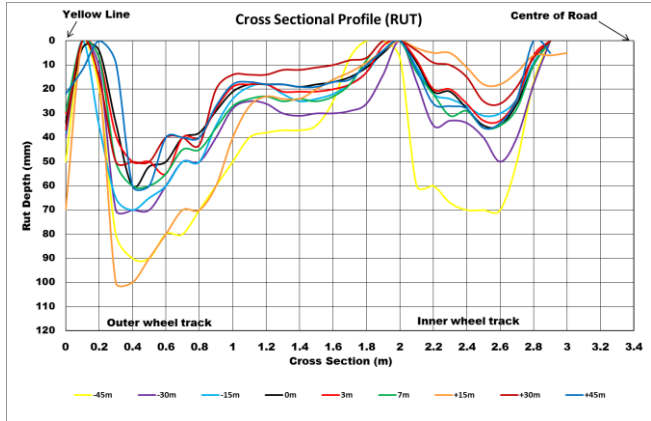
(b) Ruth depth along cross section of Mlandizi-Chalinze road

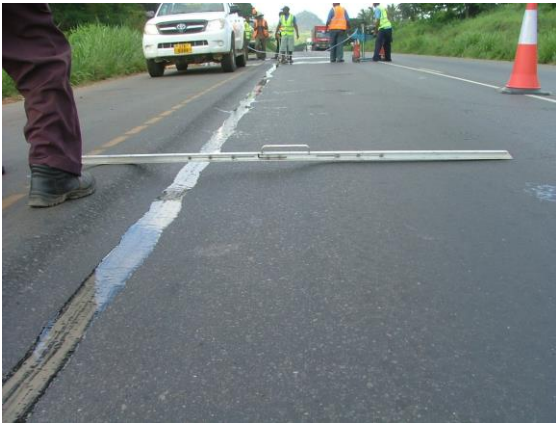
(c) Rutting on Chalinze-Morogoro road section

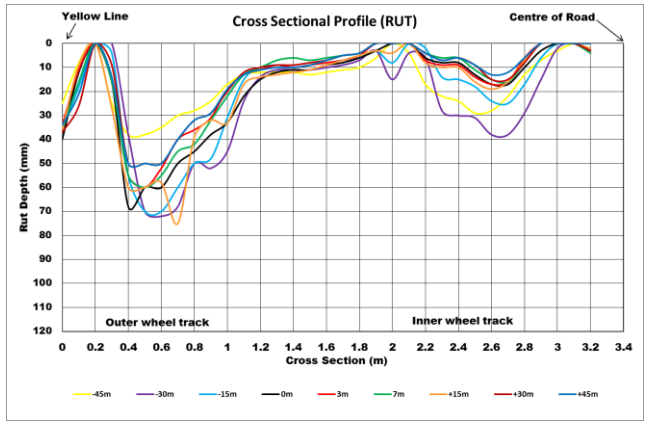
(d) Ruth depth along cross section of Chalinze-Morogoro road

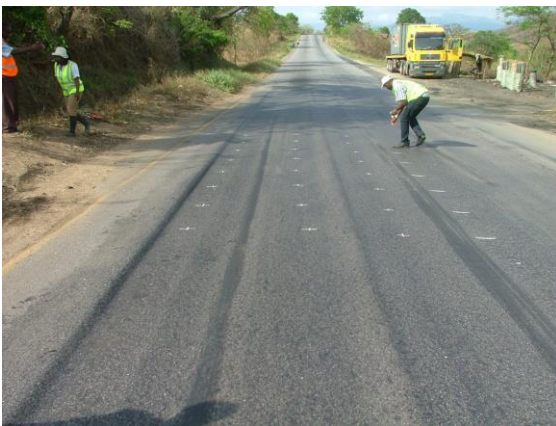
(e) Rutting on Mikumi-Iyovi road section

Mikumi-Iyovi	Poor	Rutting/shoving and bleeding.	<u>Rutting</u> : Unstable asphalt mix (poor mix design) for the heavy truck traffic and axle loads on T1. Occurred over long sections in this road possibly due to high axle loads (from heavy trucks) causing densification, or shear failure (plastic flow) in the asphalt layers. <u>Bleeding</u> : Consequence of poor mix design (bitumen content in excess of that which the air voids in the asphalt mix can accommodate usually at high temperatures. Bitumen migrates to the surface of the pavement.	Overlay, mill out and replace (full depth-asphalt, full lane width) the unstable mix with a high stability mix (> 100 mm asphalt binder/base course, 40 mm - 50 mm wearing course). Use strong stone skeleton mixes (e.g. Dense graded mixes) with or without modified binders for wearing course, and a high stiffness mixes (with or without modified binder, EVA, SBS) for base/binder course. Use high quality, angular and rough textured crushed stones in the mix. Both rutting and bleeding can be addressed by the options provided.

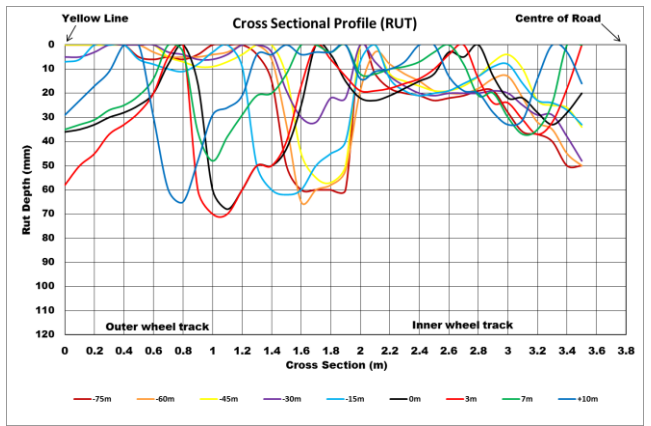
(f) Ruth depth along cross section of Mikumi-Iyovi road

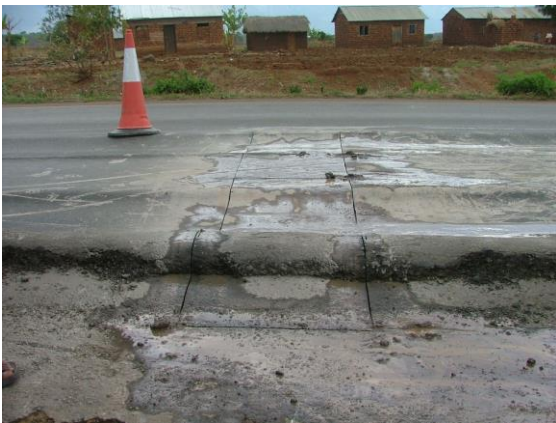
(g) Rutting on Makambako-Mbeya road section

Makambako-Mbeya	Poor, rehabilitated road section	Rutting/shoving	Unstable asphalt mix (poor mix design) for the heavy truck traffic and axle loads on T1. Occurred over long sections in this road possibly due to high axle loads (from heavy trucks) causing densification, or shear failure (plastic flow) in the asphalt layers.	Overlay, mill out and replace (full depth-asphalt, full lane width) the unstable mix with a high stability mix (> 100 mm asphalt binder/base course, 40 mm - 50 mm wearing course). Use strong stone skeleton mixes (e.g. Dense graded mixes) with or without modified binders for wearing course, and a high stiffness mixes (with or without modified binder, EVA, SBS) for base/binder course. Use high quality, angular and rough textured crushed stones in the mix.

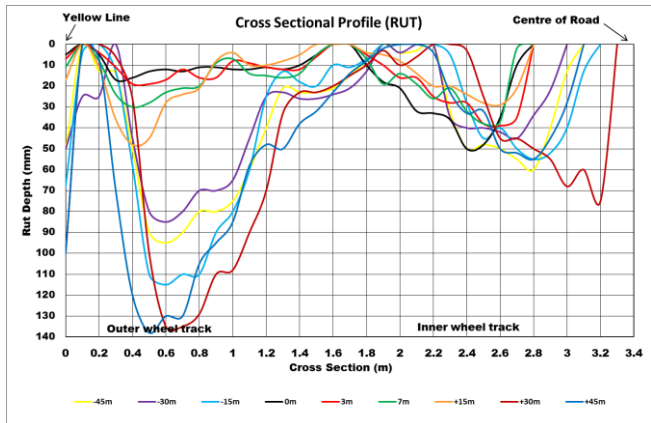
(h) Ruth depth along cross section of Makambako-Mbeya road

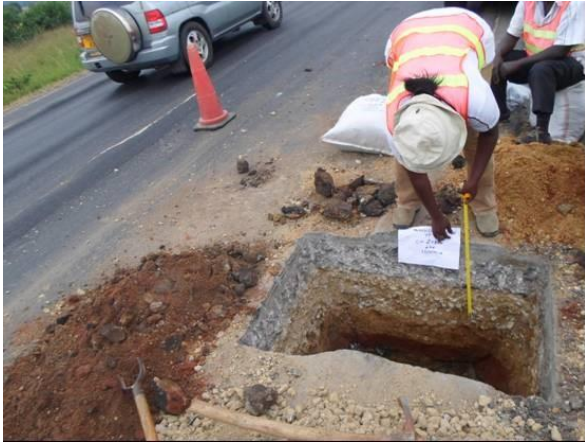
(a) Test pit at Mlandizi-Chalinze road section

- Test pit profiling results indicated that most rutting experienced in the road sections can be attributed to the asphalt layers. Contributions of underlying layers to rutting were limited in one road section (i.e. Iringa-Mafinga).

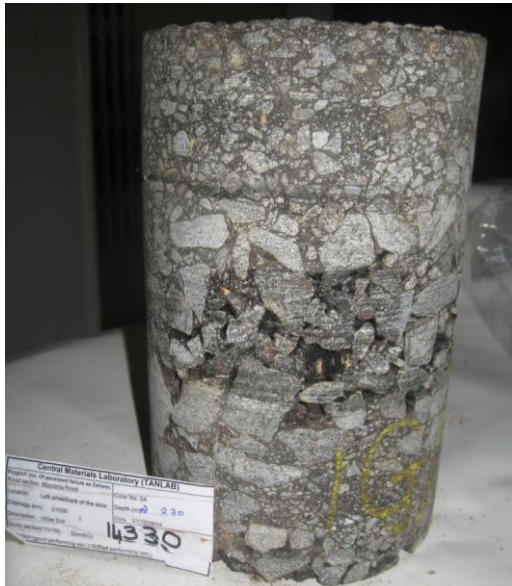
Coring at the rehabilitated road sections showed that during rehabilitation, the old asphalt layers were not milled out before new overlays were placed. Thus, the core samples extracted consist of the new and old surfacing layers.

(c) Core from Makambako-Mbeya road overlay road section

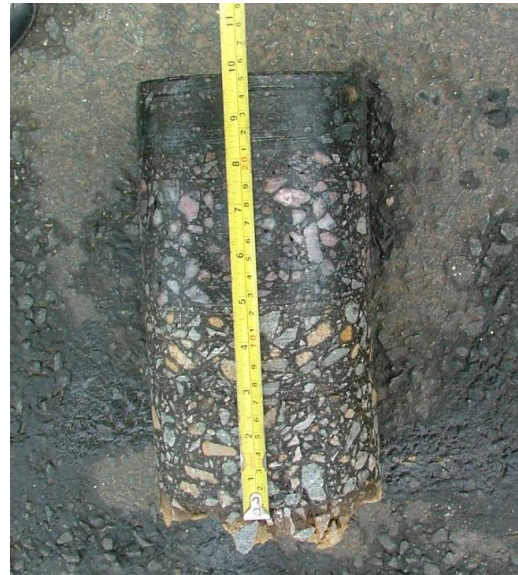
(d) Core from Mlandizi-Chalinze overlay road section
