**Safety in Mines Research Advisory Committee**

**Final Report**

**Ergonomics of mining machinery  
and transport in the South African  
mining industry**

**Project number : SIM 02 05 04 (EC 2003-0252)**

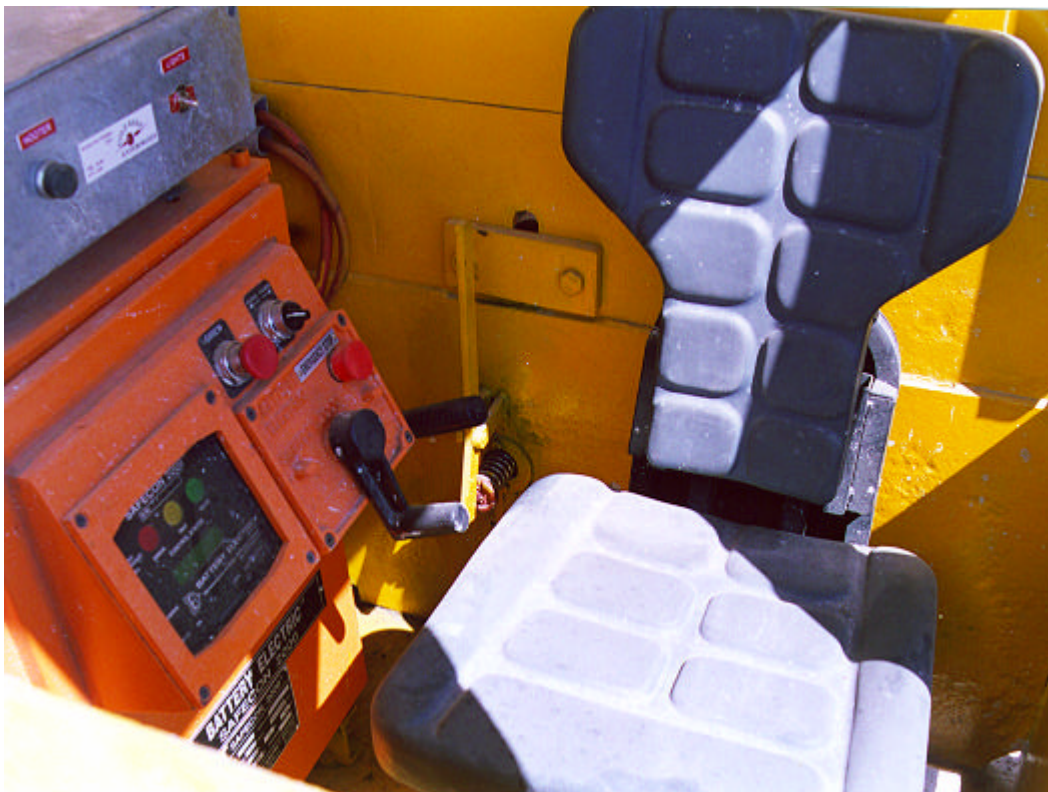
**Figure 3.2.4: Seat with T-shaped backrest**

Newer machines were fitted with polyurethane seating systems with T-shaped backrests. The T-shaped seat takes into consideration the use of a cap lamp battery and self-contained self-rescuers.

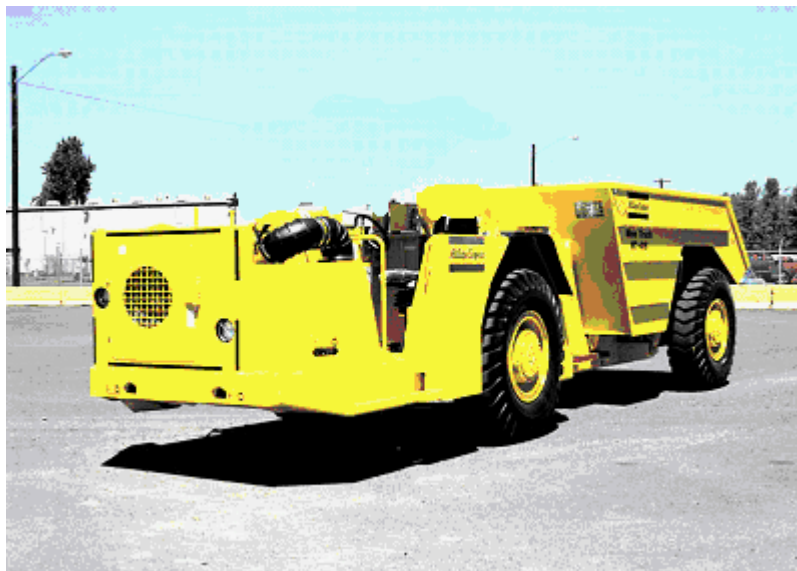
**Figure 1.2: Haulage Truck 1**

ITEM	DESCRIPTION	COMMENTS
<b>OPERATORS' WORKSTATION</b>		
Access		
	Entrance width	400 mm (inadequate)
	Entrance step height from the ground	600 mm (too high)
Clearances inside the cab		
	Canopy	None
	Canopy to seat height	N/A
	Shoulder width	Restrictive
	Knee clearance from SRP to front wall panel	750mm (adequate)
<b>SEATING</b>		
	Seat type	ISRI bucket type with a backrest
	Seat material	Vinyl
	Seat base dimensions (WxD)	470x500 mm (adequate)
	Seat backrest dimensions (WxH)	470x550 mm (adequate)
	Seat surface height from the cab floor	590 mm (too high)
	Restraint system	Lap belt fitted not utilised
<b>CONTROLS AND DISPLAYS</b>		
Steering mechanism	Steering wheel	? 300 with a knob ? 55 (acceptable)
Display panel and instruments layout		Lack of labeling
<b>VISIBILITY</b>		
	Operators field of view	Rear viewing was limited

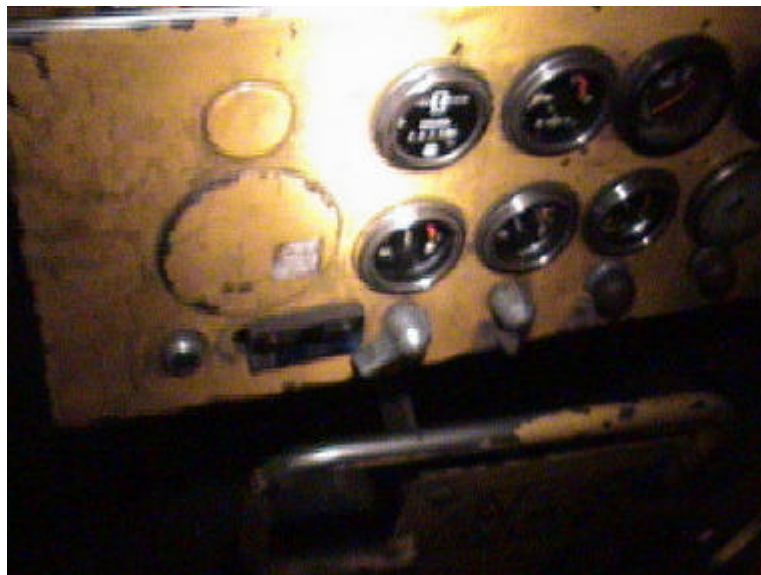
**Figure 1.3: Lack of instrument labelling**

All the controls were within the reach envelope and visual field of the seated 5<sup>th</sup> percentile to 95<sup>th</sup> percentile male South African. Labelling of the controls and instruments is lacking (see Figure 1.3).

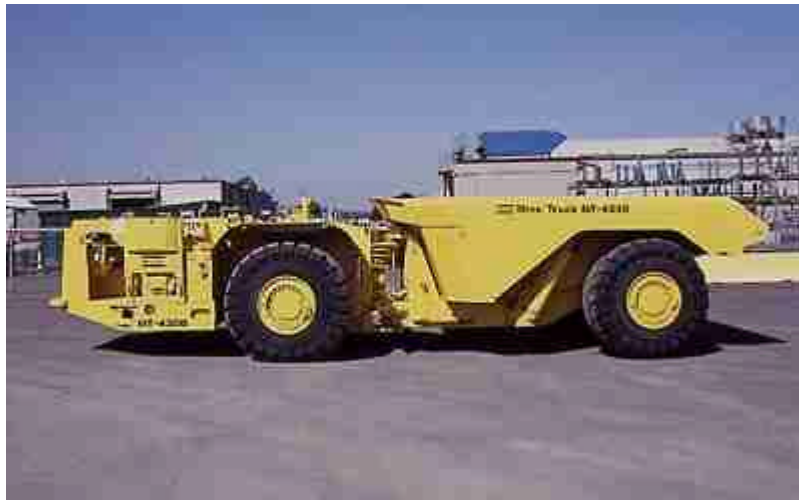
**Figure 1.4: Haul Truck 2**

ITEM	DESCRIPTION	COMMENTS
<b>OPERATORS' WORKSTATION</b>		
Access		
	Entrance width	450 mm (inadequate)
	Entrance step height from the ground	600 mm (too high)
Clearances inside the cab		
	Canopy (if fitted)	YES (Airconditioned cab)
	Height of canopy roof ceiling to SRP	1000 mm (adequate)
	Shoulder width	Adequate
	Knee clearance from SRP to front wall panel	750 mm (adequate)
<b>SEATING</b>		
	Seat type	Air suspension, bucket type chair with a backrest
	Seat material	Vinyl
	Seat base dimensions (WxD)	470x500 mm (adequate)
	Seat backrest dimensions (WxH)	470x550 mm (adequate)
	Seat surface height from the cab floor	590 mm (too high)
	Restraint system	Lap belt fitted
<b>CONTROLS AND DISPLAYS</b>		
Steering mechanism	Steering wheel lever	? 55 (acceptable)
Display panel and instruments layout		Symbols used
<b>VISIBILITY</b>		
	Operators field of view	Rear viewing camera and a VDU are fitted in the cab to aid rear viewing

The surface to entrance-level height was above the recommended height for easy entry into the cab for the 5<sup>th</sup> percentile male South African.

The operator's forward and front visual field was excellent from the seated position. A video camera is fitted on the rear frame of the vehicle and a monitor is fitted inside cab, which helps the driver to see at the rear of the vehicle when reversing it. The rear-viewing system fitted in the vehicle was found to be useful and suitable for the task. The design of the cab and sitting configuration would not enable proper rear viewing from the seated posture without the aid of the video camera.

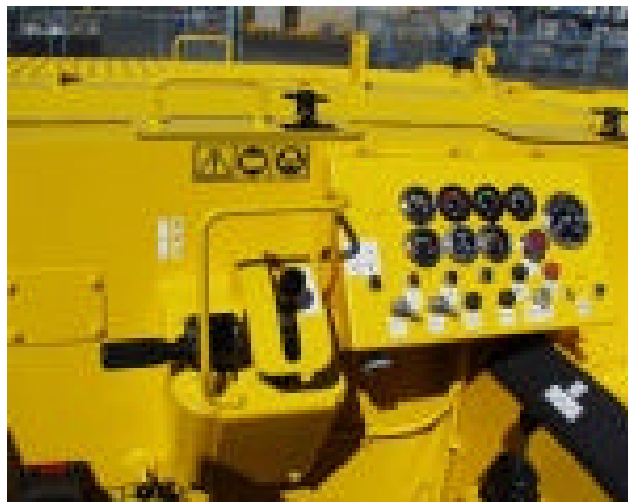
**Figure 1.5: Layout of primary controls and instruments**

All the controls were within the reach envelope and visual field of the seated 5<sup>th</sup> percentile to 95<sup>th</sup> percentile male South African. Symbols are used for the identification of the controls and instruments. The layout of the primary controls and instruments is shown in Figure 1.5. The biomechanical force required to activate the controls appeared to be within acceptable limits.

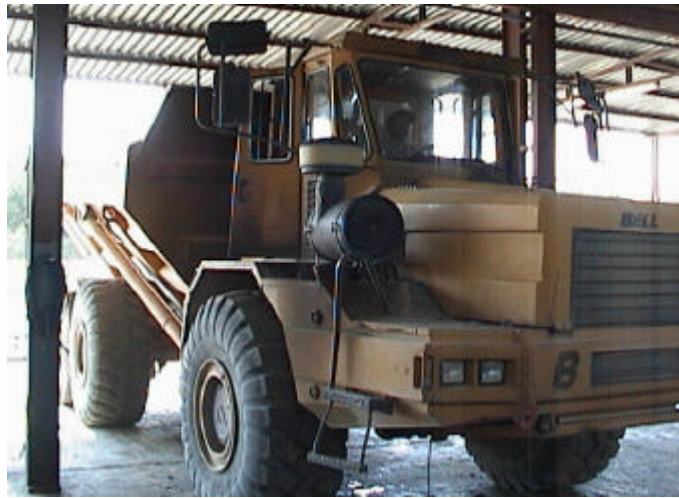
**Figure 1.6: Haul Truck 4**

The height between the surface and the first step was within the recommended height for easy entry into the cab for the 5<sup>th</sup> percentile to the 95<sup>th</sup> percentile male South African. The vehicles have steps fitted on the wheel mudguard. Handrails are fitted which enable three-point contact for easy access (see Figure 1.7).

The fabric used for the seat covers is not suitable for mining machinery. As shown in Figure 1.8, tear and wear is quite high. Also, maintenance of the fabric in a mining operation would be difficult.

The forward and rear visual fields appeared to be good for the normal forward driving.

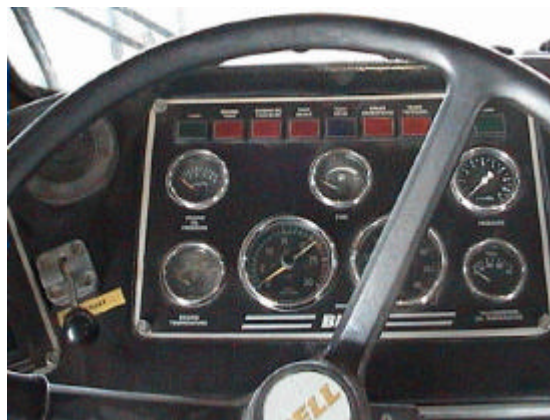
**Figure 1.9: Inconsistent labelling of the controls**

All the controls were within the reach envelope and visual field of the seated 5<sup>th</sup> percentile to 95<sup>th</sup> percentile male South African. Labelling of the controls and instruments was inconsistently applied. As shown in Figure 1.9, some of the controls have labels above the actual control and some have labels below the actual control. The biomechanical force required to activate the controls appeared to be within the acceptable limit.

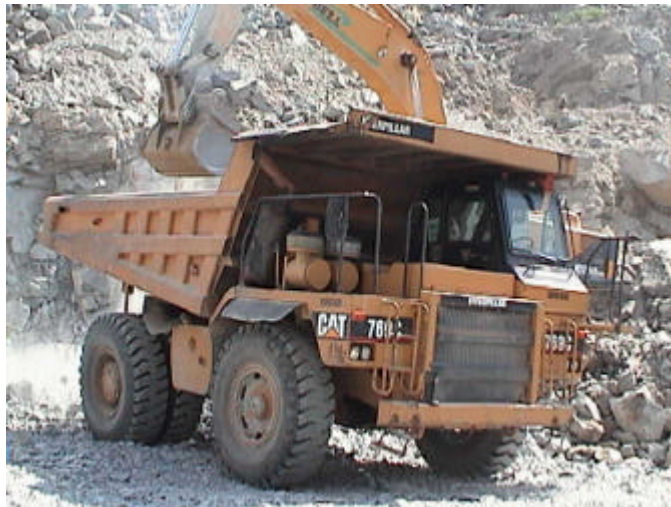
**Figure 1.10: Haul Truck 5**

The forward and rear visual fields appeared to be good for normal forward driving.

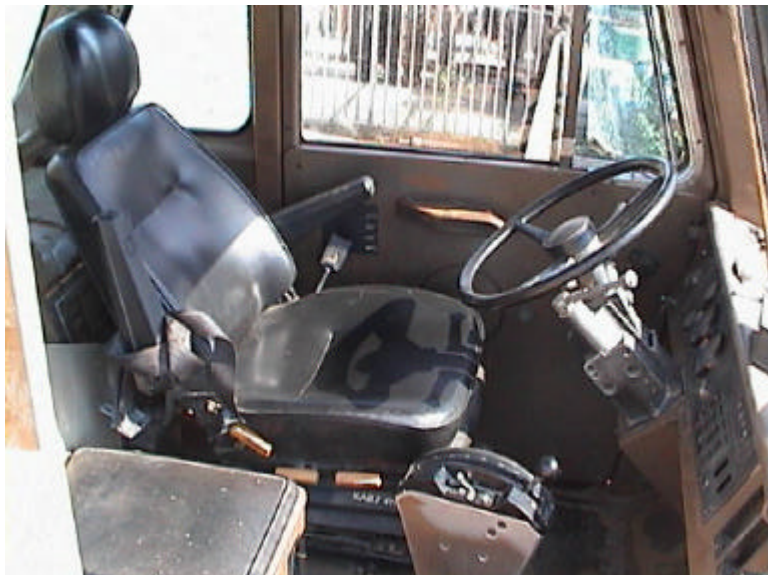
**Figure 1.11: Suitable seat material for a mining machine**

The polyurethane material used for covering the seats was suitable for mining machinery (see Figure 1.11).

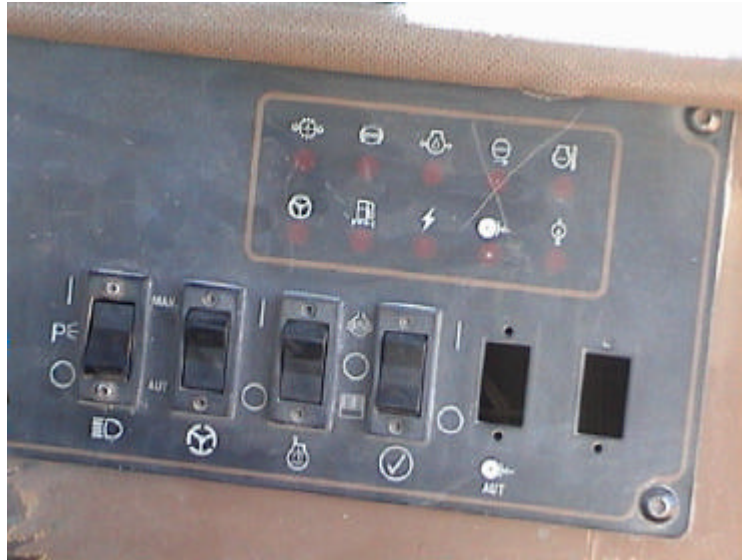
**Figure 1.12: Symbols used for labelling the controls**

All the controls were within the reach envelope and visual field of the seated 5<sup>th</sup> percentile to the 95<sup>th</sup> percentile male South African. The symbols used for labelling the controls and instruments were recognisable (see Figure 1.12). The biomechanical force required to activate the controls appeared to be within the acceptable limits.

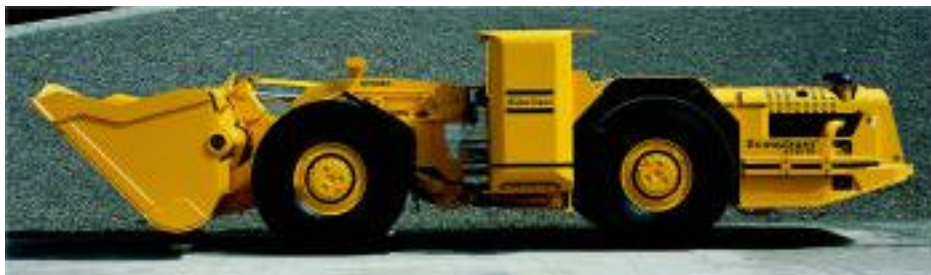
**Figure 1.13: LHD 1**

The surface to entrance-level height was above the recommended height for easy entry into the cab for the 5<sup>th</sup> percentile male South African.

Forward and side viewing was restricted by the cab canopy. From the seated posture, the visual field to the rear is severely restricted.

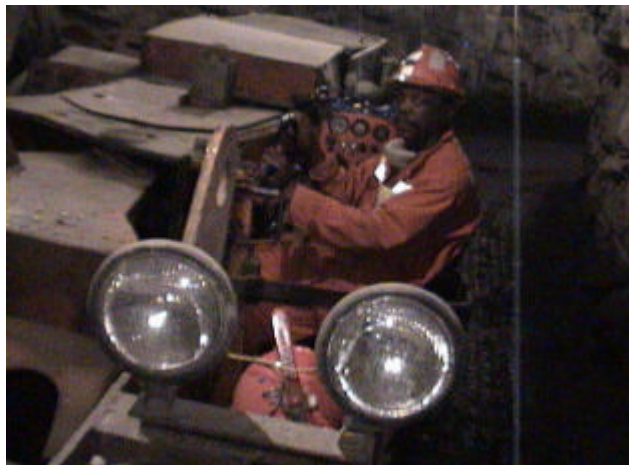
***Figure 1.14: LHD 2***

ITEM	DESCRIPTION	COMMENTS
<b>OPERATORS' WORKSTATION</b>		
Access		
	Entrance step height from the ground	745 mm (too high)
Clearances inside the cab		
	Canopy	None
	Height of canopy roof ceiling to SRP	N/A
	Shoulder width	Adequate
<b>SEATING</b>		
	Seat type	Bucket chair type (ill state of repair)
	Seat material	vinyl
	Seat base dimensions (WxD)	520x450 mm (adequate)
	Seat backrest dimensions (WxH)	450x370 mm (adequate)
	Seat surface height from the cab floor	600 mm (too high)
	Restraint system	None
<b>CONTROLS AND DISPLAYS</b>		
Steering mechanism	Steering wheel	? 370 (acceptable)
Display panel and instruments layout		Lack of labeling
<b>VISIBILITY</b>		
	Operators field of view	Restricted view at the operator's back

There is no specific provision for access to the cab. The operator enters the cab through the left side of the vehicle over the ledge of the cab. The foot pedals are located within the cab entrance area and partially obstruct access. The surface to ledge-level height was above the recommended height for easy entry into the cab for the 5<sup>th</sup> percentile to the 95<sup>th</sup> percentile male South African.

Forward and rear viewing from the driver's seated position was excellent for normal driving. When reversing, the visual field in the front (right-hand side) and to the rear from the seated position was severely restricted.

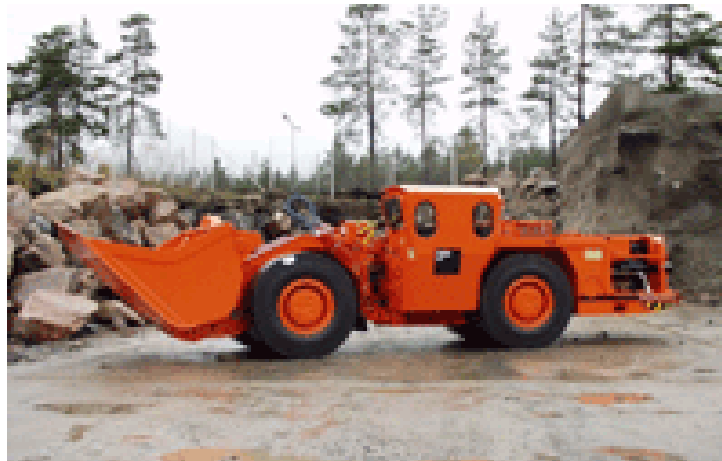
**Figure 1.15: LHD 3**

ITEM	DESCRIPTION	COMMENTS
<b>OPERATORS' WORKSTATION</b>		
Access		
	Entrance width	640 mm (adequate)
	Entrance step height from the ground	490 mm (acceptable)
Clearances inside the cab		
	Canopy	YES
	Height of canopy roof ceiling to SRP	1020 mm (adequate)
	Shoulder width	600 mm (inadequate)
	Knee clearance from SRP to front wall panel	890 mm (adequate)
<b>SEATING</b>		
	Seat type	Bucket chair type
	Seat material	vinyl
	Seat base dimensions (WxD)	370x450 mm (inadequate width)
	Seat backrest dimensions (WxH)	470x520 mm (adequate)
	Restraint system	None
<b>CONTROLS AND DISPLAYS</b>		
Steering mechanism	Steering wheel	? 350 (acceptable)
Display panel and instruments layout		Symbols used
<b>VISIBILITY</b>		
	Operators field of view	Restricted view at the operator's back

Forward and rear viewing from the driver's seated position was excellent for normal driving. When reversing, the visual field to the front and rear from the seated posture is severely restricted by the cab's blind spots.

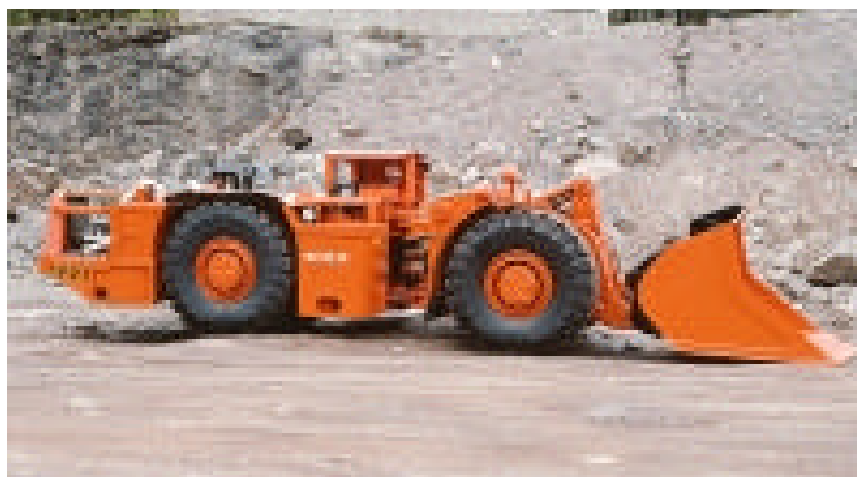
**Figure 1.16: LHD 4**

ITEM	DESCRIPTION	COMMENTS
<b>OPERATORS' WORKSTATION</b>		
Access		
	Entrance width	400 mm (inadequate)
	Entrance step height from the ground	500 mm (acceptable)
Clearances inside the cab		
	Canopy	YES (semi-canopy)
	Height of canopy roof ceiling to SRP	N/A
	Shoulder width	975 mm (adequate)
	Knee clearance from SRP to front wall panel	650 mm (adequate)
<b>SEATING</b>		
	Seat type	Bucket chair type
	Seat material	vinyl
	Seat base dimensions (WxD)	500x450 mm (acceptable)
	Seat backrest dimensions (WxH)	500x450 mm (acceptable)
	Restraint system	None
<b>CONTROLS AND DISPLAYS</b>		
Steering mechanism	Steering wheel	? 350 (acceptable)
Display panel and instruments layout		Symbols are used
<b>VISIBILITY</b>		
	Operator's field of view	Front and back view restricted

The configuration of the cab is of such a nature that access is through the front, towards the articulating frame of the bucket. It was observed that the clearance space around the entrance into the cab depends on the position in which bucket has been parked. For instance, if the front frame was turned more to the right, the clearance around the entrance was sufficient for the driver to get into the cab. With the normal straight parking of the bucket, the entrance clearance was found to be restrictive considering that the driver wears a cap lamp battery and personal protective equipment, which would require more space for easy access. As a result, the driver was observed stepping onto the bucket frame and then stepping directly inside the cab.

Forward and rear viewing along the driver's seated position was excellent for normal driving. When reversing, the visual field to the front from the seated position is severely restricted by the cab's blind spots.

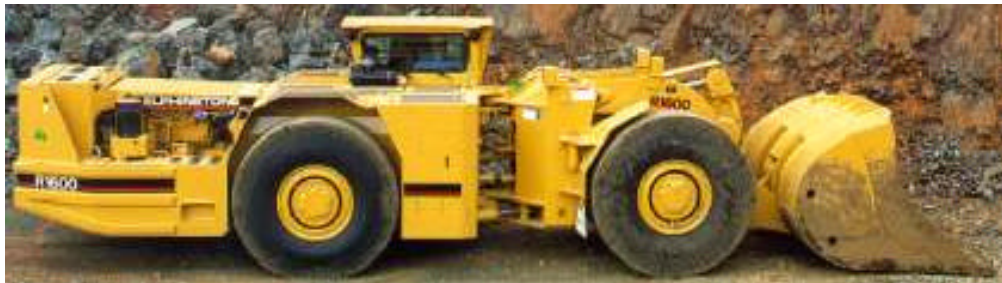
*Figure 1.17: LHD 5*

ITEM	DESCRIPTION	COMMENTS
<b>OPERATORS' WORKSTATION</b>		
Access		
	Entrance width	400 mm (inadequate)
	Entrance step height from the ground	344 mm (acceptable)
Clearances inside the cab		
	Canopy	YES (fully enclosed cab with air conditioner system)
	Height of canopy roof ceiling to SRP	N/A
	Shoulder width	975 mm (adequate)
	Knee clearance from SRP to front wall panel	650 mm (adequate)
<b>SEATING</b>		
	Seat type	T-shaped backrest chair type
	Seat material	Polyurethane
	Seat base dimensions (WxD)	480x400 mm (adequate)
	Seat backrest dimensions (WxH)	480x420 mm (adequate)
	Seat surface height from the cab floor	380 mm (acceptable)
	Restraint system	Lap belt fitted
<b>CONTROLS AND DISPLAYS</b>		
Steering mechanism	Steering wheel	? 350 (acceptable)
Display panel and instruments layout		Symbols are used
<b>VISIBILITY</b>		
	Operator's field of view	Operator's view was excellent

The configuration of the cab is of such a nature that access is through the front, towards the articulating frame of the bucket. It was observed that the clearance space around the entrance into the cab depends on the position in which the bucket is parked. For instance, if the front frame was turned more to the right, the clearance around the entrance was sufficient for the driver to get into the cab. For normal straight parking of the bucket, entrance clearance was found to be restrictive considering that the driver wears a cap lamp battery and personal protective equipment, which would require more space for easy access.

A mechanical suspension seat with a polyurethane T-shaped backrest is fitted. The seat has an adjustable weight suspension for comfort, and the T-shaped backrest provides vertical and lateral support of the spine to an operator wearing rescue and battery packs. The dimensions of the seat base are adequate for accommodating the 5<sup>th</sup> percentile to the 95<sup>th</sup> percentile male South African.

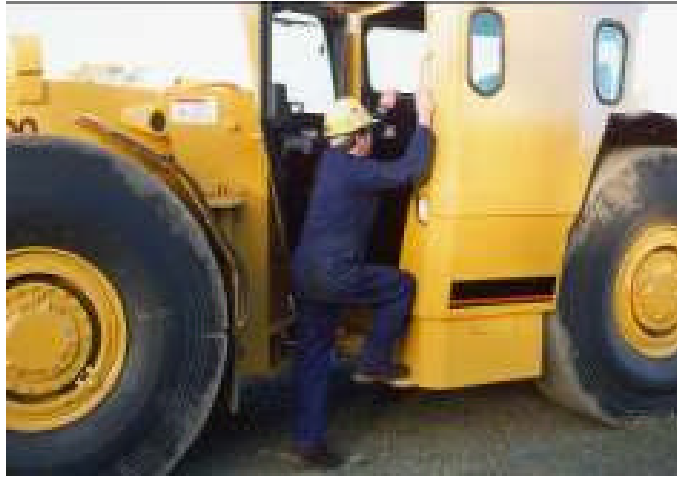
**Figure 1.18: Three-point contact for easy access**

The surface to entrance-level height provided easy entry into the cab for the 5<sup>th</sup> percentile to the 95<sup>th</sup> percentile male South African. Handrails are fitted and provide the required three-point contact for safe access to the cab (see Figure 1.18).

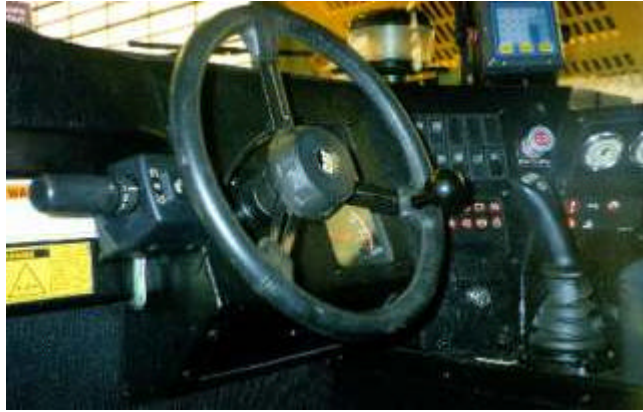
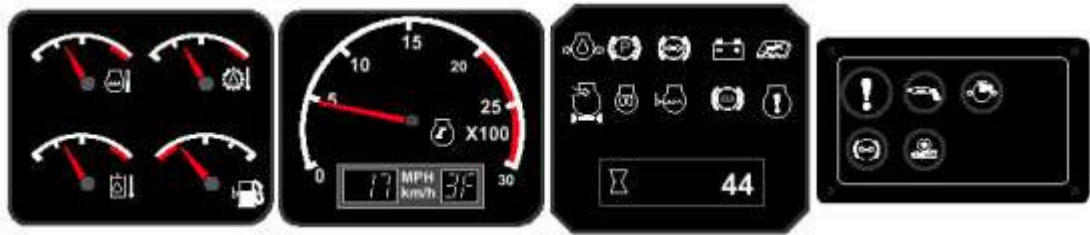
**Figure 1.19: Layout of the controls/displays and labelling**

All the controls were within the reach envelope and visual field of the seated 5<sup>th</sup> percentile to the 95<sup>th</sup> percentile male South African. The layout of the controls is such that accidental activation is prevented. The leather-like covering of the steering wheel and transmission control provides comfortable hand grips. Activation of the controls appeared to be within acceptable limits. Symbols are used for the identification of the controls and instruments (see Figure 1.19).

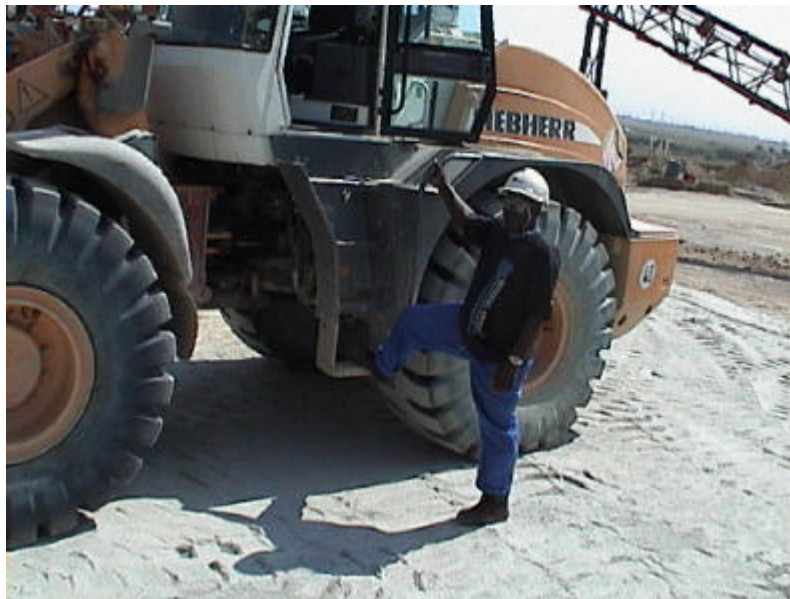
**Figure 1.23: Three-point contact for easy access**

Handrails are fitted and provide the required three-point contact for safe access to the cab (see Figure 1.23).

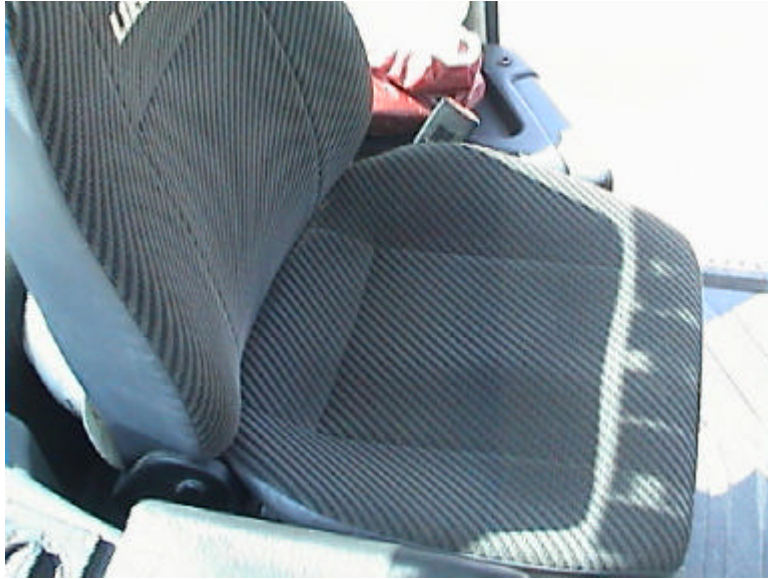
**Figure 1.24: Unsuitable seat fabric for a mining vehicle**

Although the aesthetics and design of the seat, shown in Figure 1.24, appear impressive, the fabric used to cover the seat is unsuitable for mining machinery because of the need for maintenance, and high tear and wear problems

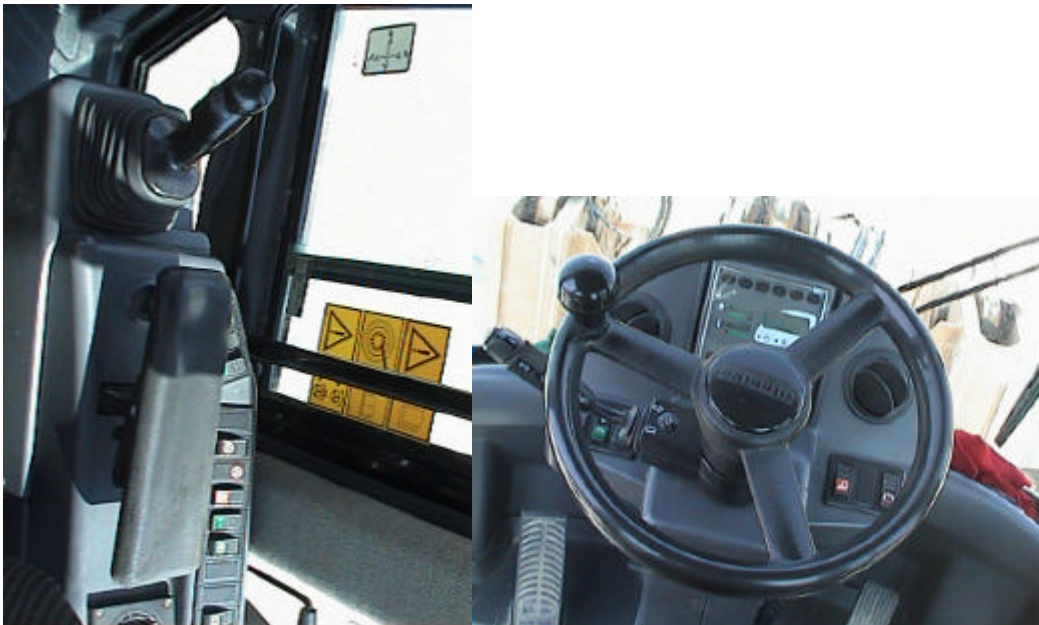
**Figure 1.25: Layout of the controls/displays**

All the controls were within the reach envelope and visual field of the seated 5<sup>th</sup> percentile to the 95<sup>th</sup> percentile male South African. The steering column is adjustable forwards and backwards, and the layout of the controls is such that accidental activation is prevented. The steering wheel and transmission control provide a comfortable hand grip. Activation of the controls appeared to be within acceptable limits. Symbols are used for identification of the controls and instruments (see Figure 1.25).

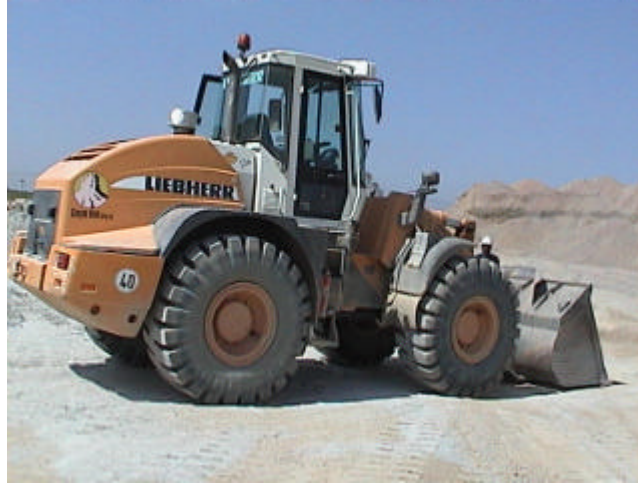
*Figure 1.26: Improved visibility around the cab*

Forward and rear viewing from the driver's seated position was excellent for normal driving. The cab canopy has large windows, which give all-round visibility (see Figure 1.26).

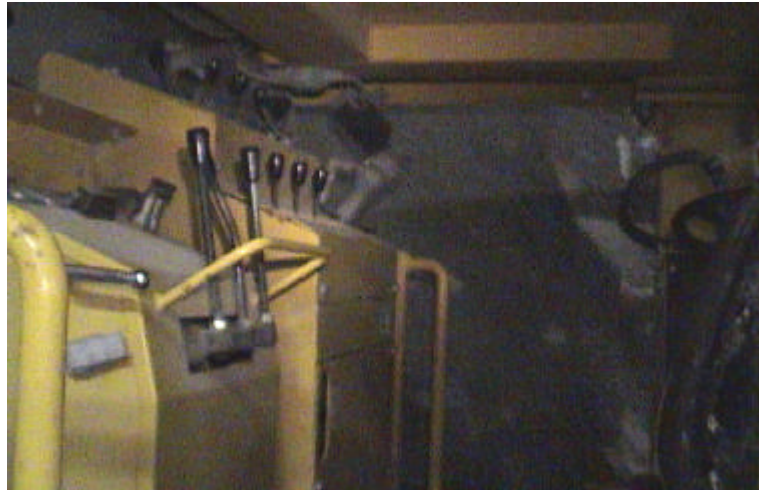
***Figure 1.28: Layout of the control levers***

All the controls were within the reach envelope and visual field of the seated 5<sup>th</sup> percentile to the 95<sup>th</sup> percentile male South African. However, the distance between the control levers would be inadequate for manipulation of the controls if the operator was required to wear protective gloves when operating the vehicle (see Figure 1.28).

Labelling of the controls and instruments was lacking.

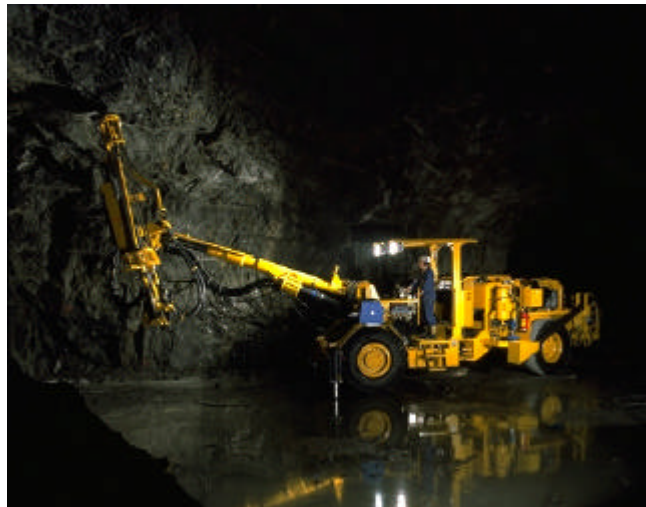
**Figure 1.29: Roof bolter/drill rig 2**

The configuration of the driver's cab is such nature that the driver adopts a sideways sitting orientation when driving the vehicle. The configuration of the cab and the complexity of the machine render the driving task very difficult. Because the cab canopy is height-adjustable between 700 and 1 460 mm from the SRP, the lowest setting of the cab would induce awkward body postures. The driver adopts a stooped and rotated neck posture when driving the vehicle. Sustained stooped and rotated neck postures are undesirable and induce fatigue. During the normal production mining processes, the driver operates the vehicle whilst standing (see Figure 1.29). The seat provided in the vehicle is only used when driving the vehicle. The dimensions of the seat were adequate for accommodating the 5<sup>th</sup> percentile to the 95<sup>th</sup> percentile male South African.

The visual field during the mining production processes was excellent. This was achieved by a height-adjustable cab with open sides (see Figure 1.29). Forward viewing from the driver's seated position was severely restricted because of the complexity of the cab configuration and mine's tunnel height restrictions.

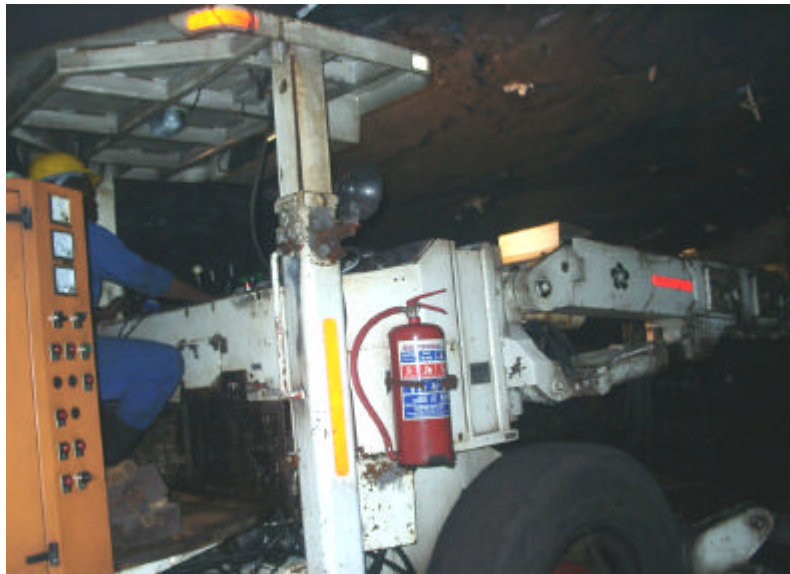
**Figure 1.30: Roof bolter/drill rig 3**

The visual field during the mining production processes was excellent. This was achieved by a height-adjustable cab with open sides. Forward viewing from the driver's seated position was severely restricted because of the complexity of the cab configuration and mine's tunnel height restrictions.

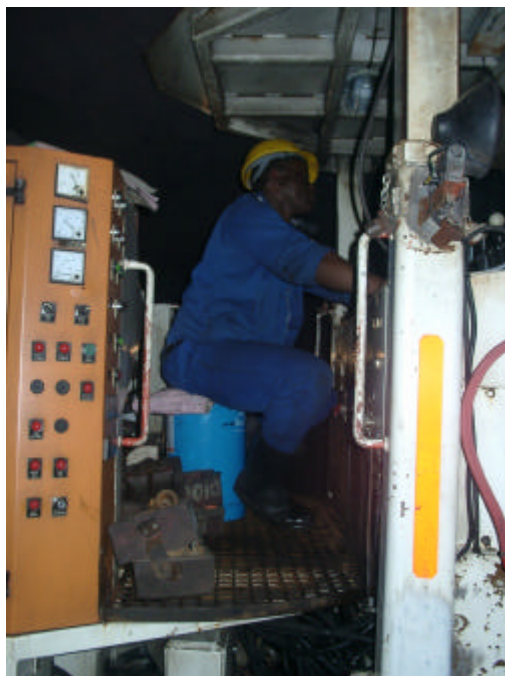
**Figure 1.31: Makeshift seat**

The driver is required to stand when operating the vehicle during the normal production mining processes. However, as shown in Figure 1.31, the operator uses a drum as a makeshift seat in order to get relief from a static standing posture, which is undesirable and harmful to the operator's musculoskeletal system.

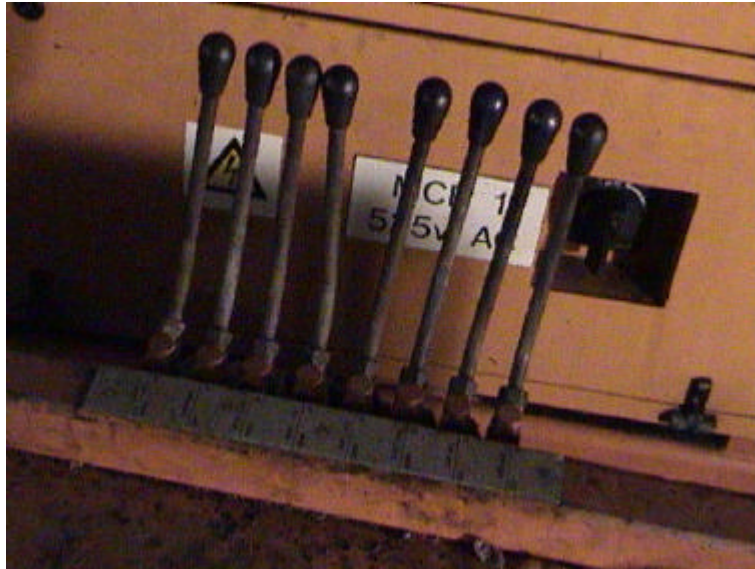
***Figure 1.32: Awkward layout of the control levers***

All the primary controls were within the reach envelope and visual field of the 5<sup>th</sup> percentile to the 95<sup>th</sup> percentile male South African. However, the distance between the control levers, as shown in Figure 1.32, would be inadequate for manipulation of the levers if the operator is required to wear protective gloves when operating the vehicle.

Labelling of the controls and instruments was lacking.

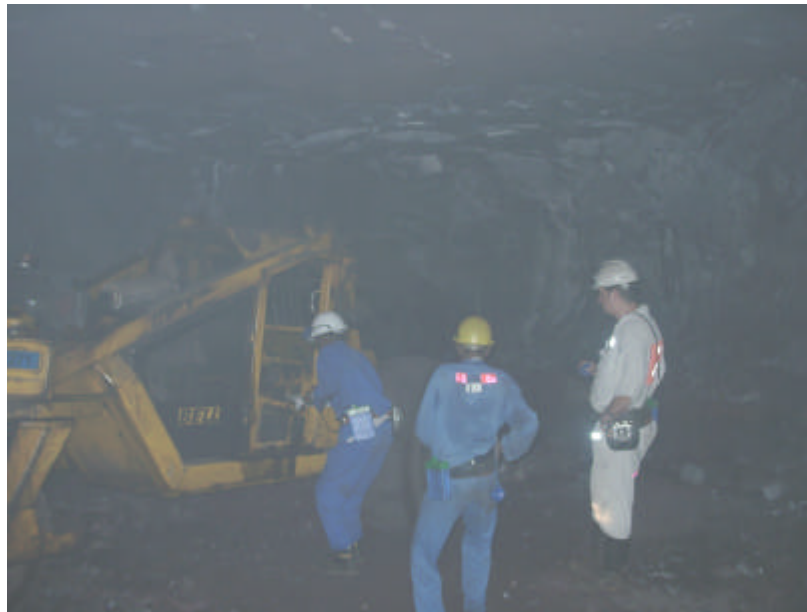
**Figure 1.33: Rock Scaler**

The visual field during the mining processes was restrictive due to the design and configuration of the cab which took into consideration primarily the inherent physical hazards of the task.

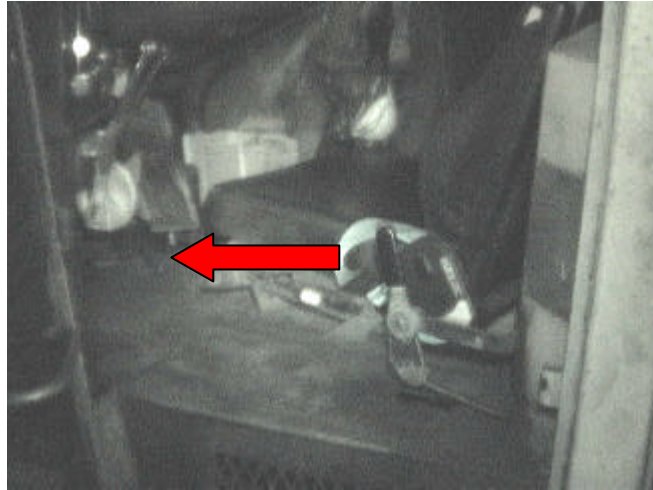
**Figure 1.34: Location of the hand-brake lever**

A hand-brake lever, which in some of the vehicles is located far behind the SRP, was found to have been repositioned in some of the vehicles to the location shown in Figure 1.34. The location of the hand-brake lever interferes with effective utilisation of the restraint system, as well as with the cap lamp battery or self-rescuer pack.

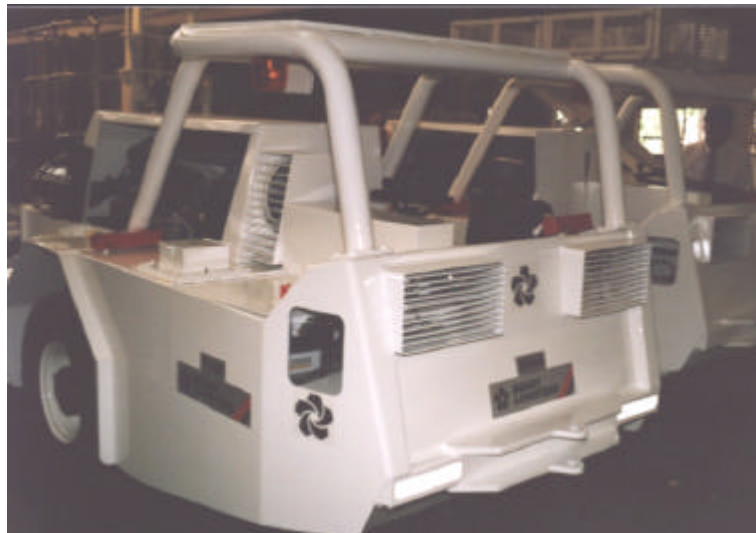
**Figure 1.35: Utility vehicle 1**

Label and symbols are used for identification of the controls and instruments. These were found to be acceptable.

The forward and front visual field from the operator's seated posture was good. The rear visual field when a personnel carrier 2 510 mm long and 1 900 mm high was fitted would be restrictive.

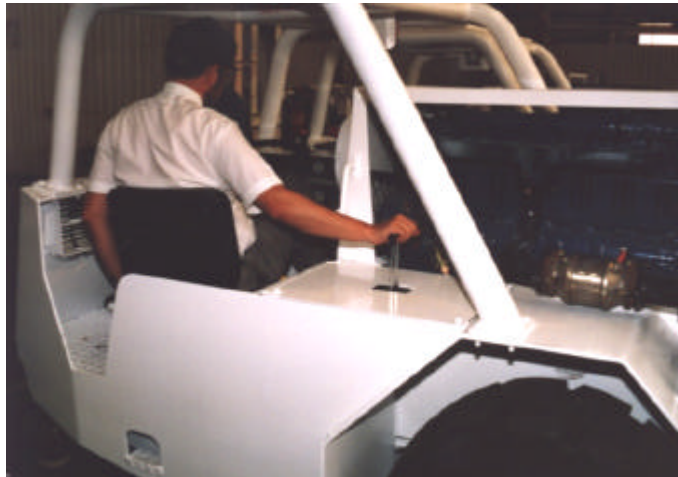
***Figure 1.36: Awkward location of the control lever***

The position of the control lever, shown in Figure 1.36, is too far for ease of manipulation. The operator would have to stretch out his arm and keep it there unsupported for a period longer than three minutes. This posture would induce shoulder strain and fatigue. The layout of the instrument panel is such way that some the instruments are obstructed by the steering wheel.

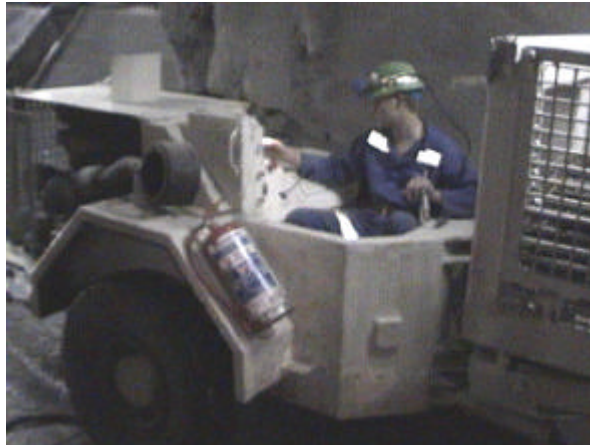
**Figure 1.37: Utility vehicle 2**

The operator's visual field was restricted due to the cab design and configuration.

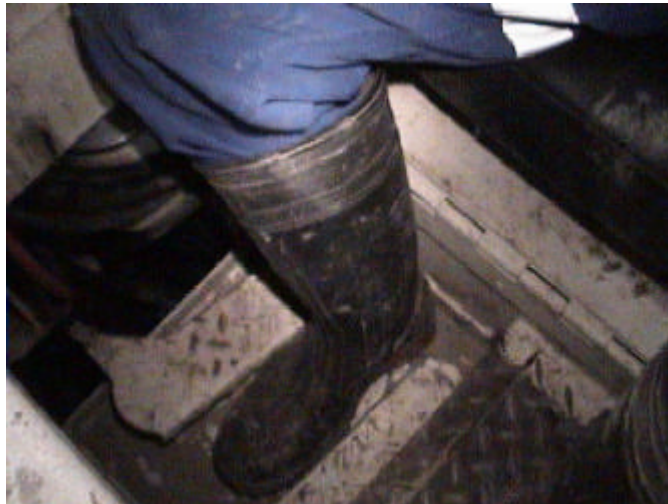
***Figure 1.38: Resting of the foot between the pedals***

The location of the foot pedals in a recess in the cab floor limits the space for proper positioning of the feet. As a result, the operator rests his foot between the pedals (see Figure 1.38).

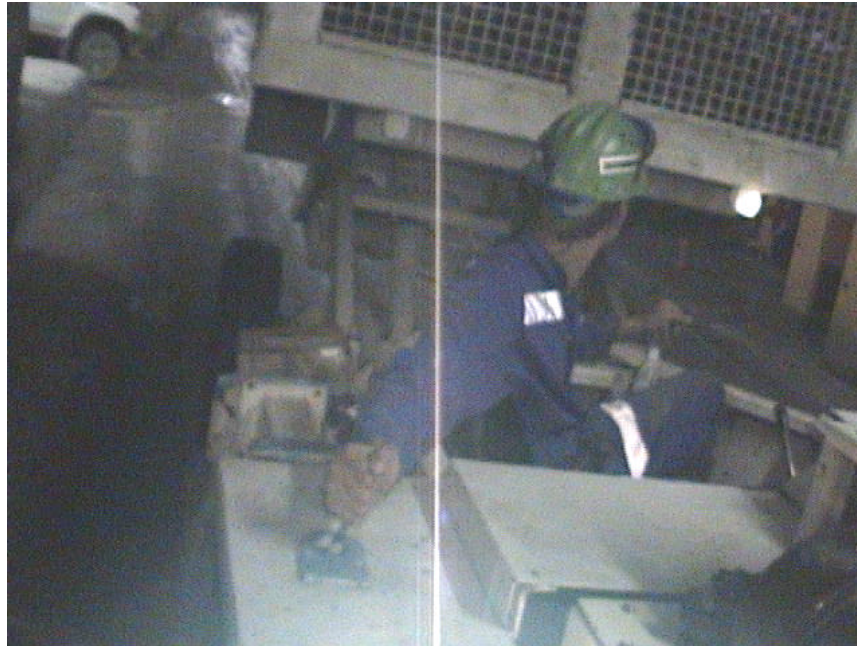
**Figure 1.39: Awkward location of the control lever**

The control levers for raising and lowering the bucket are located too far for ease of reach and manipulation of the controls (see Figure 1.39). The operator stretches out his arm and sustains it unsupported for a period longer than three minutes. The operator also has to rotate his trunk and neck towards the right to see the bucket lifting/lowering process. These postures are undesirable and would induce shoulder and neck strain.

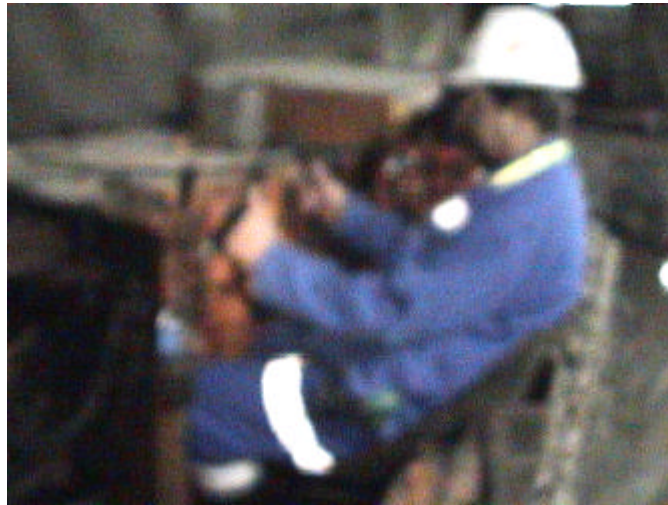
**Figure 1.40: Utility vehicle 3**

The operator has a severely restricted visual field due to the design of the cab. He is not able to see the ground in front of the vehicle without leaning out of the cab.

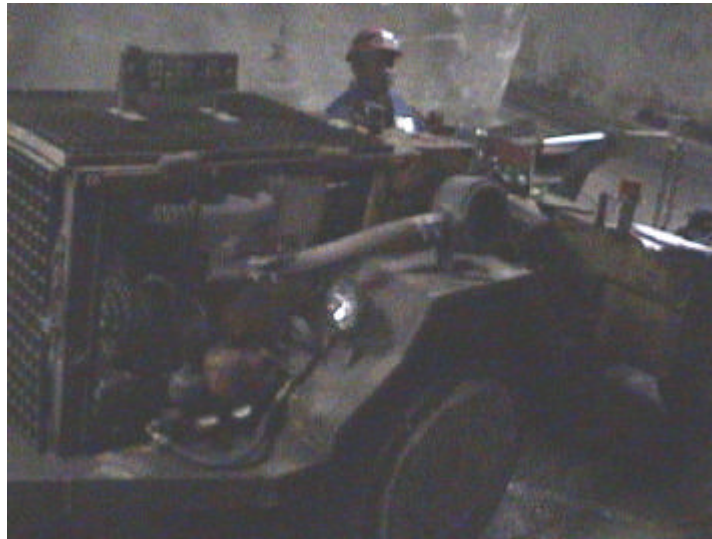
**Figure 1.41: Utility vehicle 4**

The vehicle was evaluated when it did not have a cassette fitted. Forward and rear viewing in the driver's seated position was excellent for normal driving. The visual fields to the front left corner and to the rear from the seated position are severely restricted due to the cab configuration.

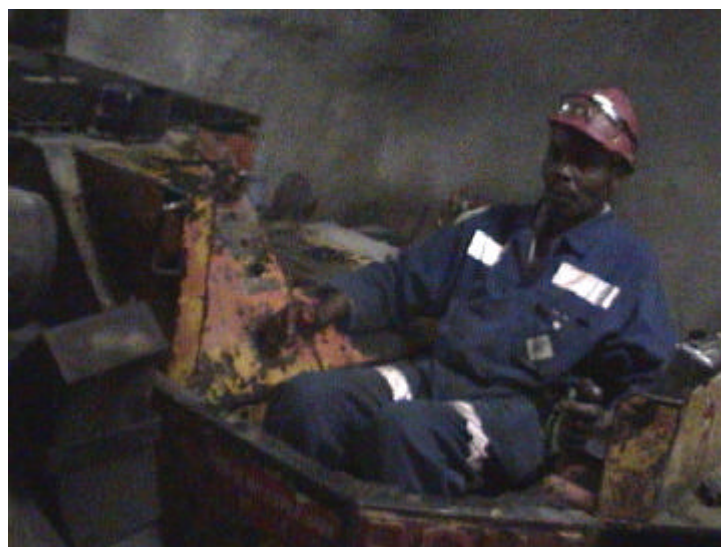
***Figure 1.42: Typical posture when activating controls***

The location of the foot pedals in the cab floor limited the space for proper positioning of the feet. As a result, the operator would have to lean slightly backwards in order to gain foot leverage when activating the foot pedals. This posture is undesirable for the application of biomechanical force. Figure 1.42 shows the typical posture adopted by the operator when activating the controls.

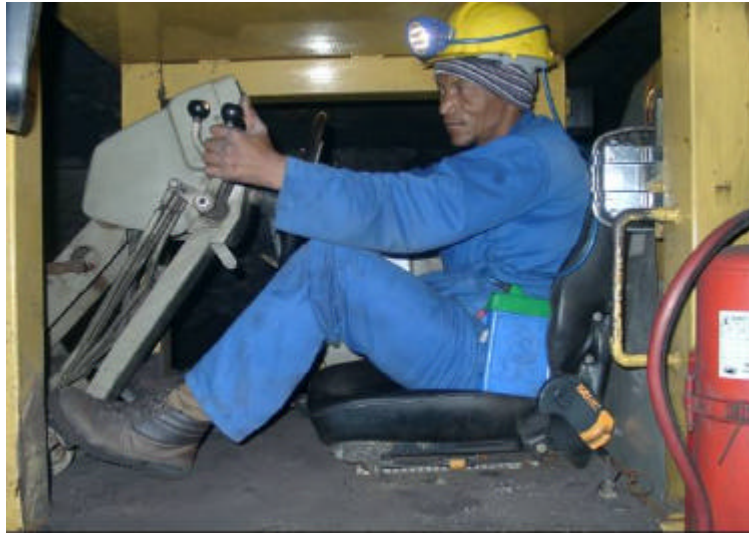
**Figure 1.43: Utility vehicle 5**

The visual field during the mining processes would be restrictive due to the design and configuration of the cab.

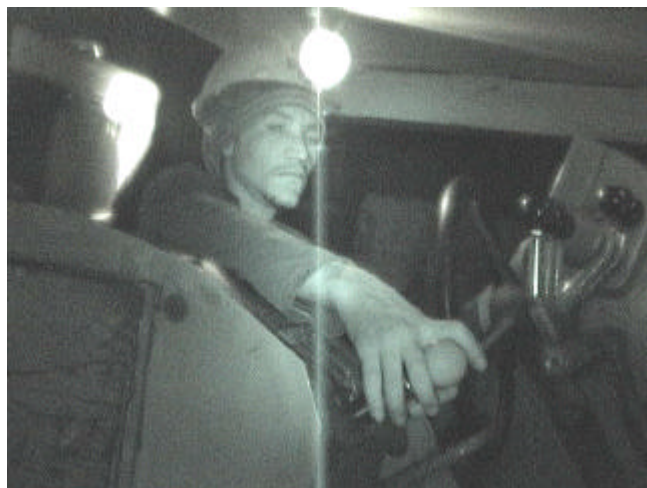
**Figure 1.44: Stretched-out arm**

The controls were not easily accessible from the operator's seated positions. As shown in Figure 1.44, the operator has to stretch out his arm in order to operate the gear lever.

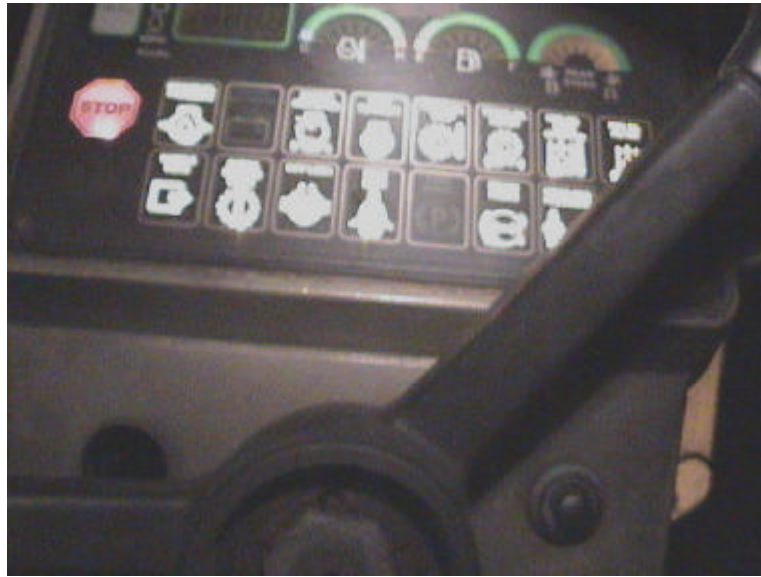
**Figure 1.45: Layout and labelling of the instrument panel**

Symbols are used for identification of the instruments. All the symbols used are nationally and internationally recognisable (see Figure 1.45).

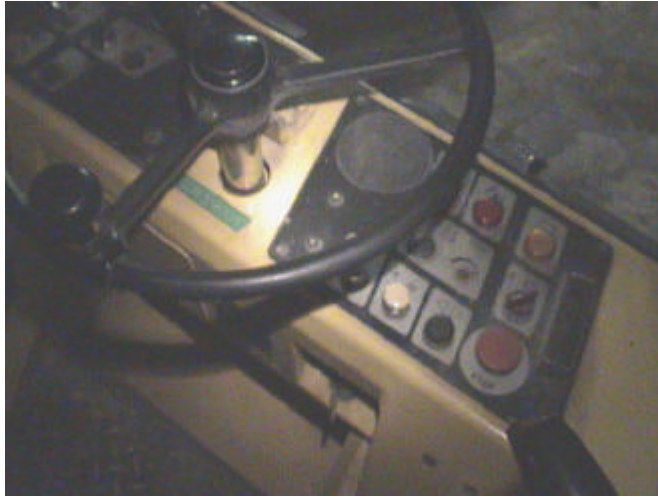
***Figure 1.47: Layout of the controls and instruments***

All the controls were within the arm reach envelope of the seated 5<sup>th</sup> percentile to the 95<sup>th</sup> percentile male South African. Activation of the controls appeared to be easy. Symbols are used for identification of the instruments. The layout of the controls and instruments was acceptable (see Figure 1.47).
