## CREEP FAILURE OF A SPRAY DRIER

P. CARTER

**Abstract**—NDT, design calculations and metallurgical analysis were performed on specimens from a collapsed spray drier. Failure modes initially regarded as possible were: corrosion leading to reduced sections and loss of strength, fatigue and fracture, and creep. The calculations pointed to creep, and no positive metallurgical or physical evidence was discovered to support any of the hypotheses. However, the compression stresses implied that creep deformation could have occurred without inducing discernible creep damage. It was concluded that buckling and collapse of the structure was due to excessive creep deformation. © 1998 Elsevier Science Ltd. All rights reserved.

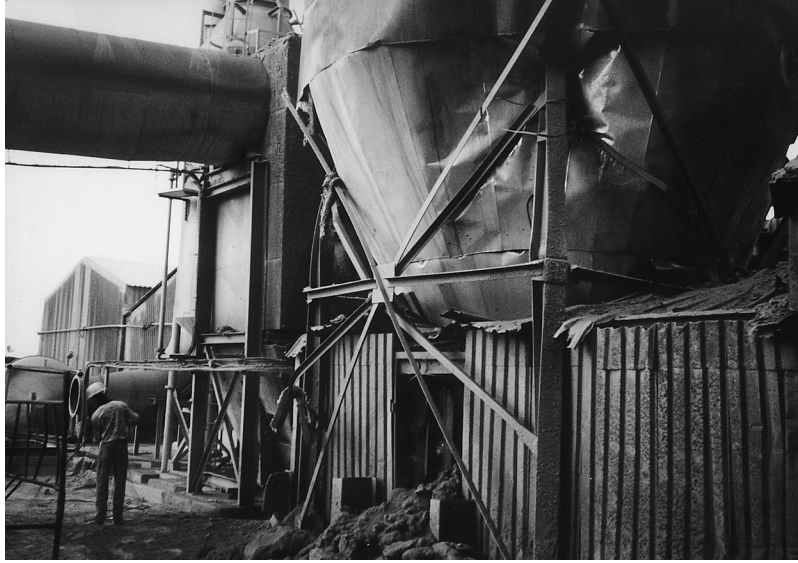
Figures 1–3 show views of the collapsed drier. Braced columns, the lagged and clad annulus and shell, and the bottom cone, are all visible.

These figures show the remarkable nature of the collapse, with the column and cone moving down axisymmetrically until the weight was supported by the cone on the ground.

Fig. 1. View of base of collapsed drier.

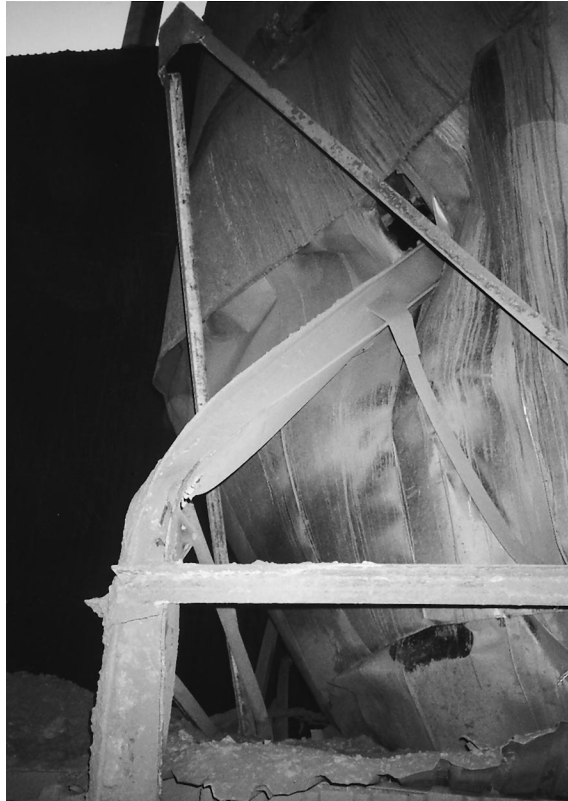
There was clear evidence of a localised buckling deformation in columns and shells in the region of the welded column-shell joint. This was distinguishable from the damage associated with a collapse event itself.

Fig. 3. View of buckled column.

To avoid a similar fate on other more recent (and stronger) spray driers, it was recommended that the lagging and cladding in the region of the annular gas duct and the column-shell joints, be removed.

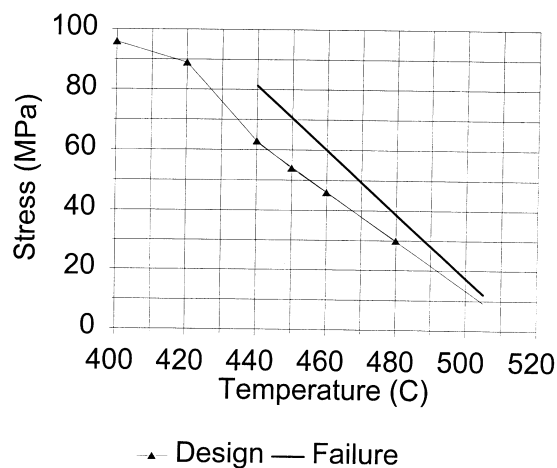
Figure 4 is a summary of design and failure data for Grade 43 steel, based on a service life of 150,000 hours or 17 years. Failure data for creep rupture is inferred from design data using the quoted safety factor of 1.3.

Further, extrapolation for temperatures  $>480^{\circ}\text{C}$  is necessary. There is a justification for using

Fig. 4. BS 5500 stress-rupture data for Grade 430 steel.

Examining the BS 5500 [1] data in Fig. 4, it is clear that for design purposes a maximum metal temperature of 480°C would be allowed for the above stresses. To explain the failure, a temperature between 490°C and 500°C is required.
