SIMRAC

Final Project Report

Title: TESTING OF TUNNEL SUPPORT: DYNAMIC LOAD TESTING OF
ROCK SUPPORT CONTAINMENT SYSTEMS (EG WIRE MESH)

Project No: GAP 221

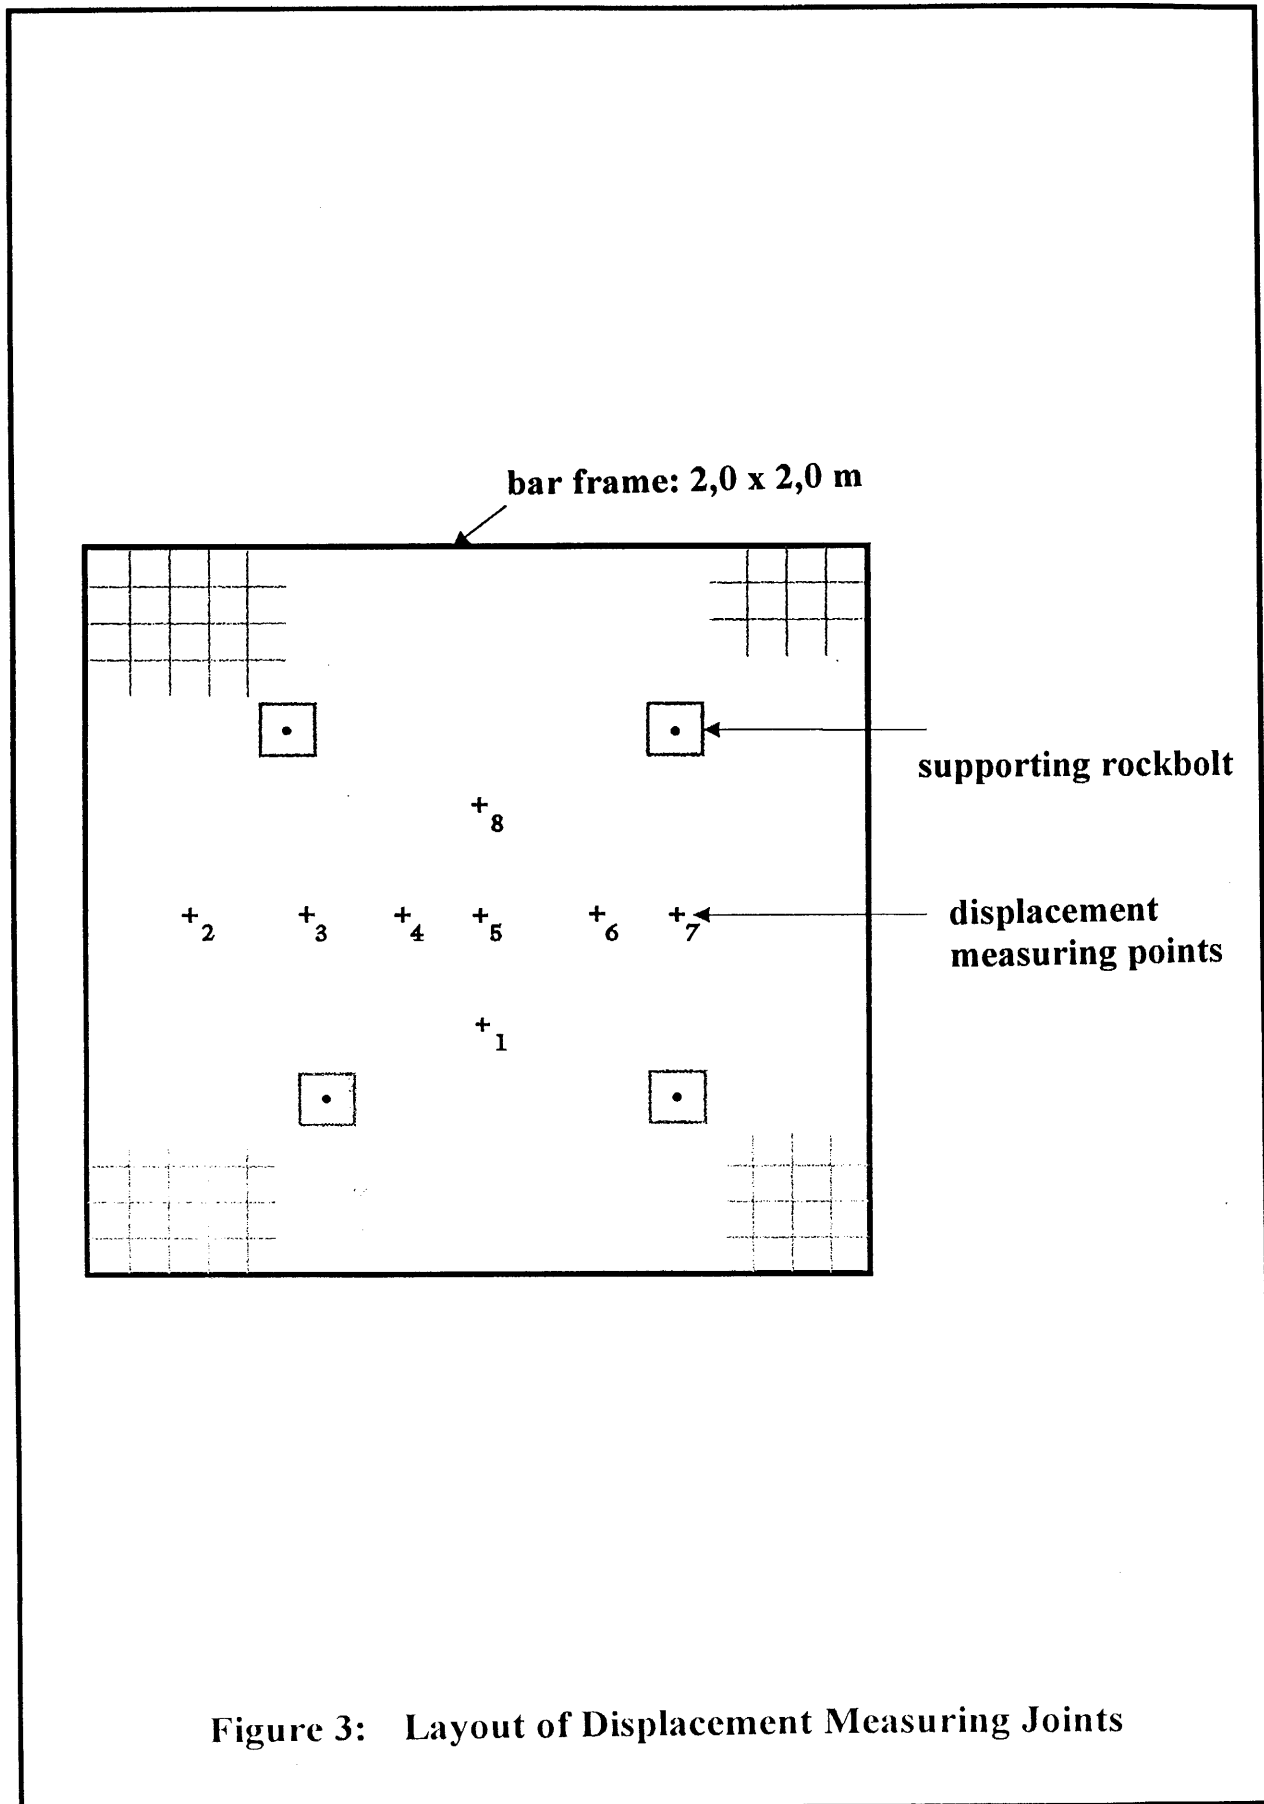
Figure 3: Layout of Displacement Measuring Joints

Deflections of the support were measured during the preliminary test at the 8 locations

shown in Figure 3, and the deflection curves are presented in Figure 4. Although these 8 measurements of deflection were made routinely before and after each drop, the displacements generally turned out to be sufficiently symmetrical to permit total deformation to be characterized by specifying only the single value of deflection at the centre of each test specimen.

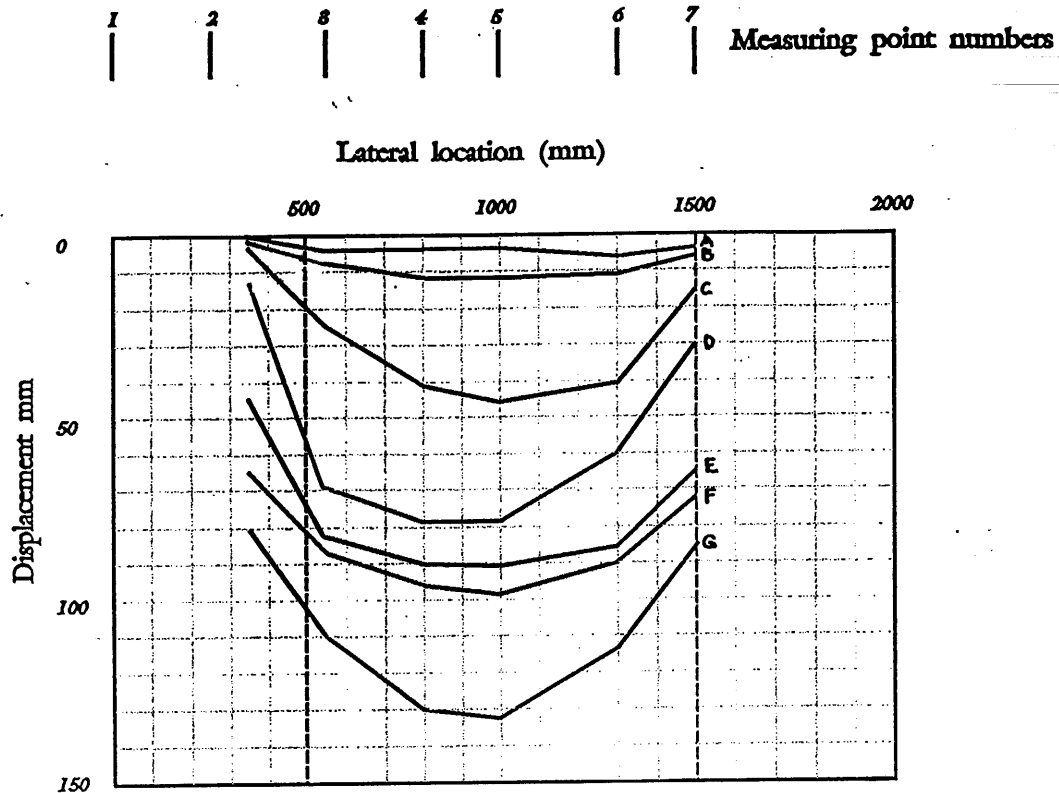
Fig. 5

KINETIC ENERGY VS DEFLECTION

The composite plot in Figure 5 of all the observations confirms, for all types of cladding, the expected tendency that increased energy delivered by the impulsive load produces greater deflection of the test panel. The trend for greater damage to the whole test assembly in terms of the number of broken wires in the cladding and broken bricks in the "rock layers" behind the mesh is also clearly evident.

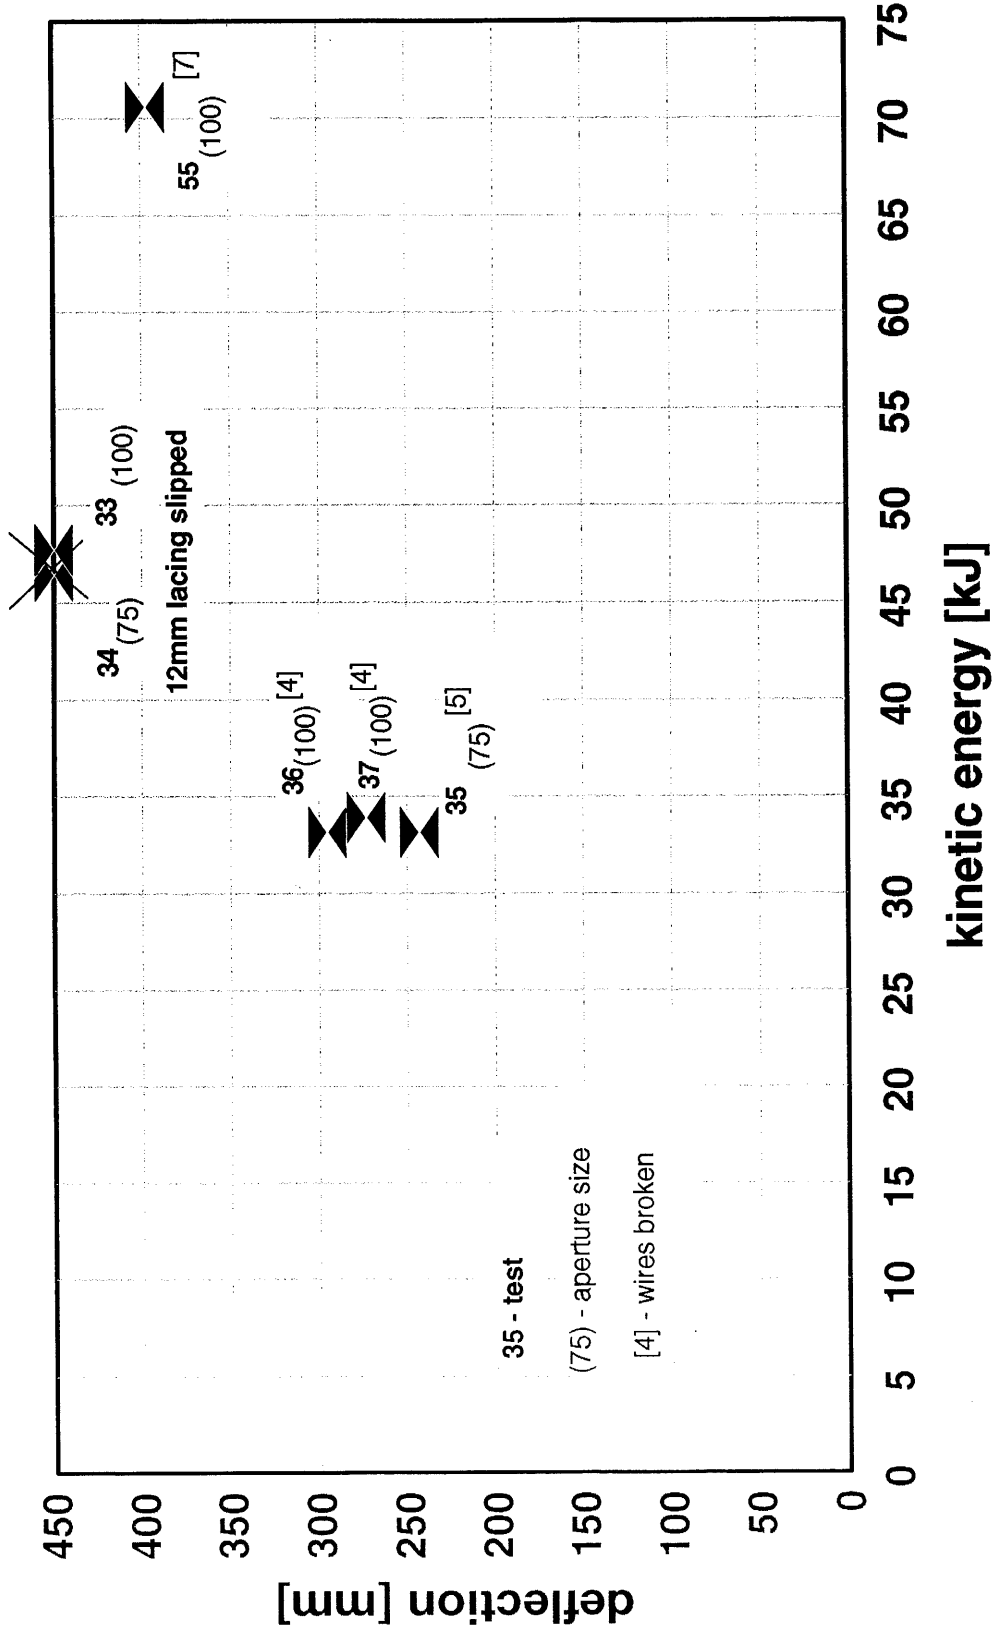
Fig. 12

KIN. ENERGY vs DEFLECTION

Series 3.3 - 100 x 3,2mm Diamond Mesh & 8mm Lacing

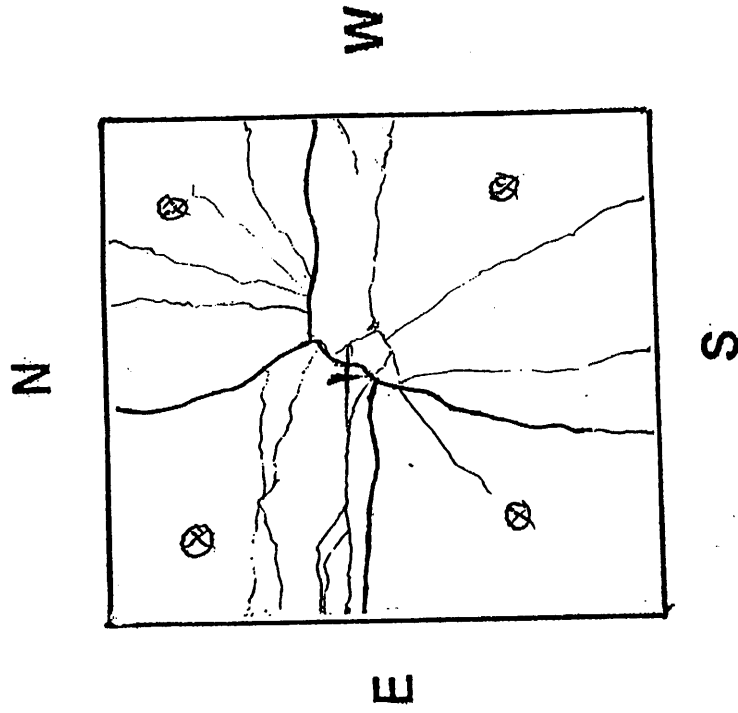
Figure 20: Shotcrete slab - crack configuration

Test No. 42. 30 mm Dramix

Test No. 48. 30 mm Dramix

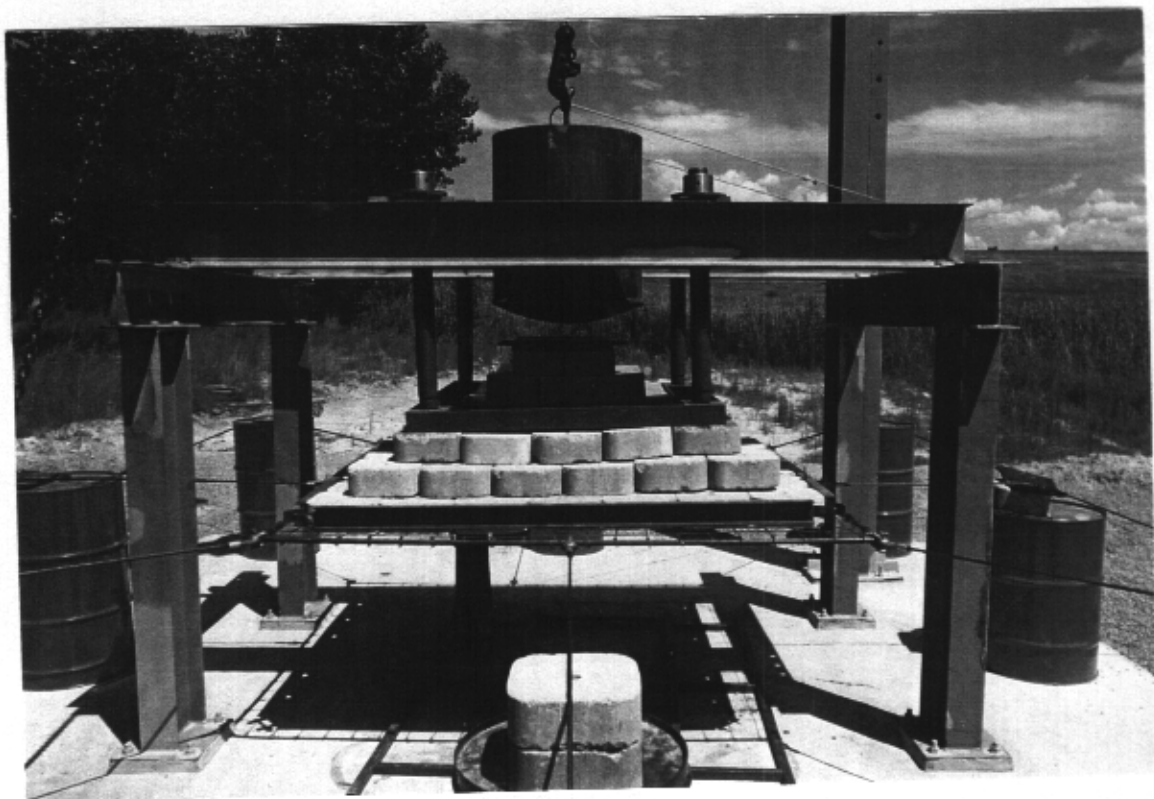
Photo 3: General view of test arrangement suspended from steel superstructure.

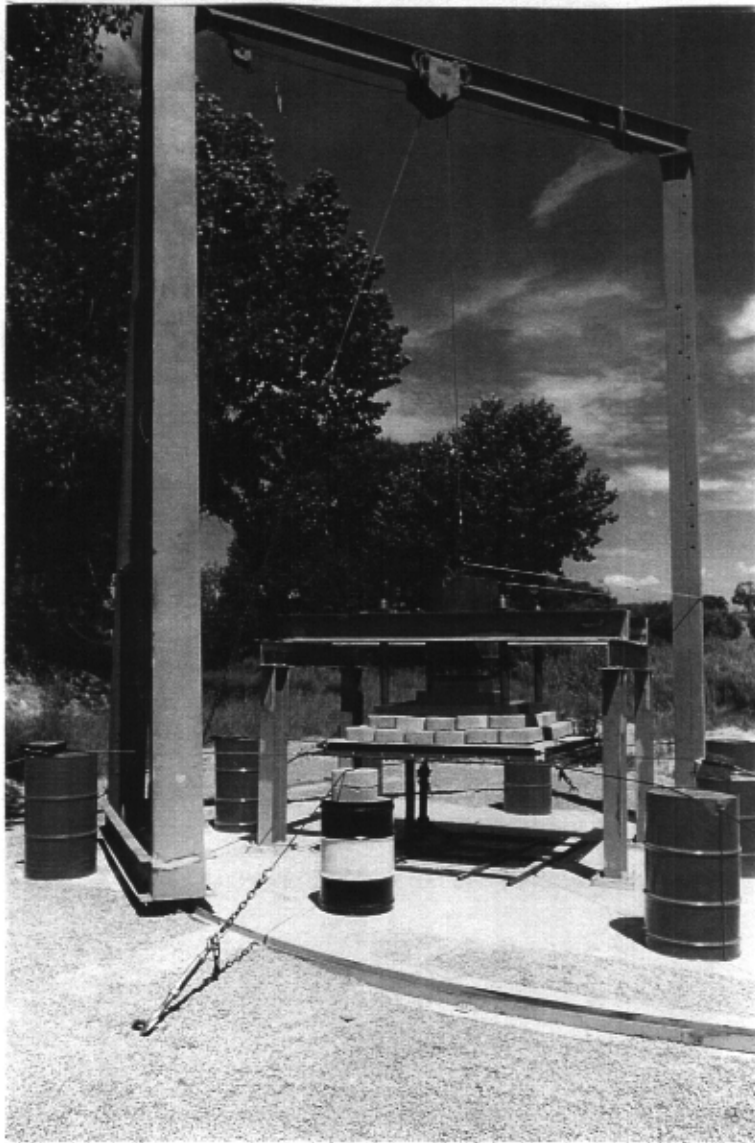
Photo 4: View of suspension of drop weight from overhead trolley.

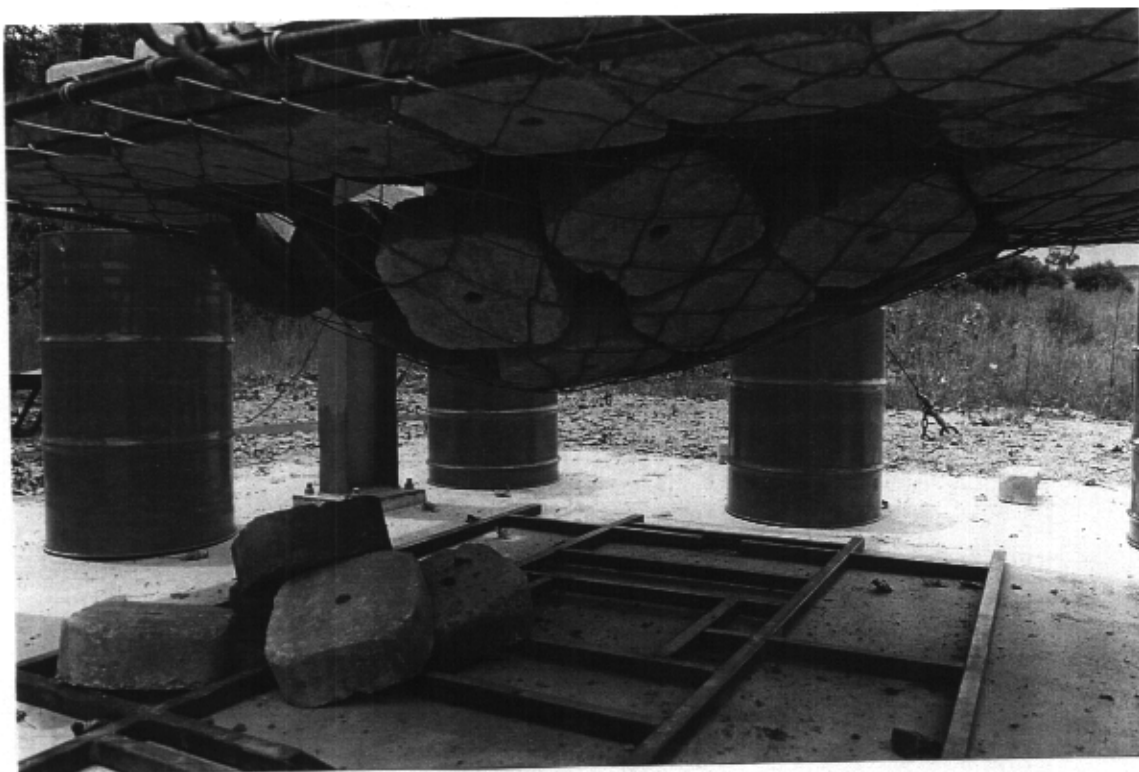
Photo 6: **Test No. 7. Impulse 12,1 kJ, 246 mm deflection.**
View of underneath of diamond mesh test specimen showing unravelling at N-W corner and five blocks spilled.

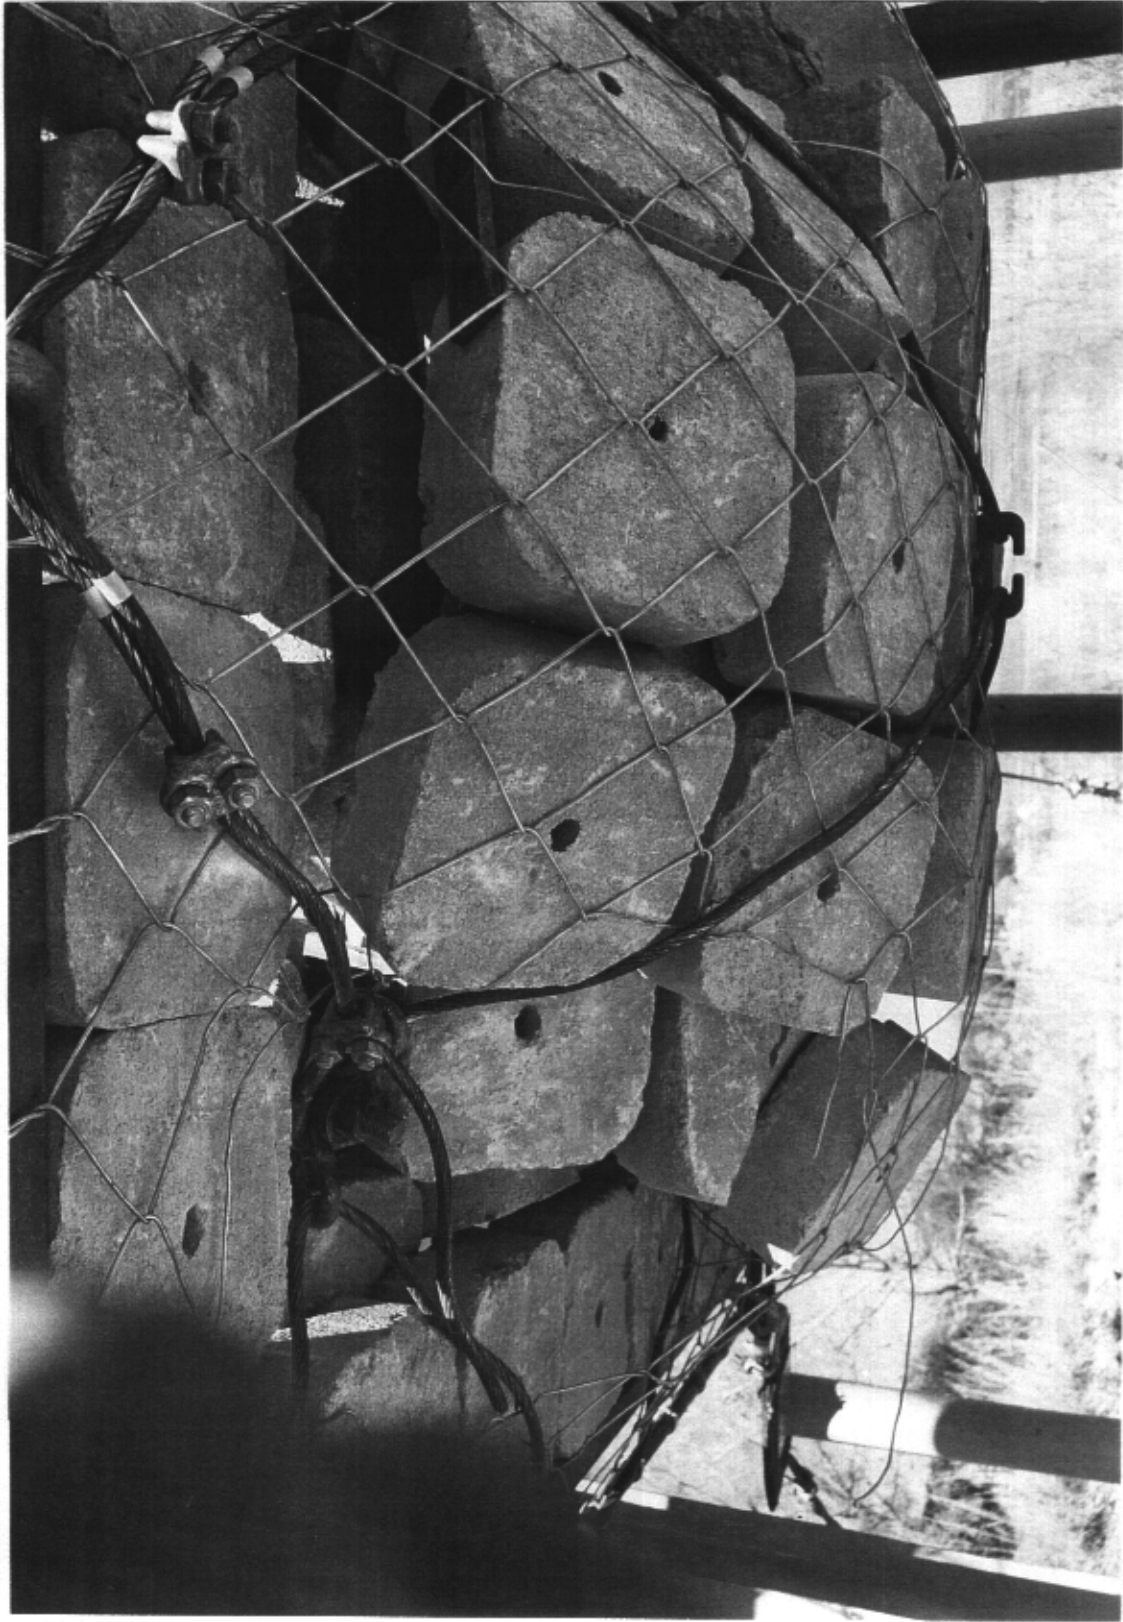
Photo 10: **Test No. 55. Impulse 70,6 kJ, 397 mm deflection.**
Mesh unraveled in all four quadrants leading to spilling of seven bricks.

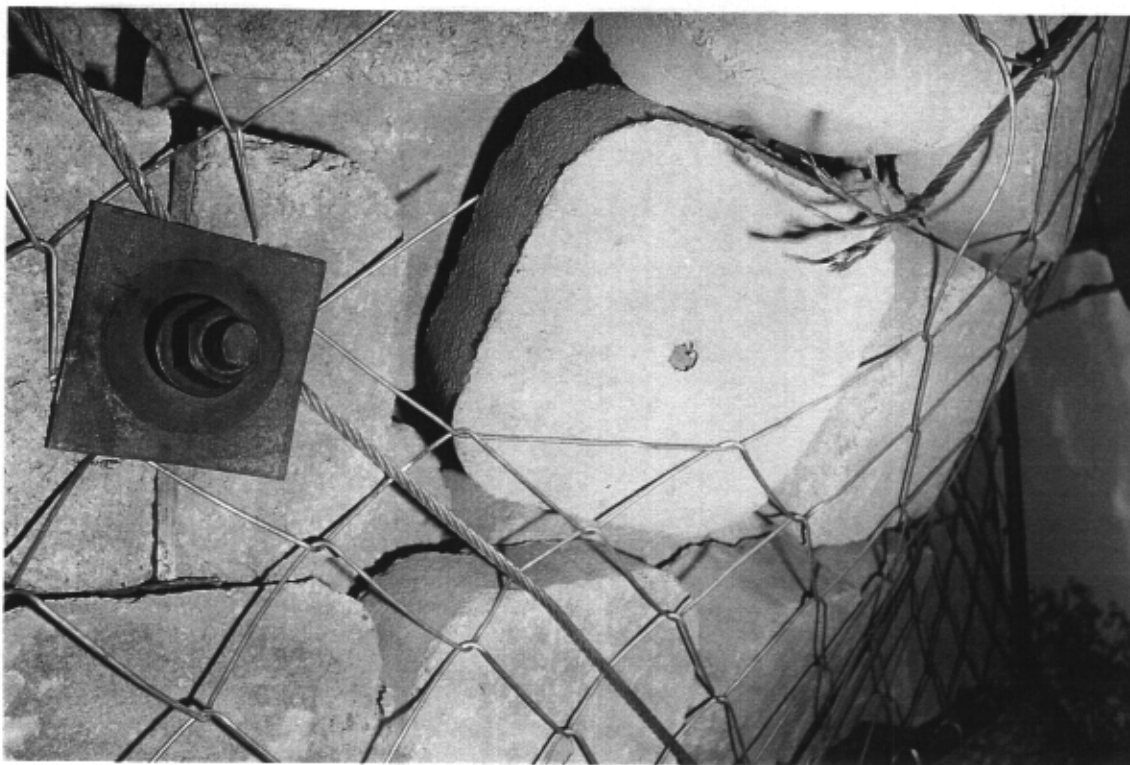
a) The 8 mm lacing failed at the N-W face plate on one diagonal.

b) The other diagonal of lacing failed at the centre.

When 8 mm flexible rope lacing was stretched tautly, failure of one or both diagonal strands occurred readily, usually at the sharp edged standard domed face-plates, but sometimes also at the central cross-over position - see photo 11.

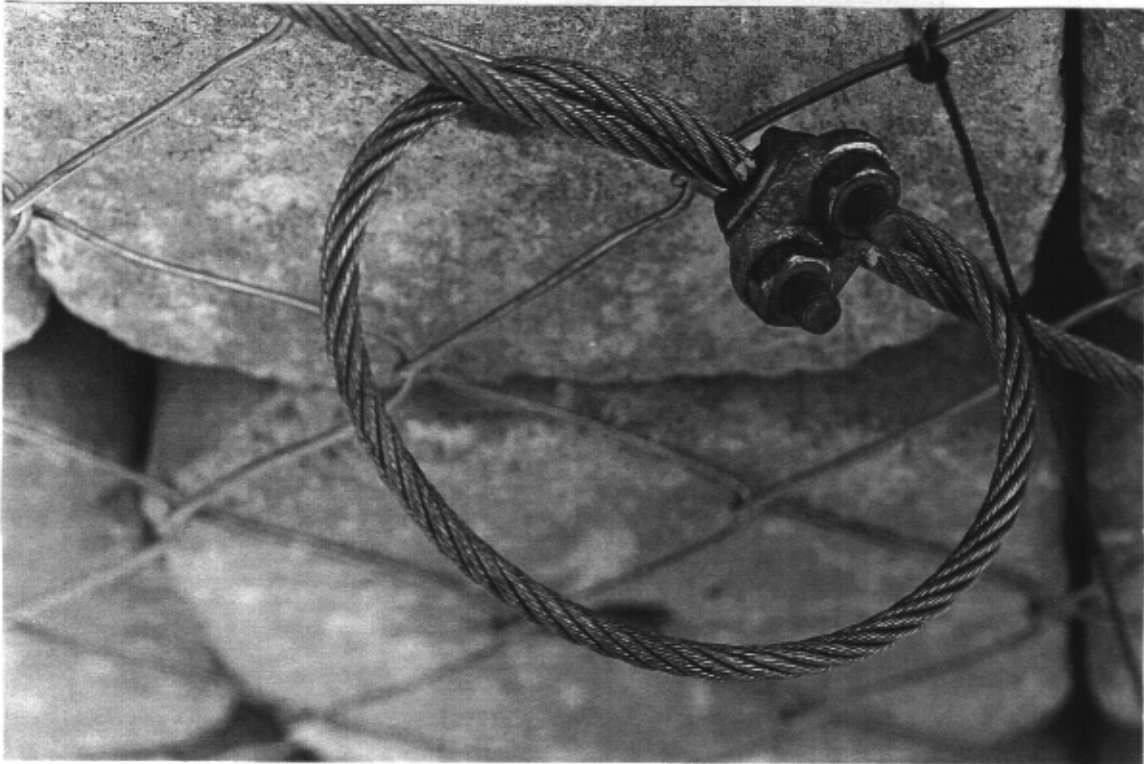
Photo 12: **Test No. 43. Impulse of 37,3 kJ caused complete collapse.**
Detail of northern loop before impact. One Crosby clamp at low torque.

It appeared possible that extending the strain limit before failure of the lacing, would improve the containment capability considerably. By introducing a single loop in each diagonal, extra length was incorporated into the lacing. Crosby clamps were used to provide resistance against the loop straightening out too readily. Photo 12 shows an example of this yielding device.

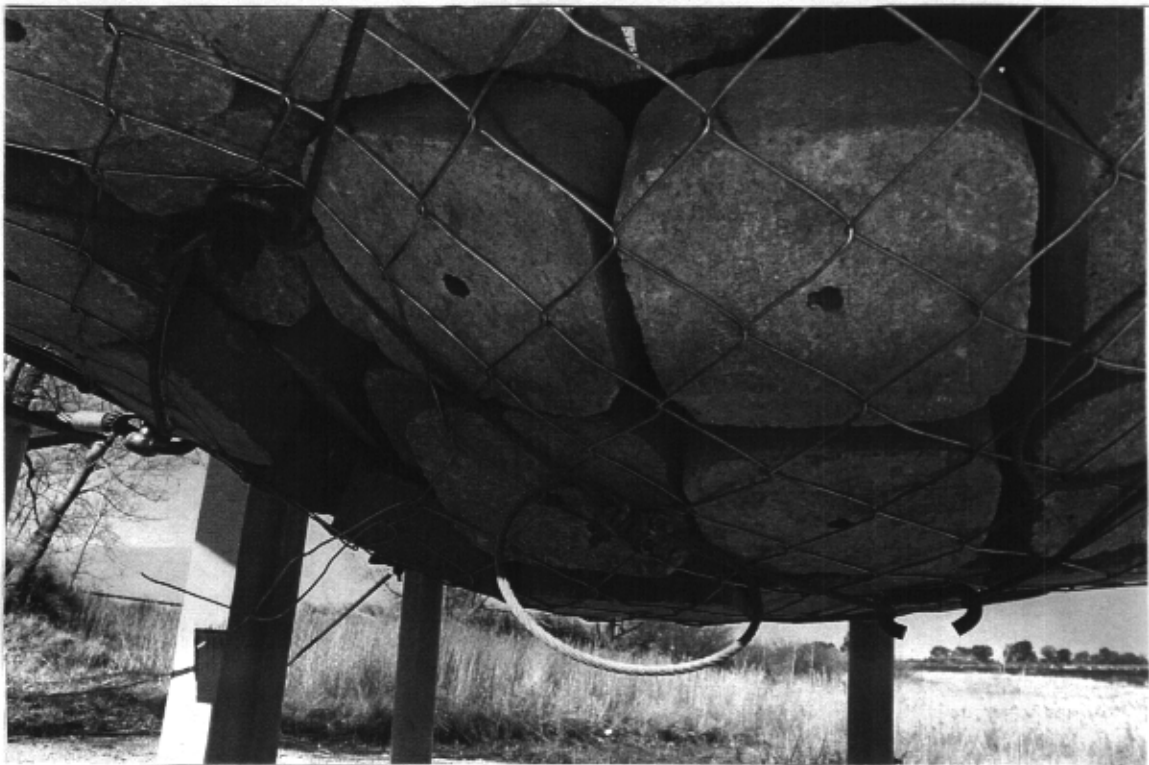
- a) Approximately 100 m/s after impact. First wire has broken and unravelling has commenced.

- b) 200 mm of yield on northern main strand of zig-zag lacing has prevented failure of lacing but bricks have spilled out.

allow the "rock" to spill through. In test 44 for example, 200 mm of controlled slip on one diagonal of lacing avoided failure of the 8 mm flexible rope lacing but 232 mm central deflection occurred which allowed mesh to unravel and spill 3 bricks - see photo 13. When slip occurred too easily as in test 43 for example, failure of the lacing was not prevented, leading to total collapse of the support system - see photo 14.

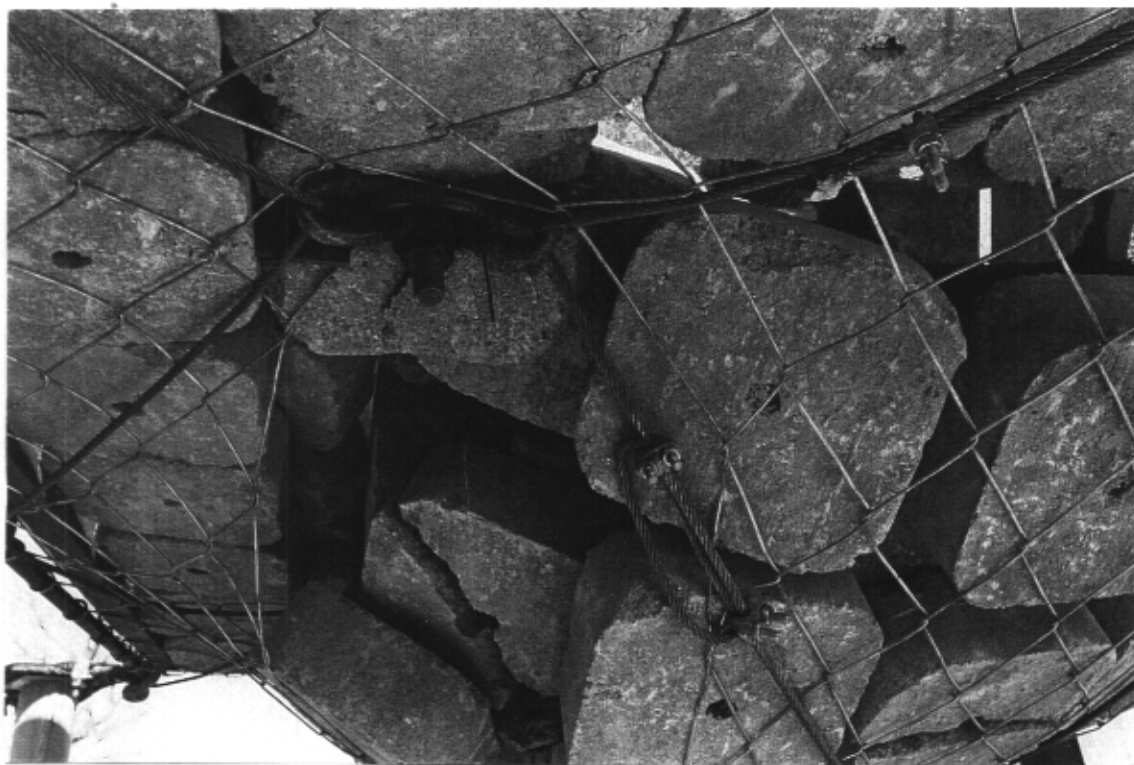
a) N-W corner; approx. 540 mm of yield occurred along centre strand of the zigzag lacing.

b) S-W corner; approx. 380 mm of yield occurred at loop clamped with 2 Crosby clamps tightened to 15 Nm.

Photo 16: **Test No. 53. Impulse 37 kJ, deflection 377 mm.**
Substantial damage was caused to mesh.

In test 53, the yielding device and the lacing pattern appear to have been satisfactorily configured but the unravelling tendency of the diamond mesh led to comprehensive failure of the overall containment of the system - see photo 16 (a) and (b).

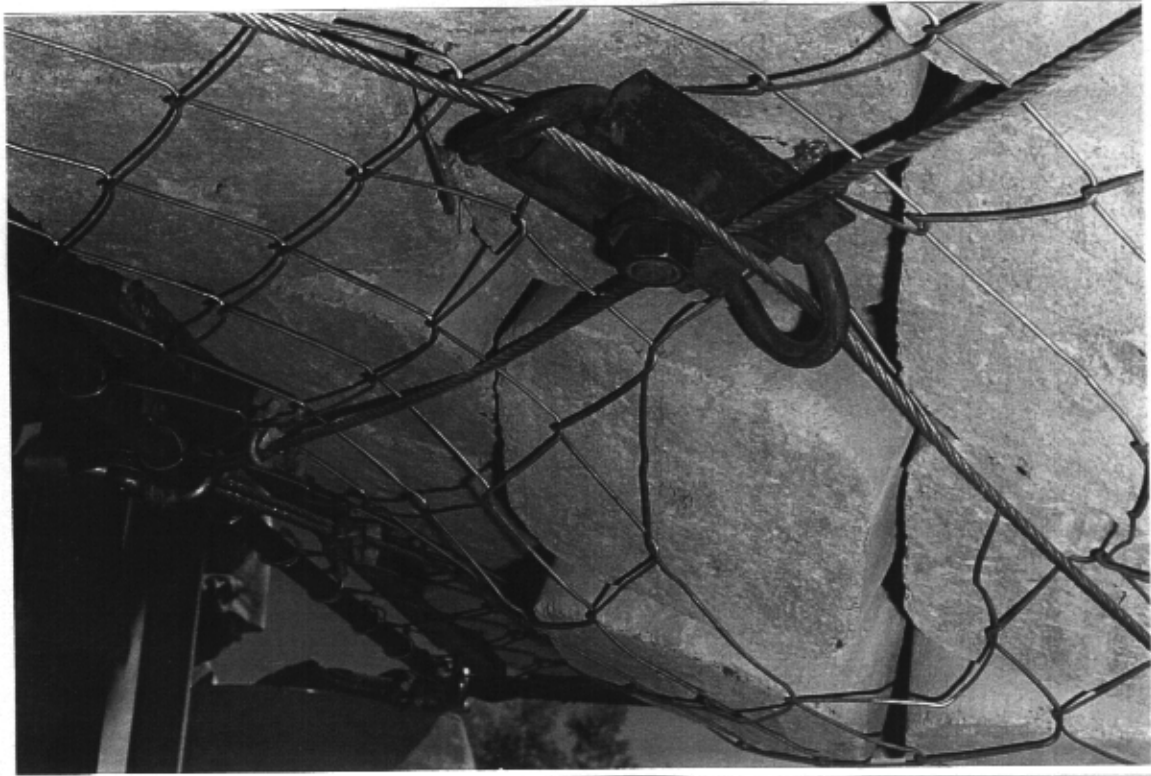
Photo 17: Test No. 31. Impulse 32,9 kJ, 176 mm deflection.
Use of 'eared' lacing-plates has prevented damage to 8 mm lacing. Unravelling of diamond mesh has commenced but no brick spilled.

However, the need for improved coupling or connections between the lacing and the rockbolts or other tendons becomes obvious. It is immediately apparent that **standard washers or face-plates cannot be made to perform this function adequately**. "Eared" lacing plates are commercially available which, as far as protection of the lacing is concerned, are probably quite adequate for all but the most severe rockbursts. The problem of sharp cropped edges of the plate itself causing damage to the mesh, still exists - see photo 17.

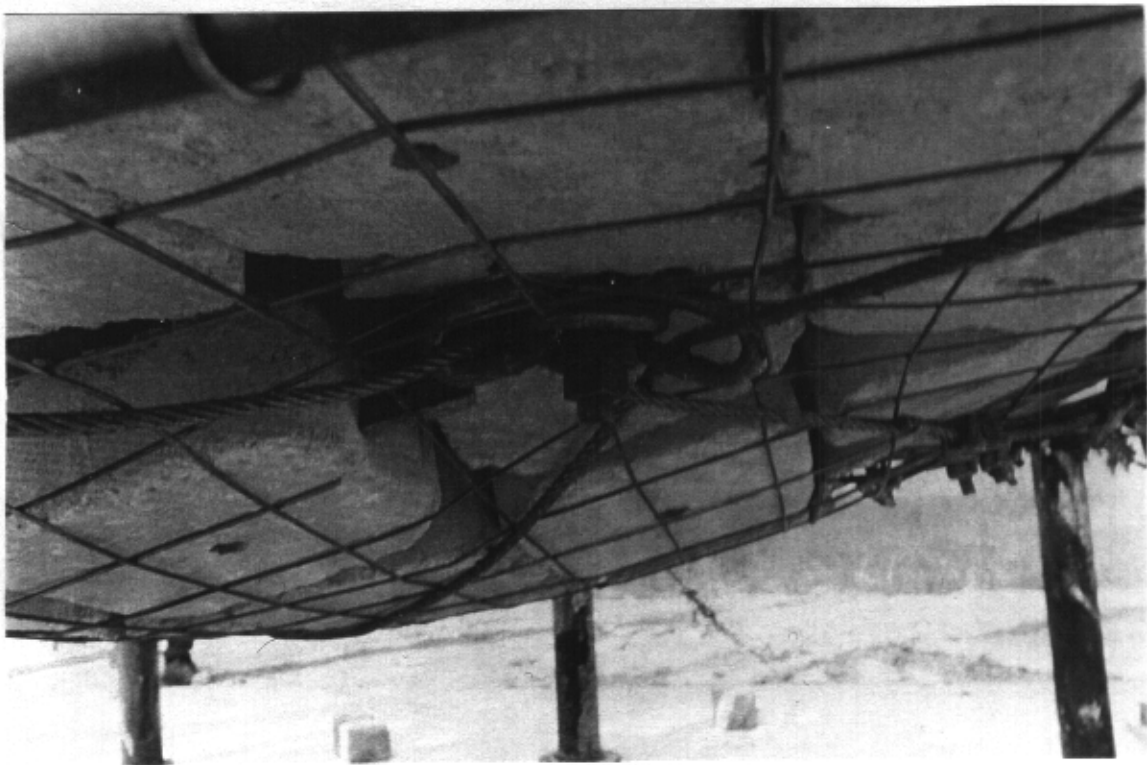
Photo 18: Test No. 39. Impulse 37 kJ, deflection 211 mm.
100 x 3,5 weld mesh was backed by 10 mm lacing connected to rock bolts by 3-link chain-link connectors.

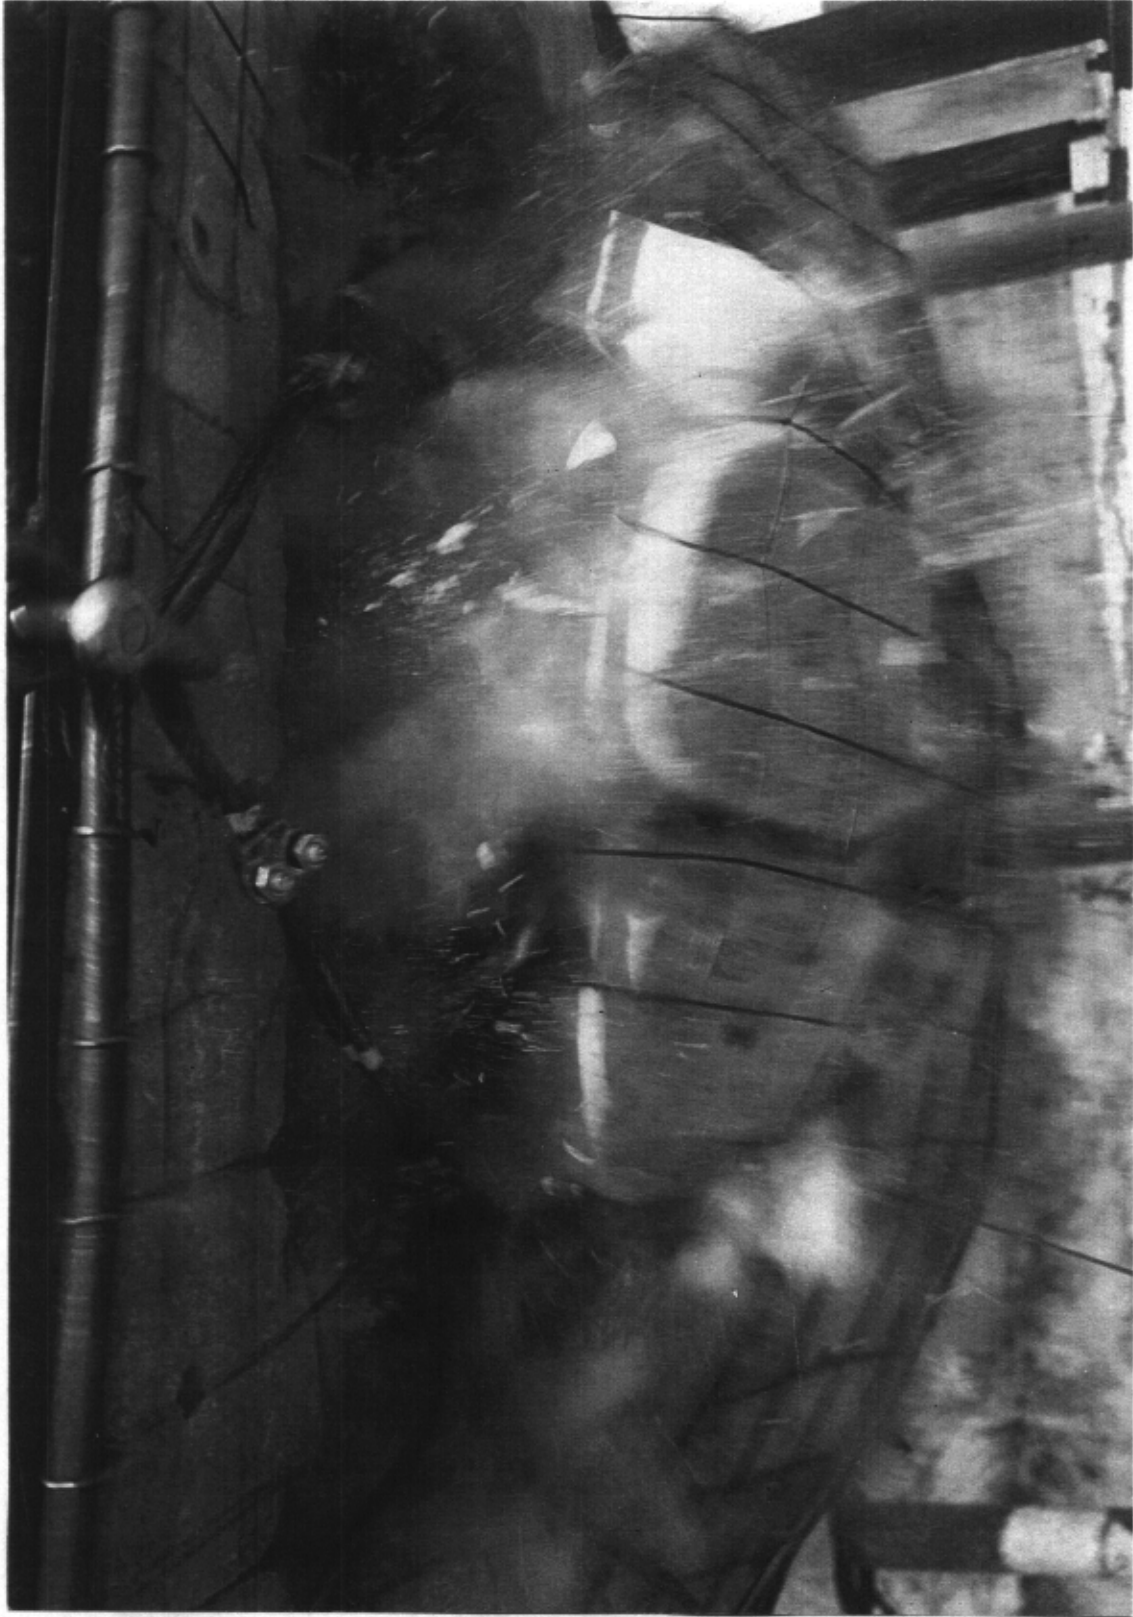
Photo 20: Test No. 56. 70,6 kJ at impact velocity of 7,3 m/s.
Photo taken about 0,3 seconds after impact.

In test 32, which was subjected to 46 kJ, many wires broke around the face plates but the mesh remained intact across the "windows" between the lacing and no bricks spilled out - see photo 19. In test 56, an impulse of 70 kJ caused massive damage to the weld mesh effectively destroying the containment even though the 12 mm lacing survived, and the 3 link chain link connectors were totally unscathed. Photos 20 and 21 give an indication of the violence and damage associated with this level of energy input.

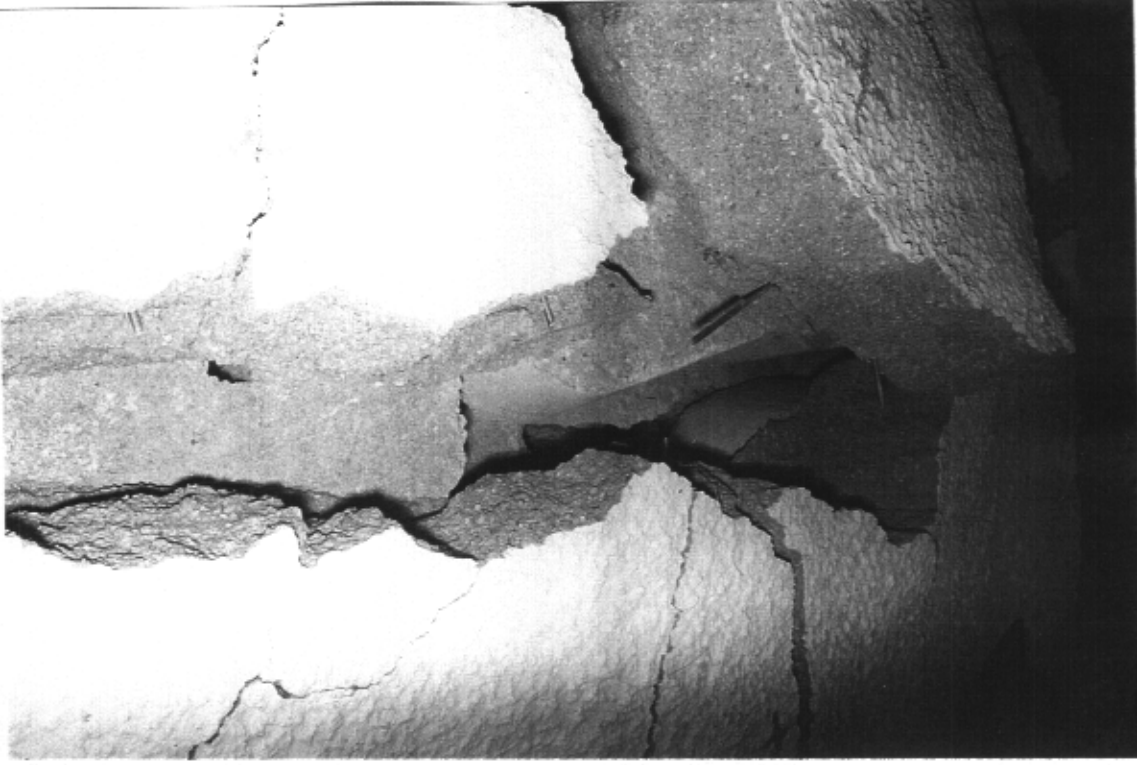
b) Detail of N-S crack, looking northward. Necking of wires can be seen.

a) Close view westward of main E-W crack. No wires left unbroken.

Photo 23: **Test No. 40. Impulse 15,4 kJ, 215 mm deflection.**
Detail of cracks in mesh reinforced shotcrete slab.

Two main cracks orientated N-S and E-W, together with several minor radiating cracks, formed at impact and the slab incurred 215mm of displacement at its centre - see photo 23.

All the wires traversing the two main cracks were broken. The test piece was comprehensively destroyed although it did not collapse because of the edge constraints.
