**Safety in Mines Research Advisory Committee**

**Final Report**

**Deterioration mechanisms of drum  
winder ropes**

**Research agency: MIKE VAN ZYL INCORPORATED**  
**Project number: GAP 501**  
**Date: December 2000**

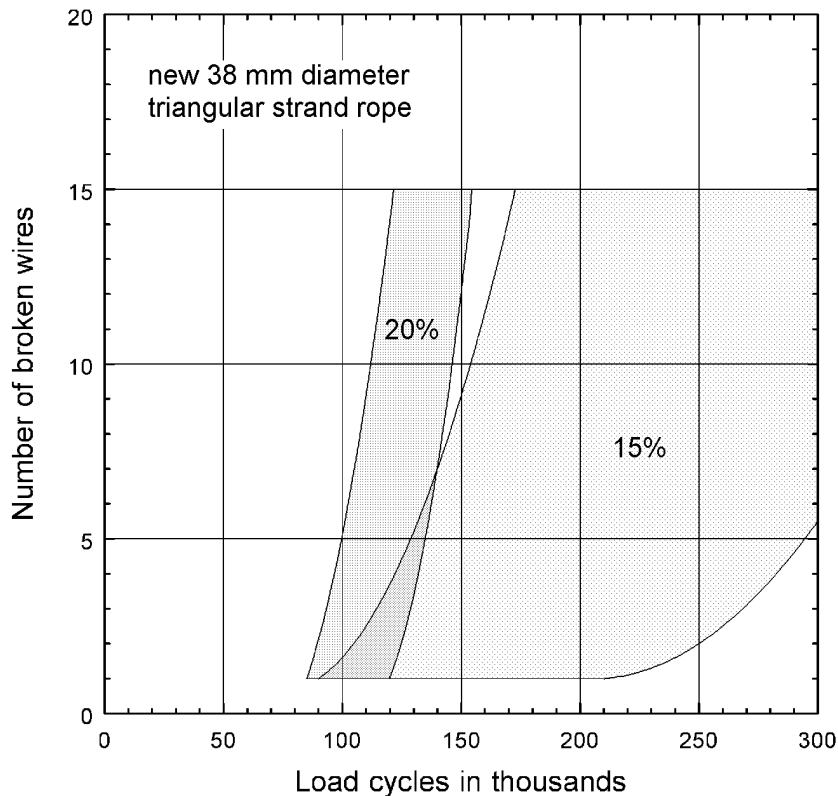
Figure 2 shows that, contrary to an earlier stated belief, broken wires did develop at a 15% load range on new triangular strand ropes. The figure further shows that at 20% load range, broken wires started to occur earlier during a fatigue test, and subsequent wire fractures were generated more rapidly. Although more tests were carried out at the 15% load range, the scatter in the results at 15% load range was surprisingly large. (Explanations are given later in this section.)

**Figure 2: Scatter plots of the new-rope fatigue tests at 15% and 20% load ranges.**

The Haggie tests are described in detail in Appendix A. Sixteen of the 85 fatigue tests were carried out at a load range of 20% and the rest of the tests were done at a 15% load range. During the fatigue tests described in Appendix A, the load cycles completed when broken wires occurred were noted. For each test a graph of "number of broken wires" against "load cycles completed" were obtained. Although some of the rope "types" had slightly different breaking strengths, the fatigue performance (and scatter of results) of the different rope "types" were much the same. The scatter of the results of all the tests carried out on rope sample lengths of 685 mm are shown in Fig. 2.

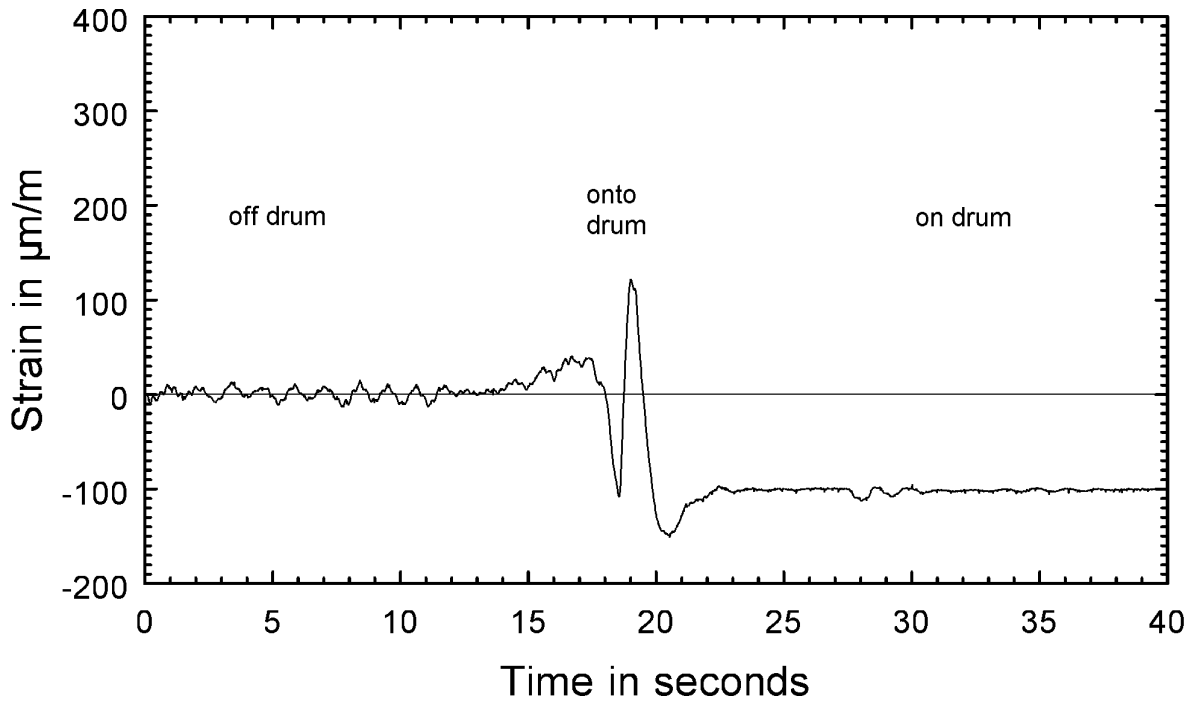
**Figure 3:** *Strain measured on the middle crown wire of a strand when wound onto the drum.*

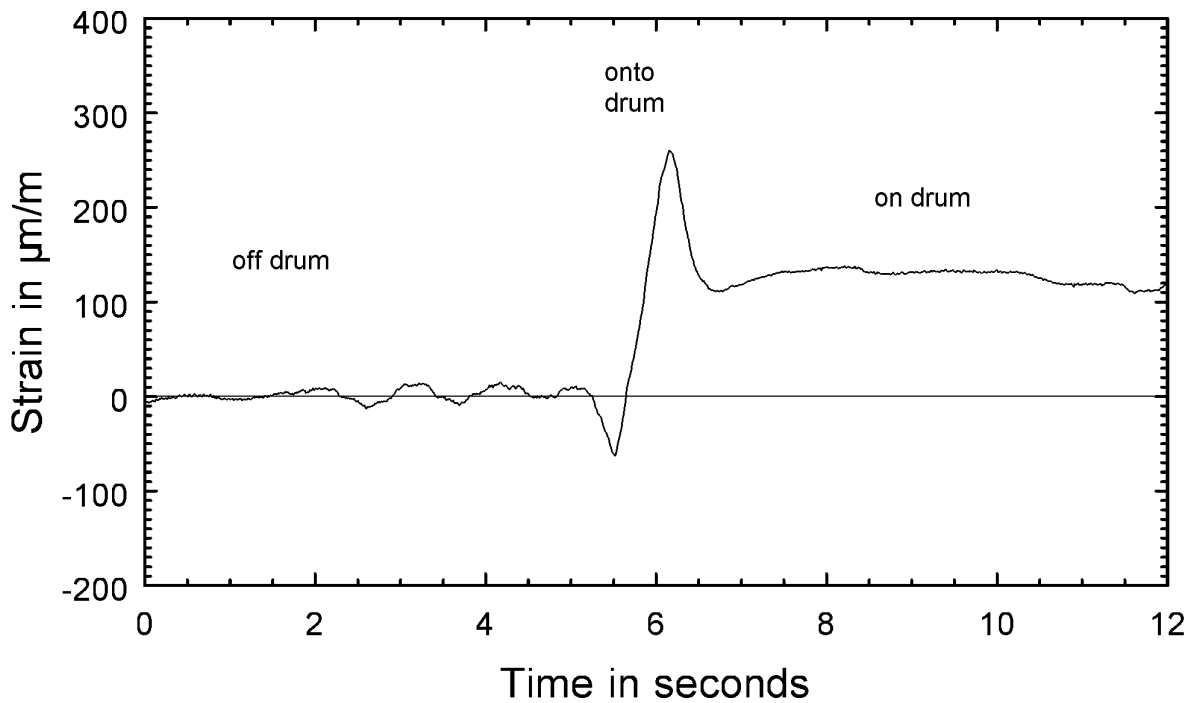
**Figure 3.1:** *Strain measured on the middle crown wire of another strand when wound onto the drum.*

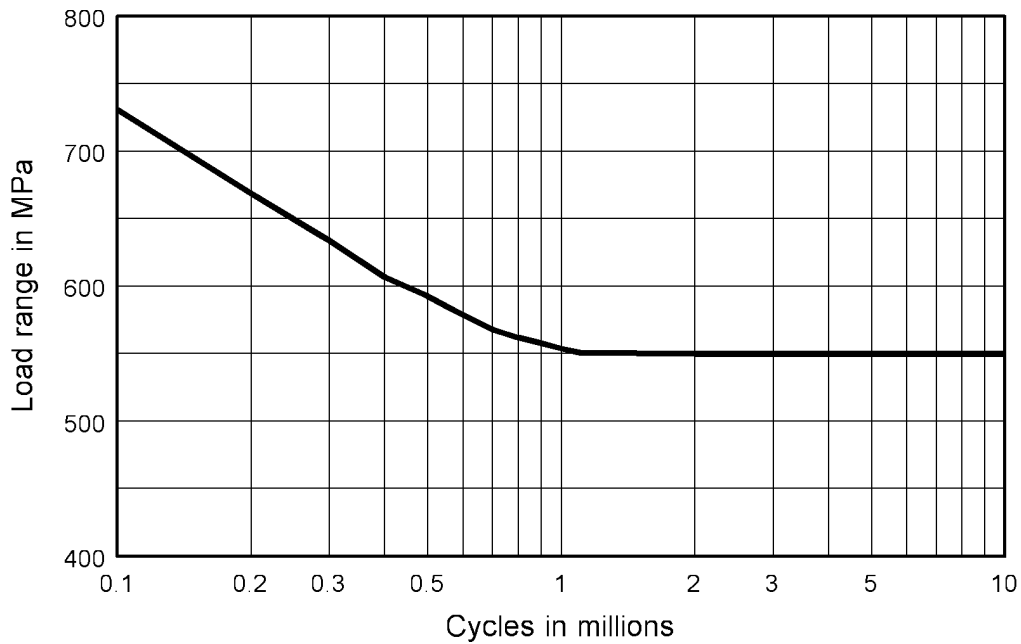
**Figure A1: An example of a fatigue curve for a single roping wire**

sources.<sup>15,16,17</sup> A summary of the general findings is given in this section. A typical fatigue curve for a 1 800 MPa single straight steel wire is shown in Fig. A1.

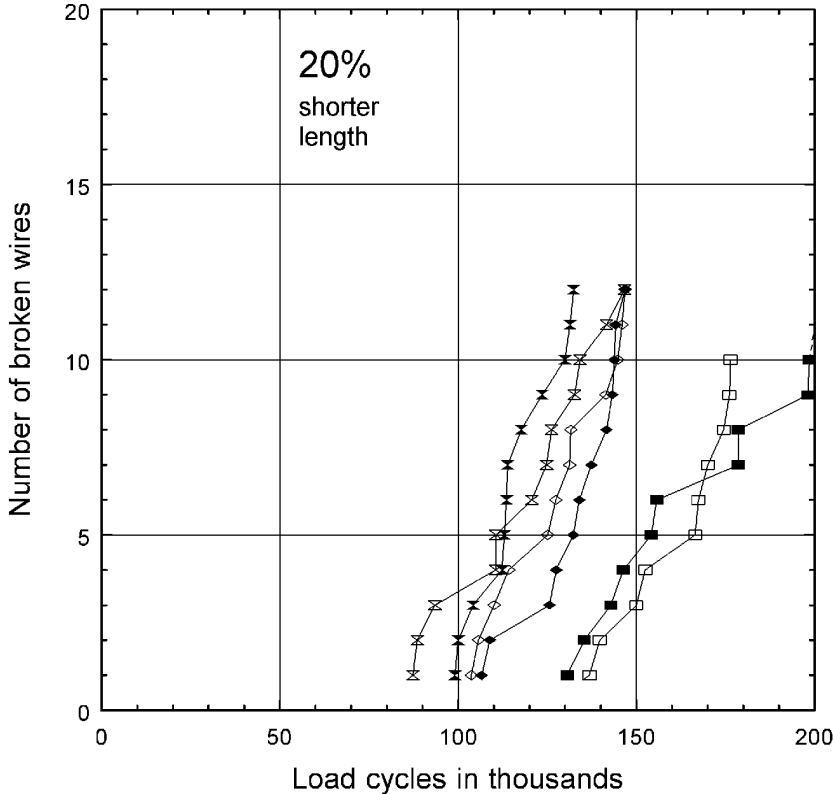
**Figure A3.1:** *Rope A, shorter specimen (460 mm long): 20% load range, load cycles at which broken wires occurred, 6 tests.*

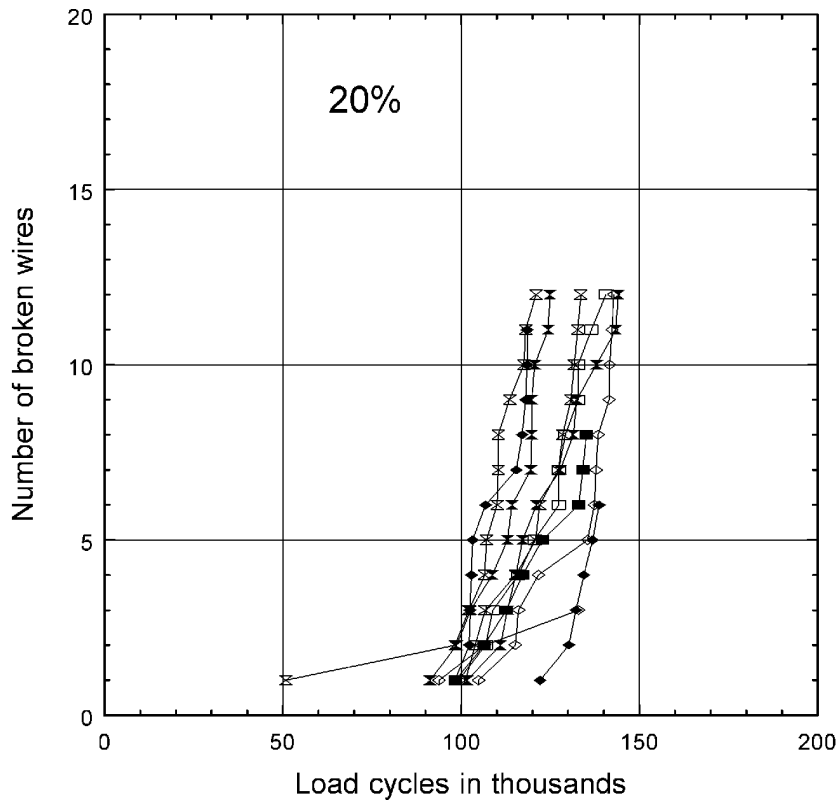
**Figure A3.1.1:** *Rope A, longer specimen (685 mm long): 20% load range, load cycles at which broken wires occurred, 10 tests.*

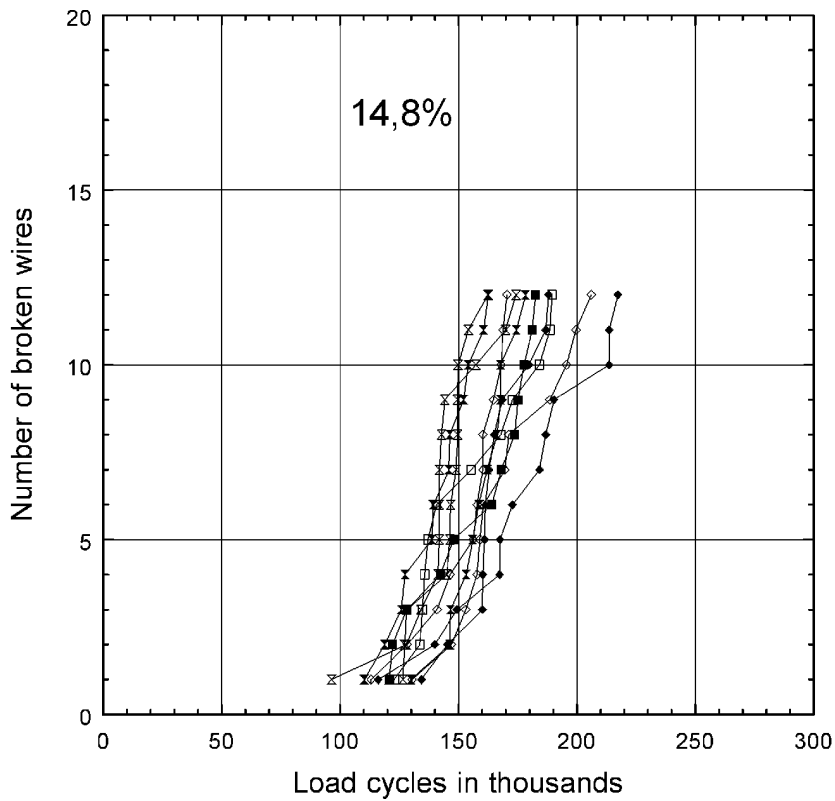
**Figure A3.2.4: Rope E: 15% load range, load cycles at which broken wires occurred, 10 tests.**

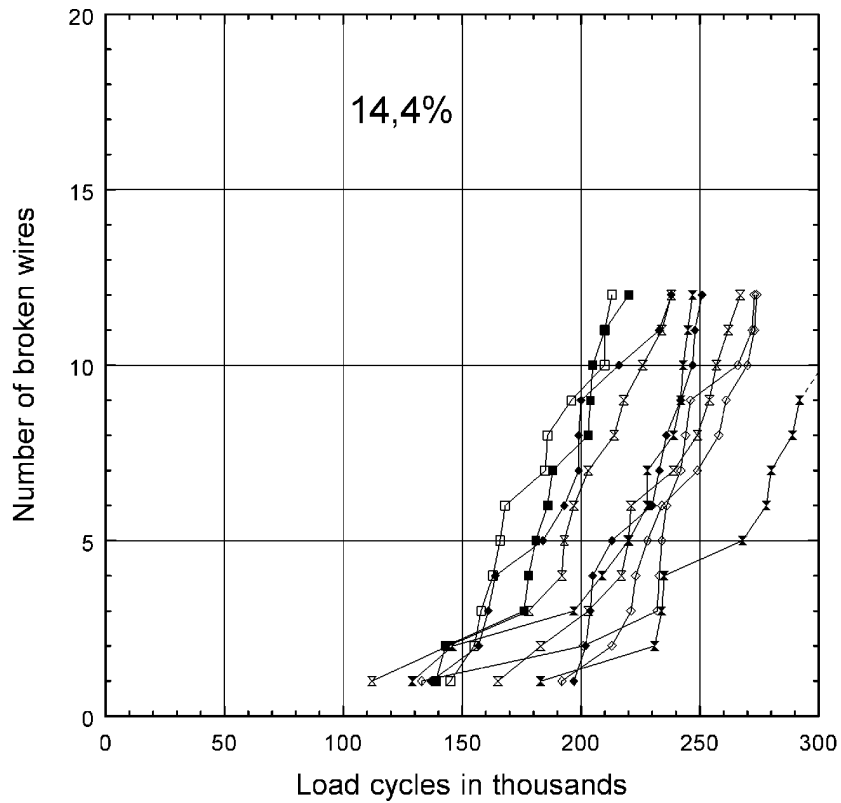
**Figure A3.2.5:** *Rope F: 15% load range, load cycles at which broken wires occurred, 10 tests.*

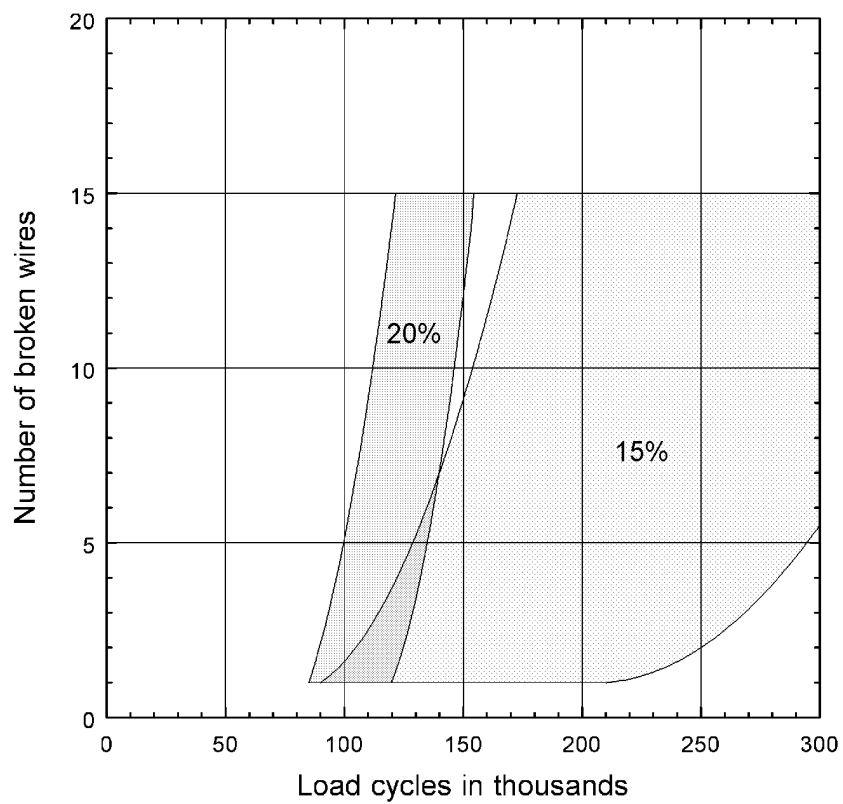
**Figure A4: Scatter plots of the new-rope tests at 15% and 20% load ranges.**

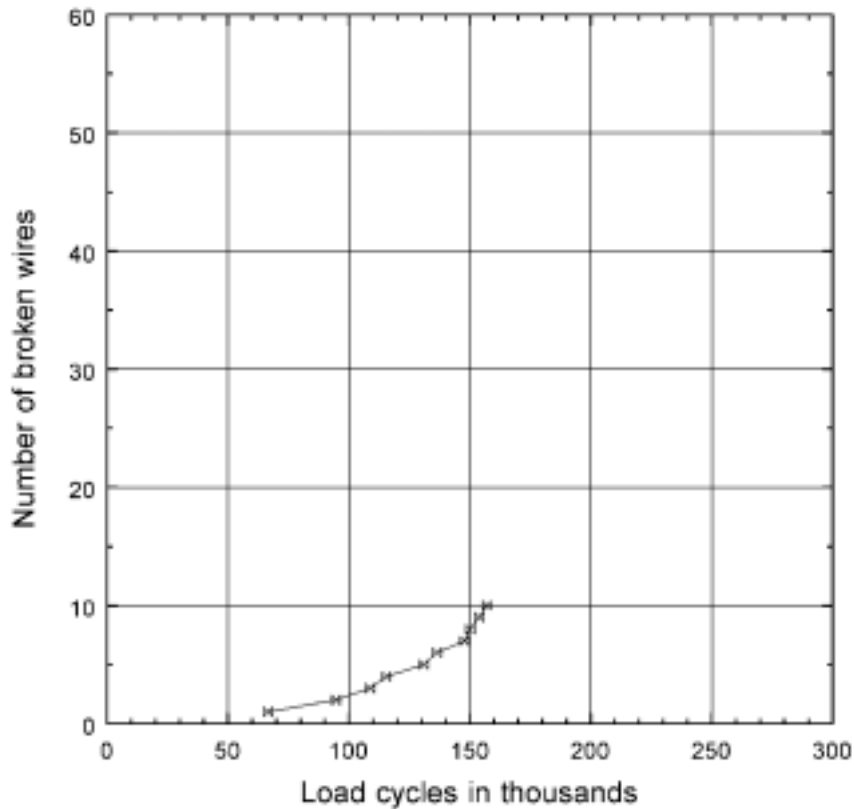
Type: Left hand lay	Front	Load range = 15%
Load cycles completed:	157 161	Tensile test = -17%
Number of broken wires:	10	
Number of cracked wires:	25	
<p>The specimen was <b>cleaned</b> during preparation, i.e. all visible lubrication (rope grease) removed.</p> <p>The broken wires were counted manually during the fatigue test.</p> <p>The broken wires originated from <b>inter strand contact</b> points.</p> <p>During the tensile test one strand failed completely at 66% of the new rope breaking strength.</p>

**Figure B6.1: Specimen no. 2: Load cycles at which broken wires occurred.**

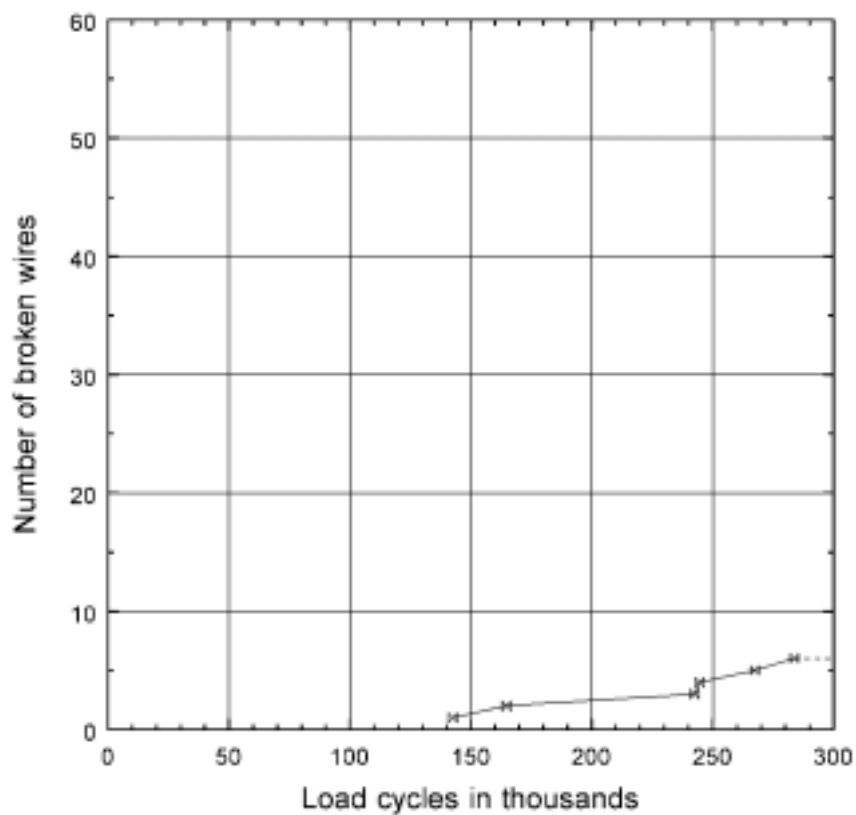
Type: Left hand lay	Front	Load range = 15%
Load cycles completed:	300 337	Tensile test = -9%
Number of broken wires:	6	
Number of cracked wires:	4	
<p>The broken wires were counted manually during the fatigue test.</p> <p>The number of broken wires registered during the fatigue test included <b>one crown wire</b>. The cracked wires included one crown wire.</p> <p>The tensile test fracture occurred inside the one rope termination.</p>

**Figure B6.2: Specimen no. 3: Load cycles at which broken wires occurred.**

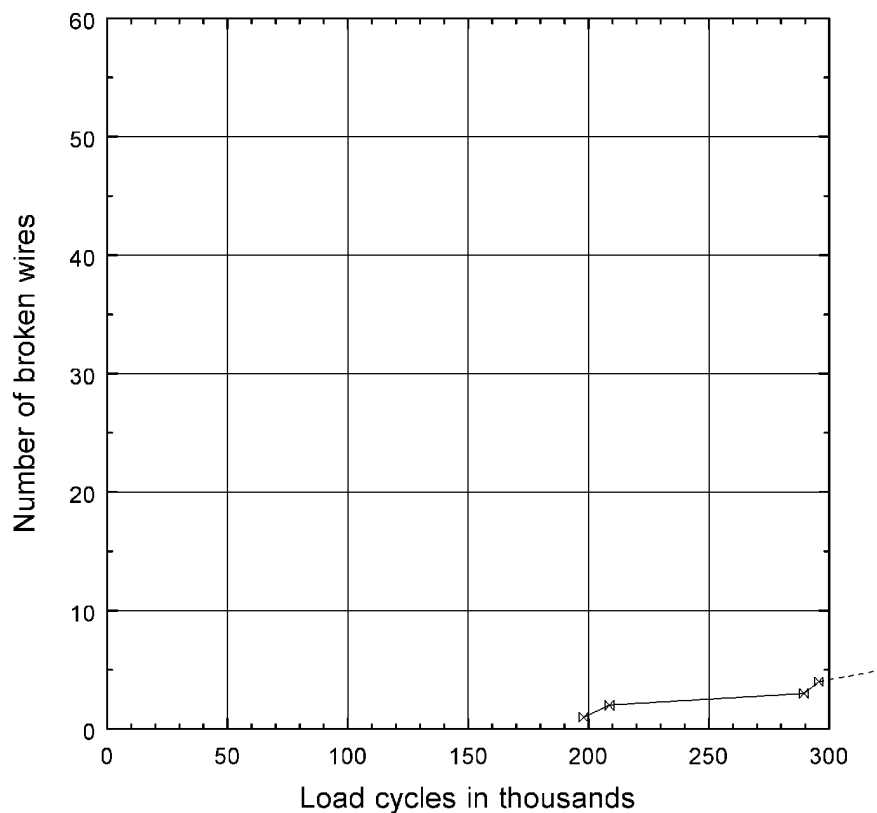
During the tensile test one strand failed completely at 40% of the new rope breaking strength.

**Figure B6.3: Specimen no. 4: Load cycles at which broken wires occurred.**

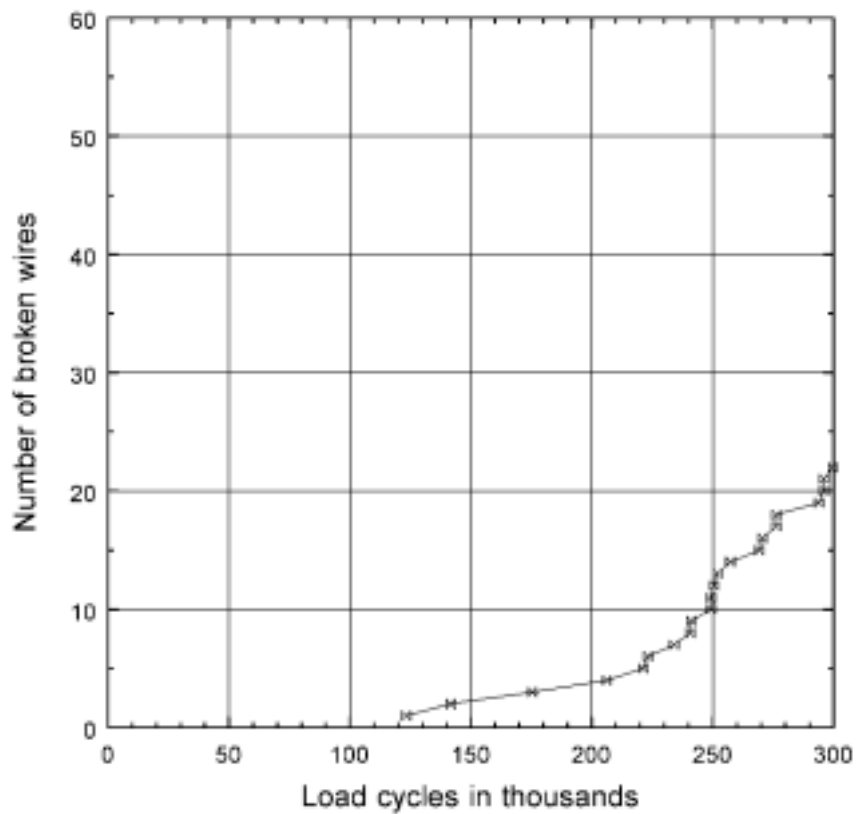
Type: Left hand lay	Midshaft	Load range = 15%
Load cycles completed:	300 000	Tensile test = -17%
Number of broken wires:	22	
Number of cracked wires:	7	
Three crown wires developed (partial) cracks during the fatigue test.		
During the tensile test, one strand failed completely at 52% of the new rope breaking strength.

**Figure B6.6: Specimen no. 6: Load cycles at which broken wires occurred.**

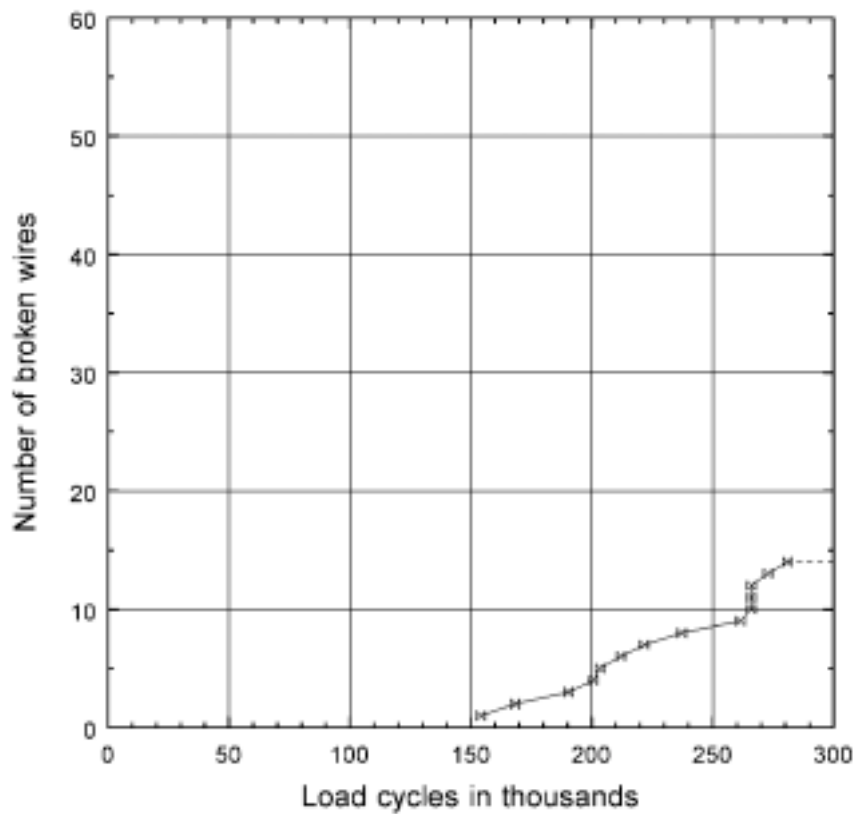
Type: Right hand lay	Midshaft	Load range = 15%
Load cycles completed:	300 000	Tensile test = -17%
Number of broken wires:	14	
Number of cracked wires:	22	
During the tensile test, one strand failed completely at 71% of the new rope breaking strength.

**Figure B6.8: Specimen no. 7: Load cycles at which broken wires occurred.**

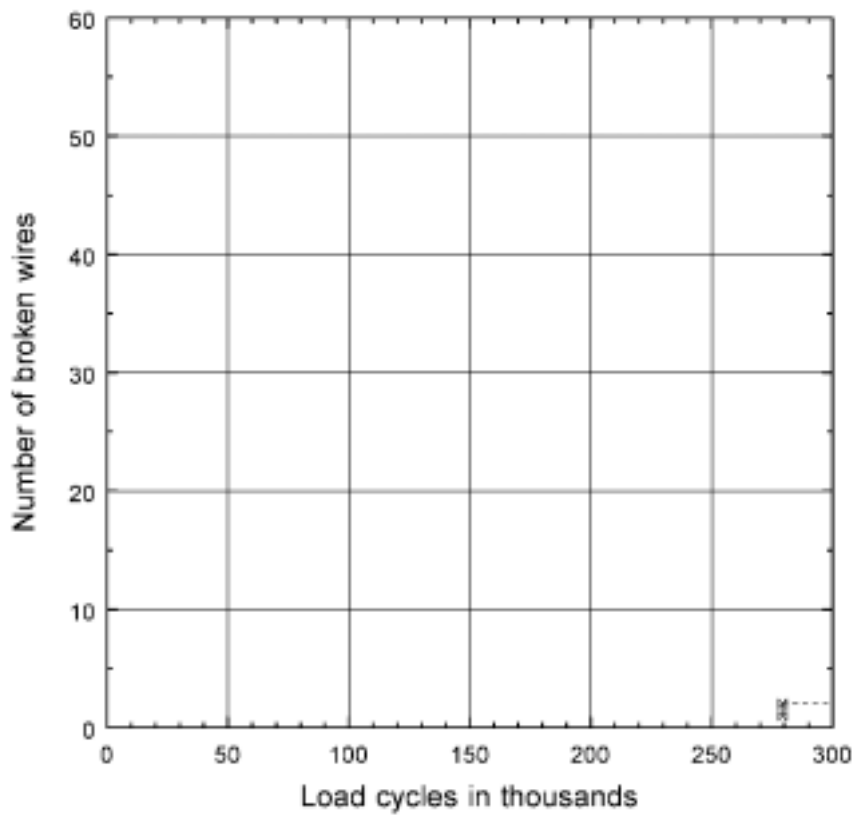
One crown wire developed a (partial) crack during the fatigue test.

**Figure B6.12: Specimen no. 10: Load cycles at which broken wires occurred.**

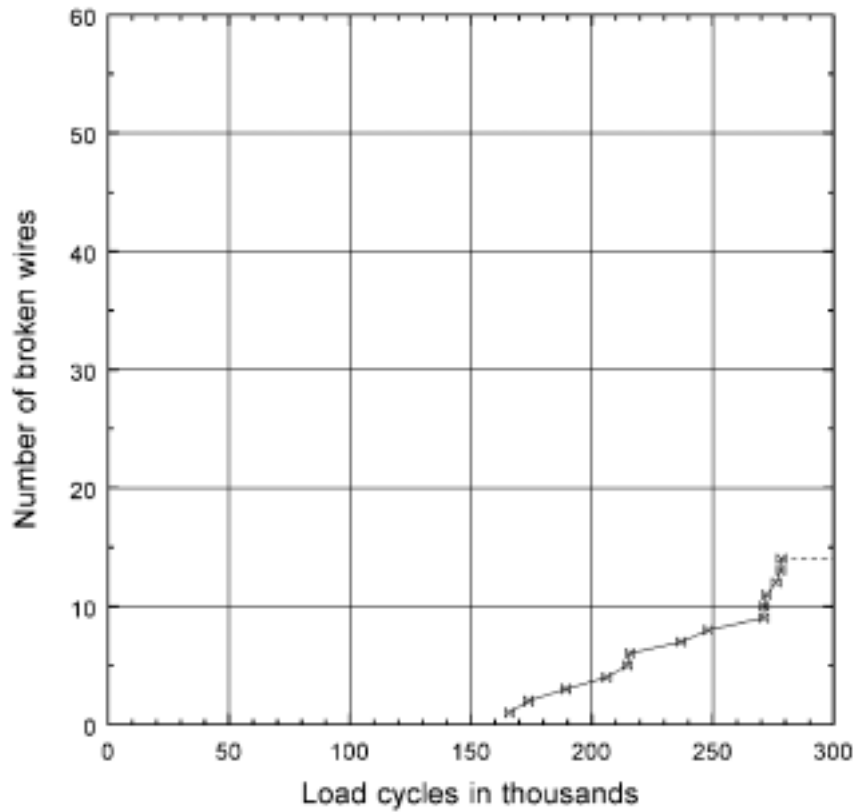
Type: Right hand lay	Back	Load range = 15%
Load cycles completed:	300 000	Tensile test = -9%
Number of broken wires:	14	
Number of cracked wires:	13	
Nine crown wires developed (partial) cracks during the fatigue test.

**Figure B6.13: Specimen no. 11: Load cycles at which broken wires occurred.**

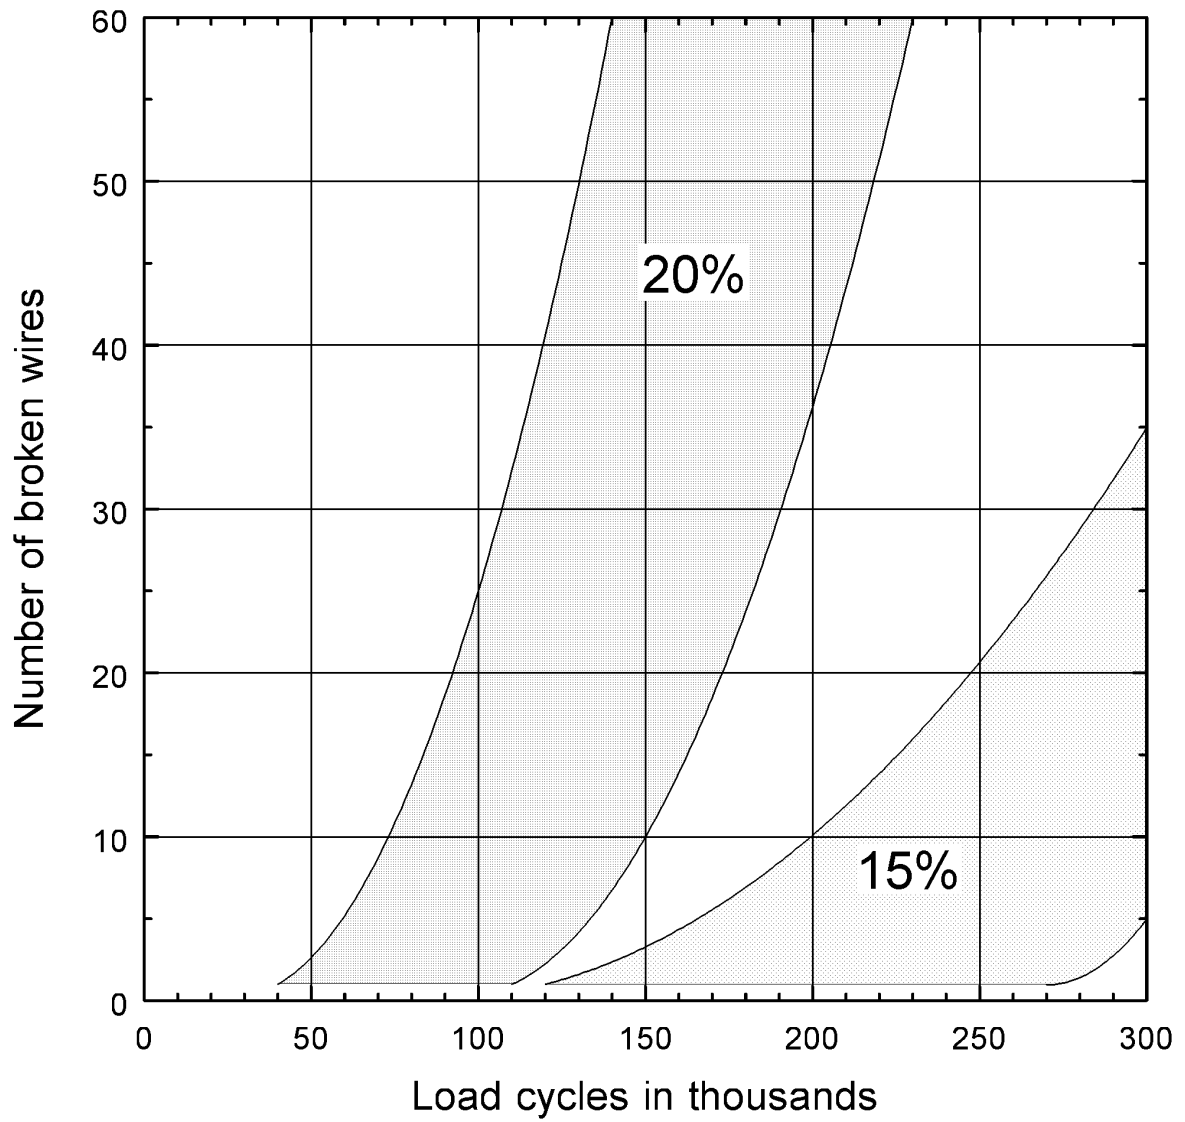
**Figure B7.2:** Scatter bands of the fatigue test results.

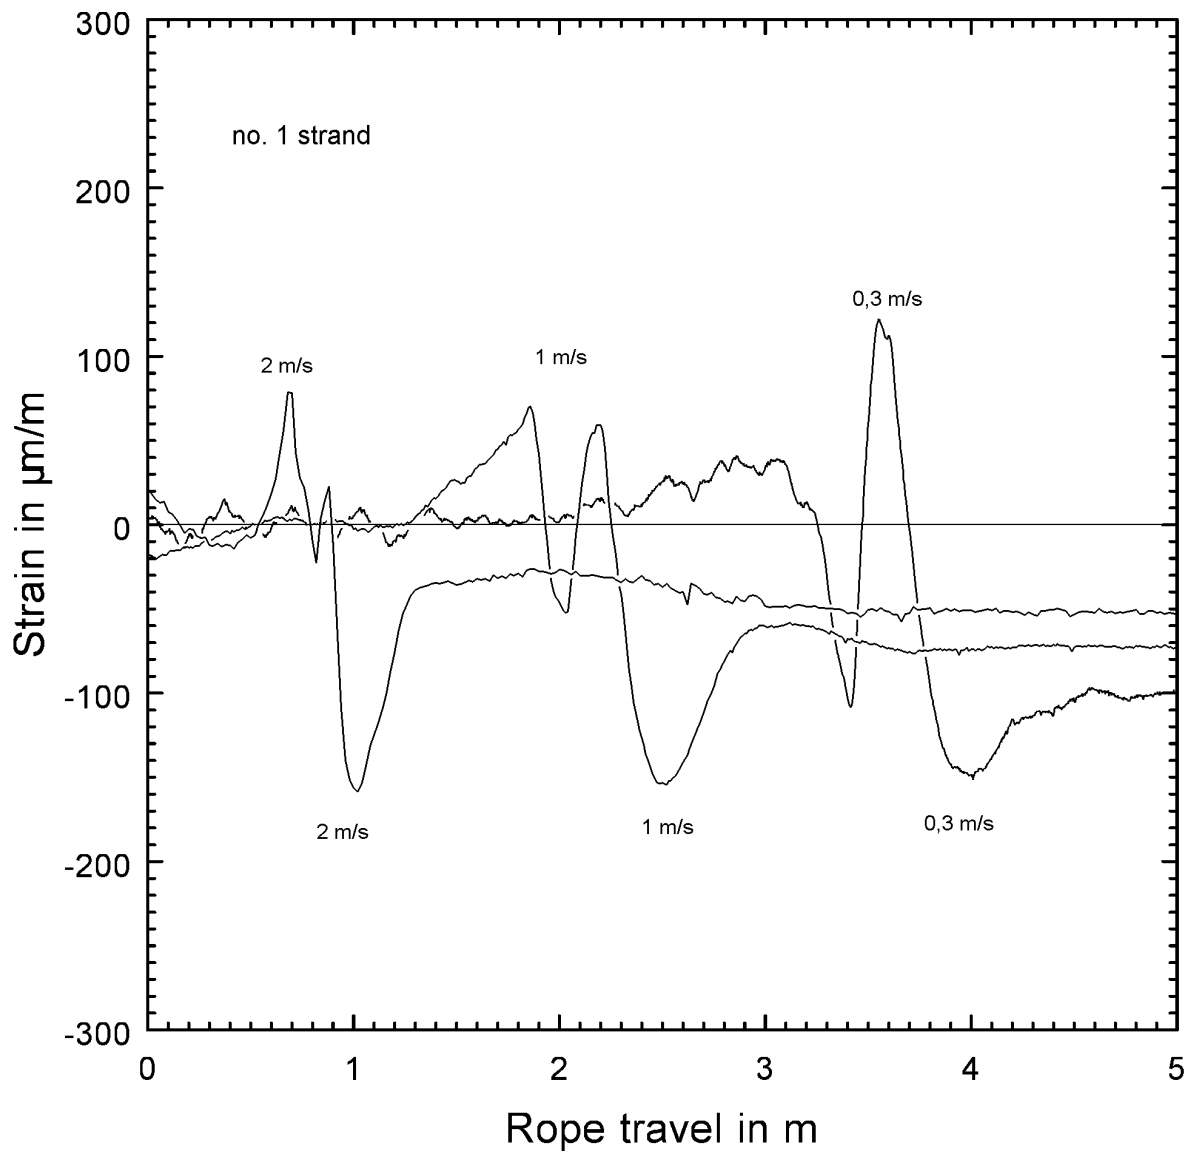
**Figure C3.4.1.4: Strand no 1: Onto the drum at different speeds.**

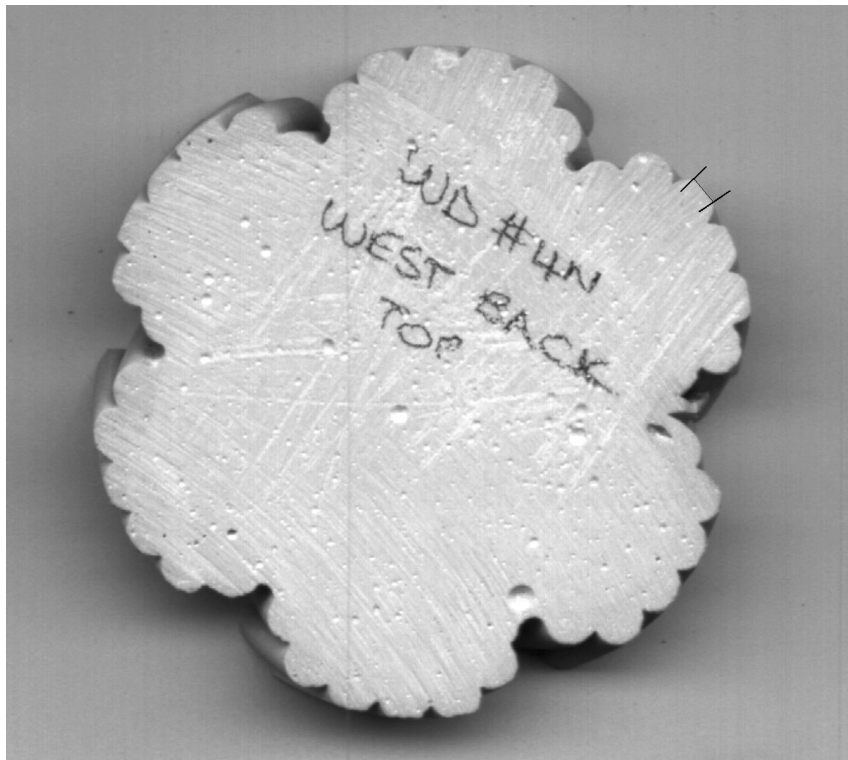
**Figure E1:** A typical section of a replica of a rope.
