**Final Project Report**

**GAP 611**

**Realistic Dynamic Stope**

**Research Agency : Steffen, Robertson and Kirsten**  
**Project Number : GAP 611**  
**Date : August 2000**

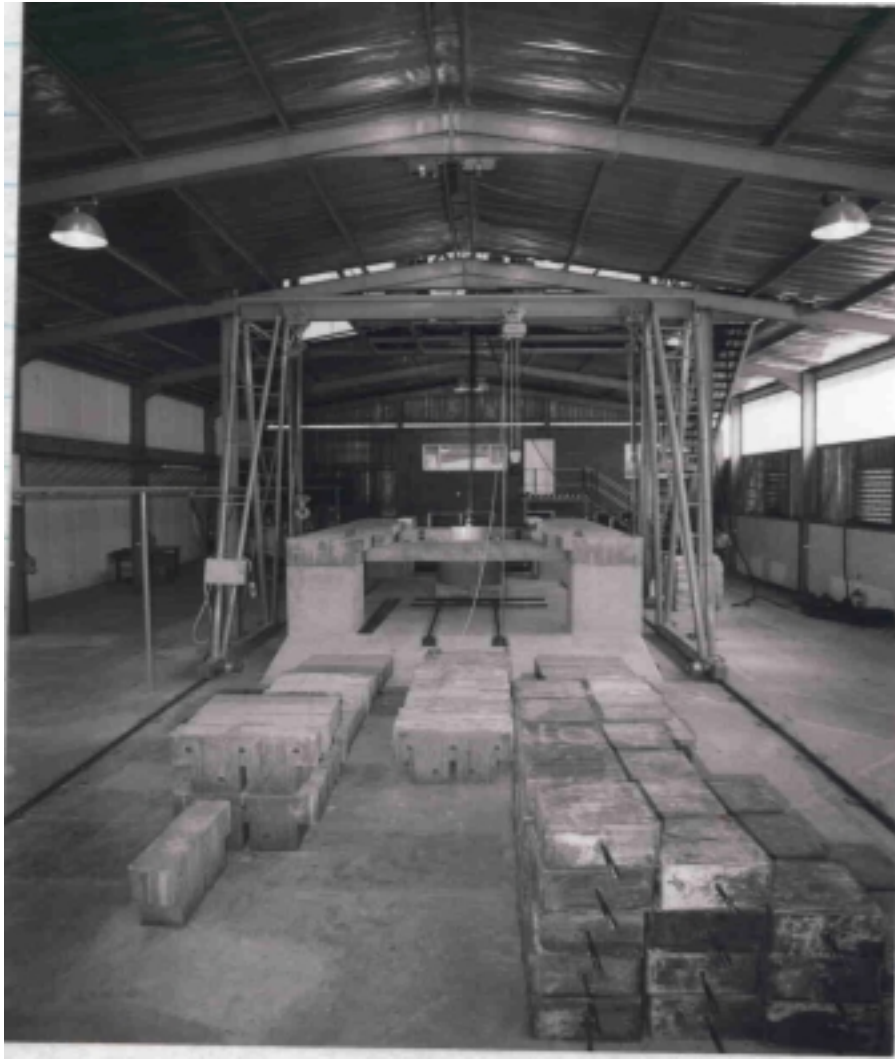
**Photograph 1:**

View towards the south, of the stope with the drop weight temporarily berthed at the centre of the stope floor. The portal crane is positioned near the north end of the stope and its legs largely obscure the four main columns which disappear into the gap in the roof where they support the hoist and traverse superstructure. The stairway which leads to the upper working floor is visible behind the west leg of the portal crane. The inverted concrete blocks of the centre Voussoir beam are visible in the centre of the middleground and the steel-clad load distribution blocks are stacked in the right foreground.

Figure 1 is a scaled diagram that illustrates the main features of the facility. Photographs 1 and 2 shows the main structures in their operating environment.

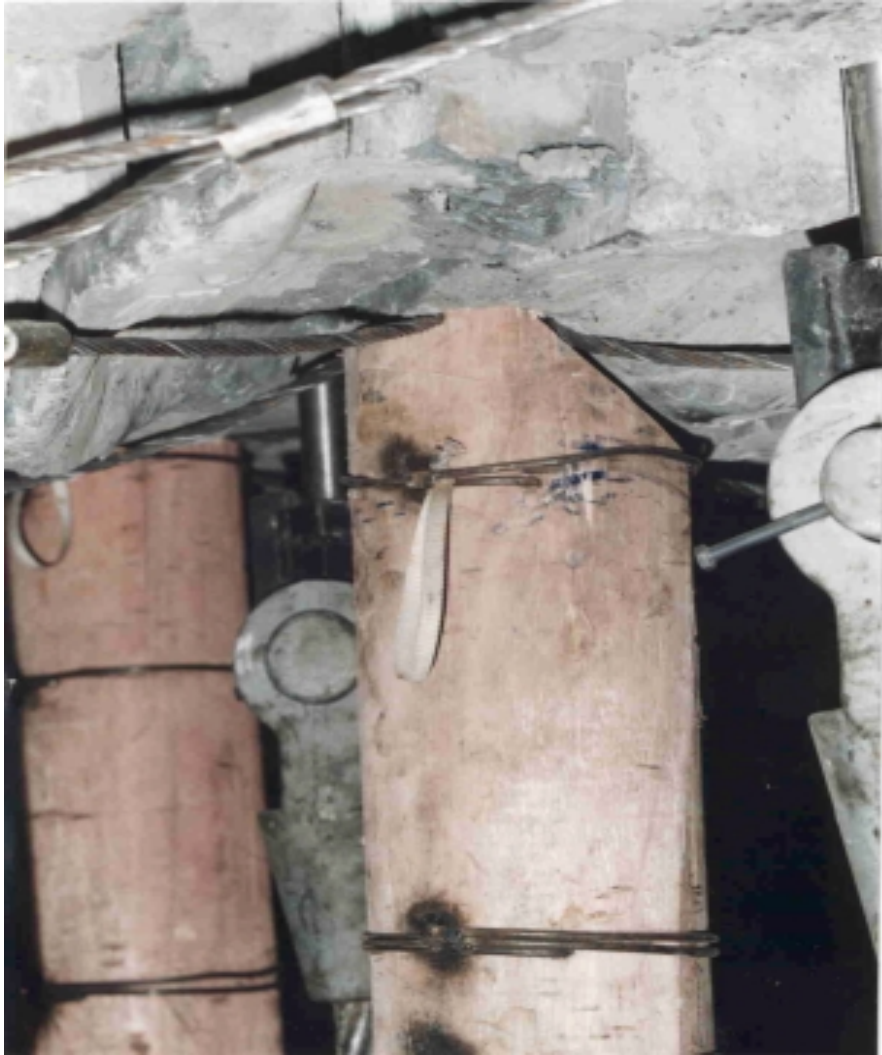
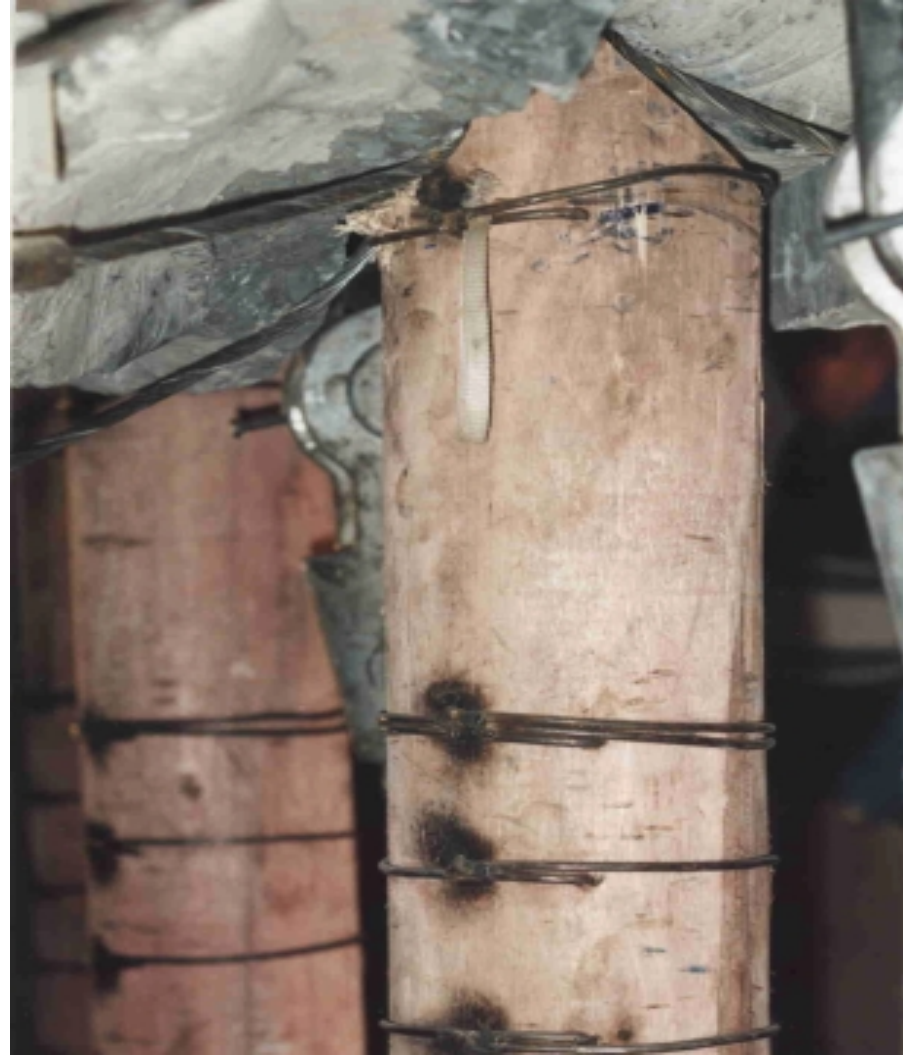
**Photograph 9:** Detailed views from west of the top of the centre south elongate a) after the first impulse of 70kJ and b) after the second impulse of 150kJ

(a)

(b)

Photographs 9(a), 9(b) and 10 show that the second impulse caused considerable sliding of the roof blocks immediately to the north, before the tension in the link prevented further movement. Viewed from the east side photograph 11 shows the extent to which the roof blocks have moved before their arrest and the appearance of connecting ring of 6 mm flexible wire rope.

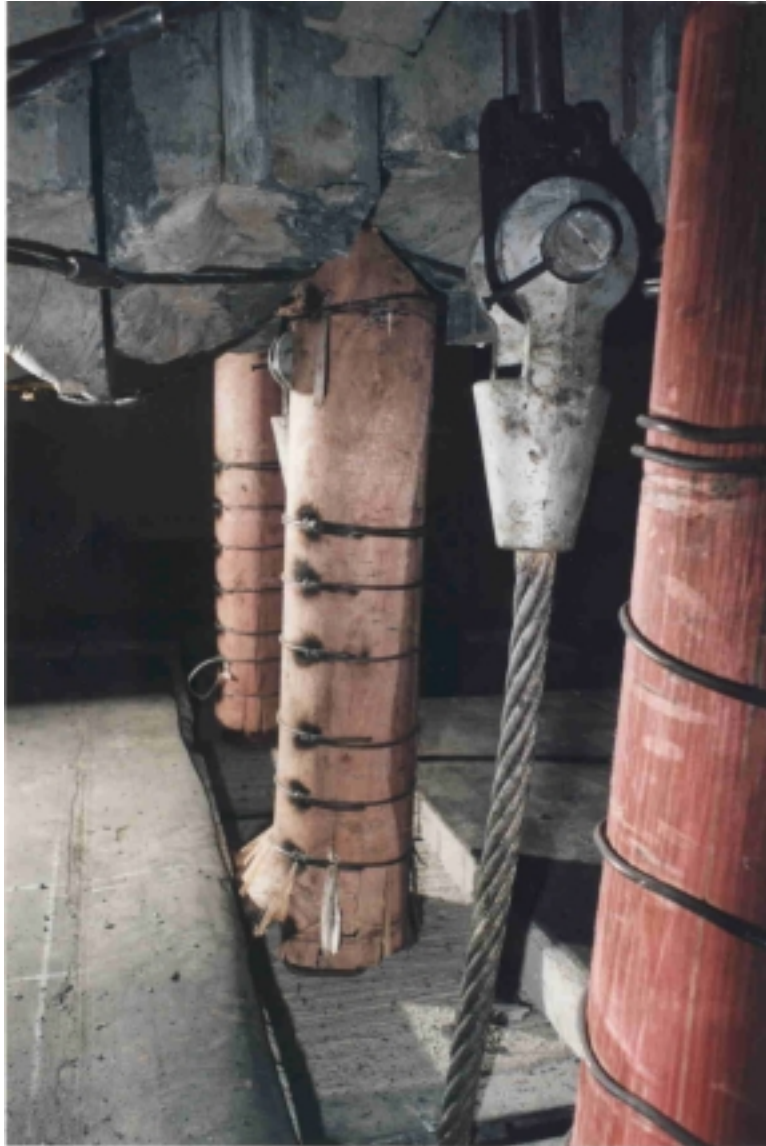
**Photograph 10:**

View from the west showing the centre elongate in the southern dip row and the considerable extent of the sliding movement of the adjacent roof blocks towards the north.

The mode of yielding of the Ebenhauser 2000 is also clearly visible.

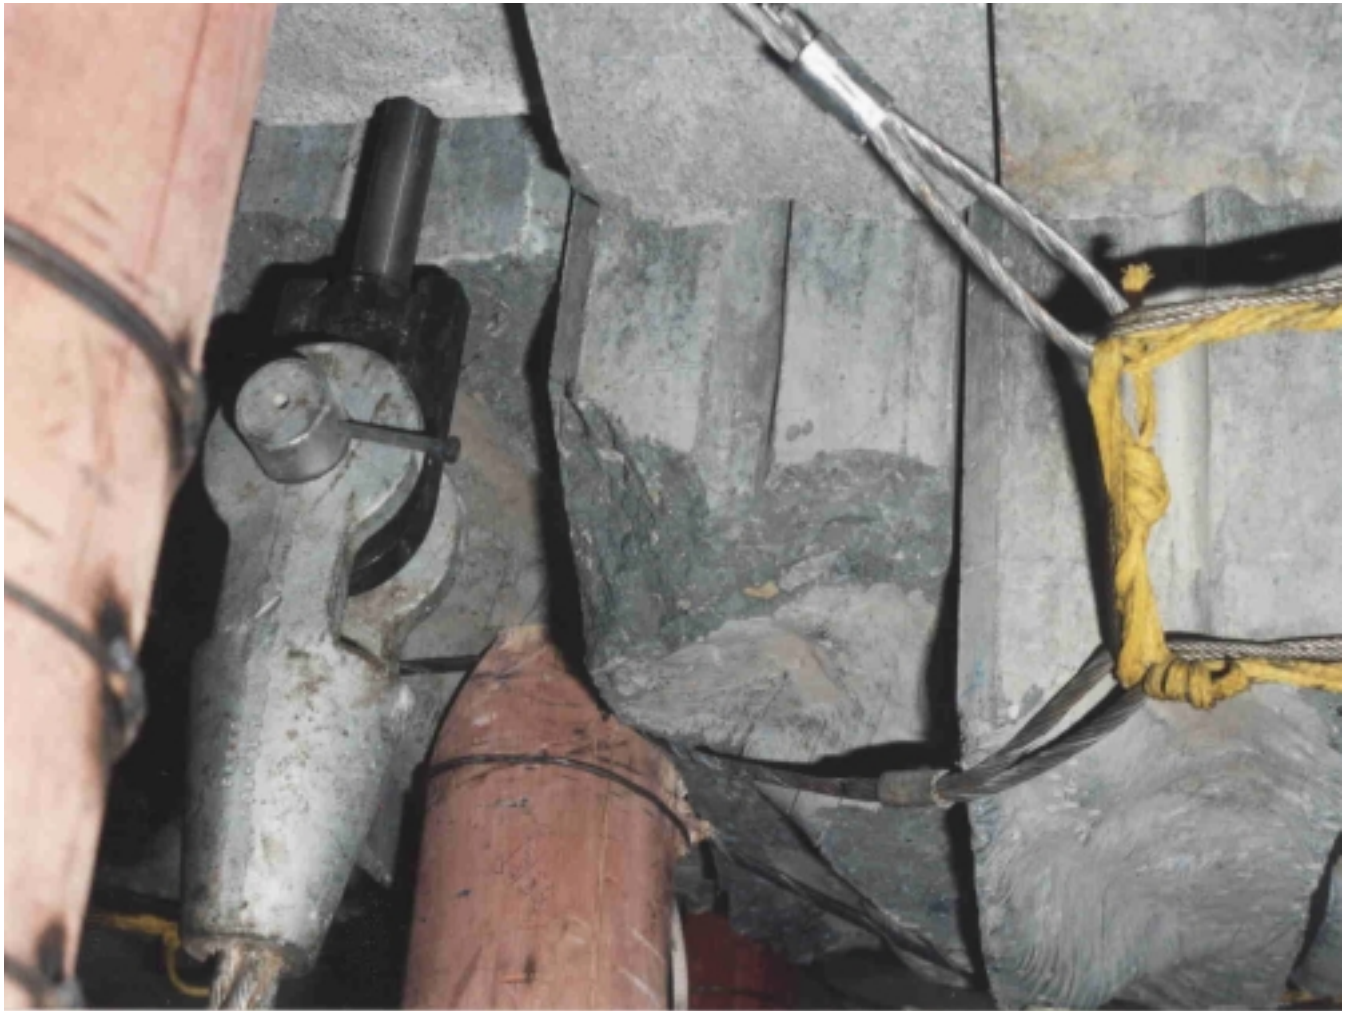
**Photograph 11:**

Close view of the large amount of slip of the roof blocks of the 'central beam' before the restraining effect of the link ropes came into play. Note the tension in the connecting ring of 6 mm dia flexible wire rope.
