Safety in Mines Research Advisory Committee

Final Report

Determine the effect of repeated dynamic loading on the performance of tunnel support systems

Project No.: GAP 616

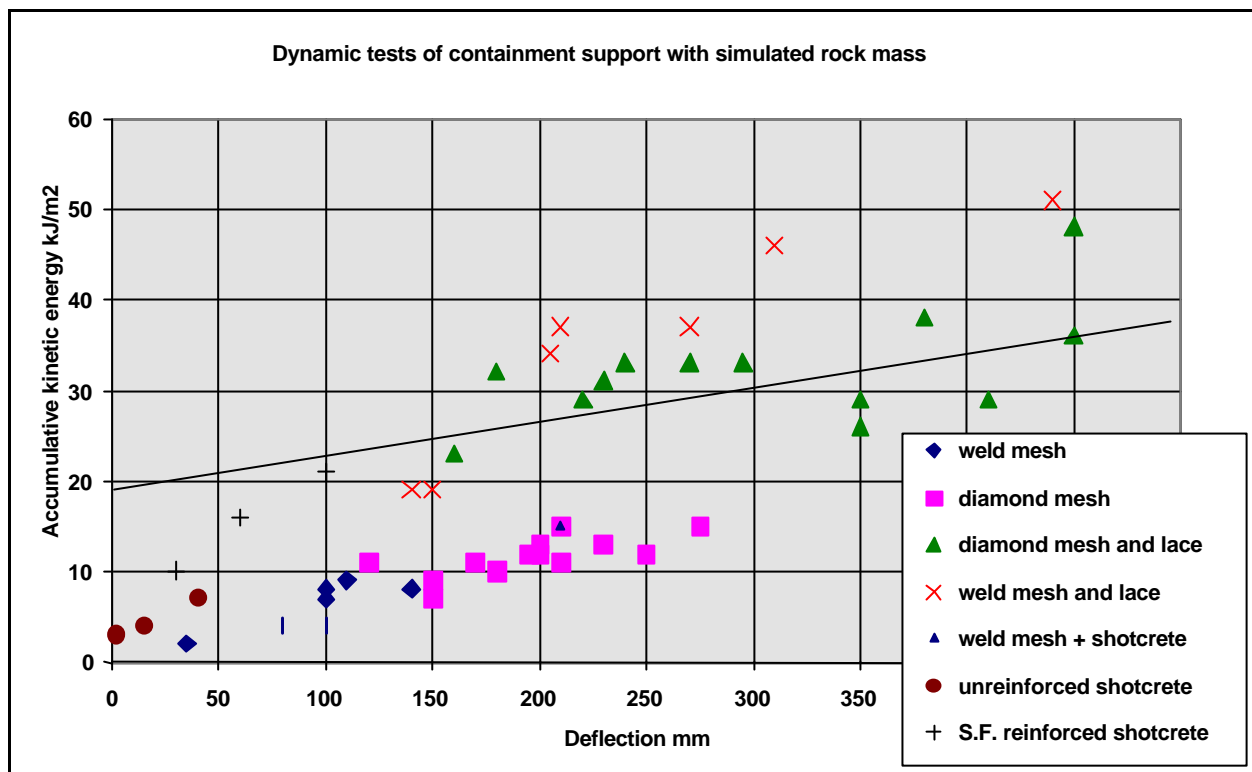
Figure 2.4. Relationship between accumulated impact kinetic energy and deformation for contained simulated rock mass system (Stacey and Ortlepp, 1997).

lead to a measurable critical kinetic energy magnitude (i.e. velocity). The absence of lacing appears to result in negligible critical energy levels, or, in other words, even extremely small impact energy levels would lead to ultimate failure in the absence of lacing.

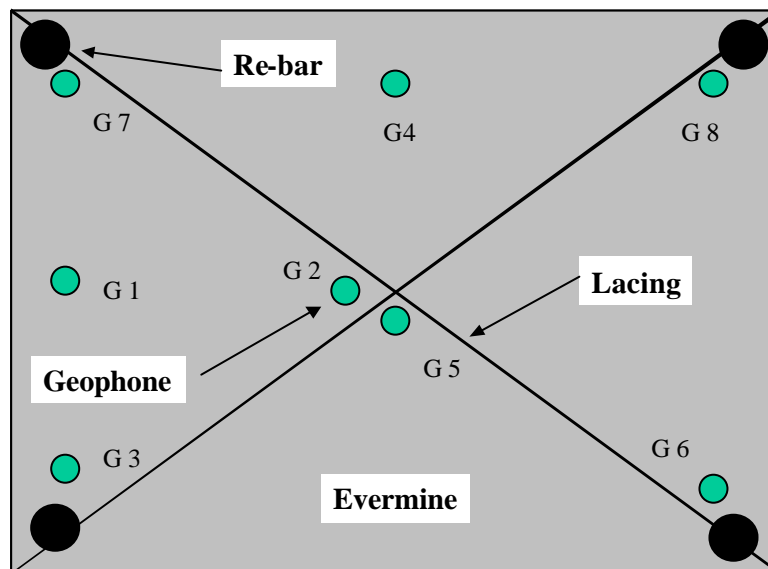
Figure 3.3. Plan view illustrating the position of various geophones at the bottom of an assembly supported with Evermine and lacing.

In addition to these deformations, the peak particle velocities (PPVs) were monitored along the bottom of the testing assembly. The PPVs generated by repeated dynamic loading were thus measured on the skin of the simulated tunnel support rock mass system. A ground motion monitor (GMM) with eight geophones was used in this experiment. The position of the geophones with respect to the support is shown in Figure 3.3.

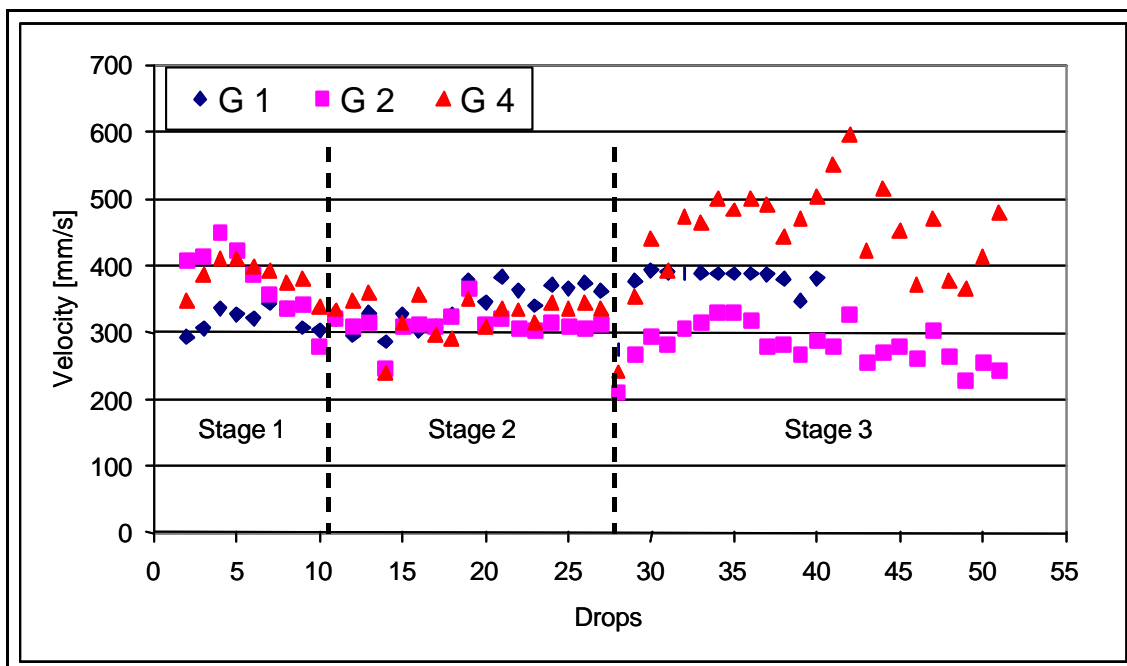
Figure 3.4. Peak particle velocities measured on the surface of the sample with Evermine and lacing.

where damage of the sample begins to occur. The PPVs at all geophones during this stage are more consistent. There is no evidence of lacing yield during this stage. The third stage, drops 29 and above, is characterized by extensive cumulative damage, which spreads outward from the centre of the sample towards geophone G4 where PPVs are significantly higher. The effect of lacing support during this stage is demonstrated by the lower PPVs recorded at geophone G 2, which is located very close to the lacing intersection. The increased velocities at G4 can be associated with increased damage and a limited support influence. The general variations in the PPVs shown in Figure 3.4 ranged from 200 to 600 mm/s. This compares to impact velocities of 1400 mm/s for this particular experiment.

The effect of support and fracturing on the PPVs was clearly illustrated in Figure 3.4, where less supported areas remote from the support were associated with higher PPVs in a fractured environment. Similar behaviour was measured underground during the simulated rock burst experiment (SIMRAC project GAP 530). The results from these measurements are shown in Figure 3.5.

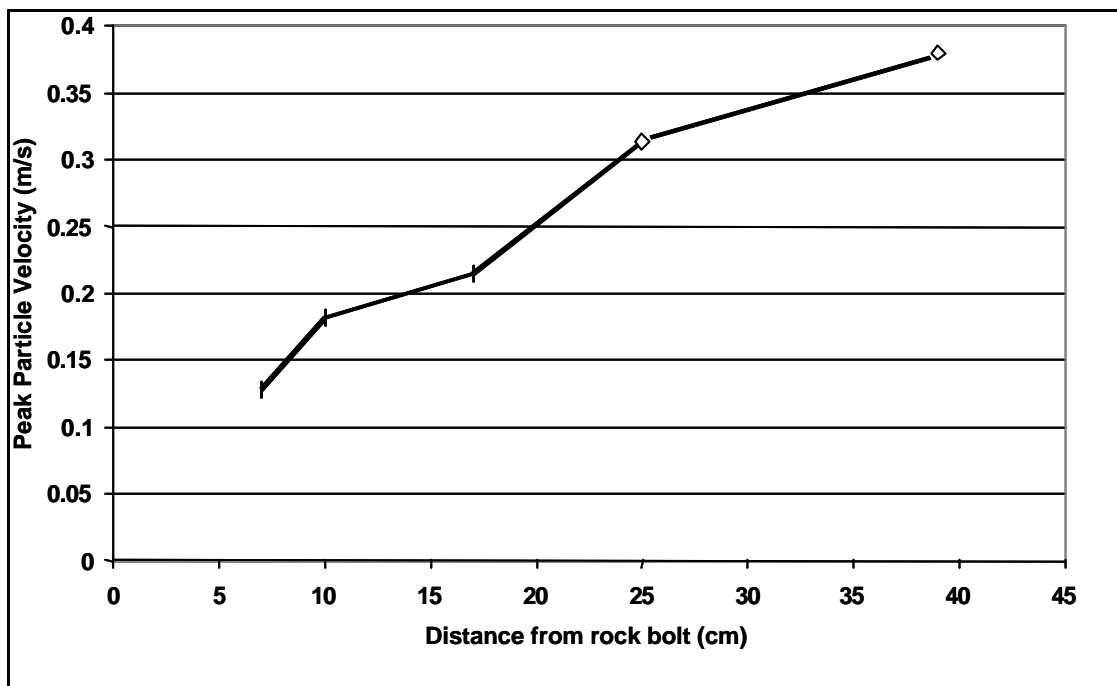
Figure 3.5. In situ relationship between PPVs and distance from a rock bolt reinforcement unit (Haile and Le Bron, 2001).

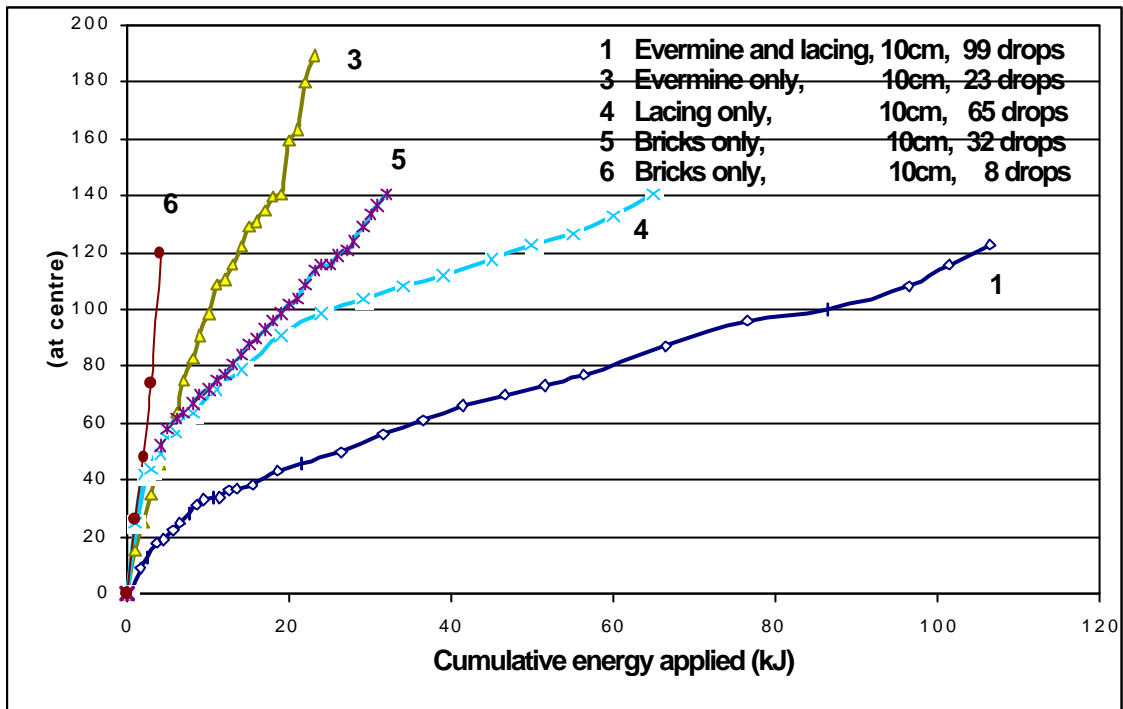
Figure 3.6. Results for 10 cm drops for various fabric supports (1 kJ per drop).

Figures 3.6 and 3.7 show the results of all impact tests performed, for 10 cm and 50 cm drop height respectively.

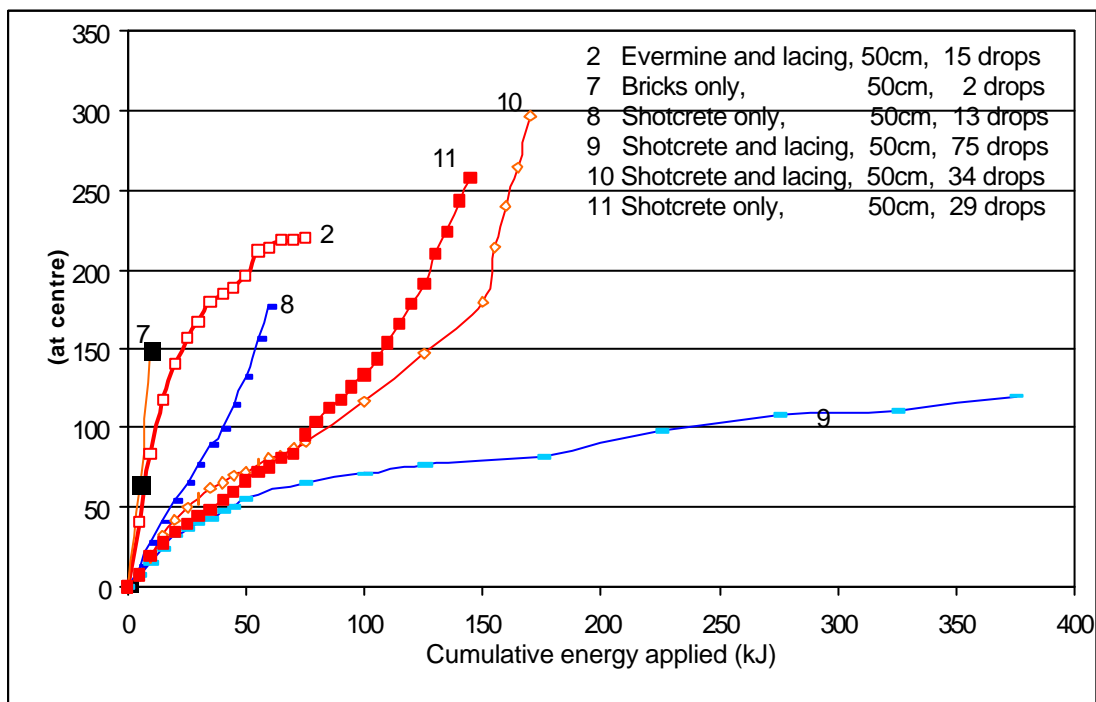
Figure 3.7. Results for 50 cm drops for various fabric supports (5 kJ per drop).

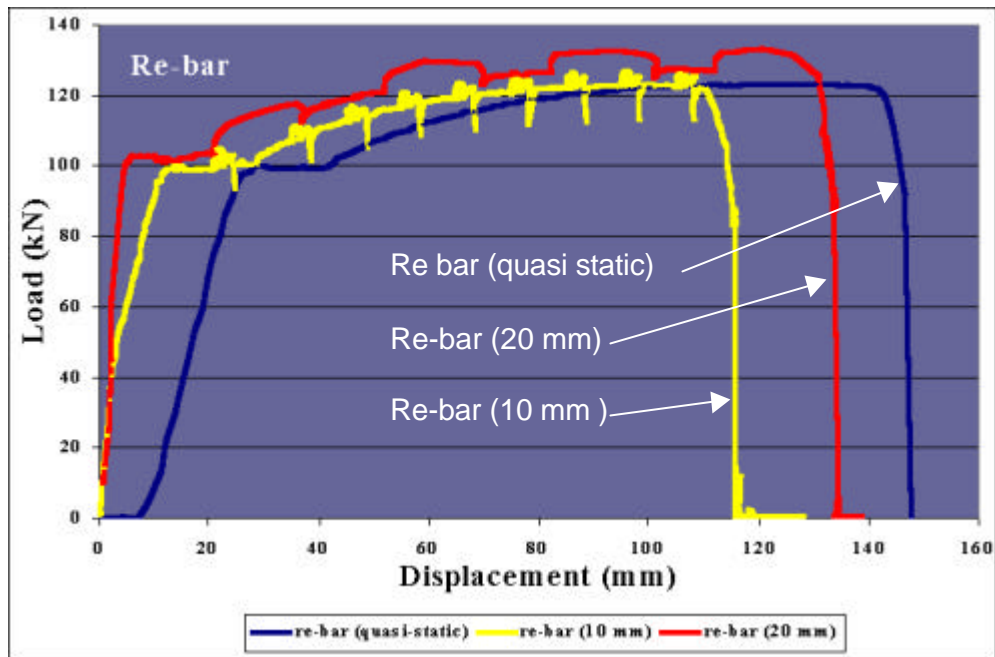
Figure 3.10. An example of re-bar testing results

Deformation curves for the re-bar show that the yield range and the peak loads are very similar in all tests (see Fig 3.10). A stiffer elastic response can be observed with the 20 mm pulse loading, something which is not evident with the 10 mm pulse. The indicated yield range associated with the pulse loading may be larger than the actual yielding range. As the forced deformations related to the final pulse were recorded in total, the exact deformation at which failure occurred during this last pulse may not be reflected. The actual yield range is obviously limited by the deformation at which failure takes place.

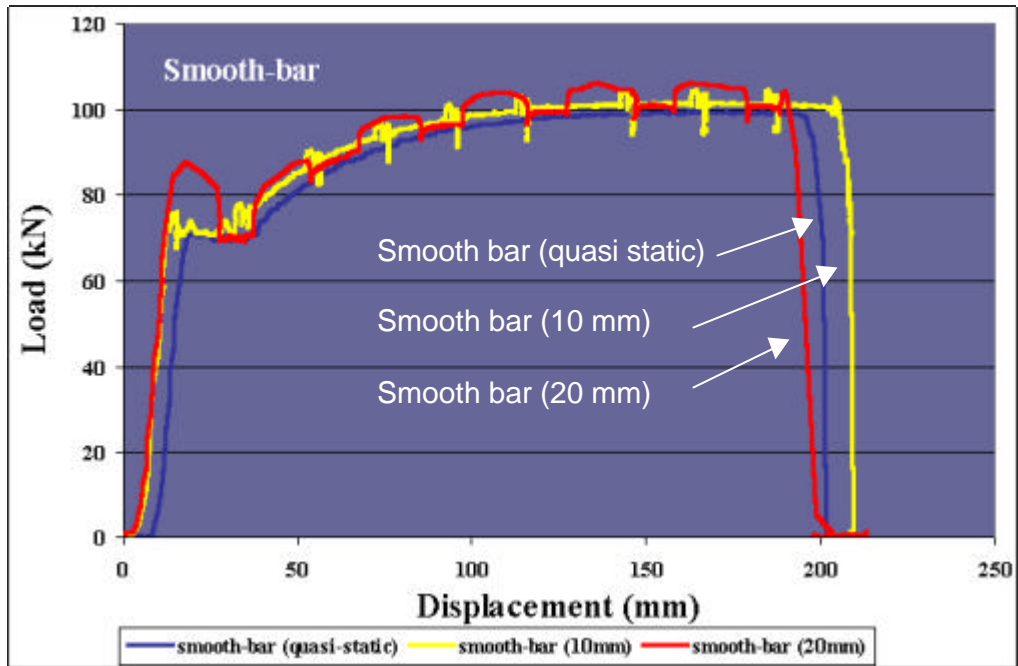
Figure 3.11. Deformation curve of the smooth bar.

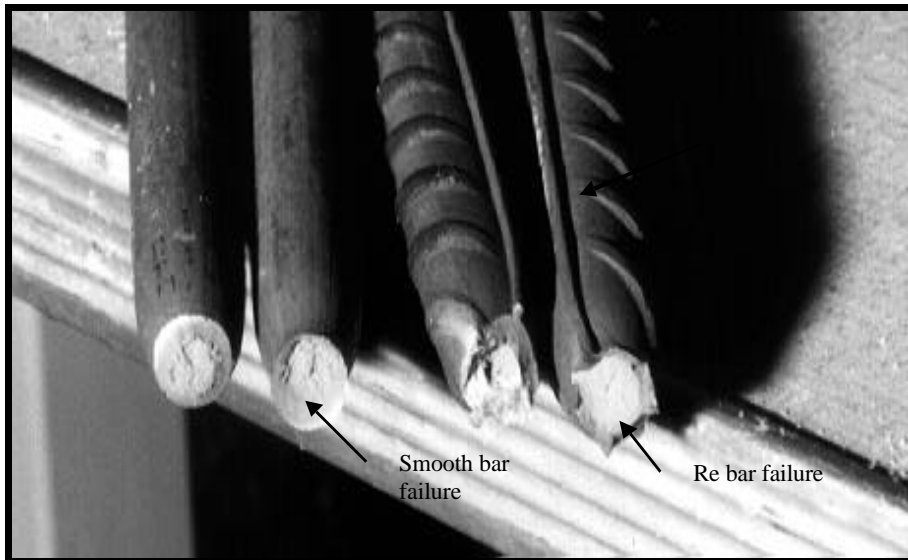
Figure 3.12. Failure mechanisms of smooth and re-bars.

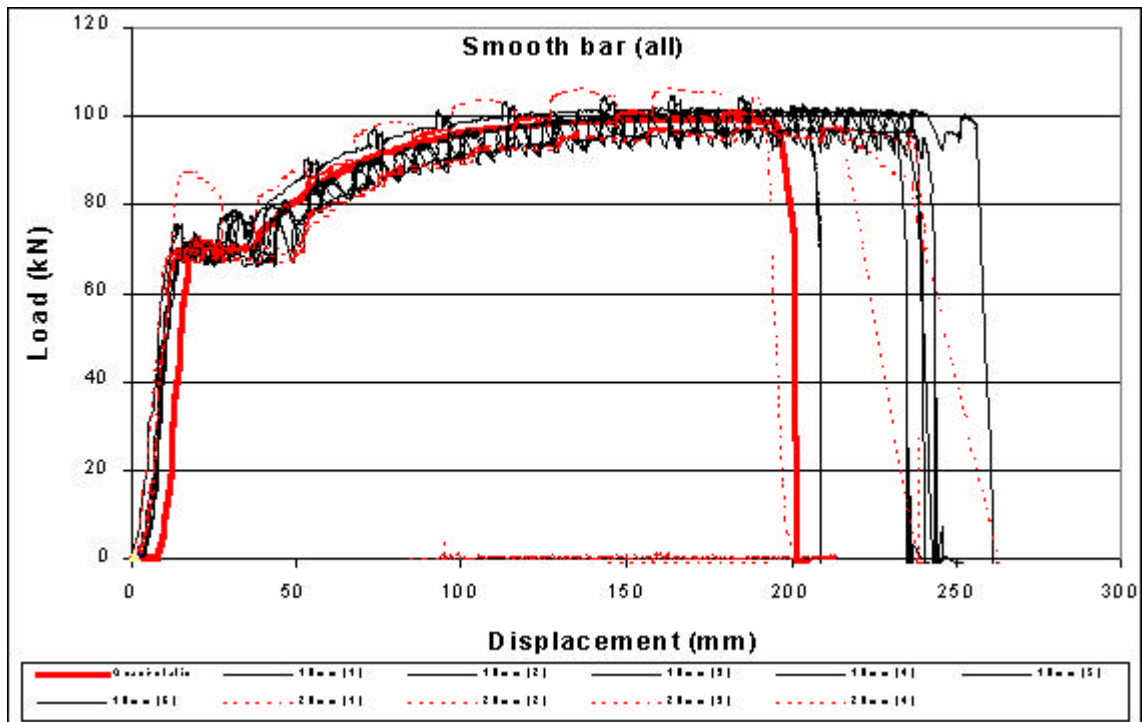
Figure 3.18. Deformation curves for all smooth bars tested.

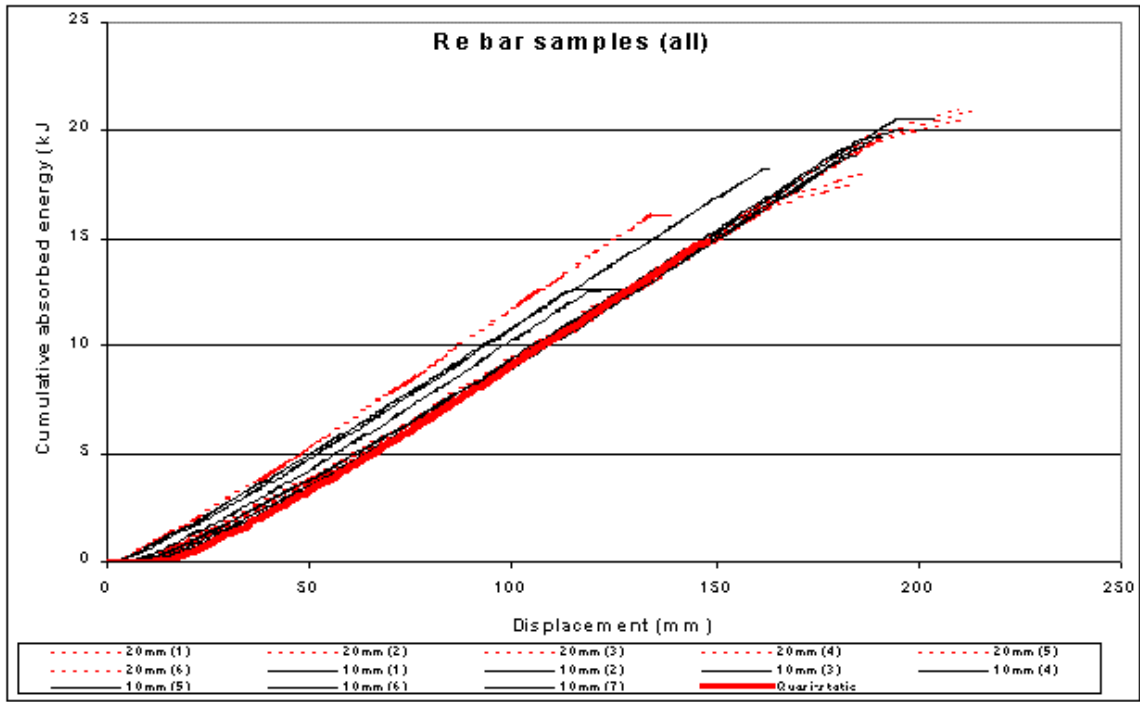
Figure 3.19. Cumulative energy absorbed (kJ) by all re-bars tested.

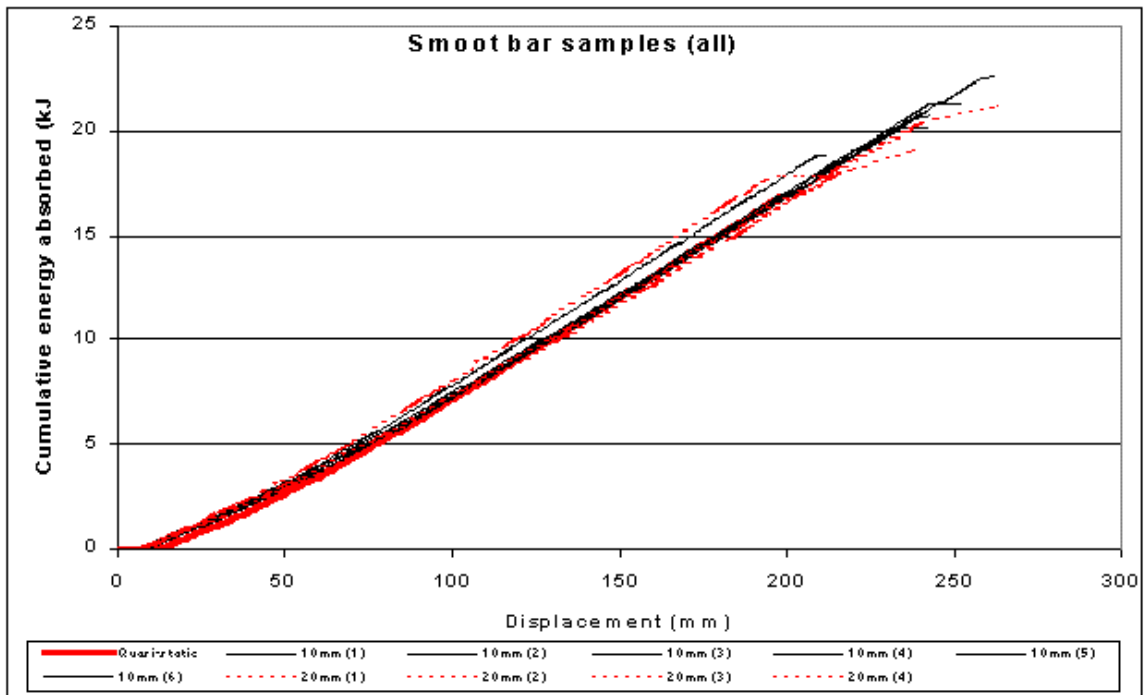
Figure 3.20. Cumulative energy absorbed (kJ) by all smooth bars tested.

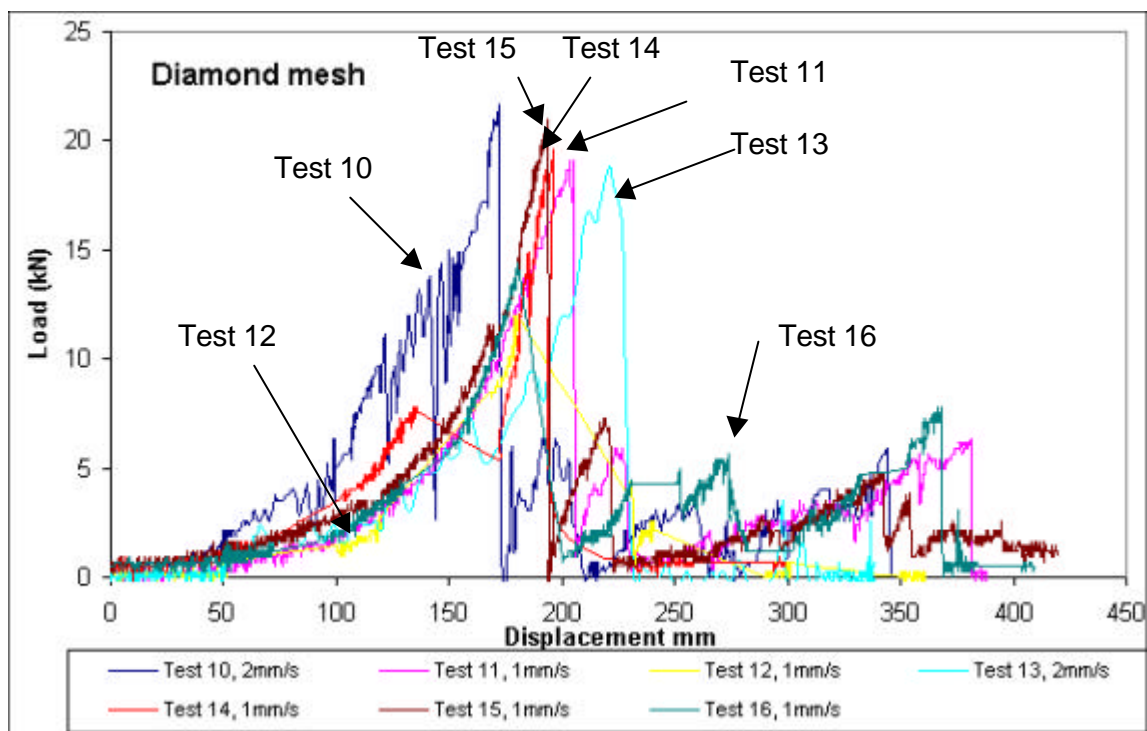
Figure 3.21. Deformation curves for all diamond meshes tested.

Testing of diamond and welded mesh was performed with a special testing frame in which a mesh panel could be clamped. The mesh consisted of mild steel with a diameter of 3.15 mm spaced at 100 mm, the dimensions of the testing frame being 600 mm x 600 mm. Varying loading rates, ranging from quasi-static to 2 m/s, were applied by the Terra-Tek to load the panel in the middle, in the direction perpendicular to the panel. The results are shown in Figures 3.21 to 3.24.

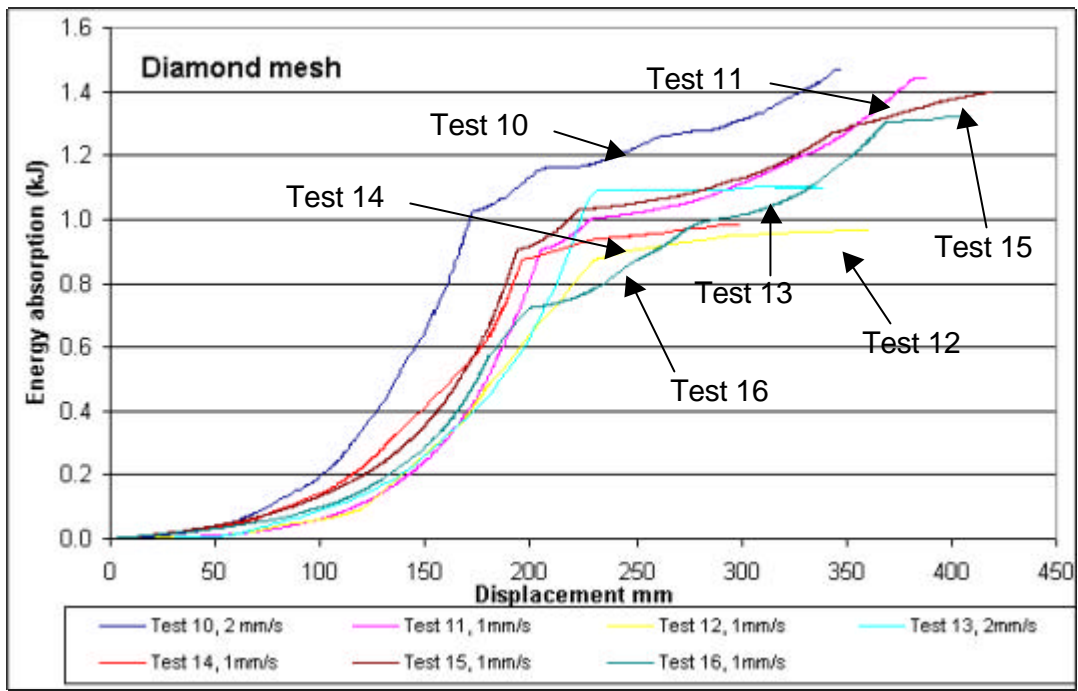
Figure 3.22. Cumulative energy absorbed in all diamond meshes tested.

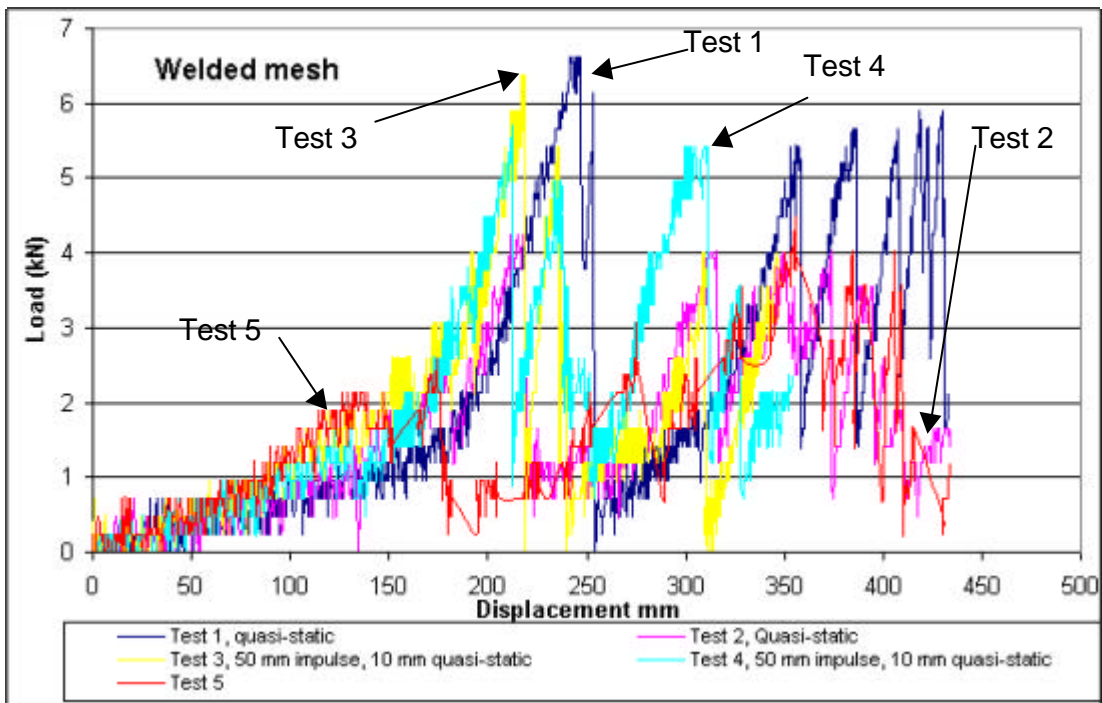
Figure 3.23. Deformation curves for all welded meshes tested.

The variability in results with welded mesh is also associated with the presence of random stress concentrations and the limited potential for stress redistribution. The diamond mesh does not demonstrate this variability and is consistently stronger and more yieldable.

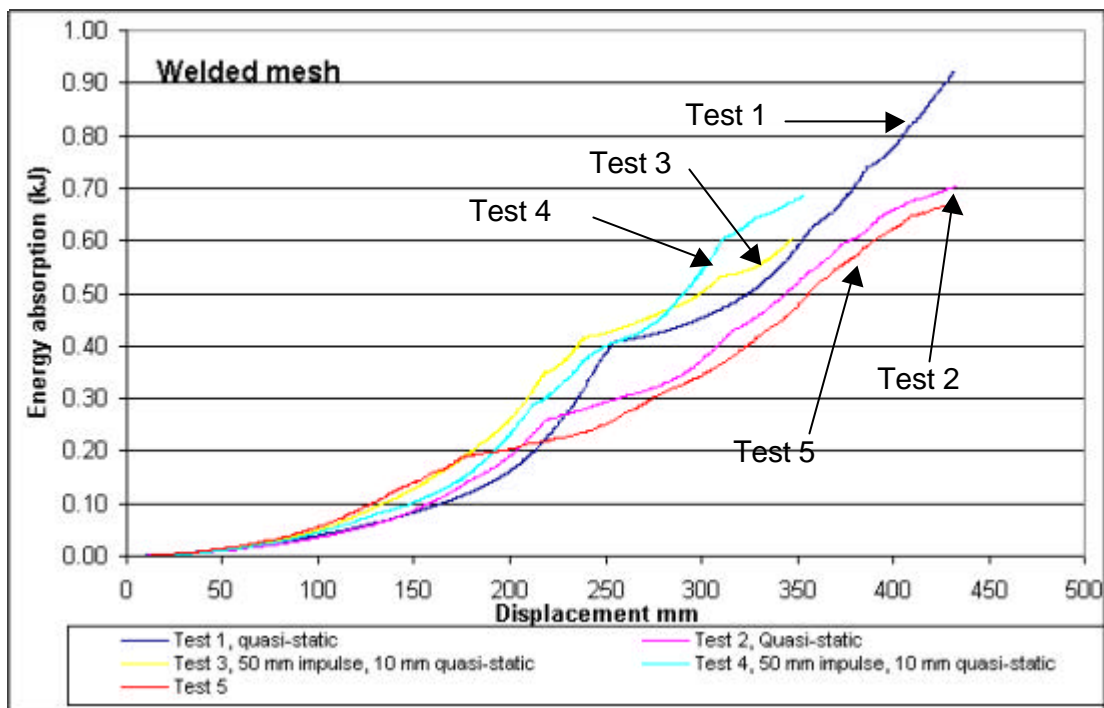
Figure 3.24. Cumulative energy absorbed in all welded meshes tested.

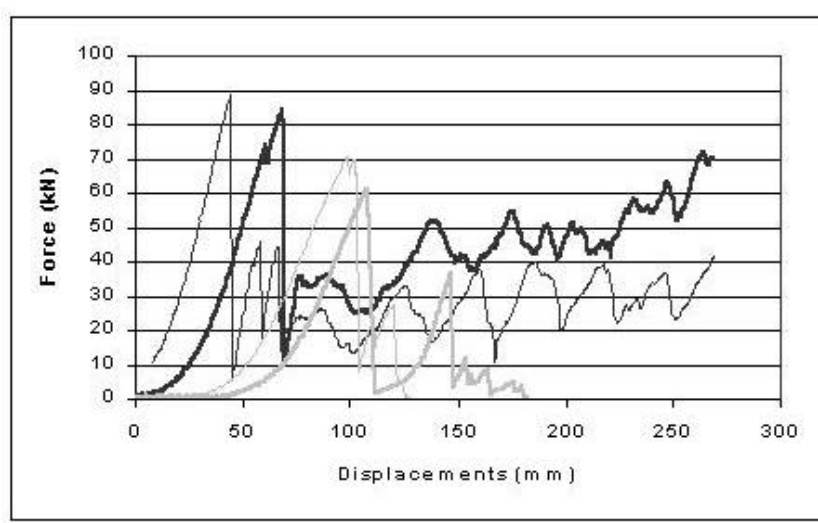
Figure 3.25. Lacing tested with clamping jaws.

The results are highly variable, as can be appreciated from the following Figures 3.25 to 3.27.

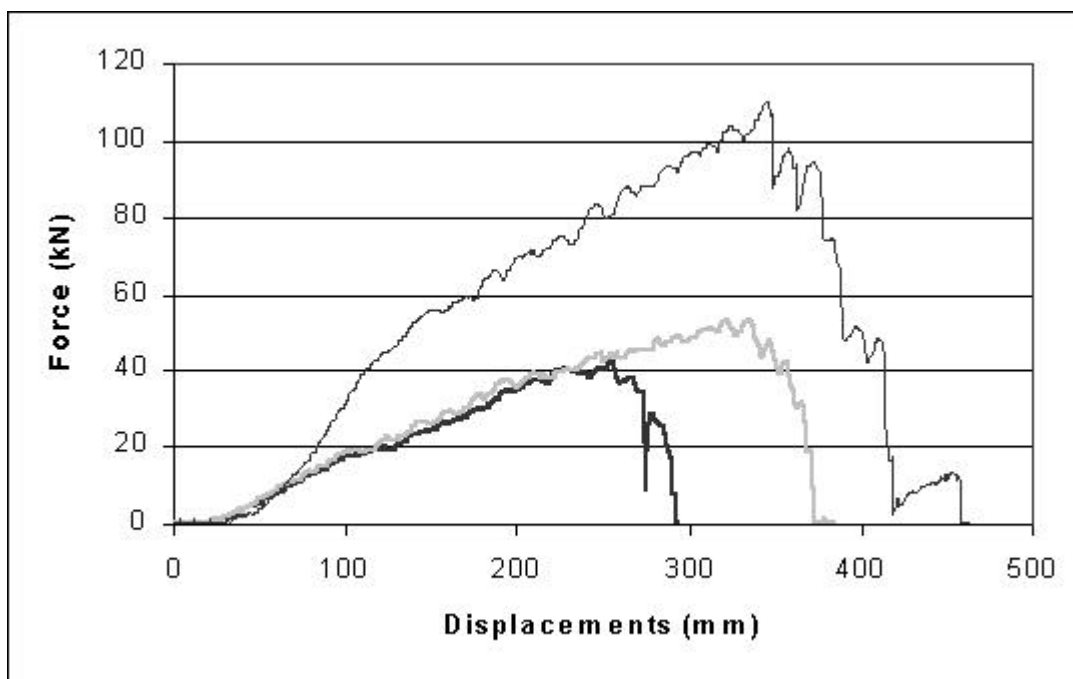
Figure 3.27. Lacing tested with three friction clamping devices.

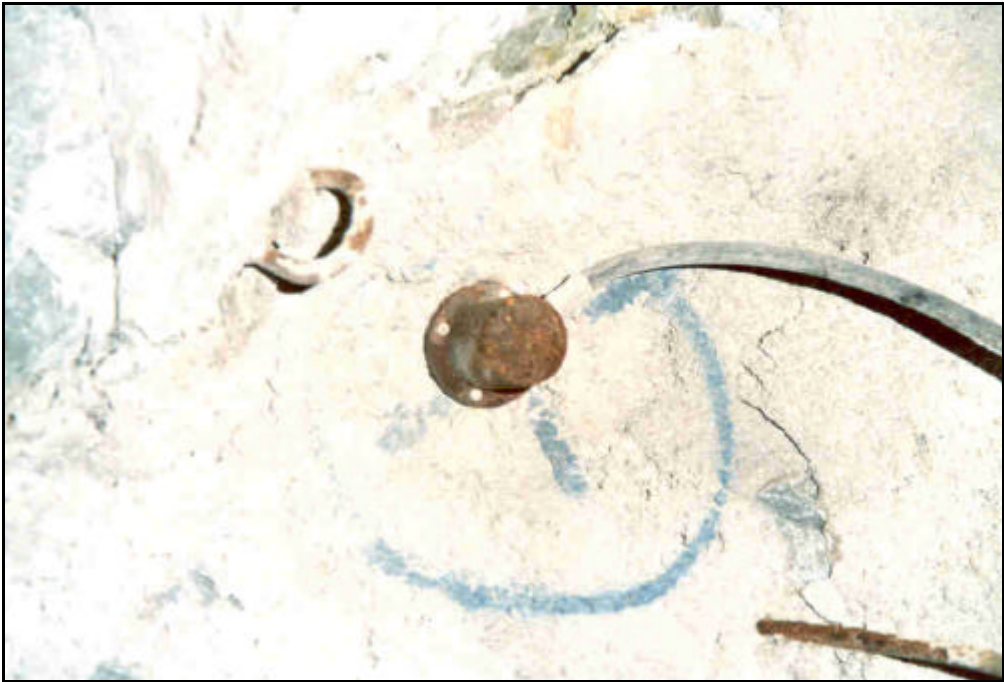
Figure 5.3. Instrumented rock tendons.

As illustrated in Figure 5.3, each instrumented tendon was incorporated into an integrated monitoring system that allowed for both dynamic and quasi-static measurements.

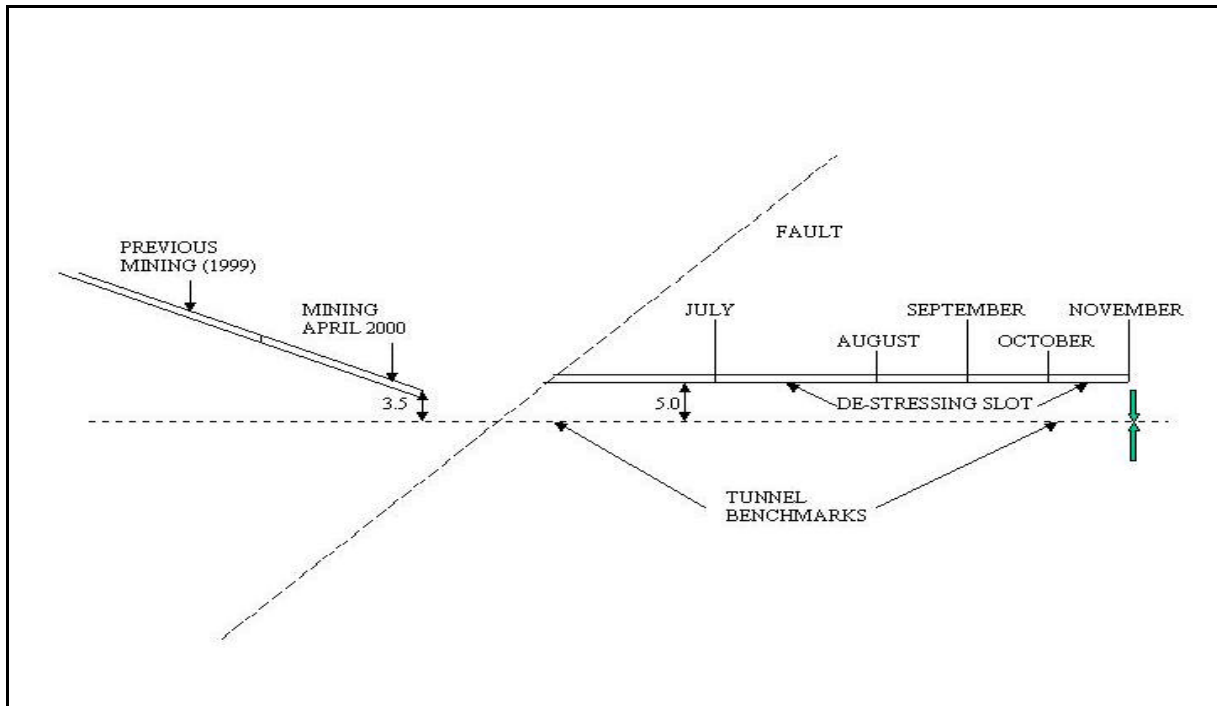
Figure 5.4. Layout of excavations and position of de-stressing slot.

The monitored area was modelled to assess the changing stresses imposed on the tunnel. The tunnel was developed in the down-dip abutment of a longwall and subsequently overtopped by a 20 m wide de-stressing slot 5 m in the hangingwall as schematically illustrated in Figure 5.4.

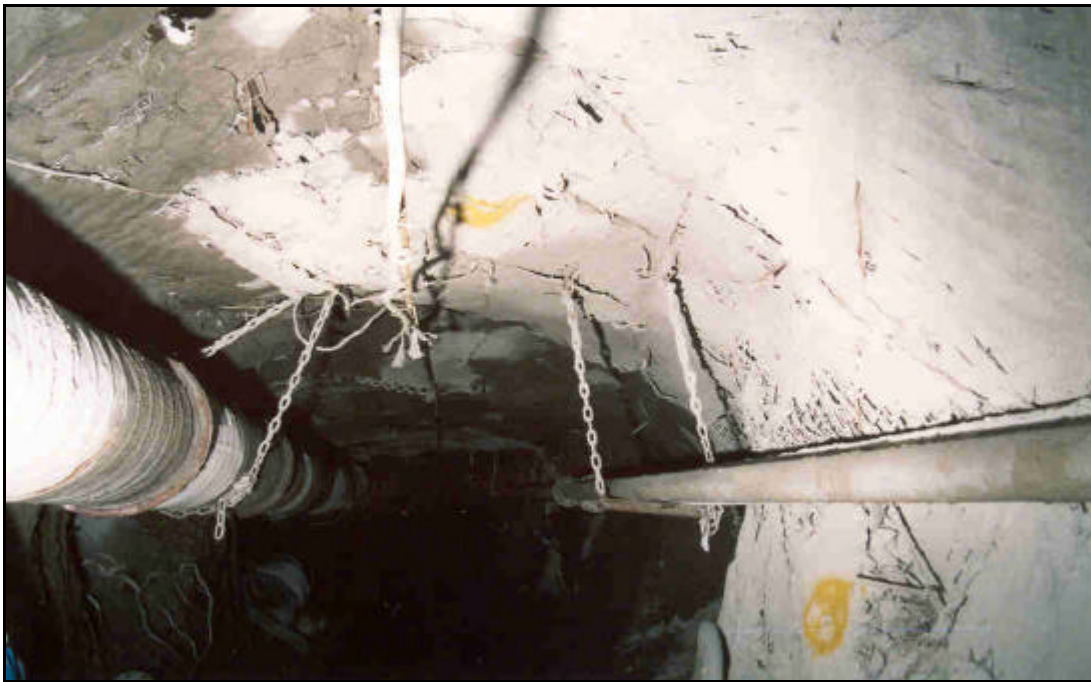
Figure 5.5. Overall tunnel condition around monitoring position 1. (October 2000).

The presence of the de-stressing slot above and good quality support installed prior to the cutting of the slot that started in June 2000, are responsible for the relatively good tunnel condition.

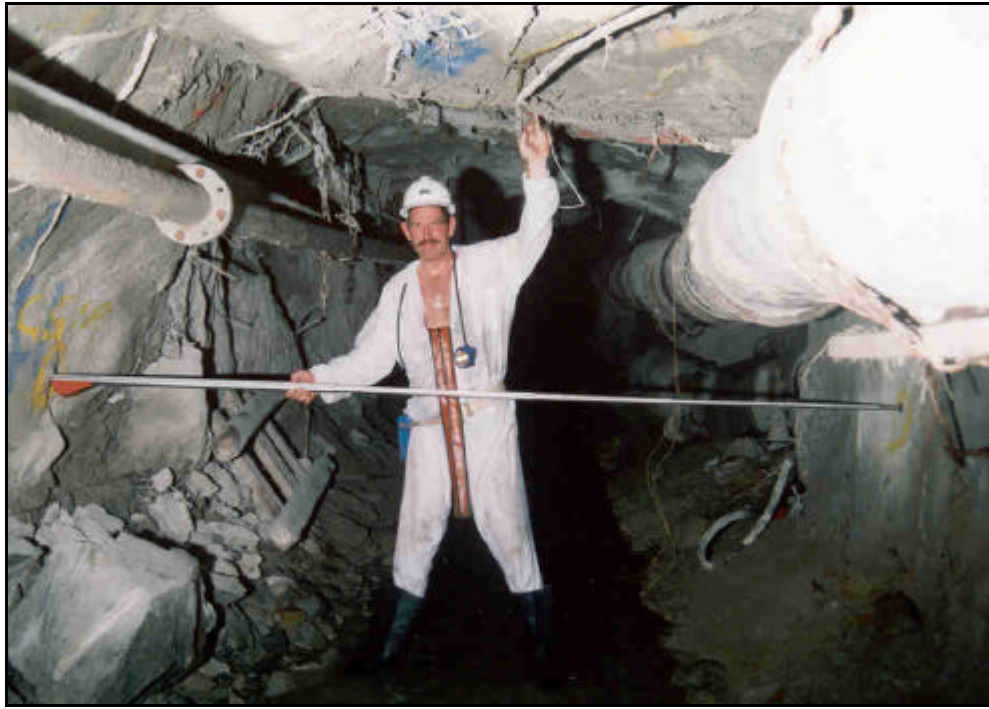
Figure 5.6. Overall tunnel condition around the monitoring position 2.

The way sidewall to sidewall and hangingwall to footwall closure measurements were taken is illustrated in Figures 5.6 and 5.7, respectively.

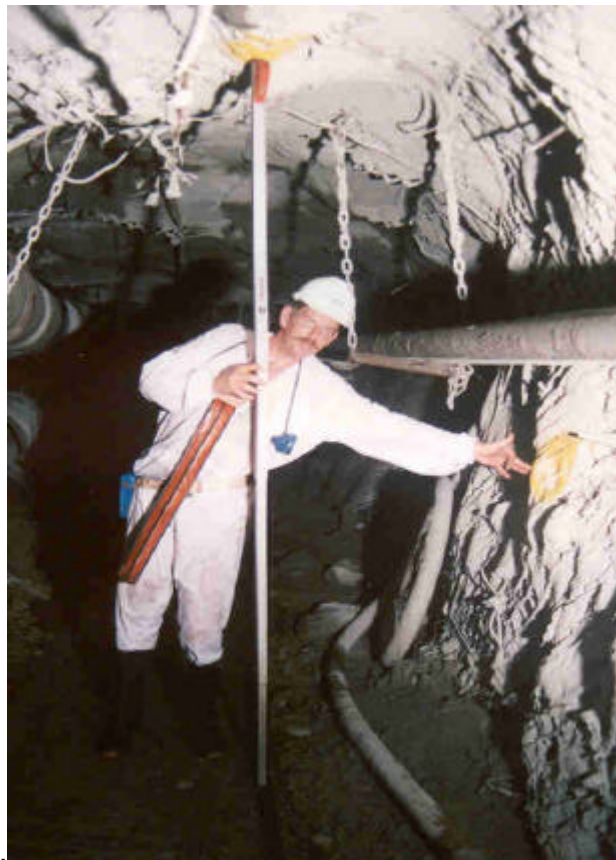
Figure 5.7. Measuring hangingwall – footwall closure at monitoring position 2.

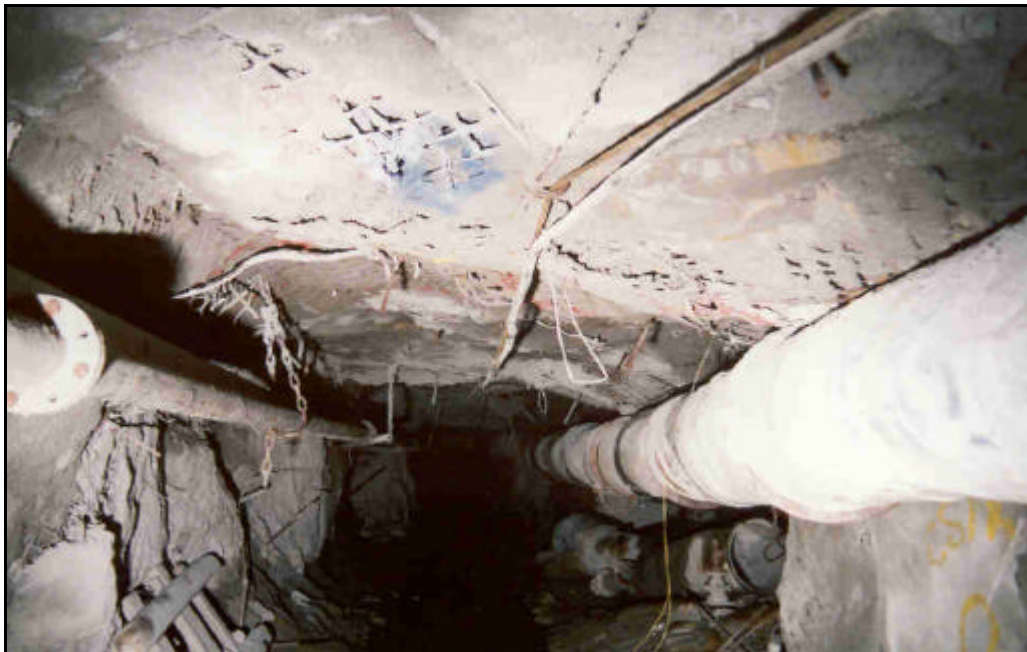
Figure 5.8. Section of monitored excavation in proximity of position 3.

The overall good condition of the excavation in the immediate vicinity of position 3 is shown in Figure 5.8. No visible damage to the excavation or support (including a relatively brittle shotcrete) was observed.

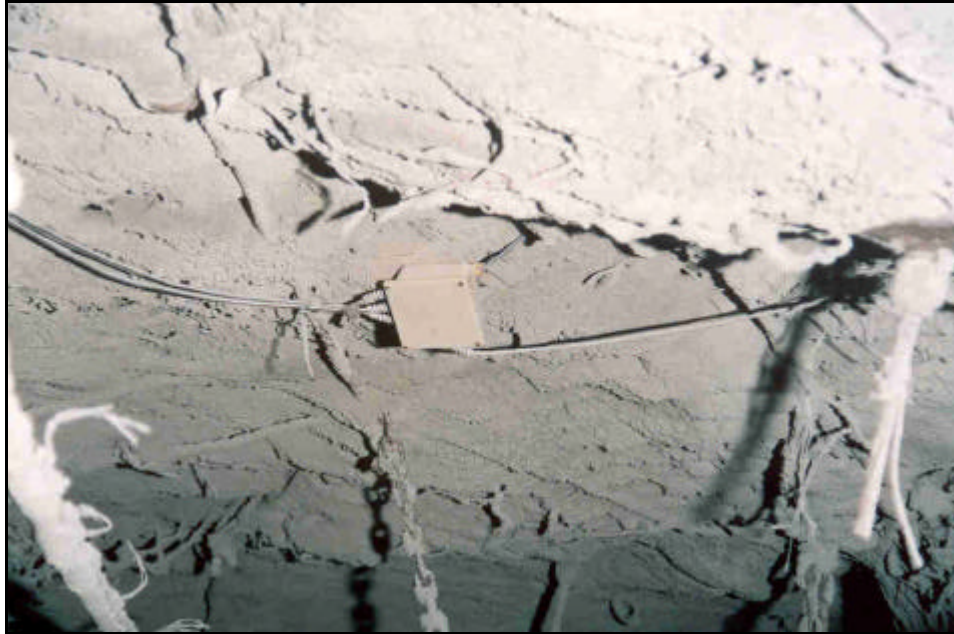
Figure 5.9. *Close-up of the hangingwall condition adjacent to position 3.*

It should be noted that despite the generally poor rock conditions the hangingwall appears to be stable and well controlled by the integrated support system as will be described later.

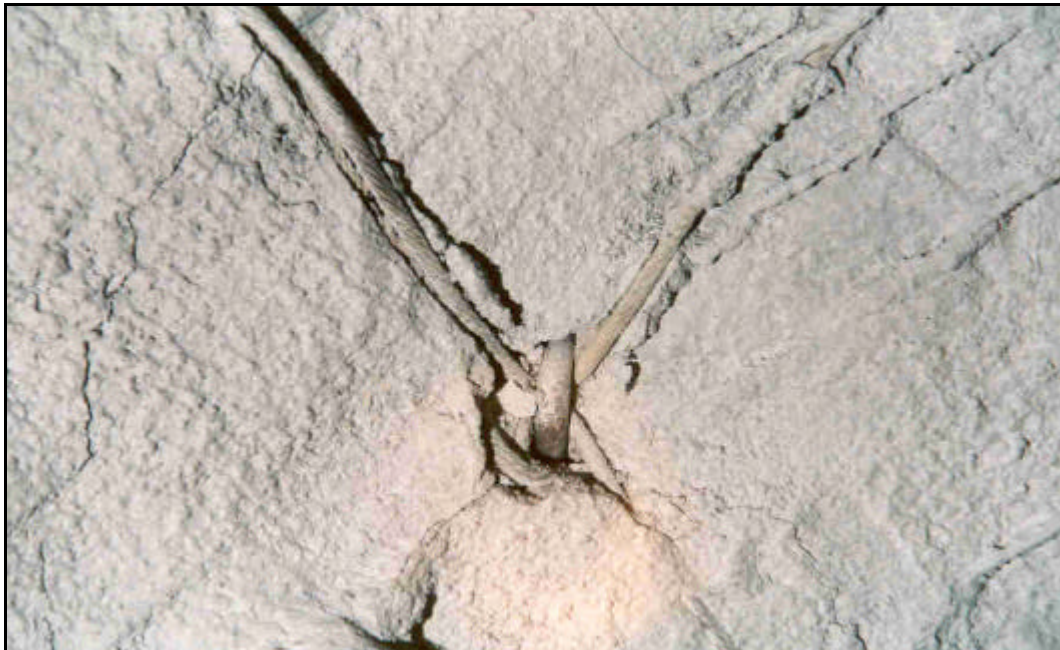
Figure 5.11. Wire mesh, rope lacing and shotcrete integrated support.

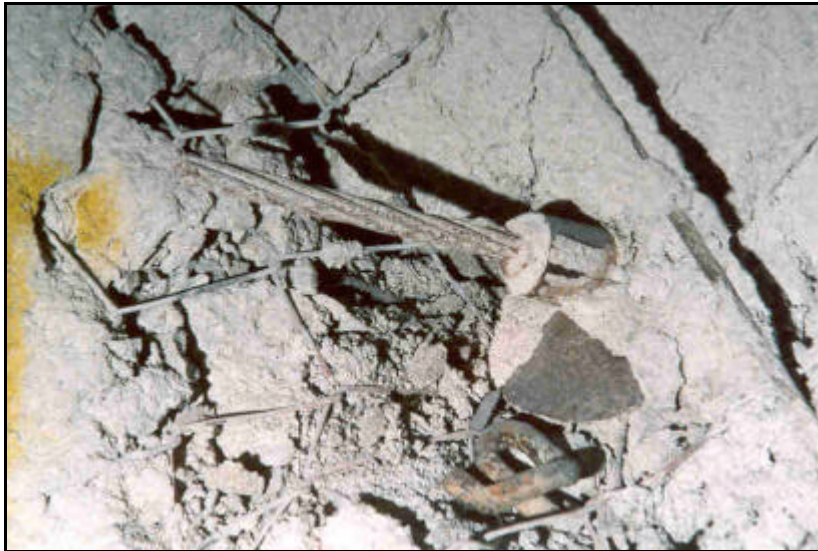
Figure 5.12. Pre-tensioned and post-grouted cable anchor.

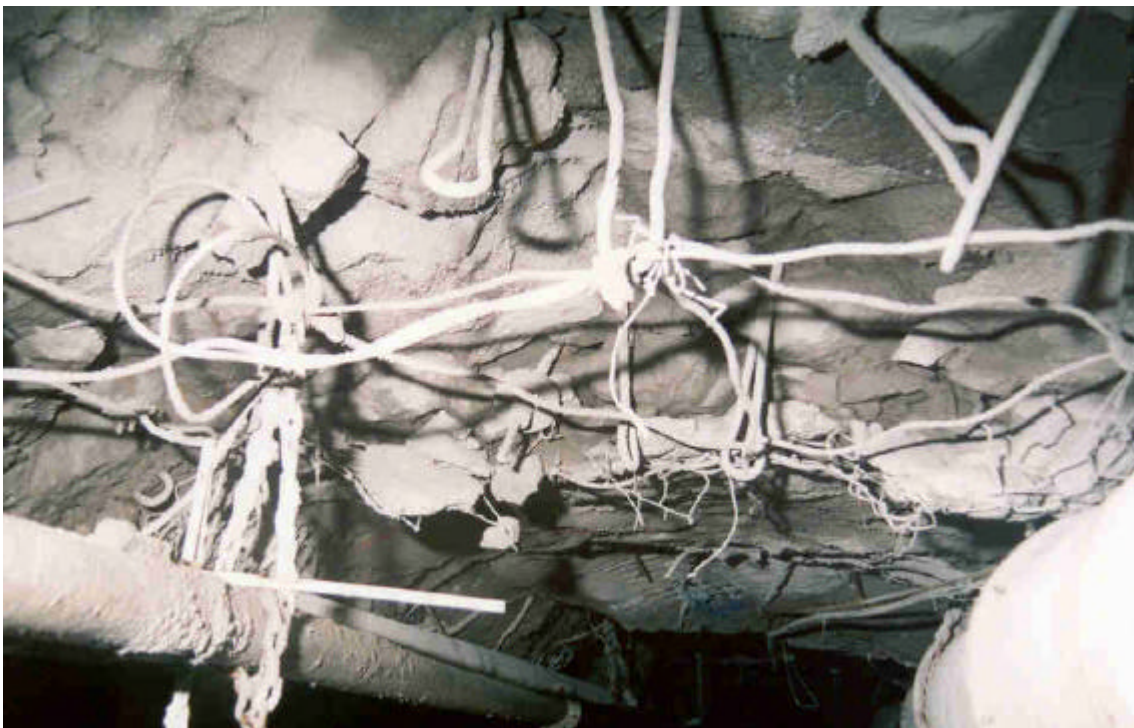
Figure 5.15. Rehabilitated area, exposing a brow.

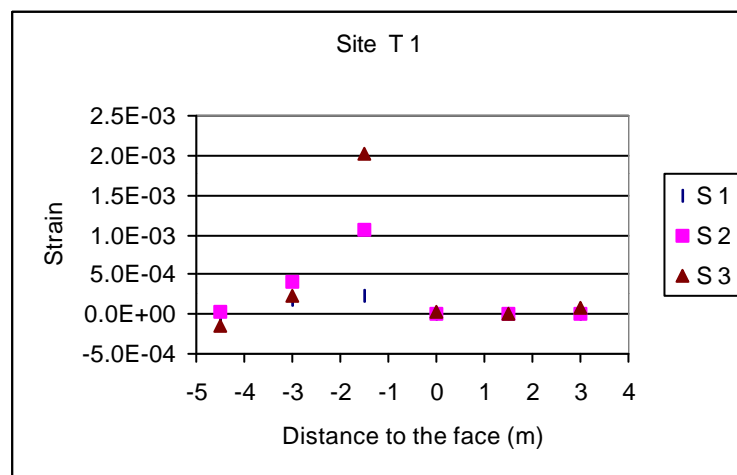
Figure 5.18. The strain at site T_1 as the face of the de-stressing slot progressed towards the instrumentation.

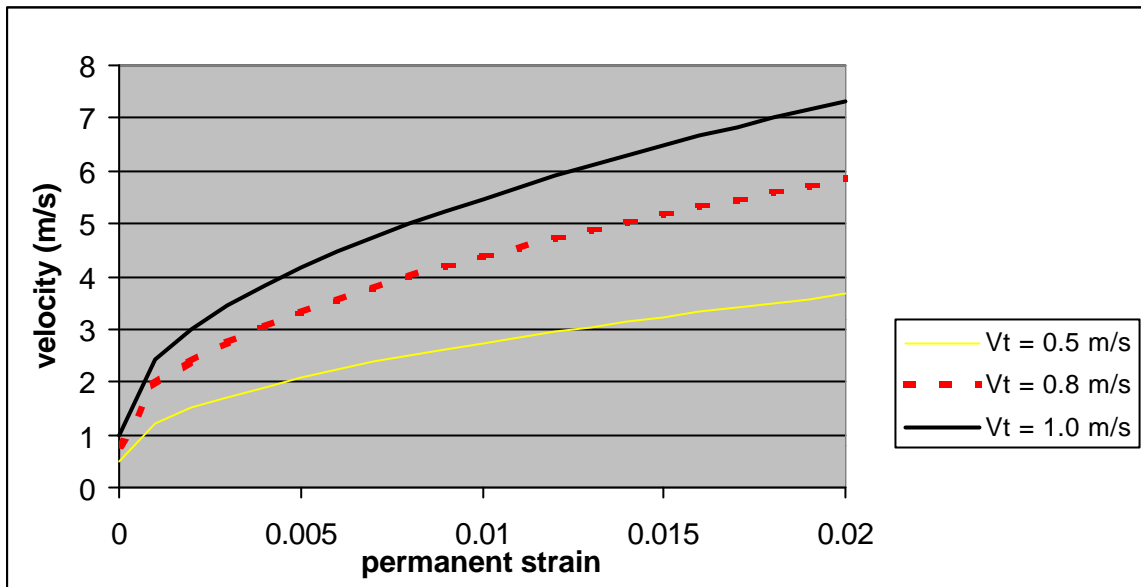
Figure 5.22 Relationship between velocities and non recoverable strain
