Safety in Mines Research Advisory Committee

Final Report

Determine the effect of repeated dynamic loading on the performance of tunnel support systems

Project No.: GAP 616

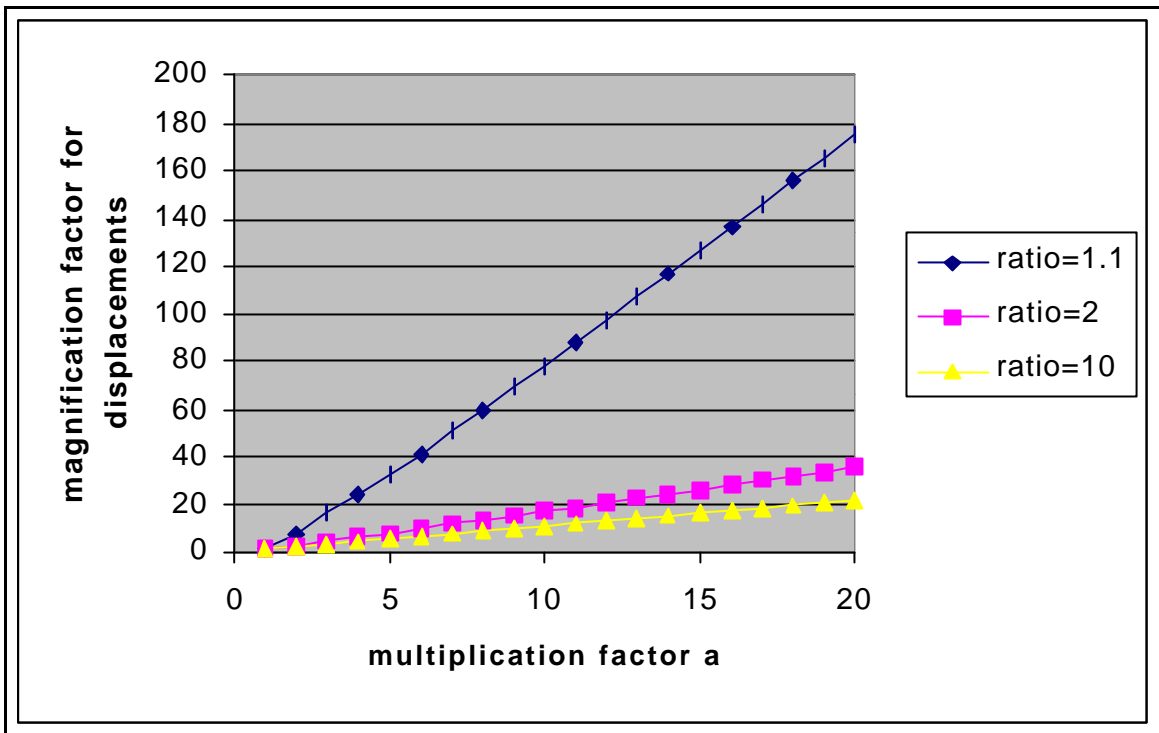
Figure 6.5. Displacement magnification factors for different ratios between impact force and resisting force with increasing drop heights.

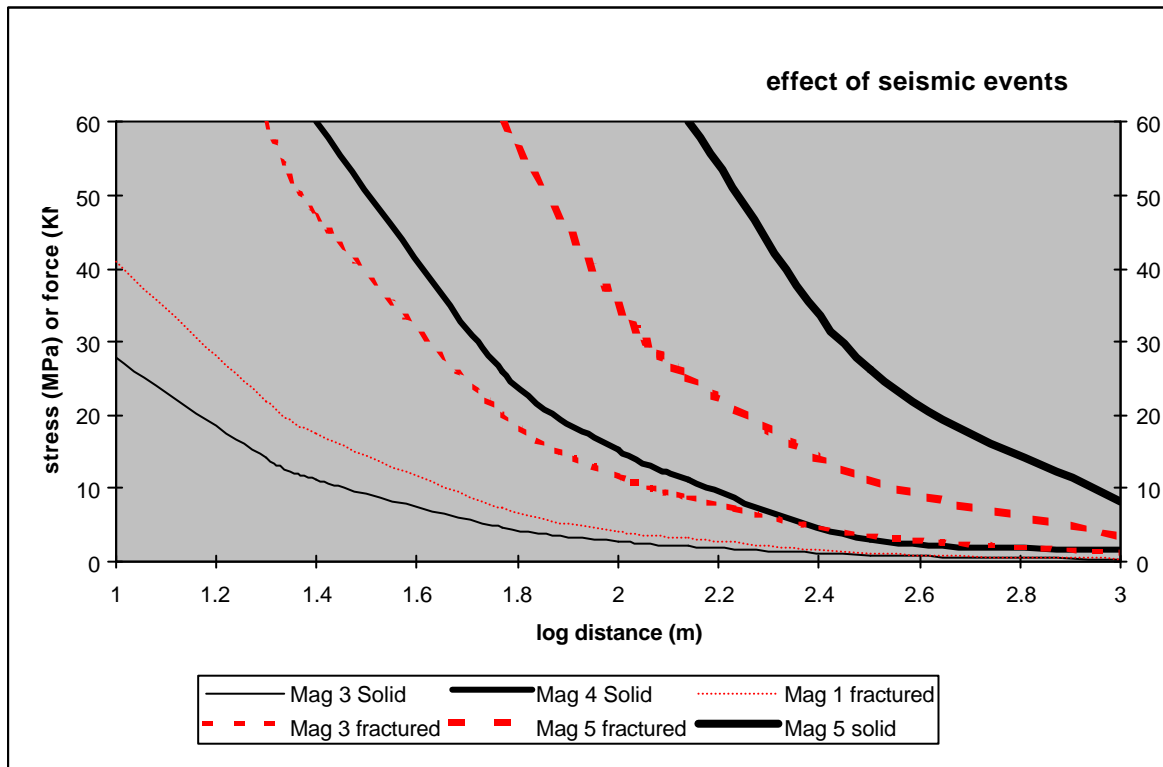
Figure 7.1. Relationship between distance from the seismic source and the induced stresses in solid rock and induced forces (volume of 1 cubic metre) for various magnitudes.

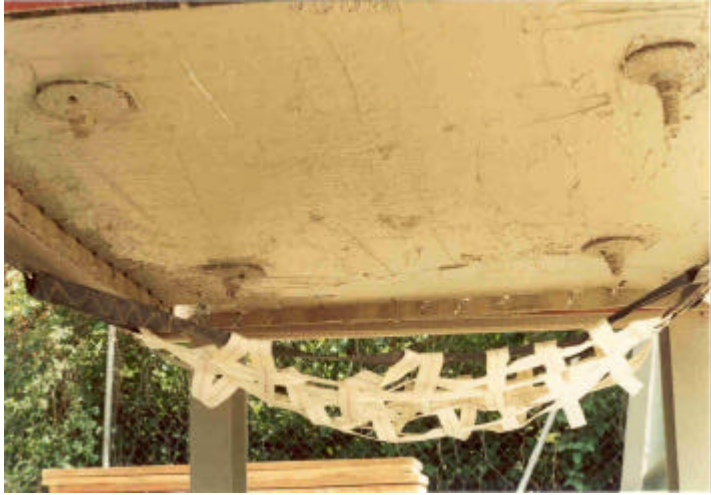
Figure A.21. Evermine 10 cm. drops.

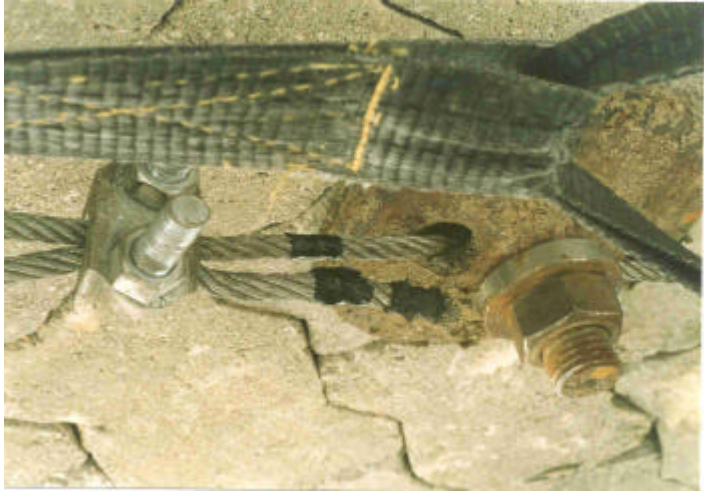
Figure A.41. Detail of lacing.

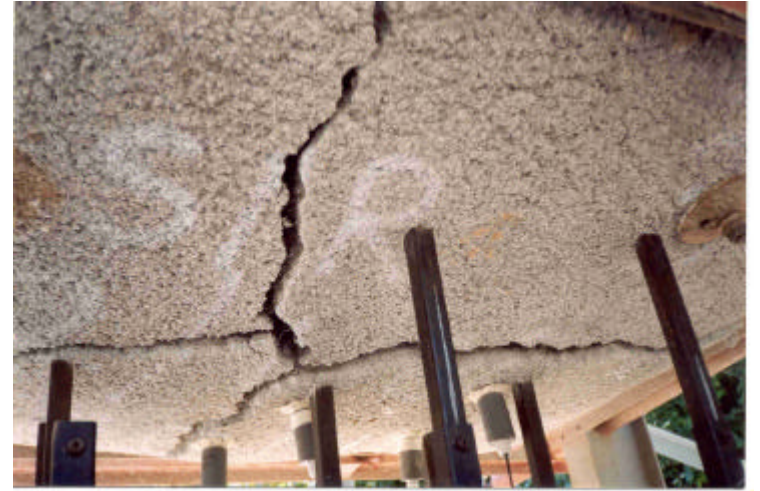
Figure A.43. Shotcrete 50 cm. drops.

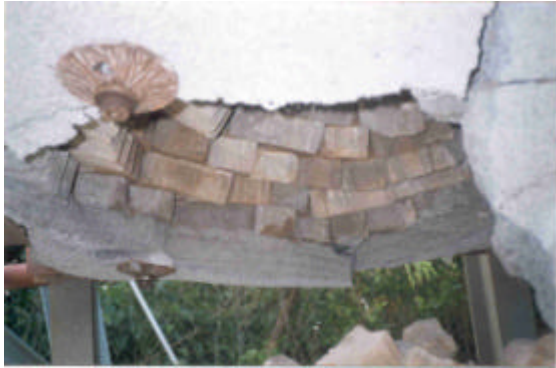
Figure A.45. Final failure of shotcreted assembly.

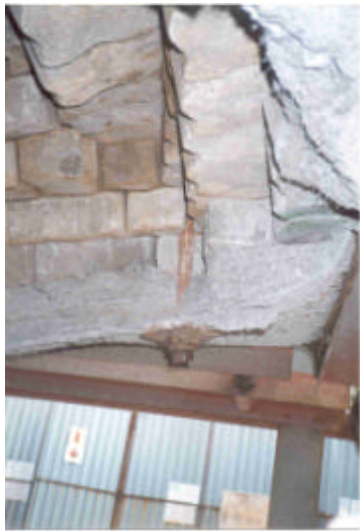
Figure A.46. Final failure of shotcreted assembly.

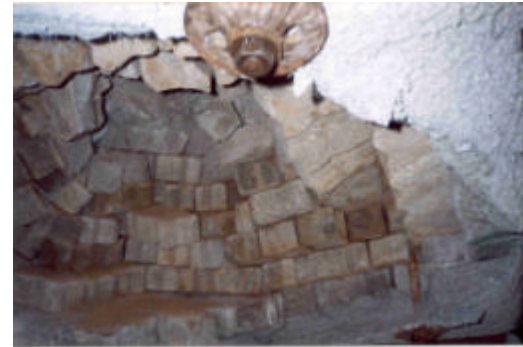
Figure A.47. Final failure of shotcreted assembly.

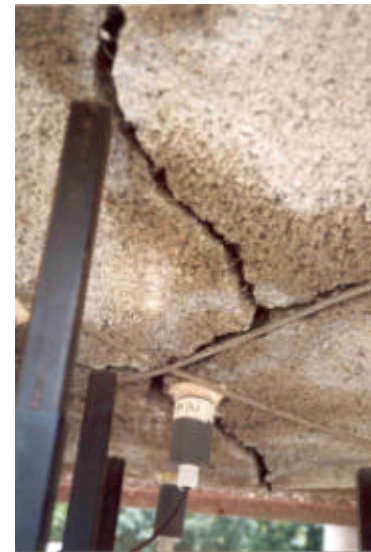
Figure A.48. Shotcrete and lacing 50 cm. drops.
