Final Project Report

Underground verification of the large deflection performance of fibre reinforced shotcrete subjected to high stresses and convergence and to dynamic loading

Project number: GAP 710

Date: April 2002

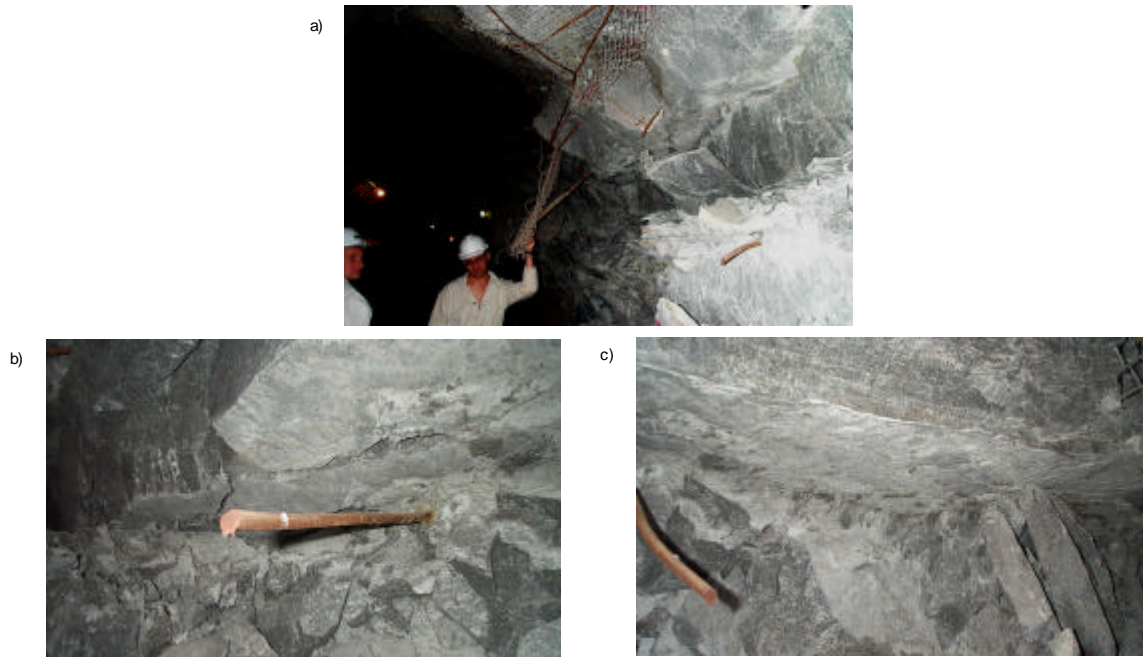
Figure 3: Conditions in the 77 Haulage North near the field test site.

Figure 3 illustrates the conditions in the 77 haulage north near the field test site in the MB6 quartzite [a) large deformations resulting in failure of mesh and lacing. Soft shale-like material visible on bedding planes in b) and c)]

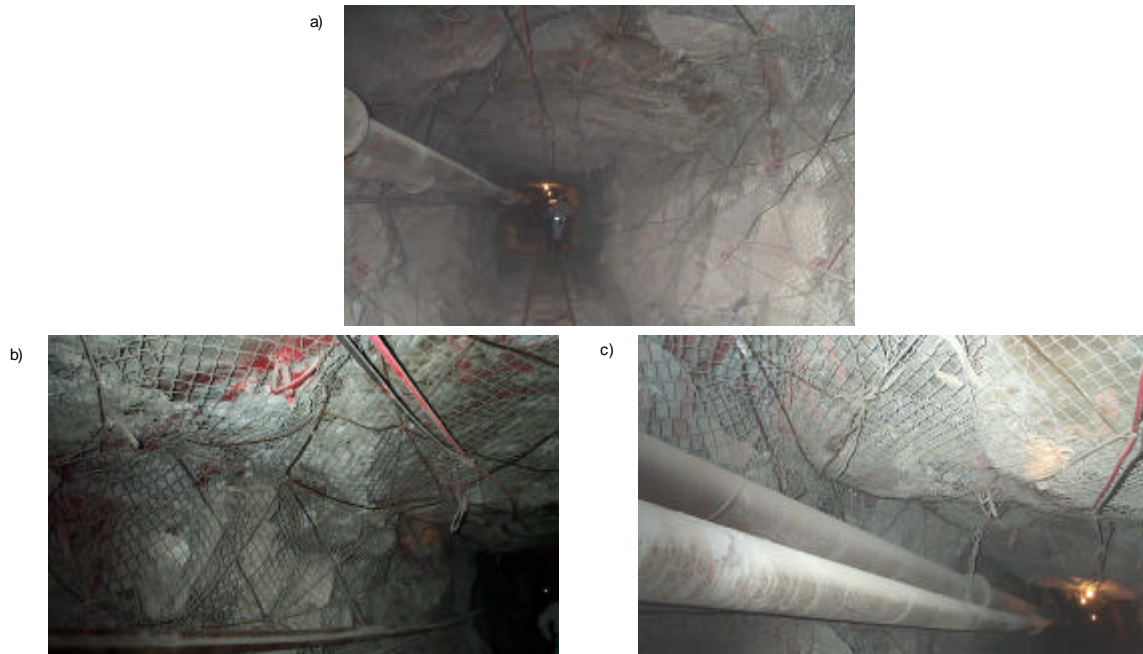
Figure 4: Conditions at field test site prior to site establishment.

Substantial deformation has already taken place as is evident in Figure 4. The failed rock has caused bulging in the mesh and lacing support.

Bulging in mesh and lacing is clearly visible in figure 4, [a) Profile looking North East. b) Hangingwall and South sidewall. c) Hangingwall and North sidewall].

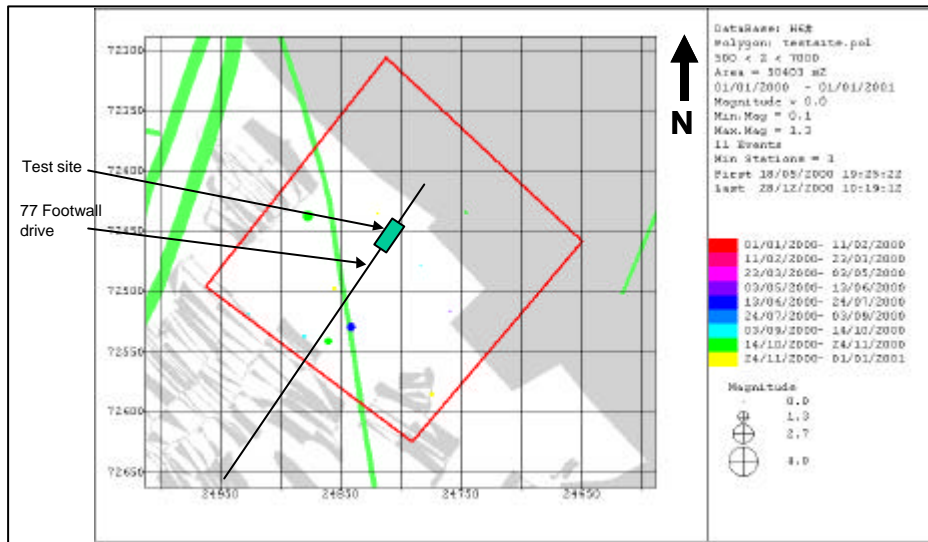
Figure 6: Seismic events recorded near the test site between 01/01/2000 and 31/12/2000

The maximum expected magnitude of a seismic event is 3.8. This analysis was updated with seismic events recorded up until 25/04/2002 and very little difference was observed. Very few seismic events were recorded near the field test site, prior to establishment (Figure 6). This is mainly due to the lack of mining nearby.

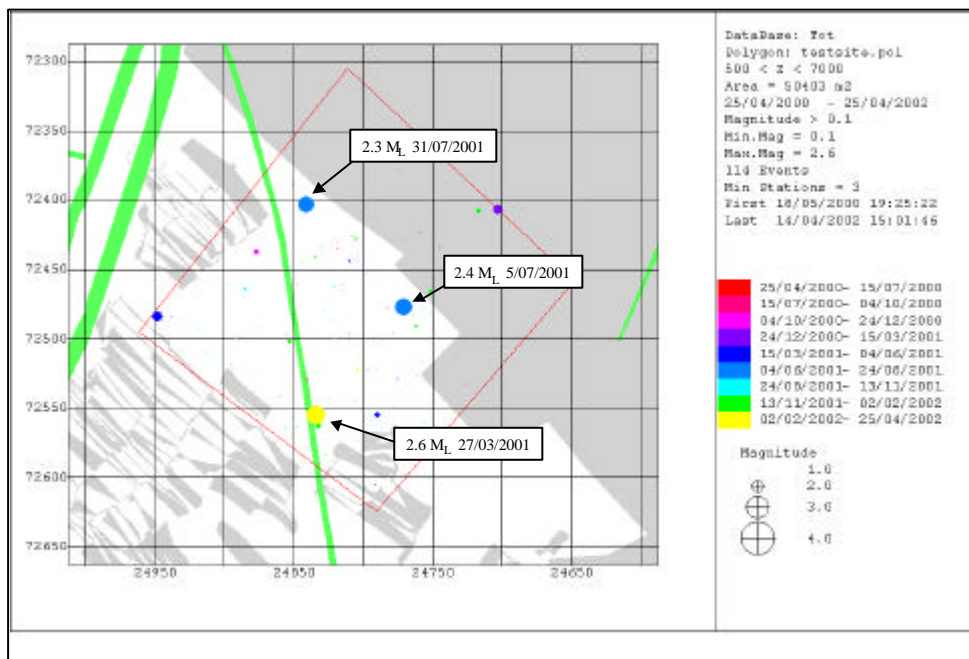
Figure 7: Seismic events recorded near the test site between 25/04/2000 and 25/04/2002

Between March 2001 and July 2001 several large seismic events were recorded near the field test site (Figure 7). This is probably due to the mining of the 23b line (see Figure 1). No increase in deformation could be linked with any of these seismic events.

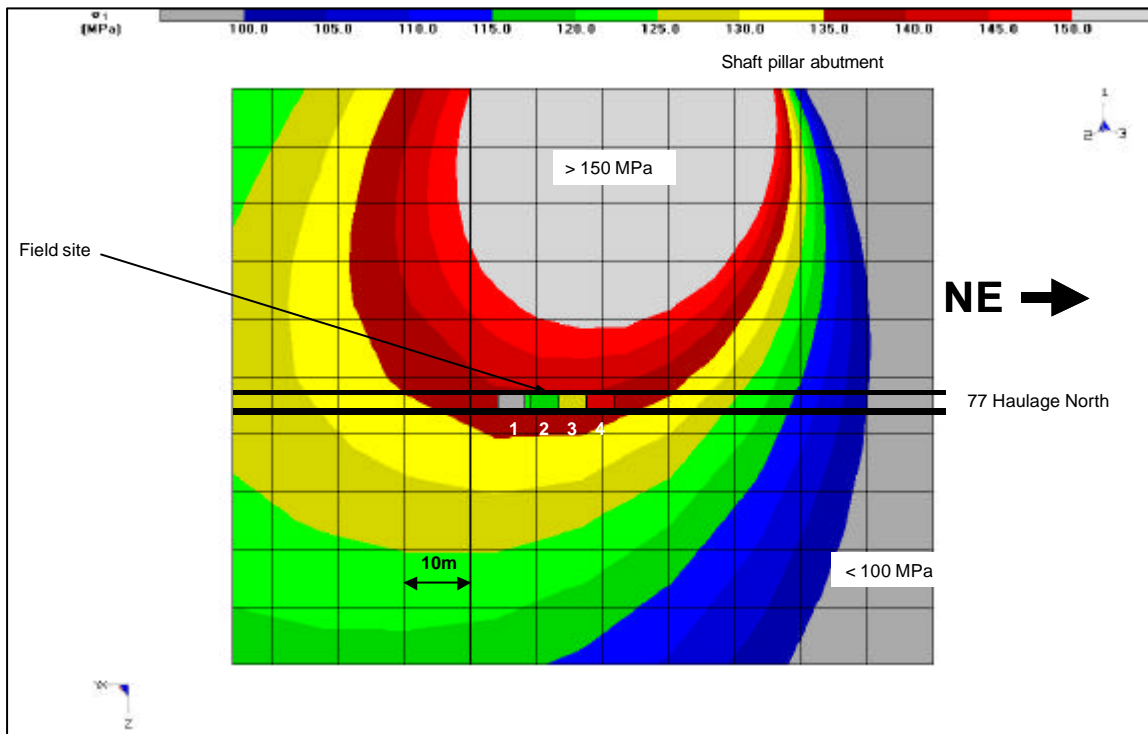
Figure 9: Vertical section showing major principal stress (s_1) in 12/2000.

The modelled stress environment prior to the site establishment in December 2000 is represented on a vertical section through the field test site (Figure 9 – The four test sections are indicated). The high stress “lobe” is caused by the shaft pillar abutment. High stresses extend deep into the footwall, due to the large size of the shaft pillar.

The field test site is situated in a zone where σ_1 ranges from 140 MPa to 145MPa. The change in stress with mining between December 2000 and February 2001 is indicated in Figure 10.

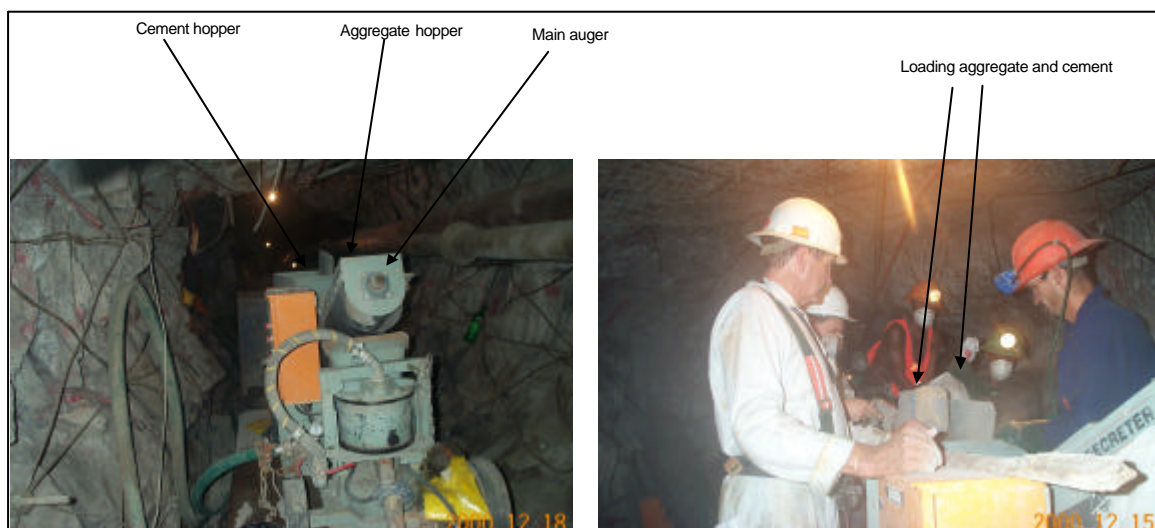
Figure 13: Shotcreting machine

The river sand complied with the SABS 1083:1994. Samples were tested and this is discussed in Section 5.1.1. Moisture is retained in the sand (5%) and the GDS-3 additive allows agglomeration of fines and coarse while pumping. The sand, fly ash, silica fume, GDS-3 additive and fibre (where required) are pre-mixed and supplied in 30kg bags. Where tailings aggregate is used, the tailings replace the river sand in the mix. The aggregate mix is mixed with the OPC in the shotcreting machine using a screw feed process. OPC and the aggregate mix are fed through separate primary augers onto the main auger, which feeds the rotary pump. The shotcreting machine is shown in Figure 13.

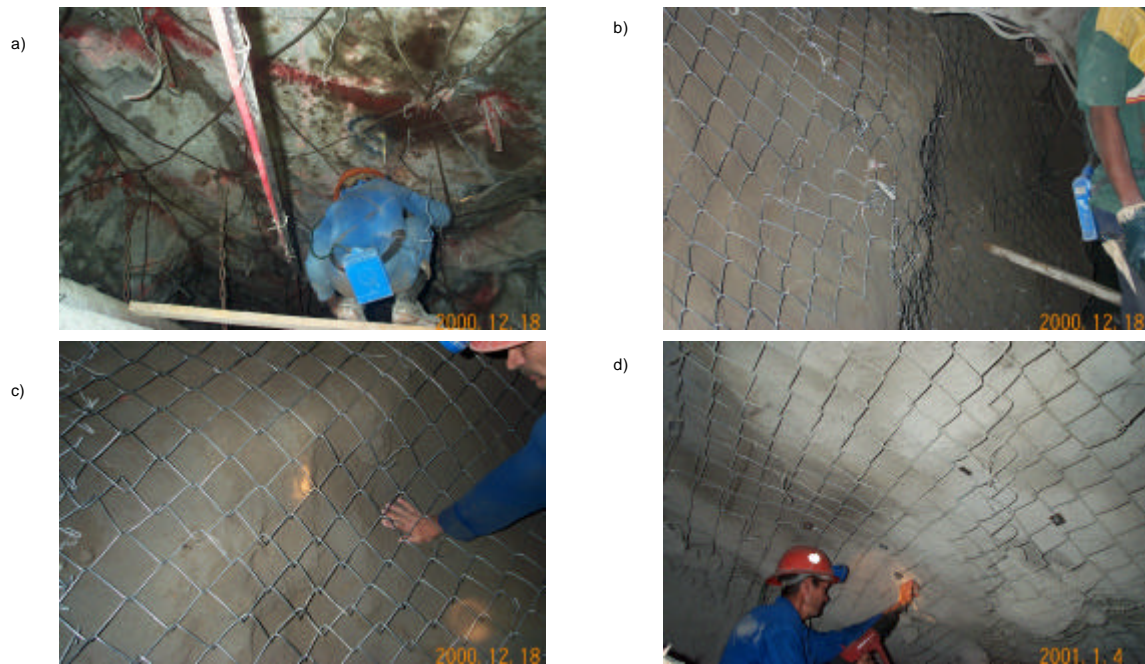
Figure 14: Application of mesh reinforced shotcrete.

Figure 14 illustrates the application process of the mesh reinforced shotcrete [a) wire attached to rope lacing before spraying. b) attaching mesh to wires after spraying. c) mesh not flush with shotcrete due to undulating rock surface. d) pinning of mesh to shotcrete using a Hilti gun.

Preparation of the mesh reinforced test section (4) was a little more involved. The original mesh was removed, as it would have been difficult to spray through the 50mm apertures. The mine insisted that the lacing be left intact, as removal of the lacing would have resulted in extensive re-drilling and re-supporting. 100mm aperture mesh was therefore used and was attached to the outside of the lacing. Prior to attaching the mesh, shotcrete was sprayed to fill the cavities. Wire was attached to the lacing before spraying to fasten the mesh to the lacing. Due to the undulating rock surface and the application of mesh over the lacing, it was difficult to bring the mesh close enough to the initial shotcrete layer. A "Hilti" gun was then used to pin the mesh into the set shotcrete. Shotcrete was then sprayed over the mesh to cover it satisfactorily.

This process is shown in Figure 14. In some areas the mesh could not be pinned to the shotcrete and the mesh could not be covered with shotcrete (Figure 15). This represented only a small portion of the total surface area. Considerably more material was used for the mesh reinforced shotcrete application.

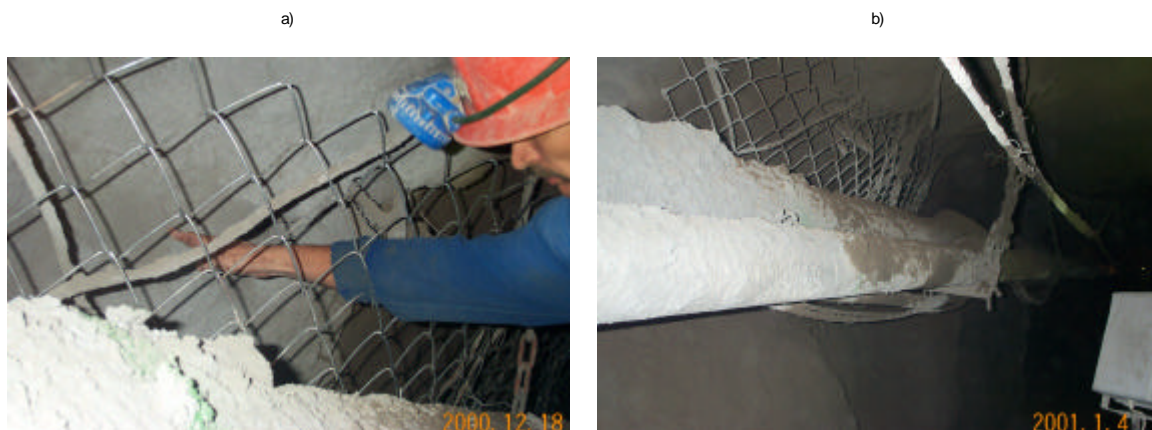
Figure 15: Areas where mesh could not be pinned to the shotcrete.

Figure 15 shows the areas that could not be pinned and shotcreted [a) prior to final spraying. b) after final spraying].

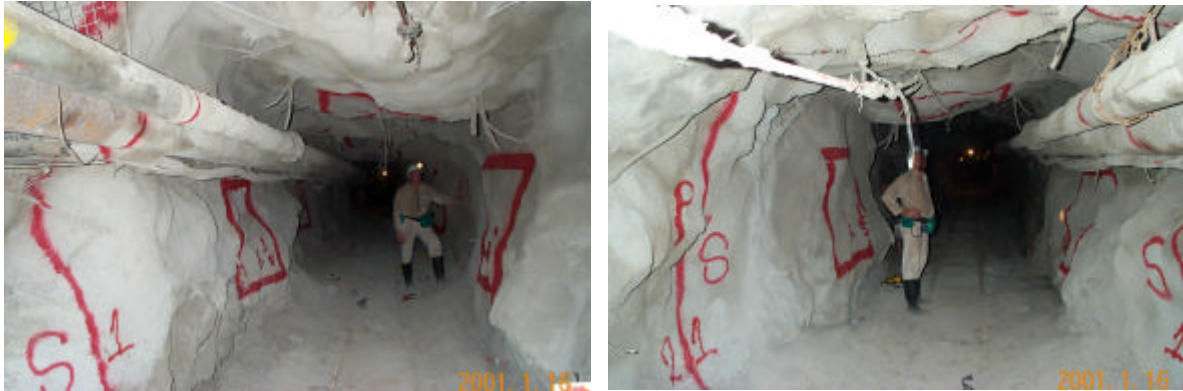
Figure 16: Profiles of section 1.

Profiles of section 1 - Steel fibre reinforced shotcrete [Left: looking North East. Right: looking South West] (figure 16).

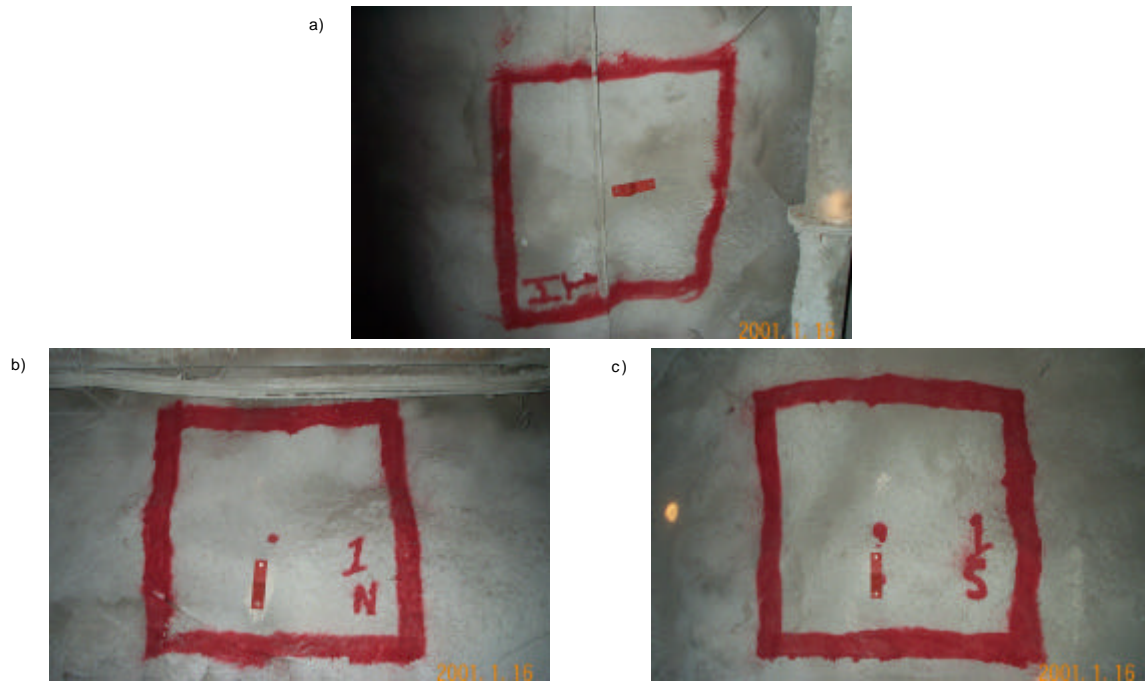
Figure 20: Panels for Section 1.

Figure 20 shows the section 1 panels - Steel fibre reinforced shotcrete [a) Hangingwall b) North West sidewall c) South East sidewall]

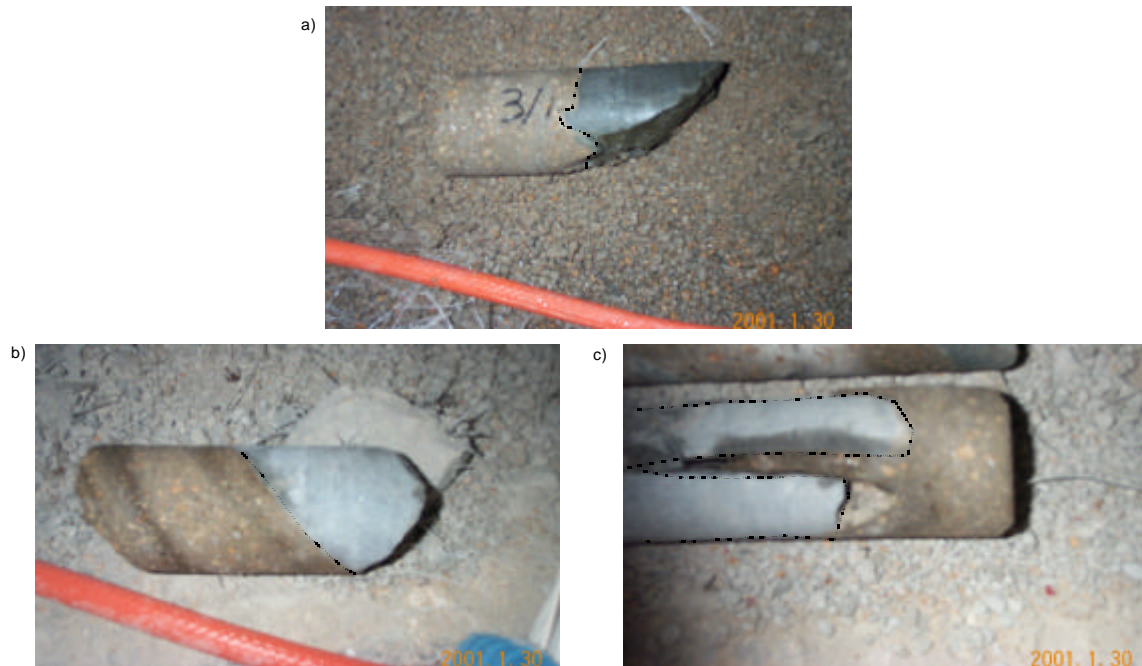
Figure 24: Examples of bonding of sprayed shotcrete.

Examples of good bonding and penetration (dotted line indicates contact between rock and shotcrete) [a) and b) bond remains intact after drilling. c) deep penetration into rock fractures] (figure 24).

In general the bonding between the shotcrete and the rock surface appeared to be good. Figure 24 shows examples where the bond remained intact after drilling. Figure 24c shows the penetration into rock fractures. Photographs of the boreholes and cores are given Appendix F.

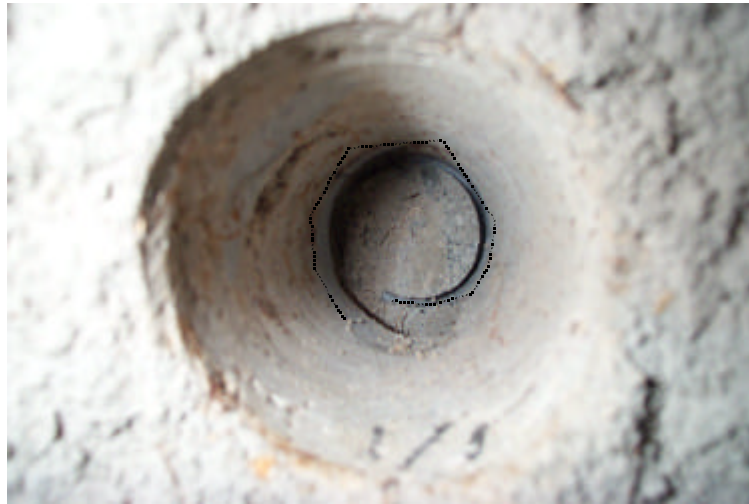
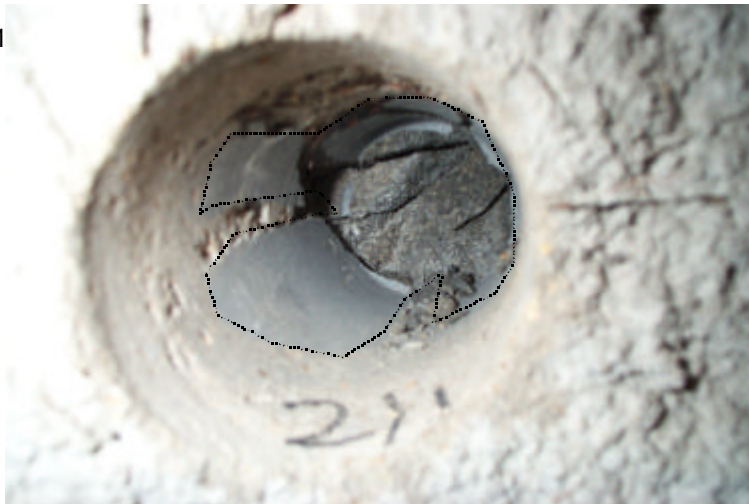
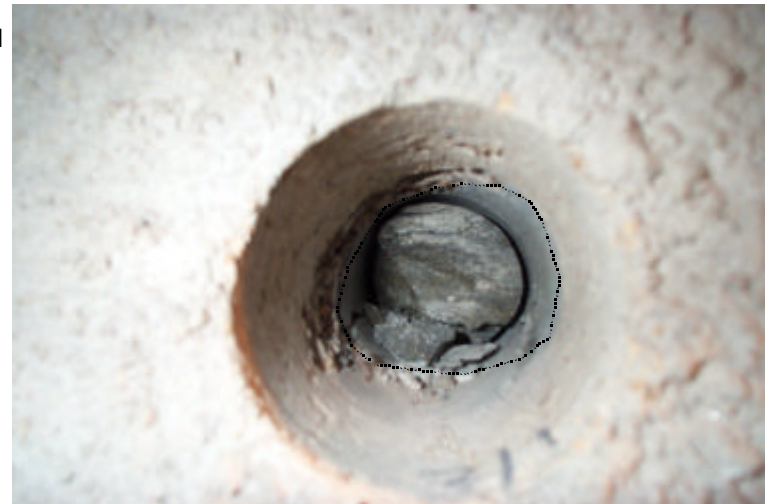
FIG. No.
F1

Section 1 (Steel fibre reinforced shotcrete) boreholes (dotted line indicates the contact between shotcrete and rock)

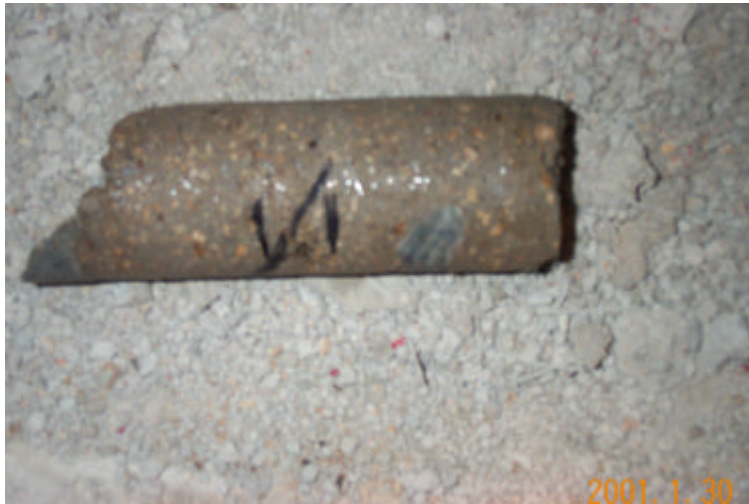
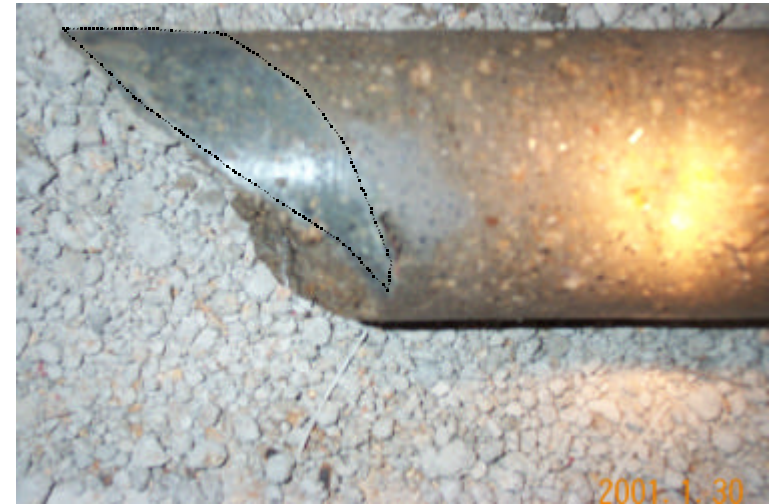
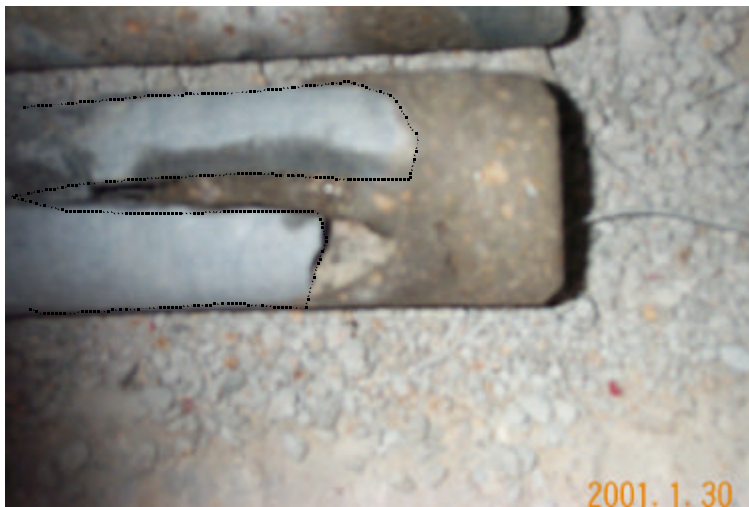
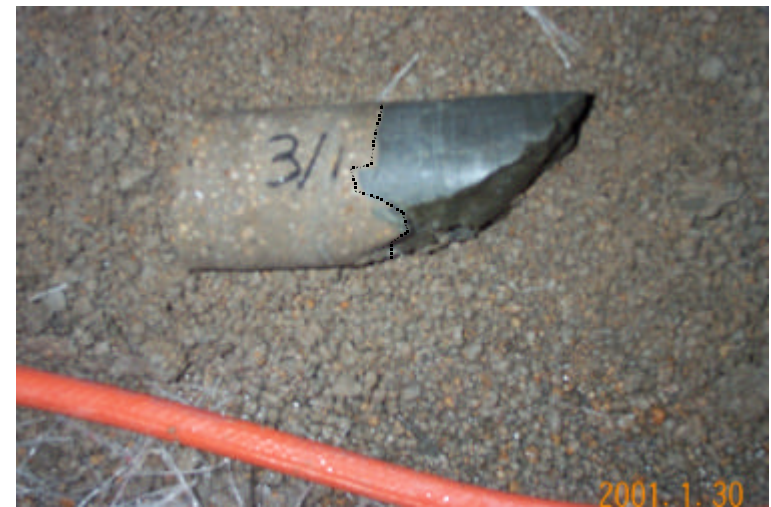
FIG. No.
F2

Section 1 (Steel fibre reinforced shotcrete) cores (dotted line indicates the contact between shotcrete and rock)

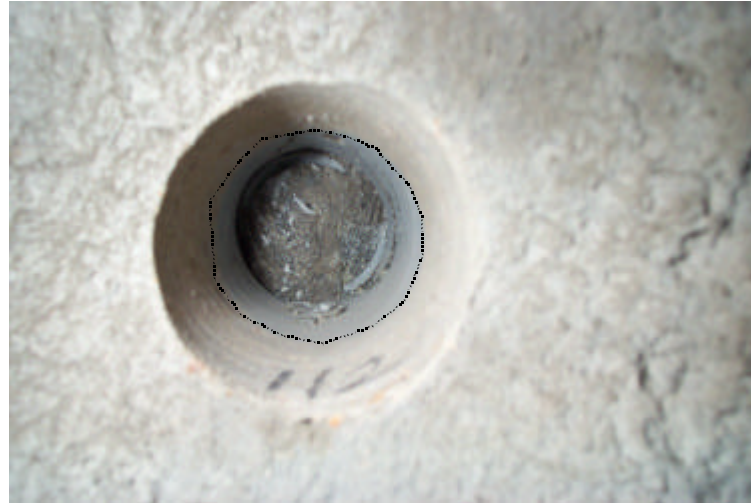
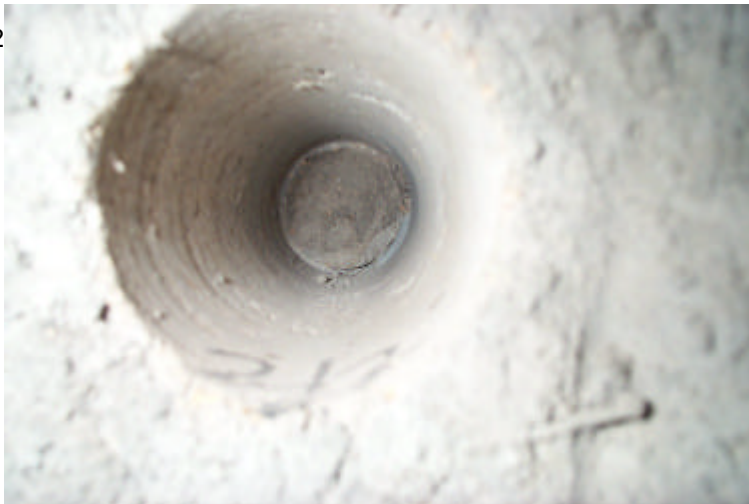
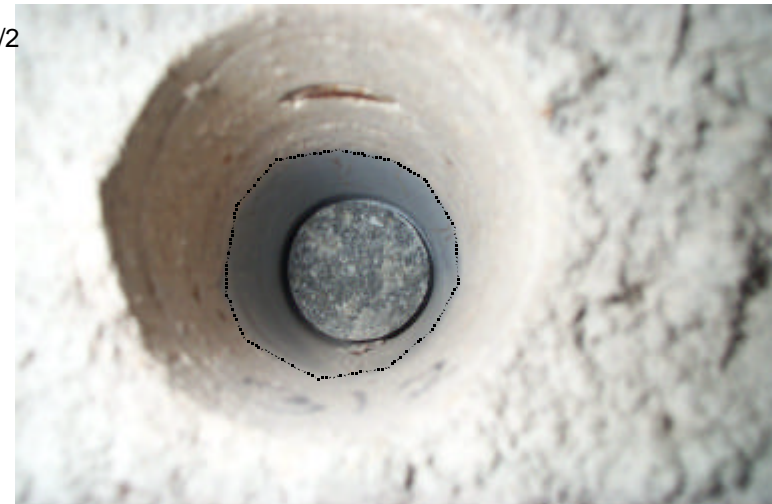
FIG. No.
F3

Section 2 (Polypropylene fibre reinforced shotcrete) boreholes (dotted line indicates the contact between shotcrete and rock)

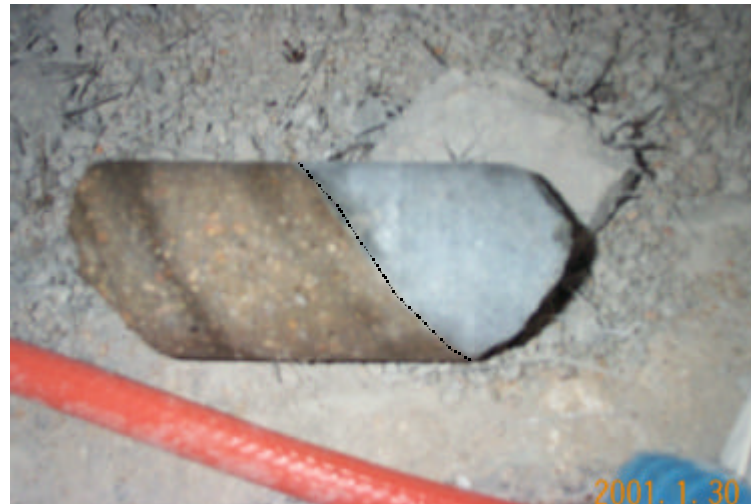
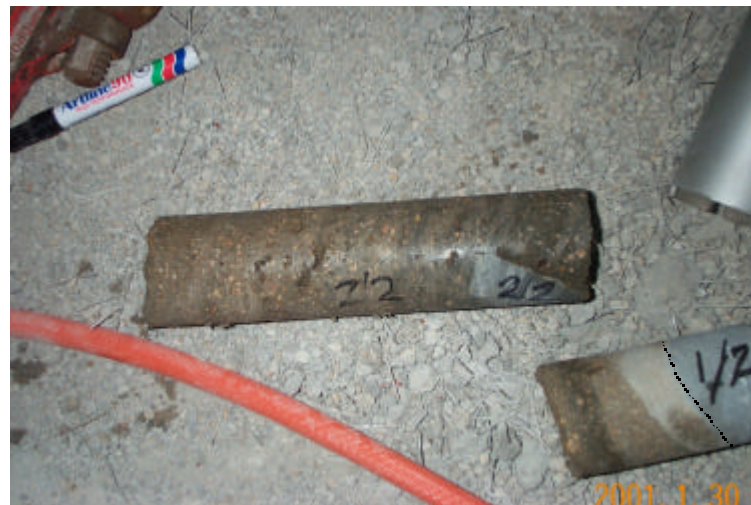
FIG. No.
F4

Section 2 (Polypropylene fibre reinforced shotcrete) cores (dotted line indicates the contact between shotcrete and rock)

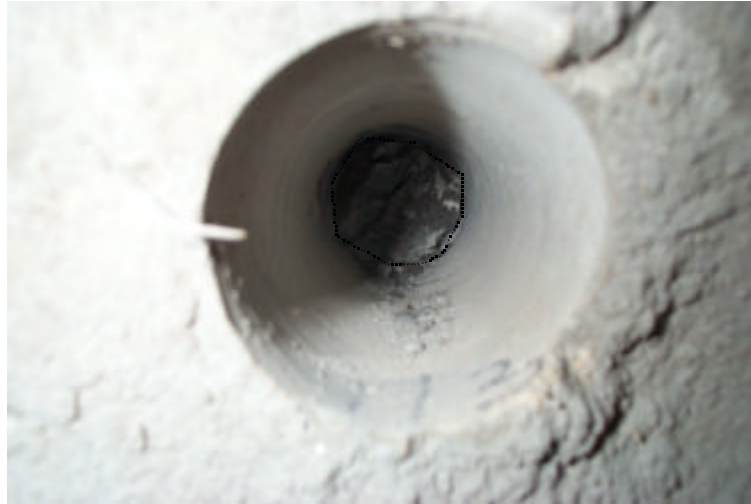
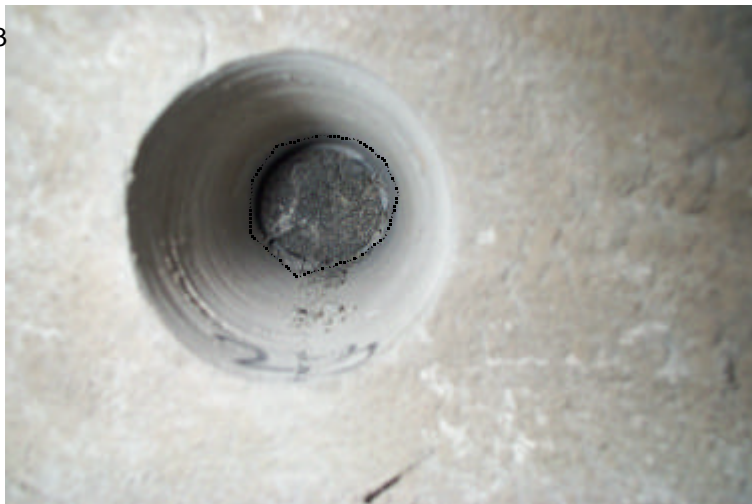
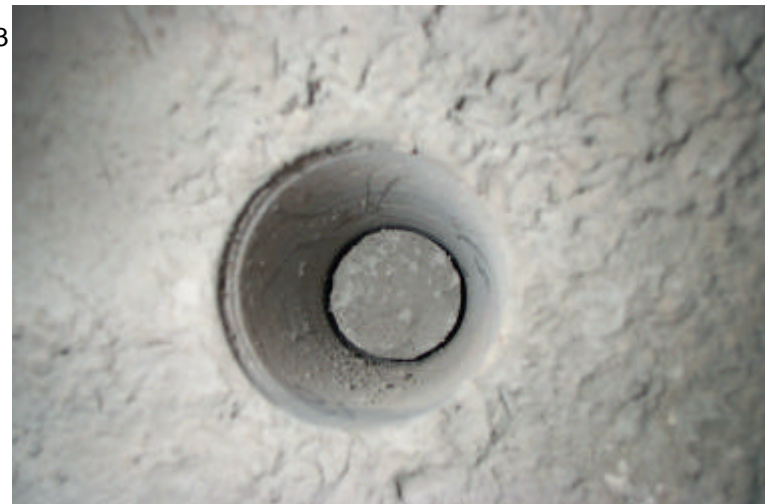
FIG. No.
F5

Section 3 (Tailings aggregate polypropylene fibre reinforced shotcrete) boreholes (dotted line indicates the contact between shotcrete and rock)

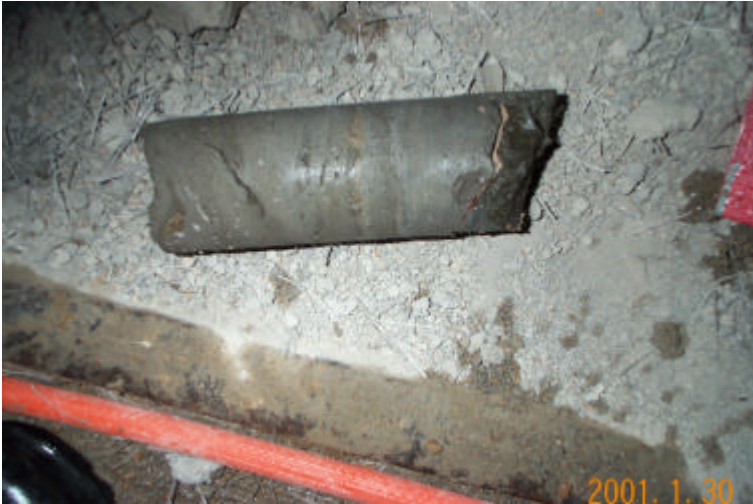
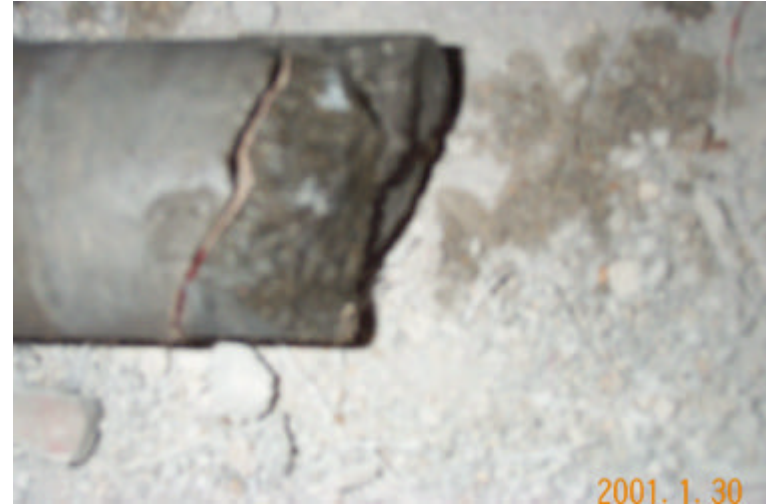
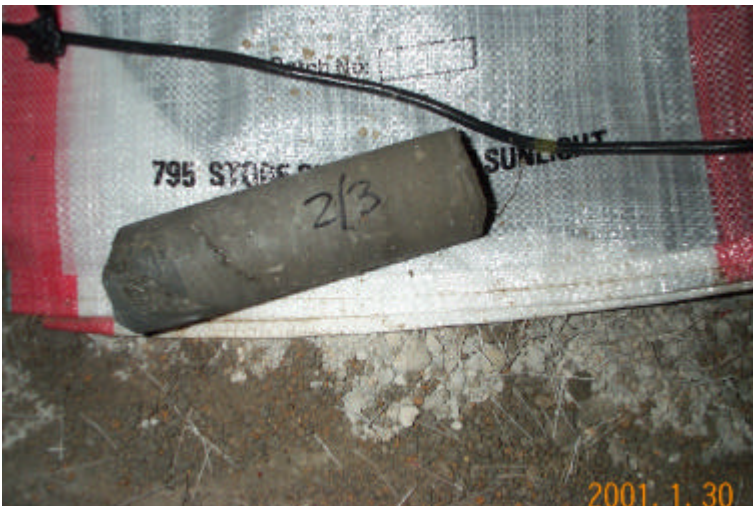
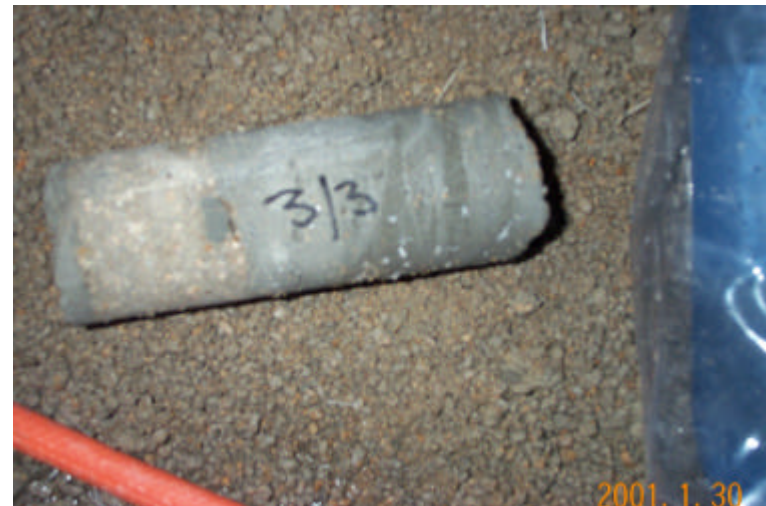
FIG. No.
F6

Section 3 (Tailings aggregate polypropylene fibre reinforced shotcrete) cores (dotted line indicates the contact between shotcrete and rock)

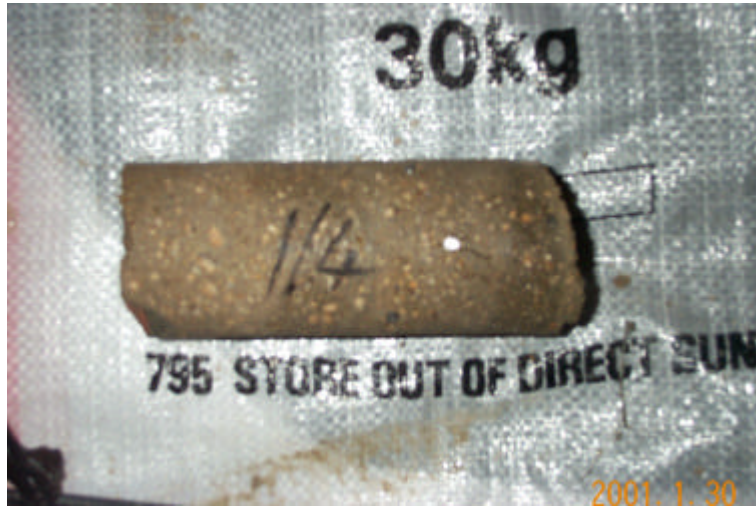
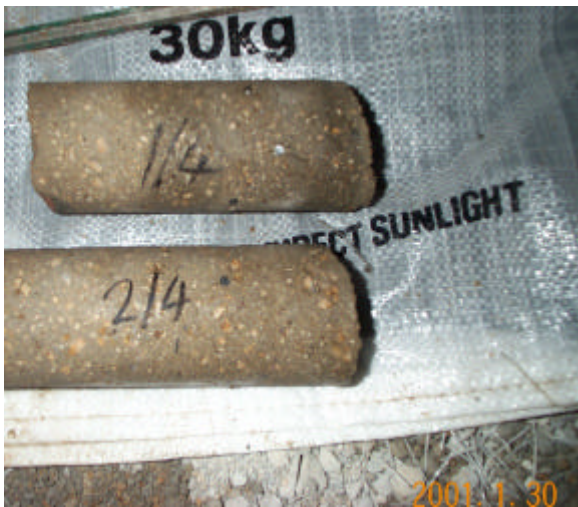
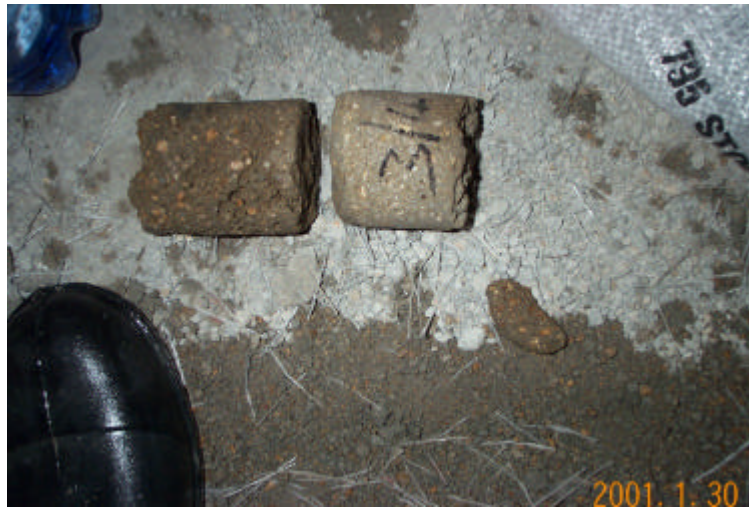
FIG. No.
F8

(Mesh reinforced shotcrete) cores (dotted line indicates the contact between shotcrete and rock)

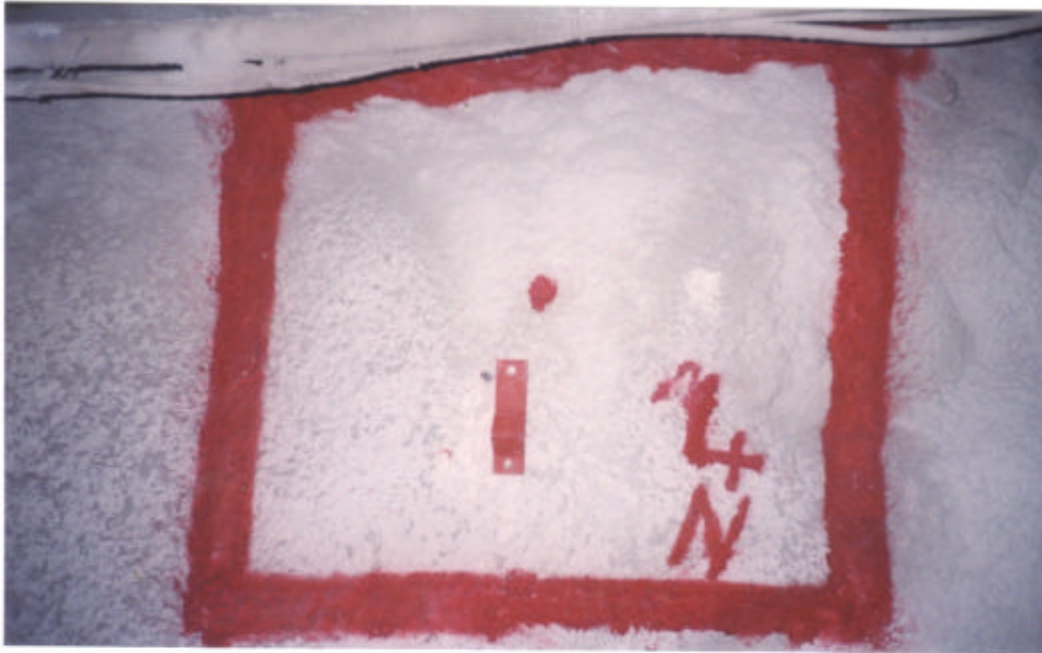
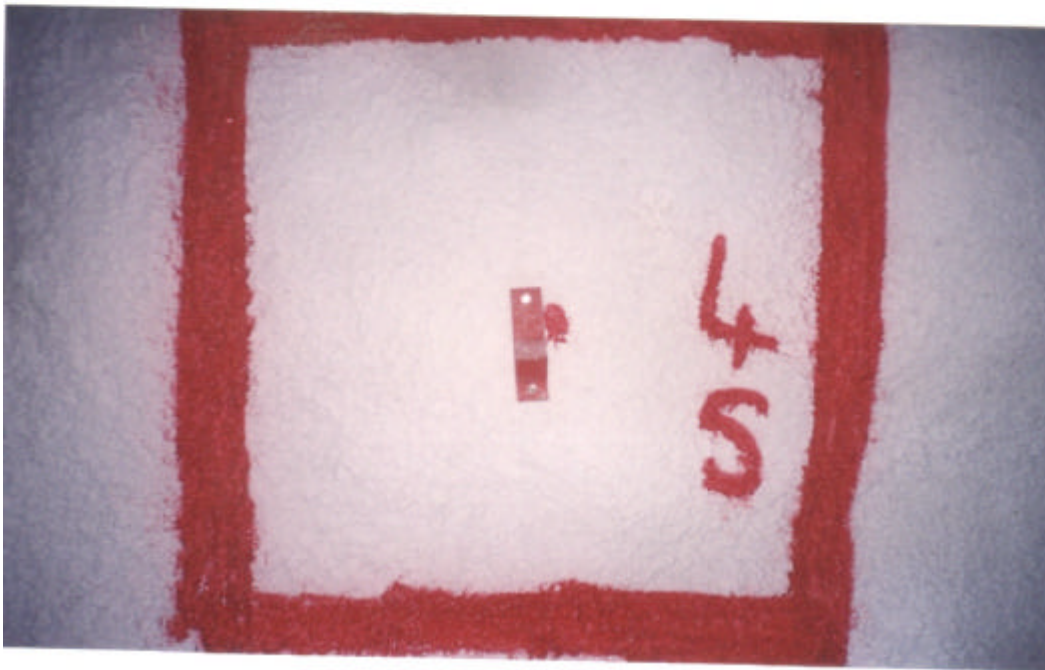
Panel 4 North (16/01/2001)

Section 4 with the mesh-reinforced shotcrete exhibited the most fracturing in the southern panel.

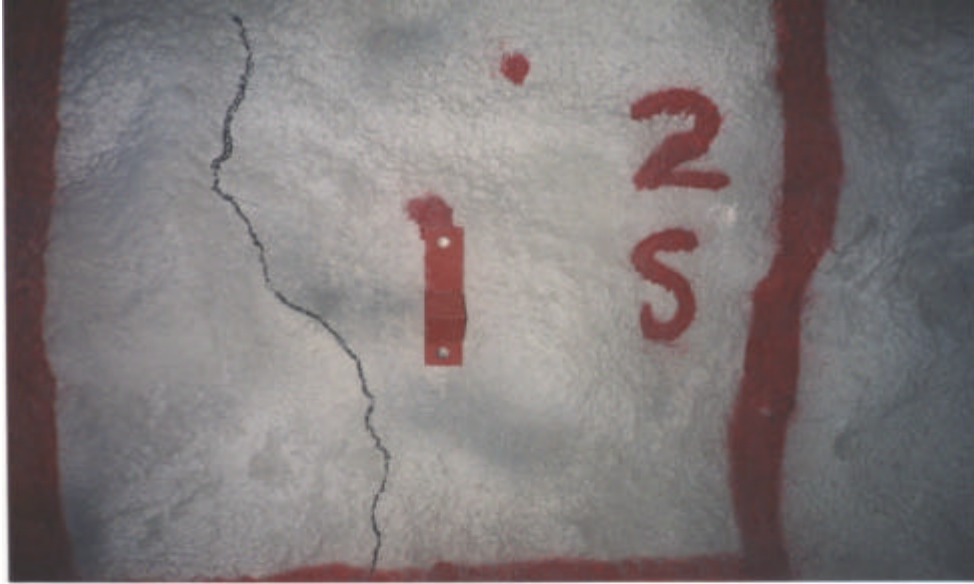
Panel 2 South

Crack width: 0.5mm crack

Observations: On the left side of the 2 South panel. A crack of 84cm is developing

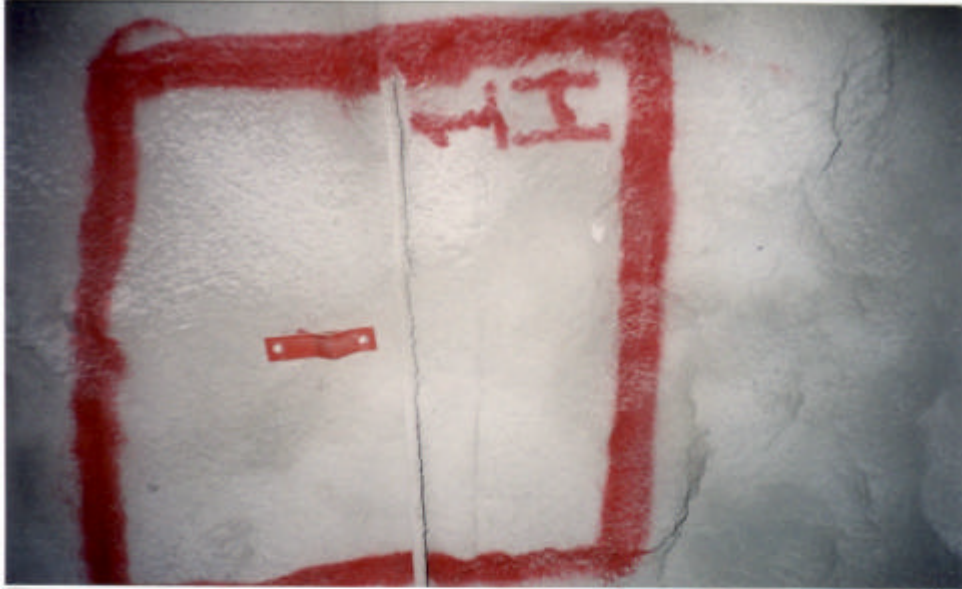
Hanging wall 1

Crack length: No cracks

Crack width: No cracks

Observations: No closure was recorded. Hanging wall No 1 seems to be stable

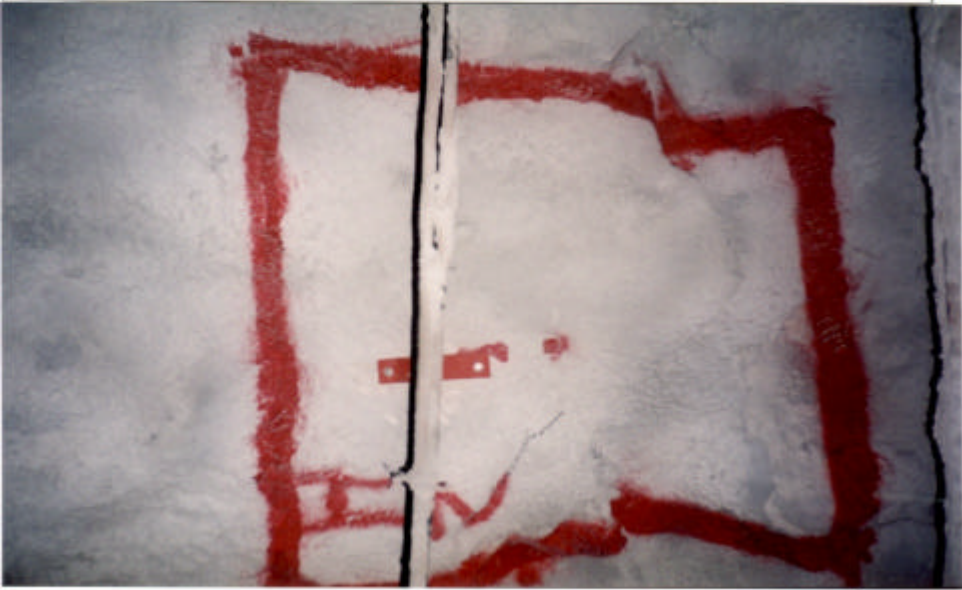
Hanging wall 2

Crack length: 30cm crack developing

Crack width: 0.5mm crack width

Observations: A crack of 30cm long and 0.5mm wide was noticed on hanging wall No 2

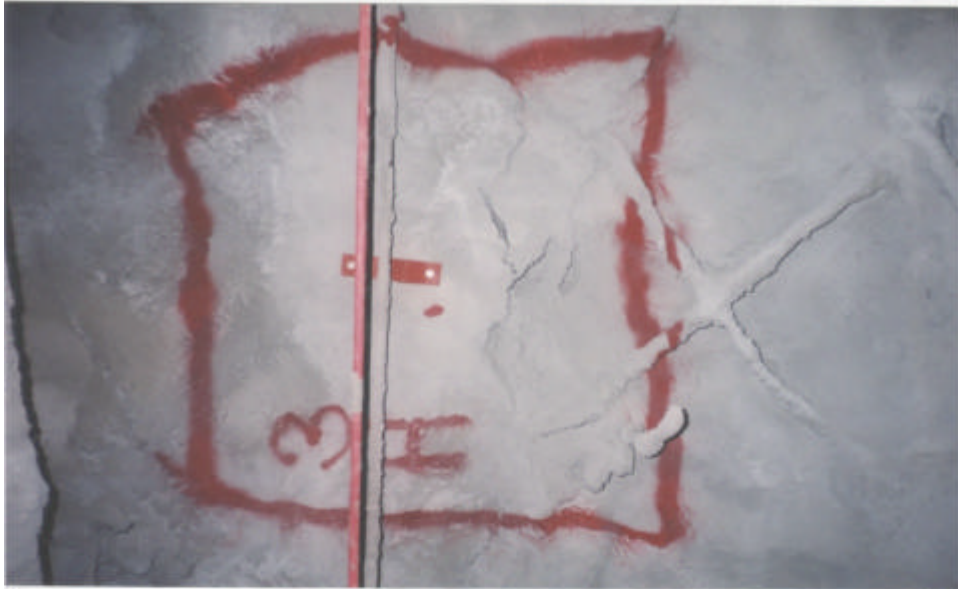
Hanging wall 3

Crack length: 16cm and a 18cm crack

Crack width: Both cracks are 1mm wide

Observations: A 16cm long and 1mm wide crack was noticed, as well as a 18cm long developing crack of 1mm in width.

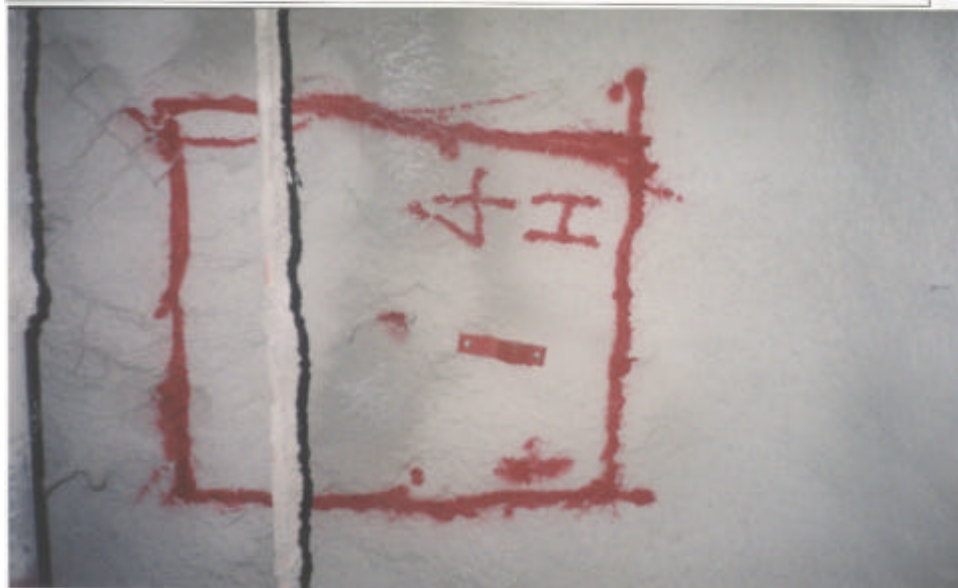
Hanging wall 4

Crack length: No cracks

Crack width: No cracks

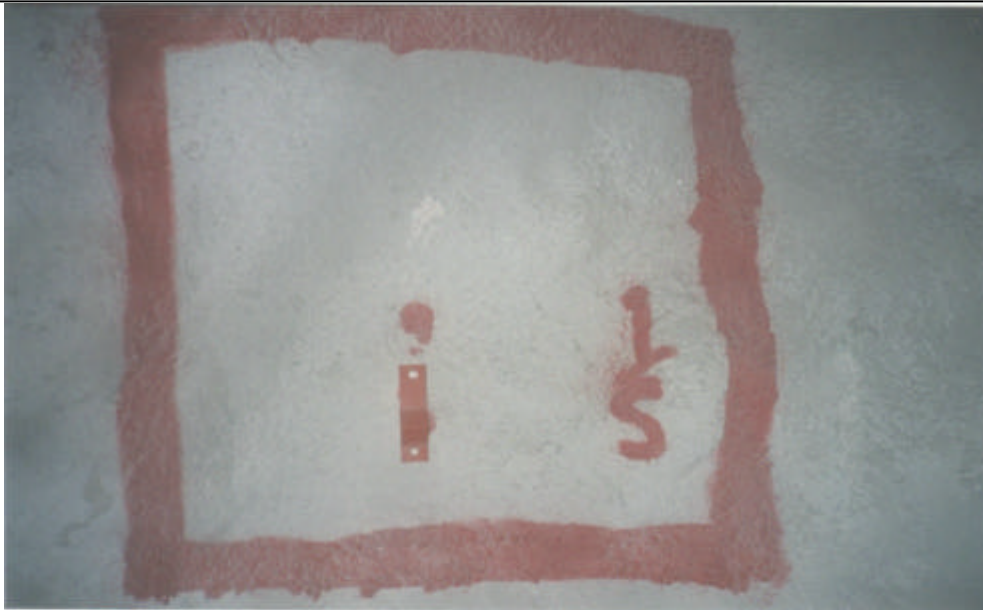
Crack length: No cracks

Crack width: No cracks

Observations: No closure was recorded. Panel 1 South seems to be stable

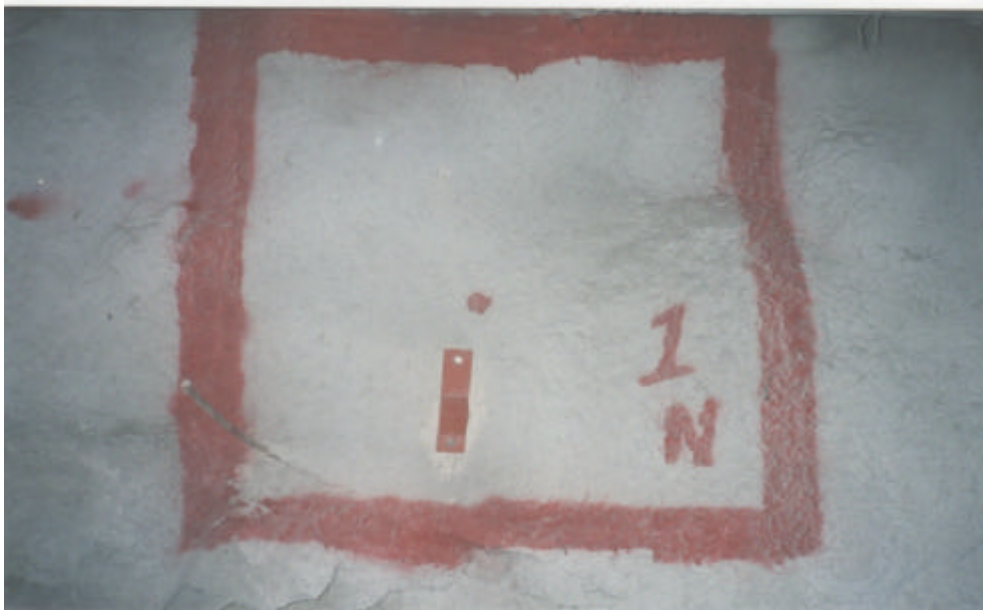
Panel 1 North

Crack length: No cracks

Crack width: No cracks
