Final Project Report

Underground verification of the large deflection performance of fibre reinforced shotcrete subjected to high stresses and convergence and to dynamic loading

Project number: GAP 710

Date: April 2002

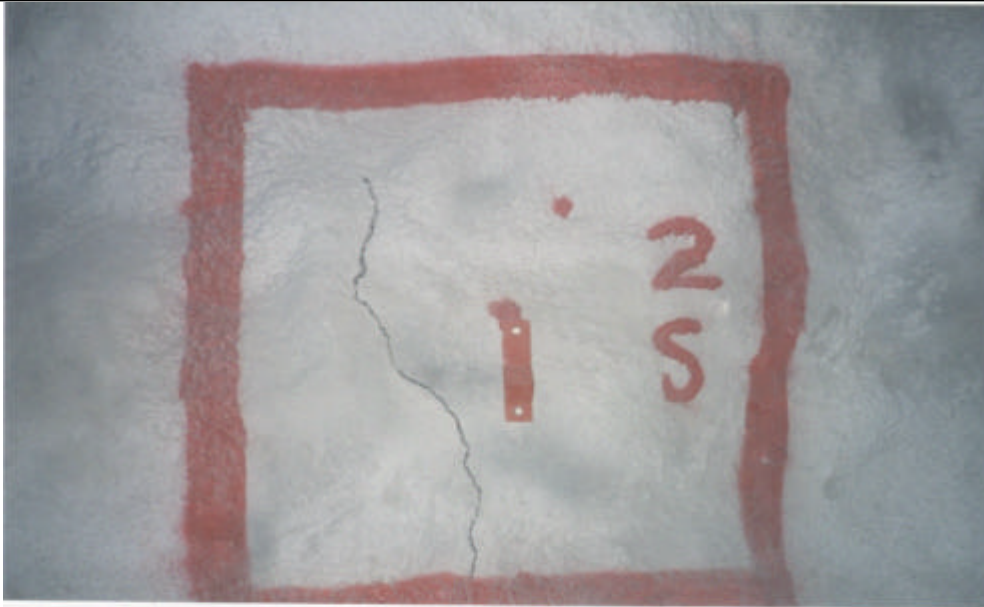
Panel 2 South

Date measured and photo taken: 18/04/2001
 Crack length: 84cm crack developing
 Crack width: 0.5mm crack
 Observations: On the left side of the 2 South Panel, a crack of 84cm is developing.

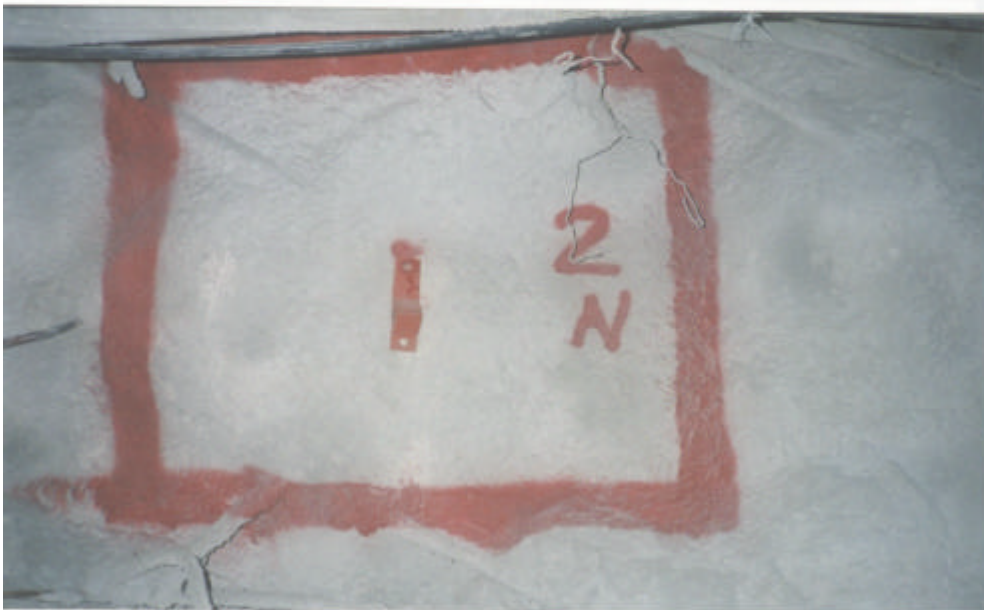
Date measured and photo taken: 18/04/2001
 Crack length: No cracks
 Crack width: No cracks
 Observations: No closure was recorded. Panel 2 North seems to be stable

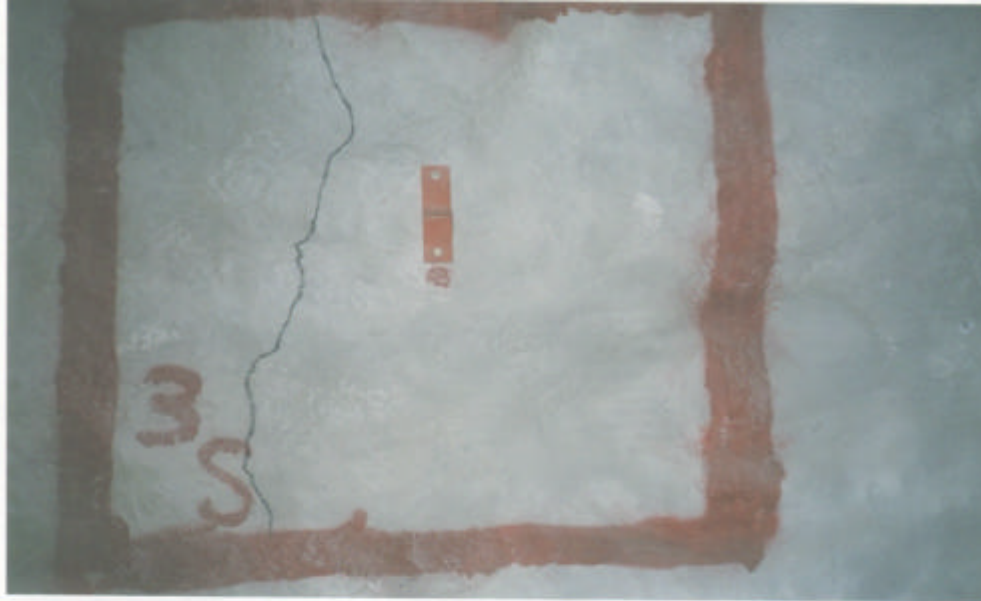
Panel 3 South

Date measured and photo taken: 18/04/2001
Crack length: 97cm long crack developing
Crack width: 0.5mm crack
Observations: A developing crack in the 3 South panel was noticed.

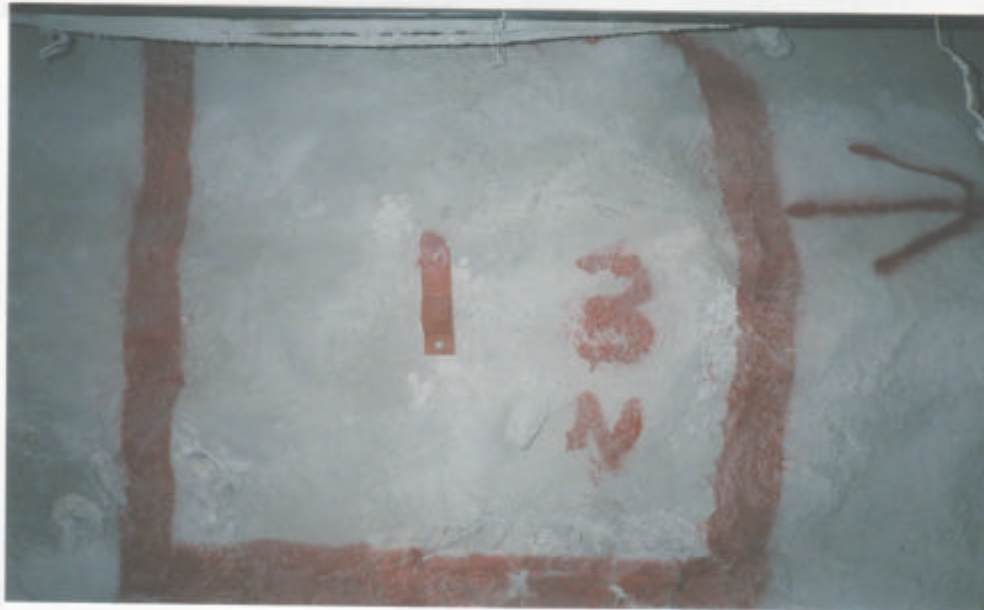
Date measured and photo taken: 18/04/2001
Crack length: No cracks
Crack width: No cracks
Observations: No closure was recorded. Panel 3 North seems to be stable

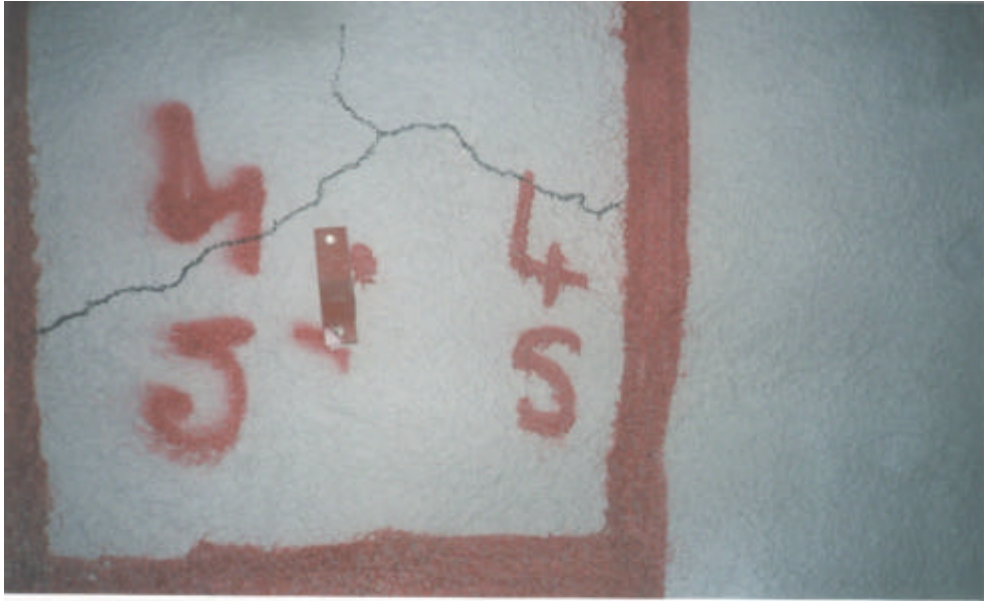
Panel 4 South

Date measured and photo taken: 18/04/2001
Crack length: 110cm long crack and a 20cm long crack
Crack width: Both cracks are 0.5mm wide.
Observations: A 110cm crack developing of width 0.5mm runs horizontally across the panel

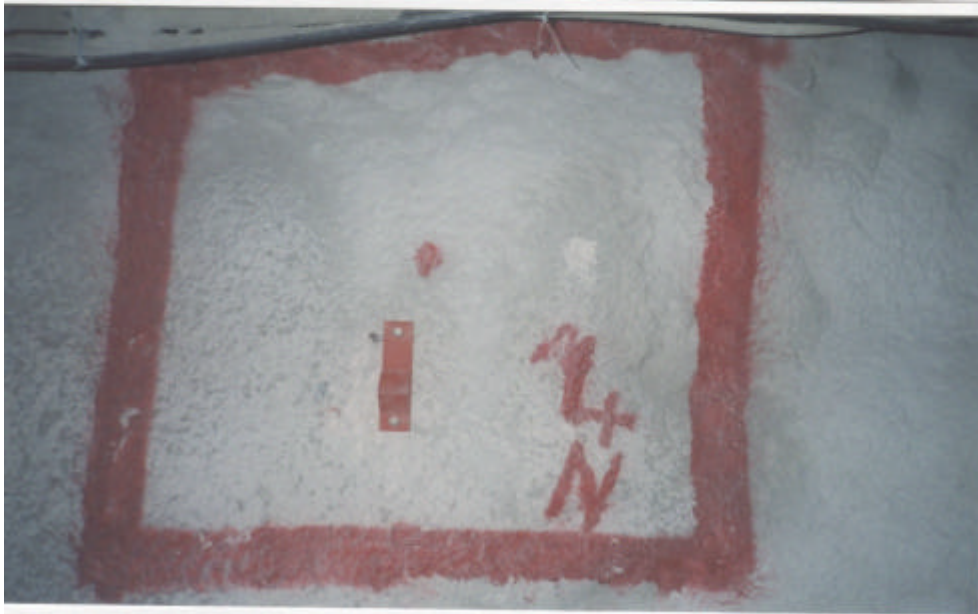
Date measured and photo taken: 18/04/2001
Crack length: No cracks
Crack width: No cracks
Observations: No closure was recorded. Panel 4 North seems to be stable

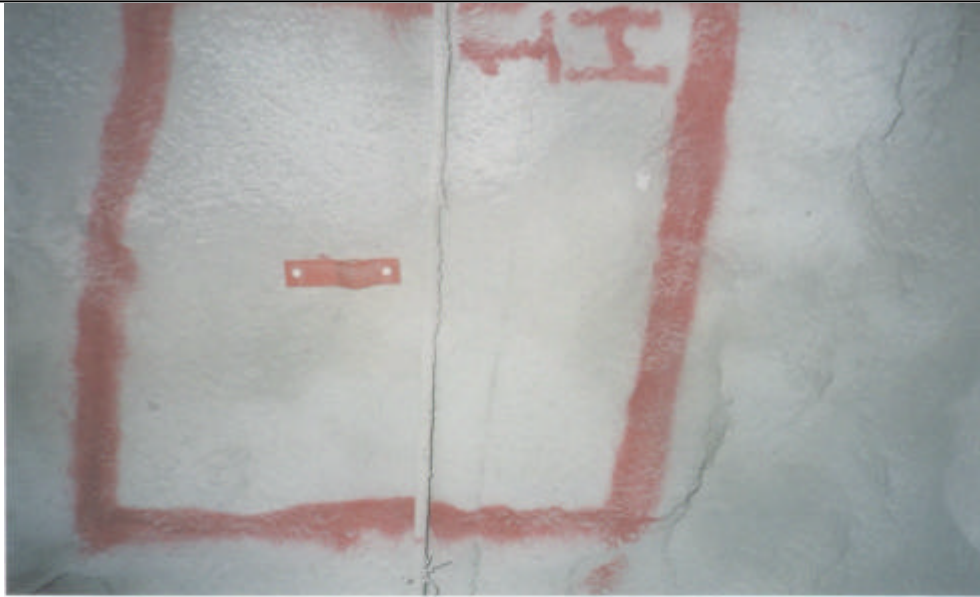
Hanging wall 1

Crack length: No cracks

Crack width: No cracks

Observations: No closure was recorded. Hanging wall No1 North seems to be stable.

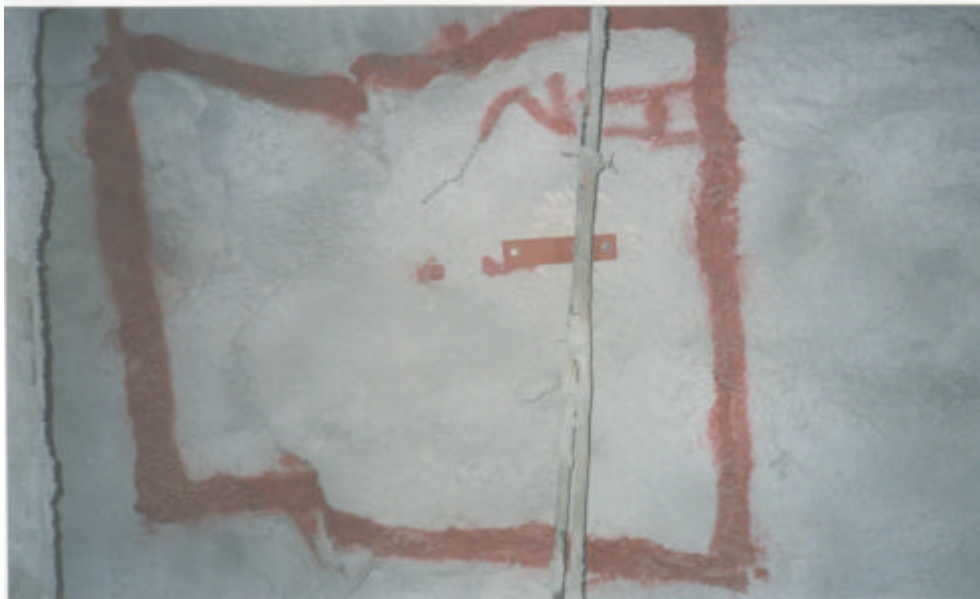
Hanging wall 2

Crack length: 30cm crack developing

Crack width: 0.5mm crack width

Observations: A crack of 30cm long and 0.5mm wide was noticed on hanging wall No 2

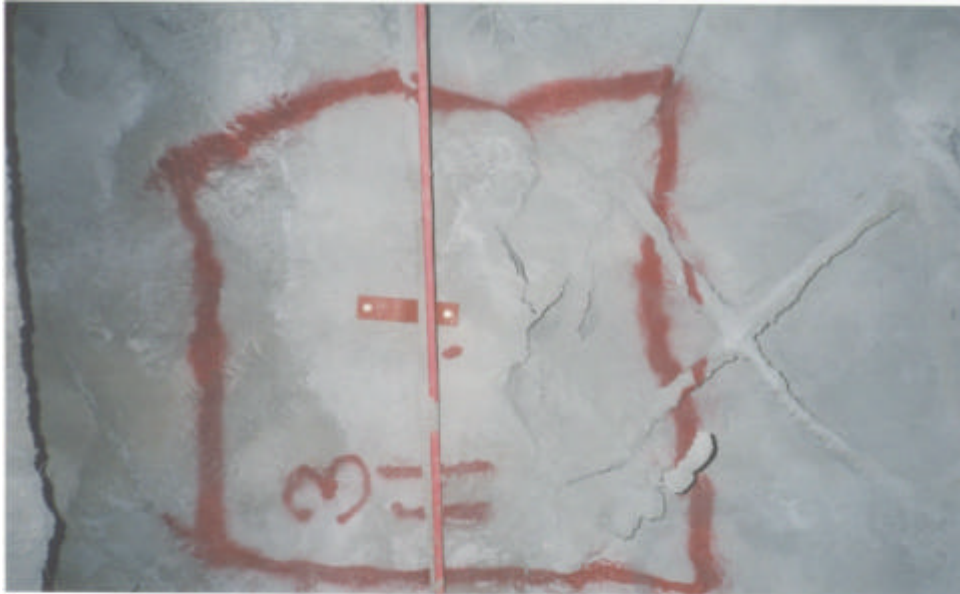
Hanging wall 3

Crack length: 16cm and a 18cm crack

Crack width: Both cracks are 1mm wide

Observations: A 16cm long and 1mm crack was noticed, as well as a 18cm long developing crack of 1mm in width.

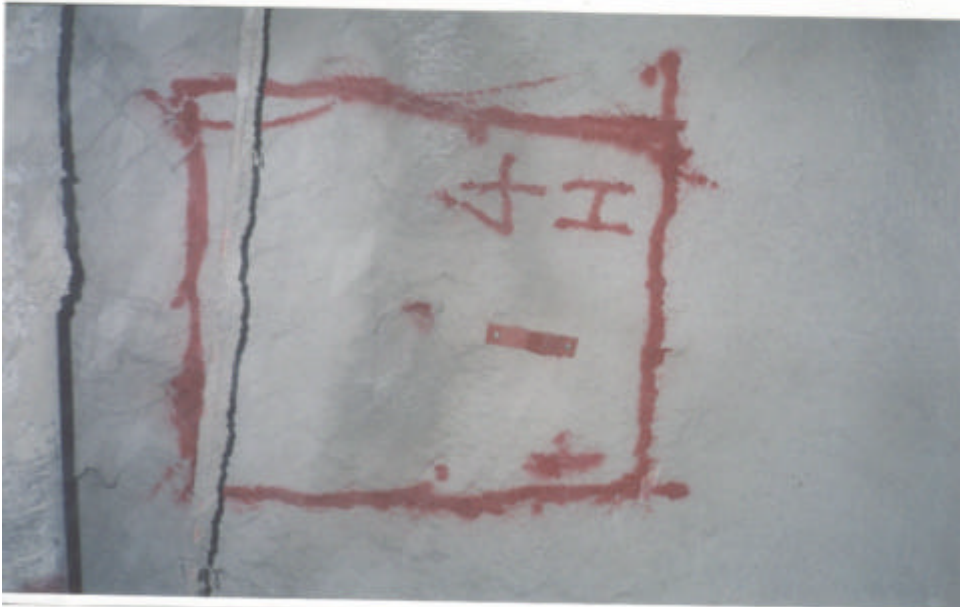
Hanging wall 4

Crack length: No cracks

Crack width: No cracks

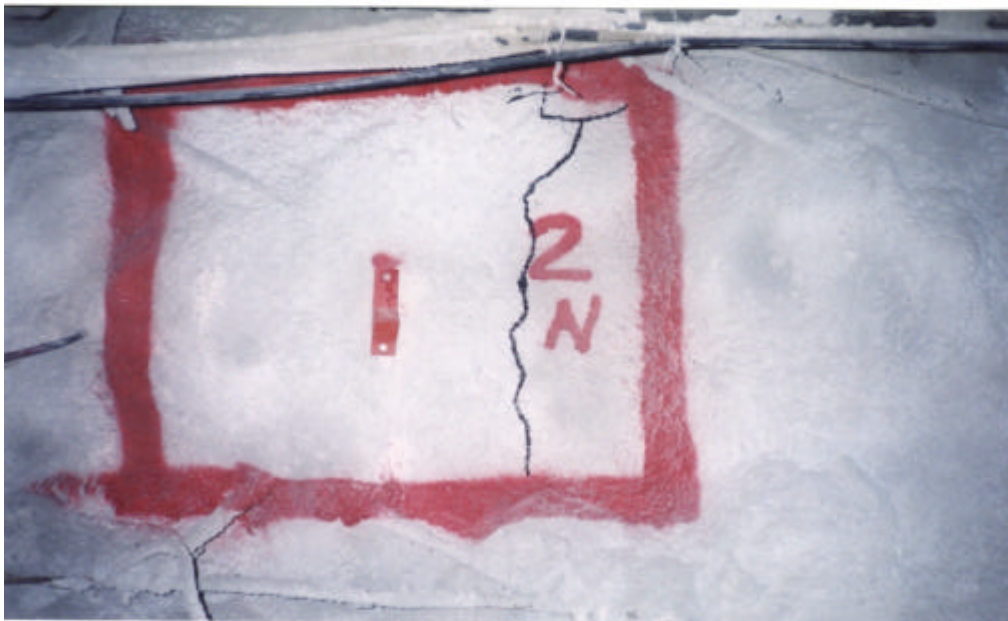
Panel 2 North

Observations: A 1m long crack of 0.5mm developed from the top of the panel to the bottom on the right side.

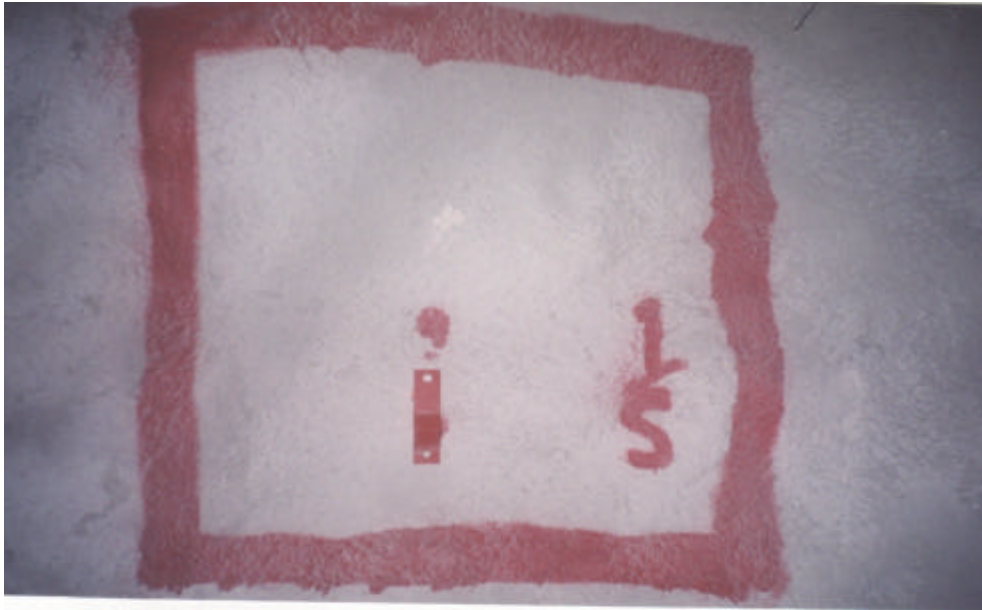
Panel 1 South

Observations: No cracks were observed. No closure was recorded.

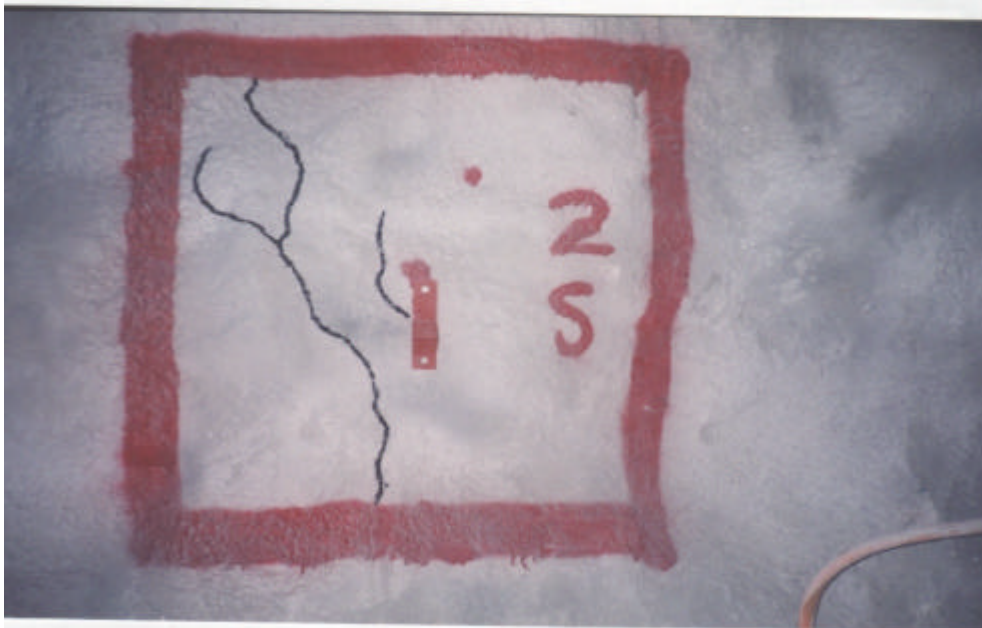
Panel 2 South

Observations: A small crack of 15cm long extended out of the original crack.

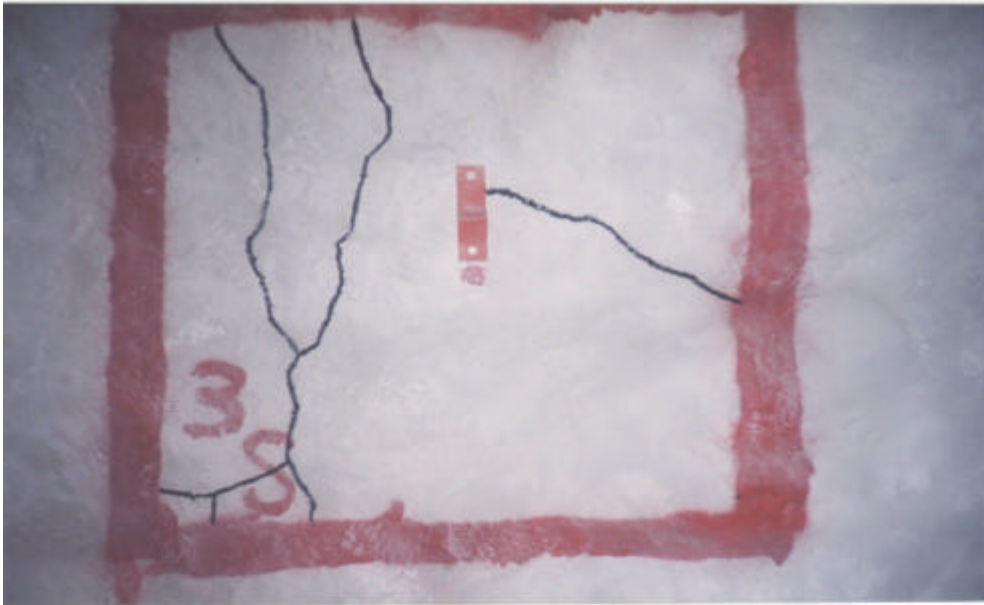
Panel 3 South

Observations: The original crack on the left hand side of the panel developed two additional cracks as well as a 0.5mm thick crack on the right hand side of the panel.

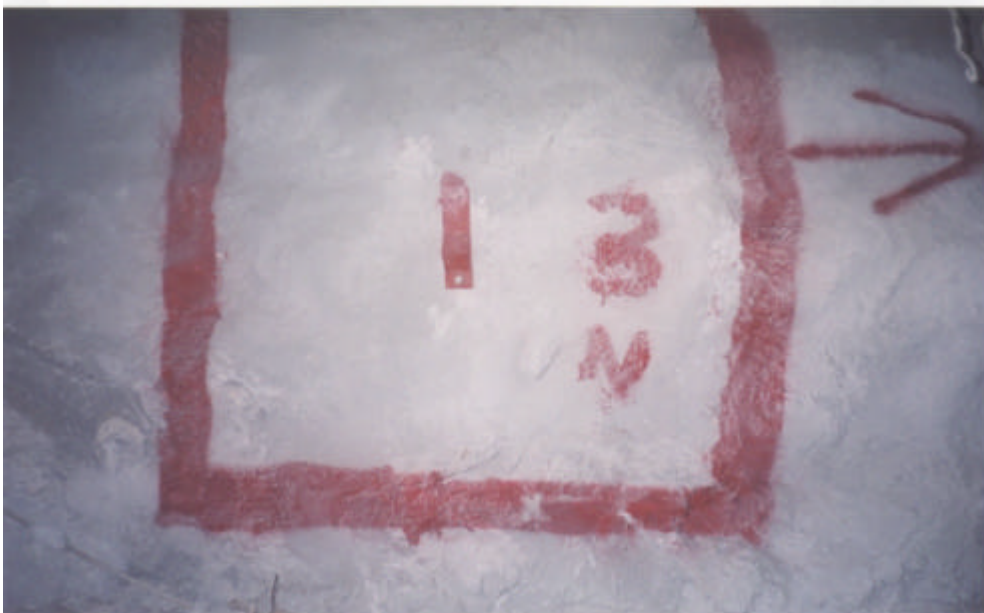
Panel 3 North

Observations: No cracks are seen in the No 3 North panel

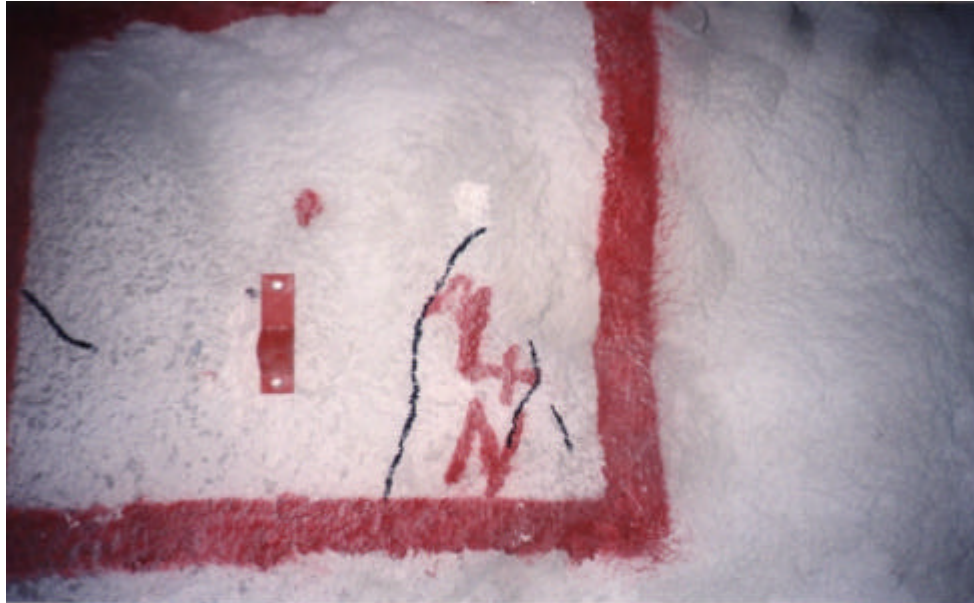
Panel 4 North

Observations: A 20cm crack seems to be developing in the bottom right hand corner of the panel.

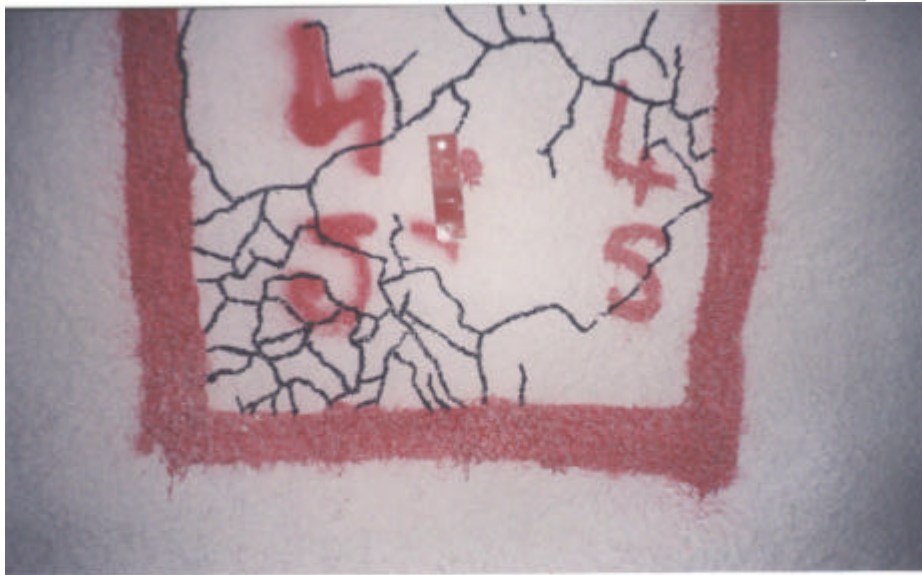
Panel 4 South

Observations: As seen in the photo, a group of cracks extended from the previous crack.

The bottom left of the panel seems to be cracking the most.

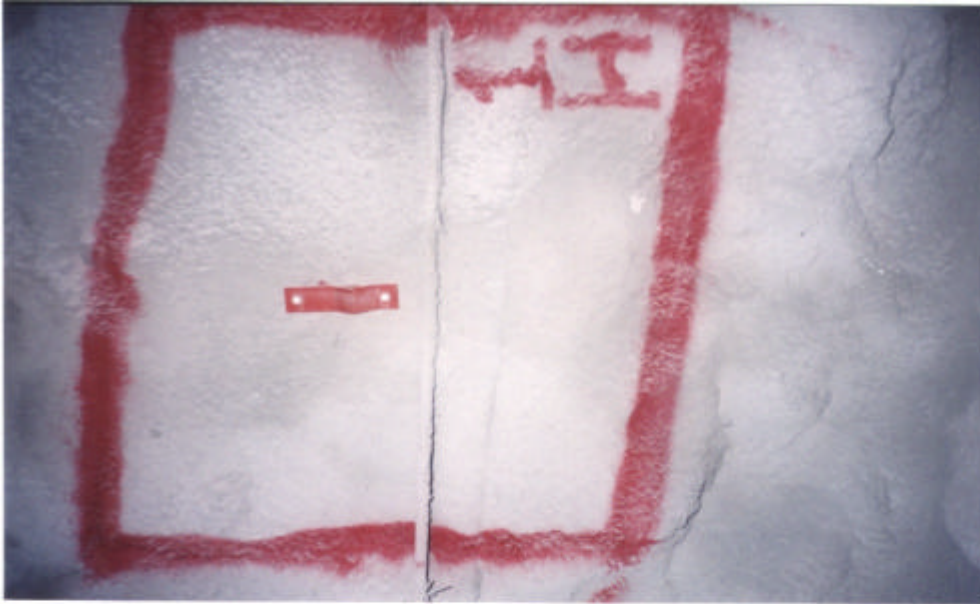
Hanging wall 1

Date measured and photo taken: 15/5/2001
Observations: No cracks observed

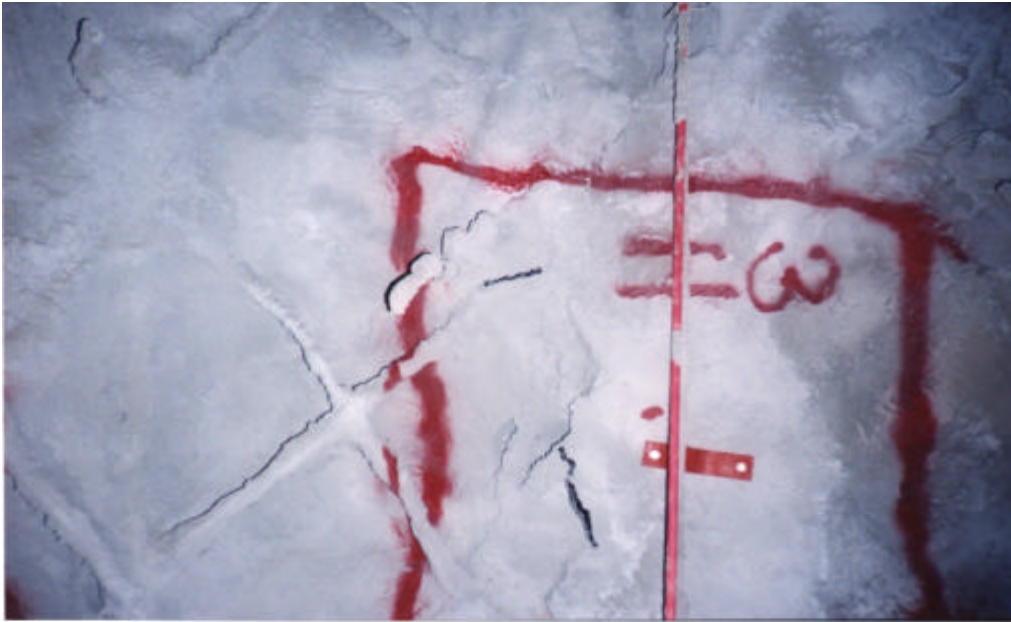
Hanging wall 3

Observations: The same cracks as in the previous photographs are seen.

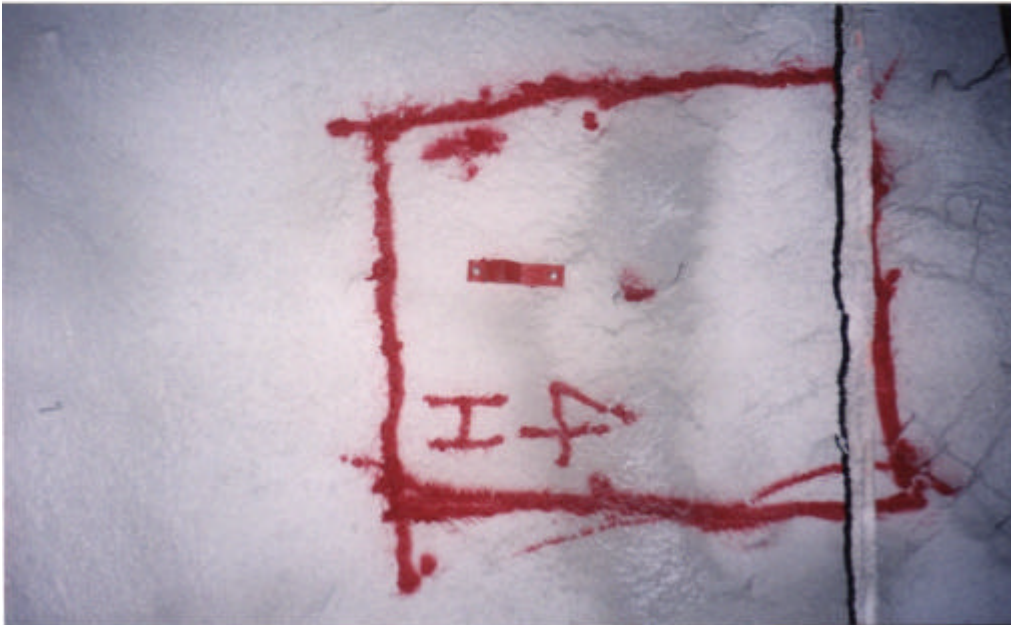
Hanging wall 4

Observations: No cracks can be seen.

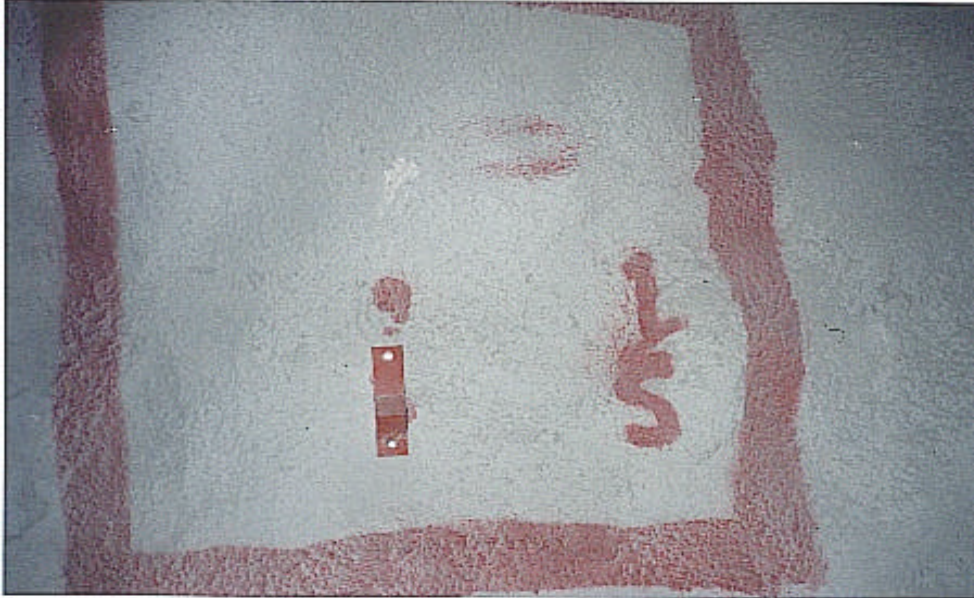
Date measured and photo taken: 22/11/2001

Observations: Same conditions as last observed

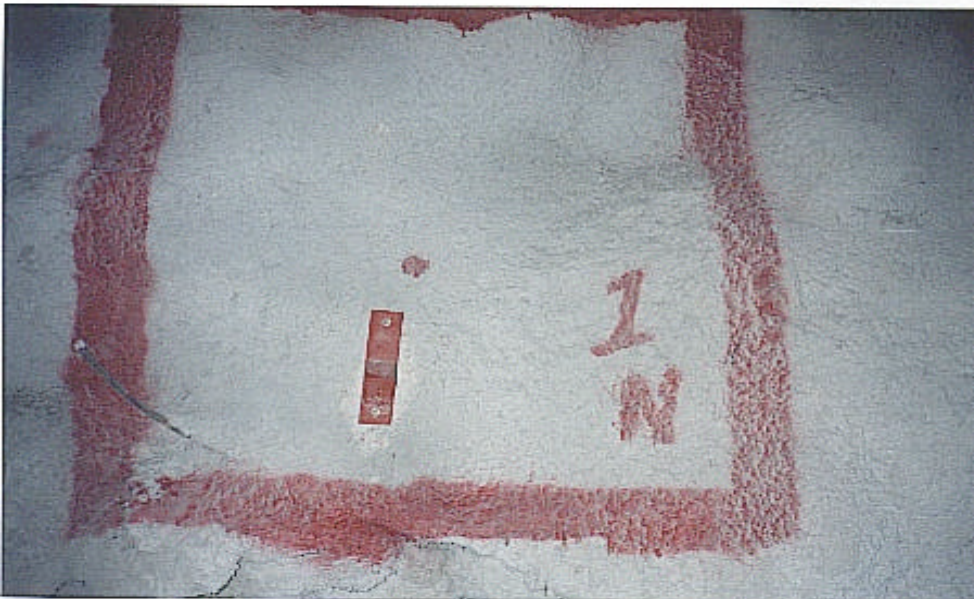
Panel 1 North

Date measured and photo taken: 22/11/2001

Observations: Same conditions as last observed

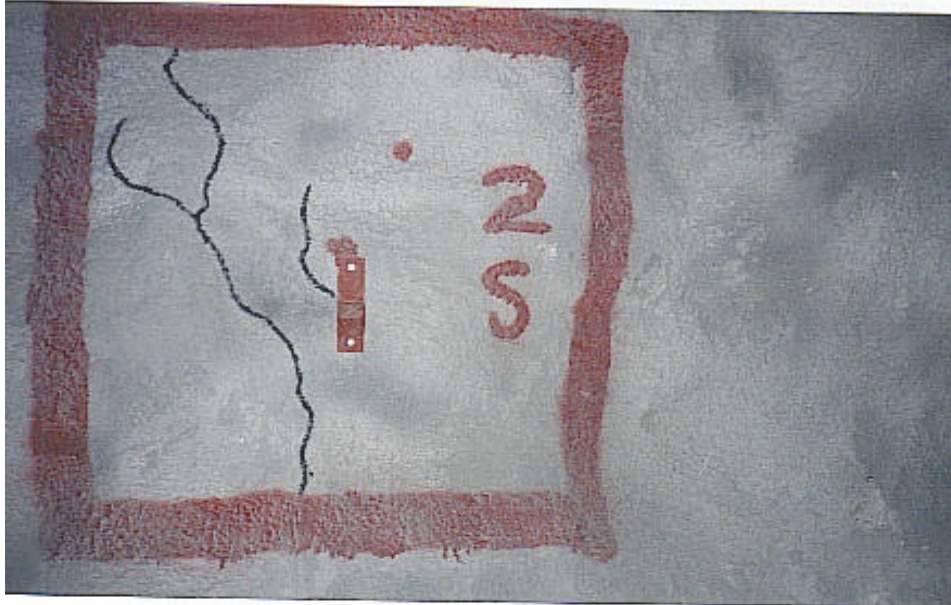
Date measured and photo taken: 22/11/2001

Observations: Same conditions as last observed

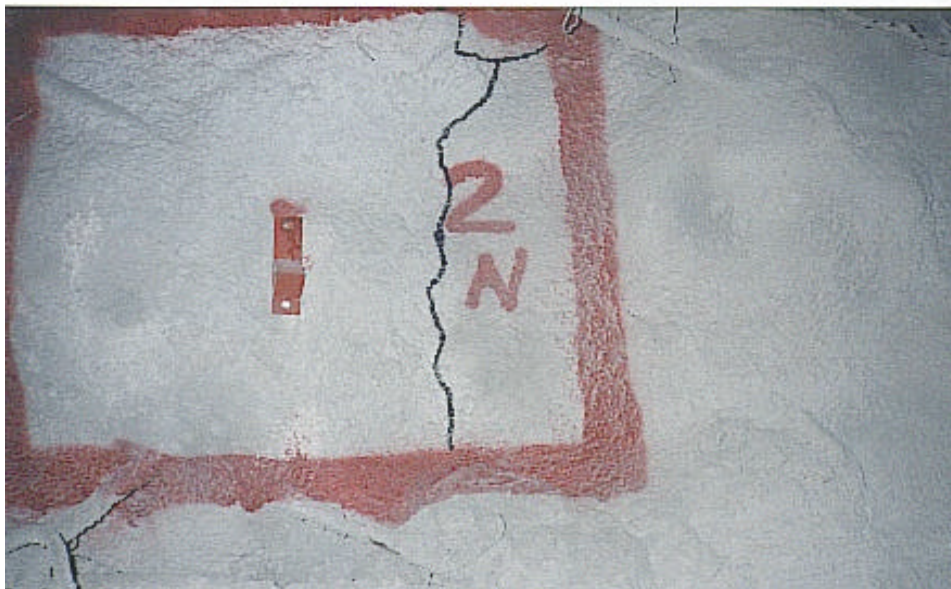
Panel 2 North

Date measured and photo taken: 22/11/2001

Observations: Same conditions as last observed

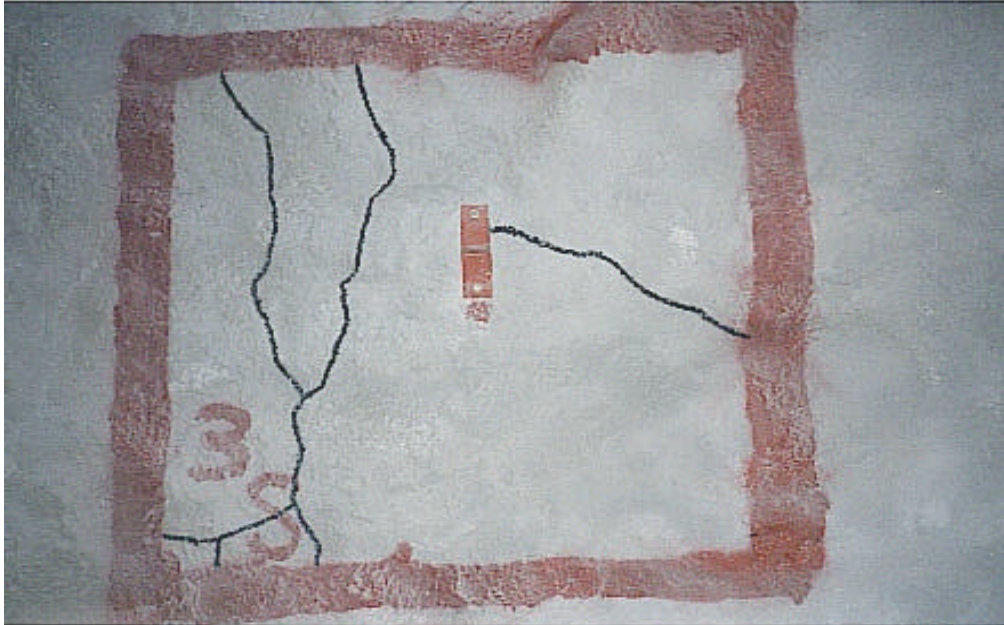
Panel 3 South

Date measured and photo taken: 22/11/2001
Observations: Same conditions as last observed

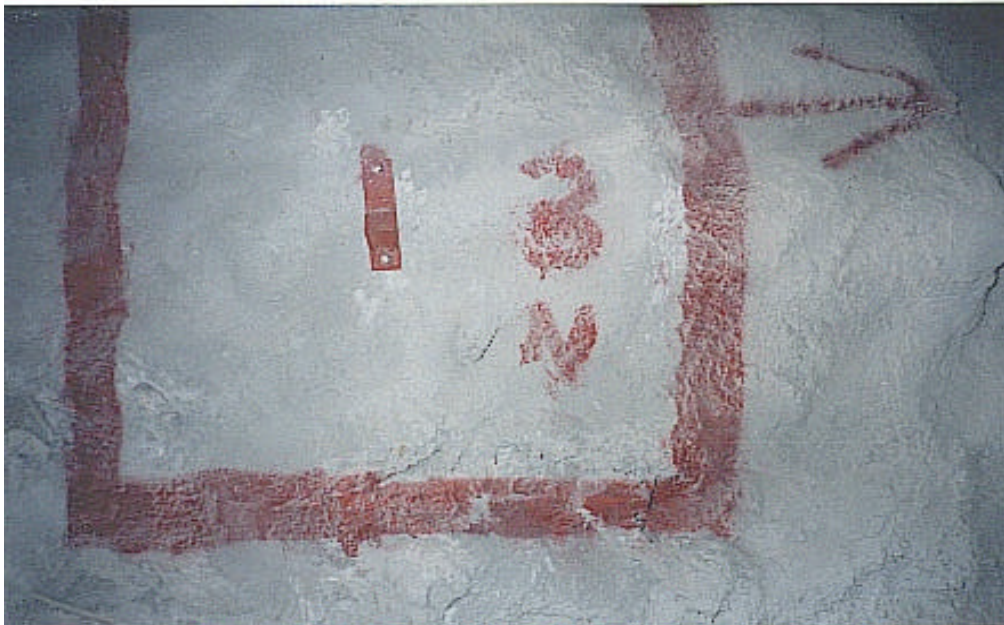
Panel 3 North

Date measured and photo taken: 22/11/2001
Observations: Same conditions as last observed

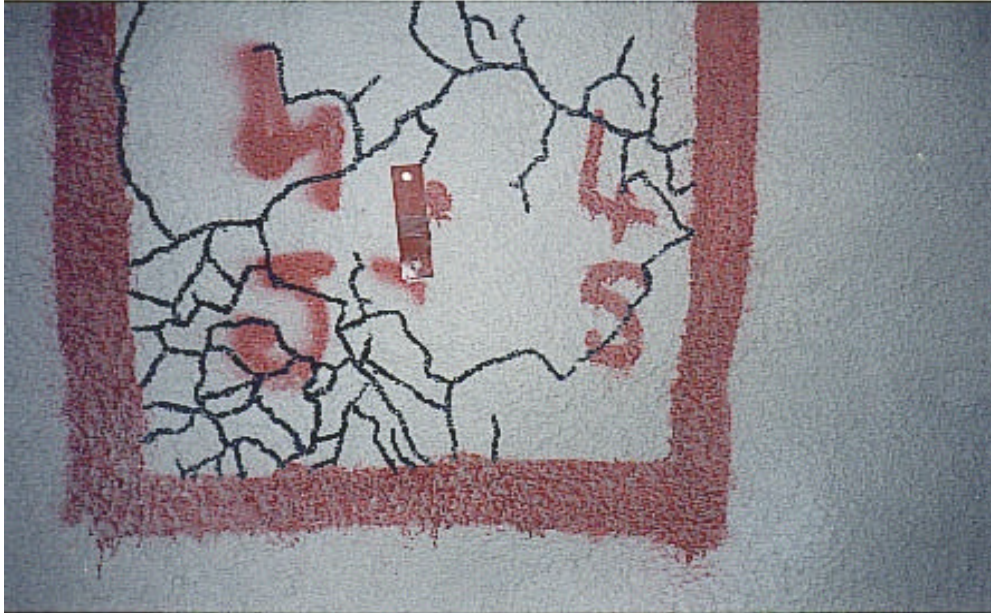
Date measured and photo taken: 22/11/2001

Observations: Same conditions as last observed

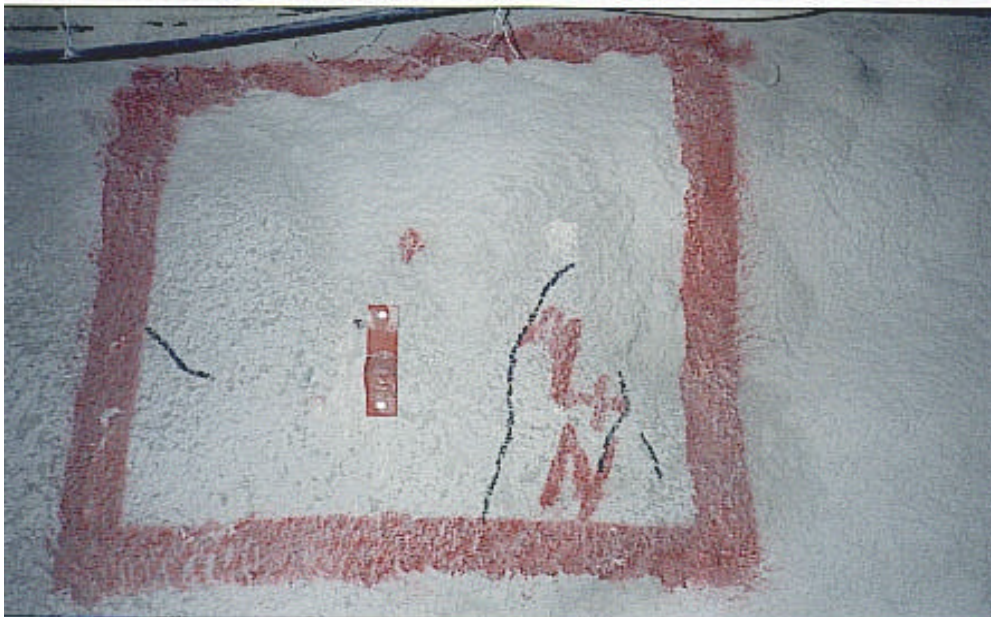
Panel 4 North

Date measured and photo taken: 22/11/2001

Observations: Same conditions as last observed
