Safety in Mines Research Advisory Committee

Final Project Report

Extended use of the Savuka dynamic test facility to improve material and analytical technology in deep-level stope support

Research agency : SRK Consulting
Project number : GAP 818
Date : November 2002

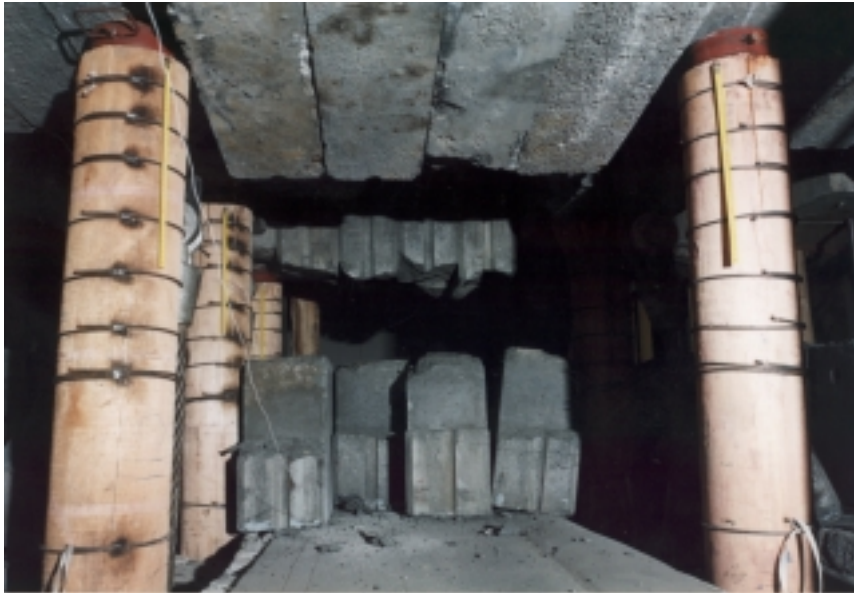
Photograph 5.1 Test # 4, approximately 50 milliseconds after impulse of 147 kJ at impact velocity of 5,4 ms⁻¹

This higher rate of ejection is demonstrated by the fact that the small weights at the ends of the block measuring tapes are falling more slowly than the blocks, and the tapes are crumpling. Close examination of the right hand edge of Photograph 5.1 will show that blocks 11 and 12 are not yet significantly displaced at this instant. Shortly afterwards, as the centre four blocks fell completely away from the tensioning rod thereby totally relaxing the clamping force, blocks 1 to 3 and 10 to 12 also collapsed (Photograph 5.2).

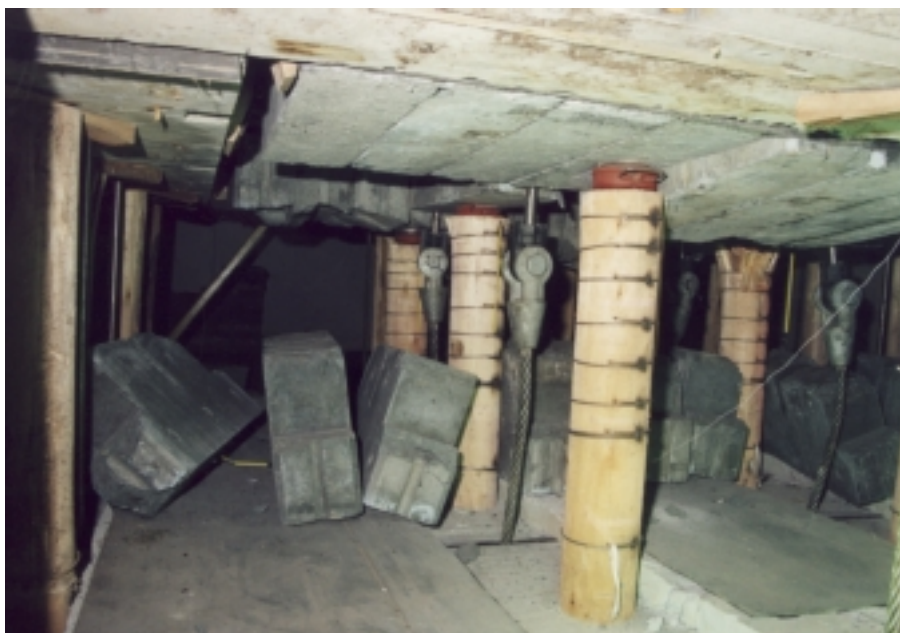
Photograph 5.2 Test # 4, all roof blocks collapsed except those directly above the elongates.

Apart from the presence of the linking rope ties in the early GAP 611 test, all the other constraints in test # 4 were identical. In the former test an impulse of 150 kJ produced only limited sag of the unsupported hangingwall while the same impulse caused dramatic collapse of the unsupported roof blocks in test # 4. **Clearly the rope links were very effective in preventing collapse of roof between supports.**

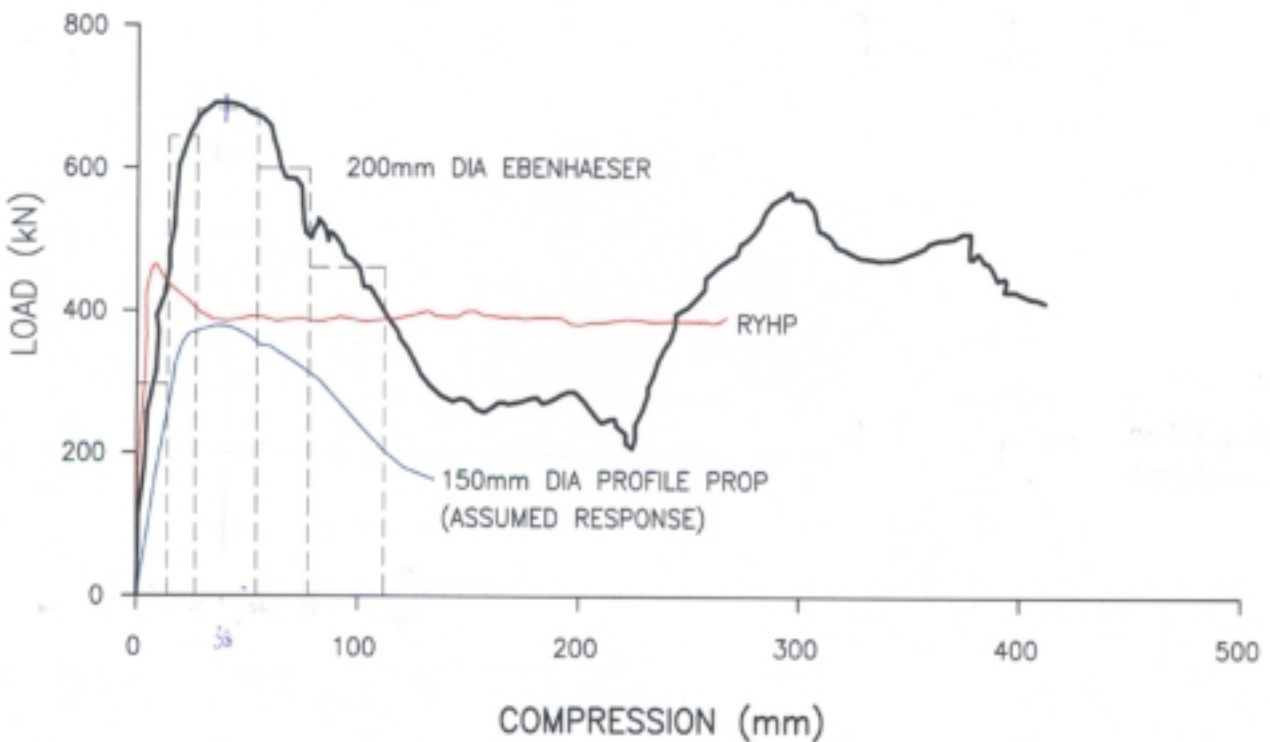
Apart from central convergence of 38 mm for the first impulse and 88 mm for the second, the measured convergences were too small to allow reliable estimation of the energies absorbed by the various support units. From load-displacement curves provided by the manufacturers – Figure 5.3 – it can be estimated that 20 kJ and 65 kJ were absorbed at the central position during the 50 kJ and 150 kJ impulses, respectively.

Figure 5.3 *Dynamic load-compression characteristics for 200 mm diameter Ebenhaeser elongates compared to 400 kN RYHP*

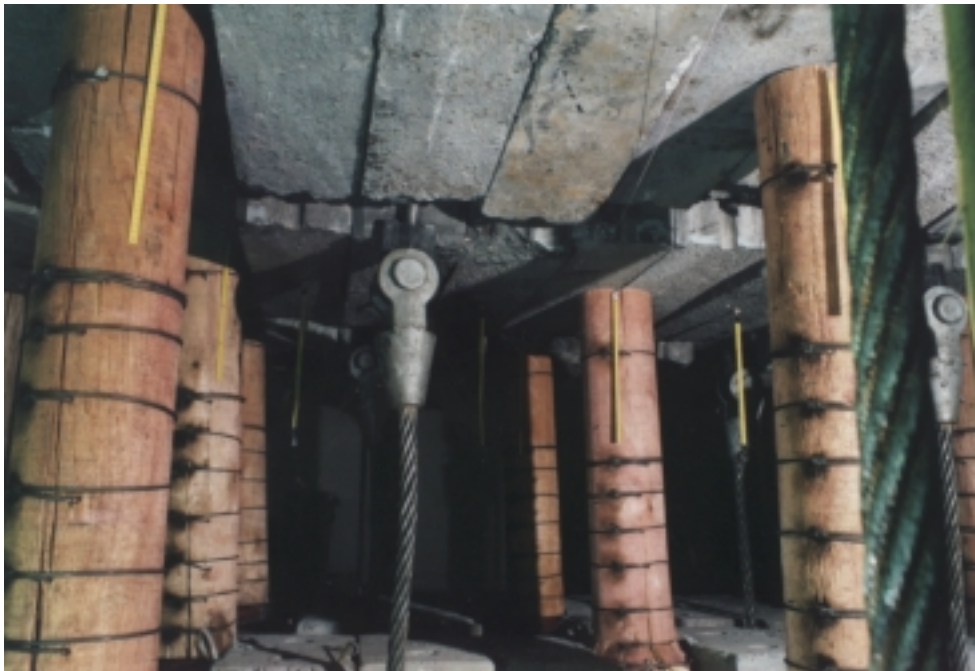
As might have been expected, and was clearly confirmed by this test, the stability of the 3-block unsupported span between supports was dramatically improved compared with that of the four-block unsupported span of the previous test. The maximum block displacements of the northern 3-block unsupported span was 41 mm and 176 mm, and of the southern 3-block span was 57 mm and 143 mm, after the 50 kJ and 150 kJ impulses respectively. Photograph 5.3 shows the relatively limited and uniform nature of the roof deformation between the North prop and the centre prop.

Photograph 5.3 Test # 5, after impulse of 147 kJ at impact velocity of 5,4 ms⁻¹ showing 88 mm convergence on centre elongate.

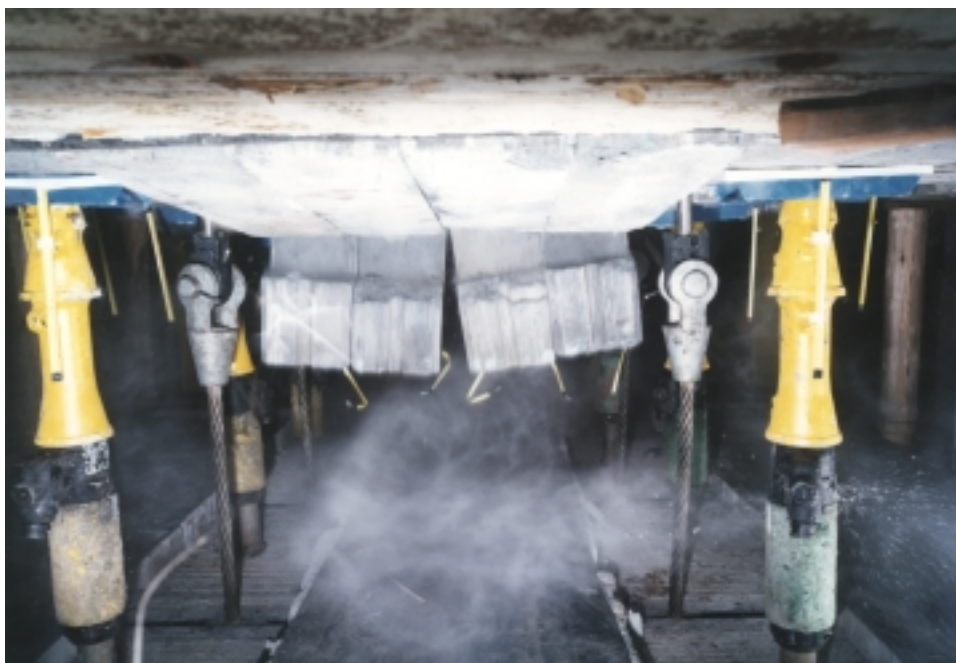
It is presumed that the balance of the 140 kJ which was not absorbed by the props would have been partly expended in overcoming the friction between the ejected blocks and blocks 3 and 4 and 9 and 10 which remained supported by the North and South props.

Photograph 5.4 Test # 1, possibly 100 milliseconds after impact of 140 kJ striking at impact velocity of $4,8 \text{ ms}^{-1}$. Note vapour expelling from SW prop.

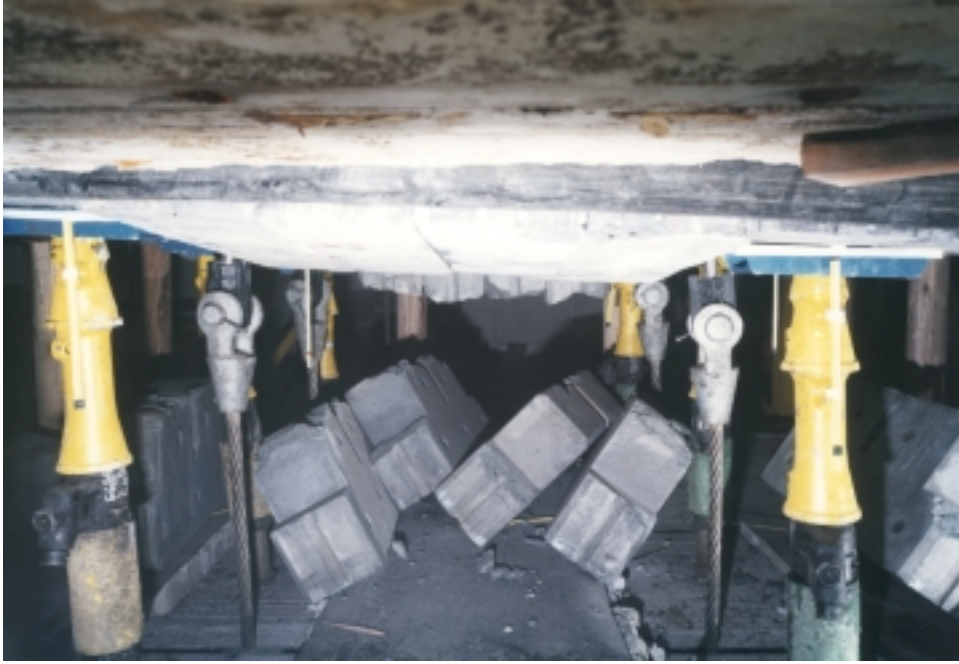
Photograph 5.5 Test # 1, all blocks collapsed except above each 400 mm headboard.

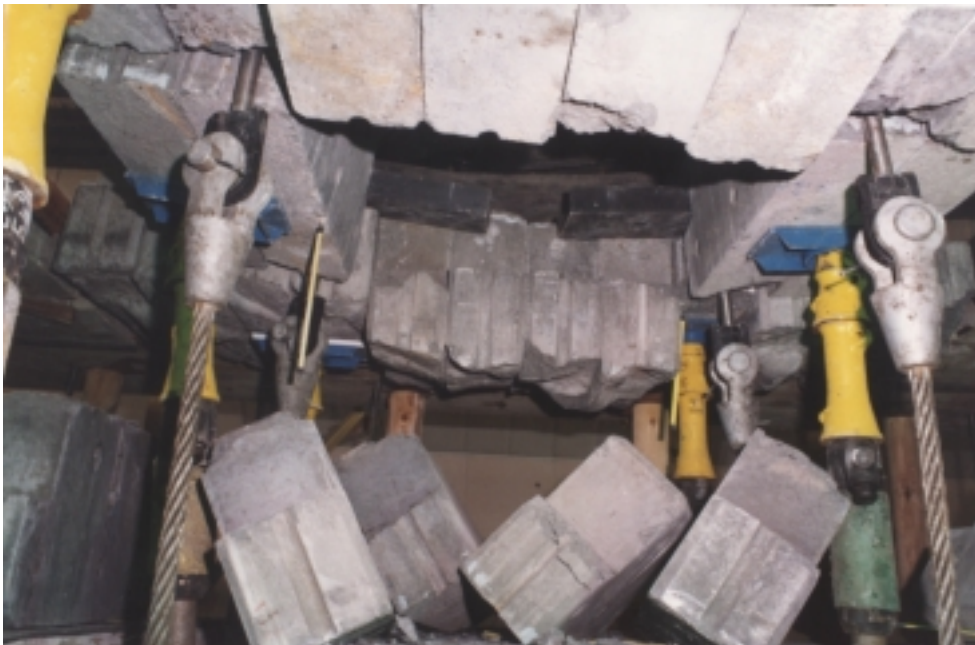
Photograph 5.6 Test # 1, showing significant sliding of centre four blocks in East beam and in West beam.

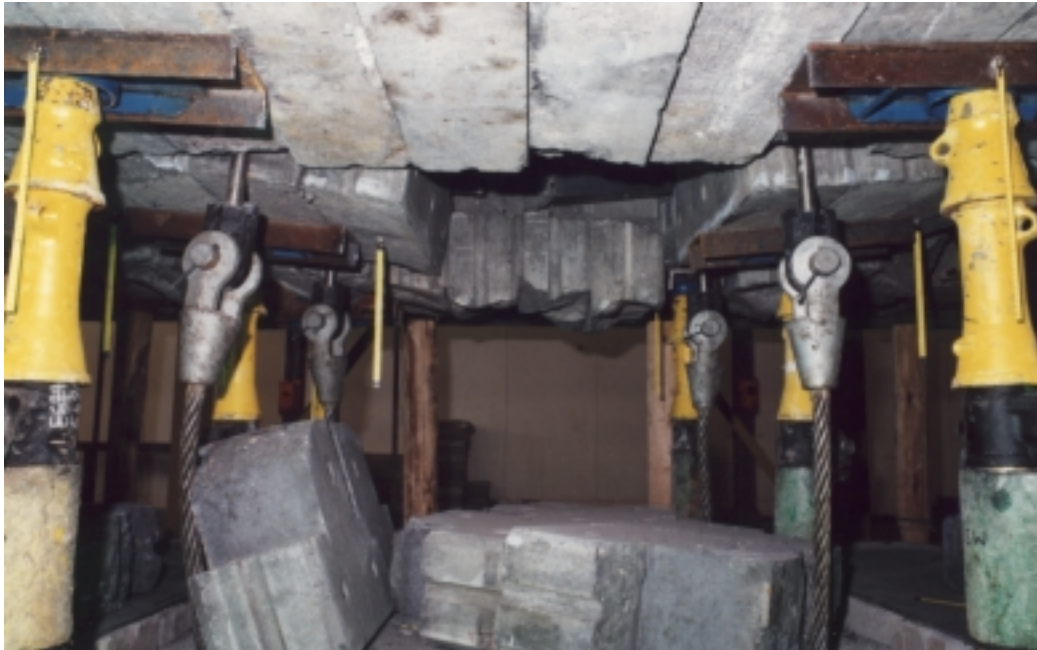
The impulse of 140 kJ caused the collapse of blocks # 1, # 6, # 7, # 8 and # 12. Photograph 5.7 shows that the 50 mm purchase of the South end of the 600 mm northern headboard was sufficient to support block # 5. The counterpart 50 mm 'overlap' of the North end of the southern headboard did not prevent the collapse of block # 8, however. With the loss in clamping force along the length of the three centre blocks, blocks # 1 and # 12 at the extreme ends of the beam also collapsed. The 600 mm long headboards were, not unexpectedly, more effective in maintaining hangingwall stability than the shorter standard headboards.

Photograph 5.7 Test # 2 showing loss of three of the centre roof blocks after 140 kJ impulse which impacted at a velocity of 5,3 ms⁻¹.

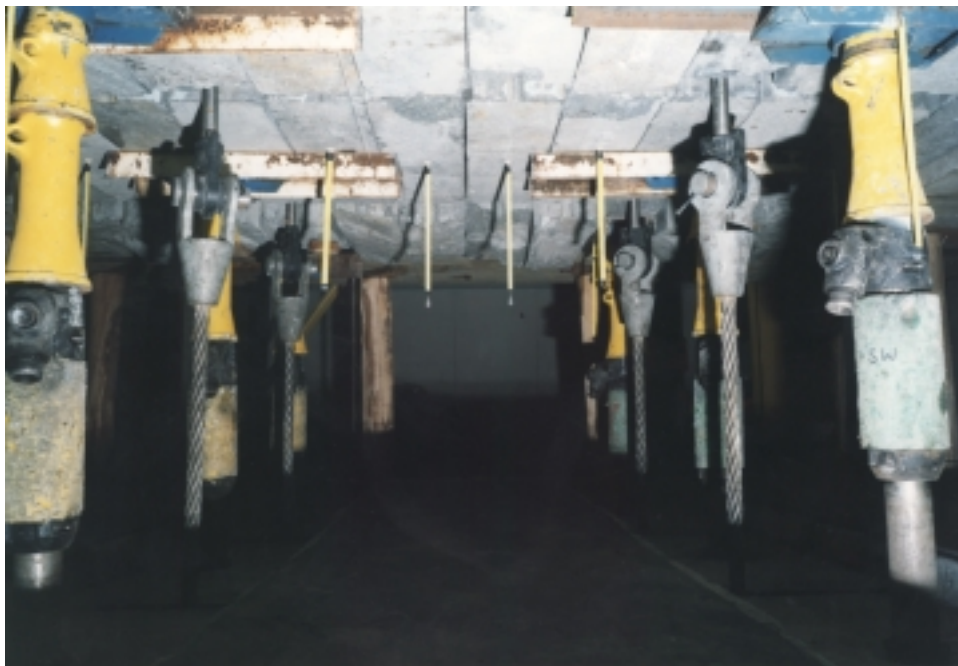
In the final test of this series, the 800 mm long headboards were positioned so as to provide a 50 mm overlap across the outer edges of the two central blocks, # 6 and # 7. This meant that no roof block was completely free of support. In order for the prop axes to be spaced 1,5 m apart consistent with tests # 1 and # 2, the headboards had to be located asymmetrically with respect to the prop axis – Photograph 5.8. The fact that the headboards might be subjected to a degree of rotational moment was not viewed with great concern because, it was argued, such eccentric loading must often occur in reality where the stope roof undulates and may make point contact with the headboard at varying distances from the prop centre-line.

Photograph 5.8 Test # 3, showing asymmetrical location of 800 mm headboards.

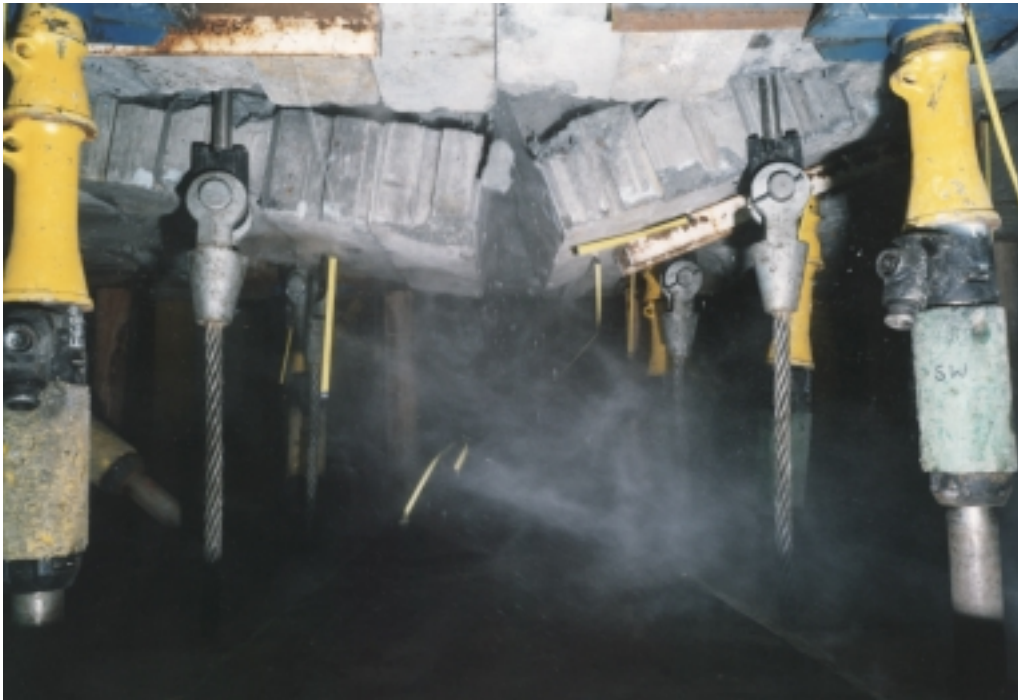
It transpired that the eccentricity proved to be the immediate cause of total collapse. Photograph 5.9 shows that blocks No. 6 and 7 have pulled apart as a result of outward rotation of the two halves of the centre Voussoir beam. The relatively steeply-inclined headboards have caused the tops of the North and South props to slide outwards very rapidly. Photograph 5.9 shows that the northern headboard has disappeared while only the lower portion of the prop is still visible in the lower left corner of the photograph. The top of the southern prop has slid along the headboard and is about to disappear! The final result was that the entire centre Voussoir beam collapsed en-masse throwing the prop and headboard several metres northward – Photograph 5.10.

Photograph 5.9 Test # 3 approximately 50 milliseconds after impulse of 139 kJ with an impact velocity of $5,3 \text{ ms}^{-1}$.

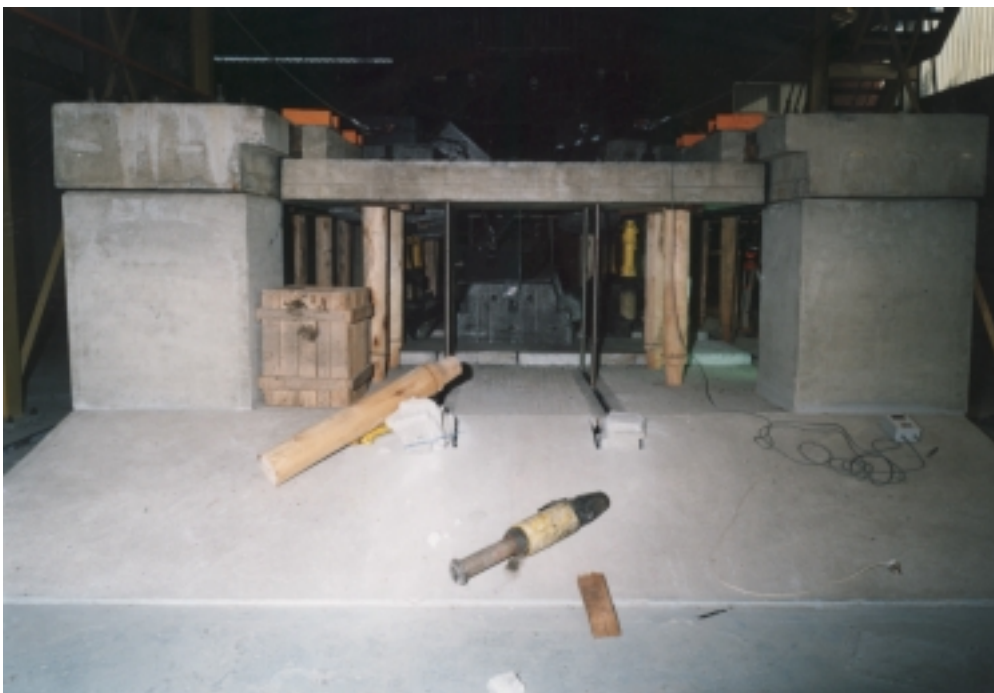
Photograph 5.10 Test # 3, showing collapse of centre Voussoir beam and dramatic ejection of northern prop.

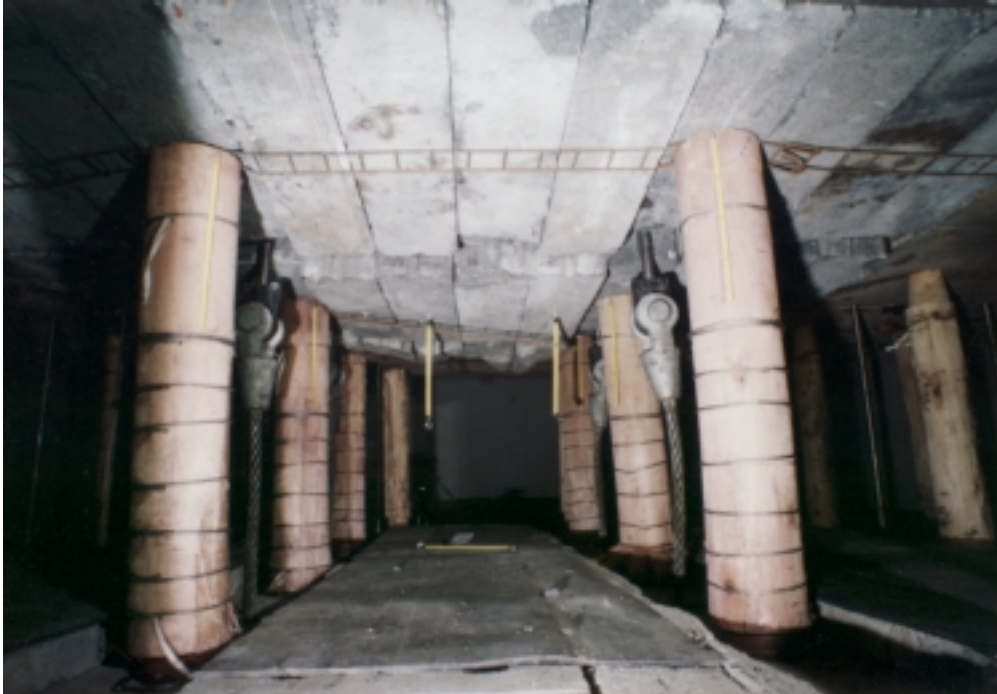
after the second impulse – Photograph 5.11. It is this ‘step’ displacement that imposes the ‘shearing’ strain on the Samson strap. Although the measurements showed, somewhat surprisingly, that the step had decreased with the second impulse (and this was confirmed by careful study of the photographs) the strap broke only after the second energy pulse.

Photograph 5.11 Test # 6 after the second impulse of 88 kJ which impacted at a velocity of 4,3 ms⁻¹.

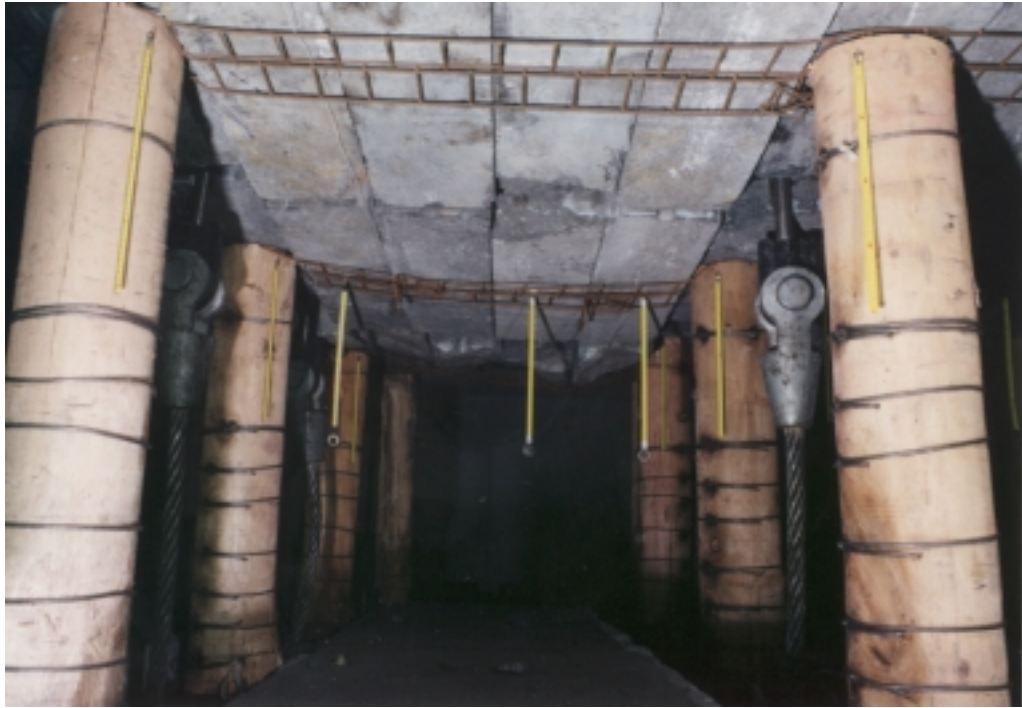
In this test, the props and prop spacing were the same as before but the Samson straps were doubled in a side-by-side arrangement. Each strap had an over-lapped junction at a point somewhere along its length, between the two centre props – see Photograph 5.12.

Photograph 5.12 Test # 7 after third impulse of 147 kJ at impact velocity of $5,4 \text{ ms}^{-1}$.

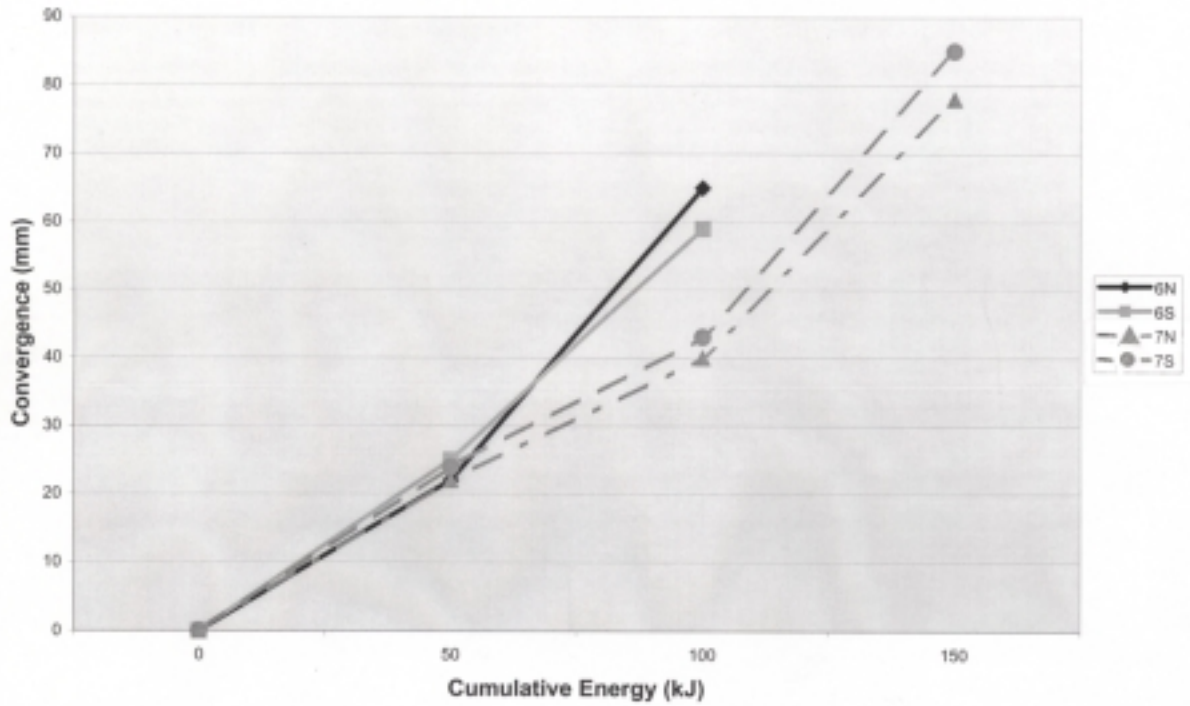
Figure 5.6 Plot of convergence of North and South elongates in test # 6 and # 7

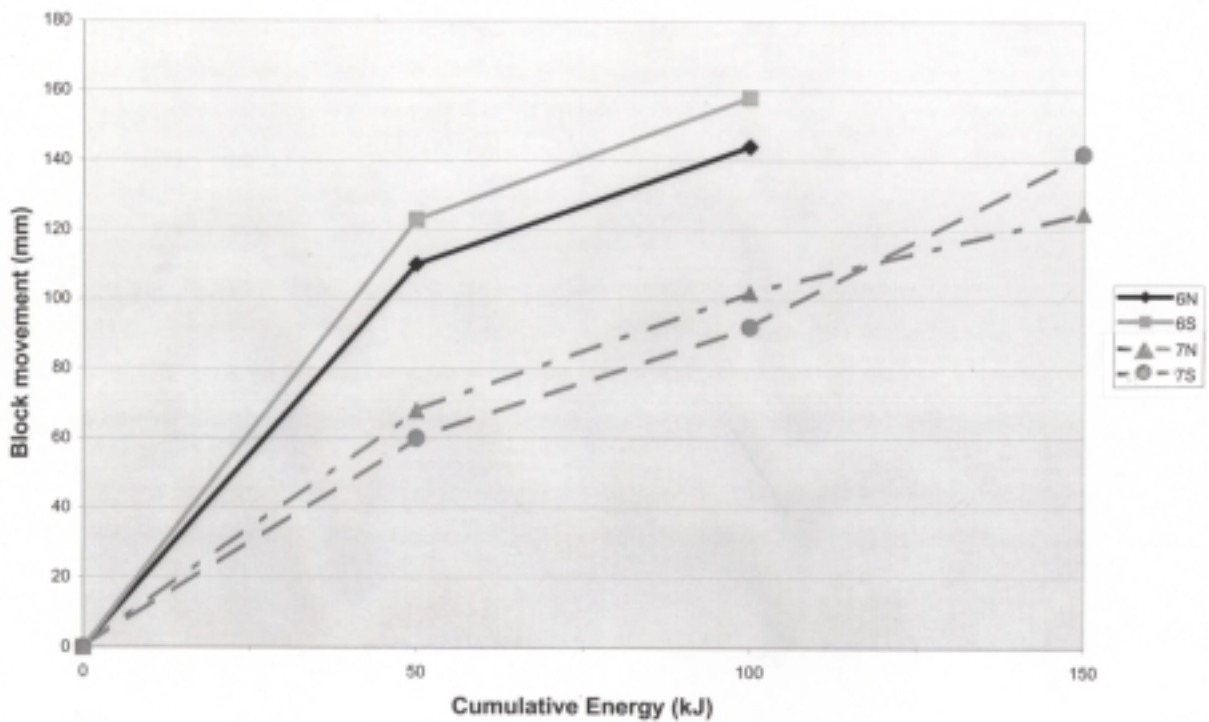
The step displacements of test 7 were significantly less than those of test # 6 for similar pulse energies – see Figure 5.7. This further confirms the indication that the doubled (side-by-side) Samson straps were effective to some extent in preventing collapse of the hangingwall between the point supports.

Figure 5.7 Plot of step displacements adjacent to North and South elongates in test # 6 and # 7.

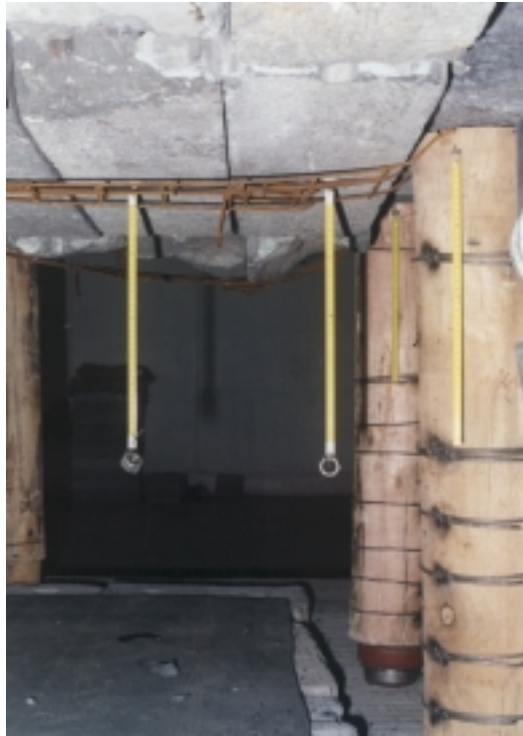
The closer views of the Samson straps in Photograph 5.13 and Photograph 5.14 show that the overlap yielding device came into play at block # 8 adjacent to the South elongate and also at the southern block of the eastern Voussoir beam. This may well have been the reason that the strap survived the 57 mm step displacement experienced against the South prop.

Photograph 5.13 Test # 7 showing 57 mm of step displacement at the southern prop and overlap starting to open.

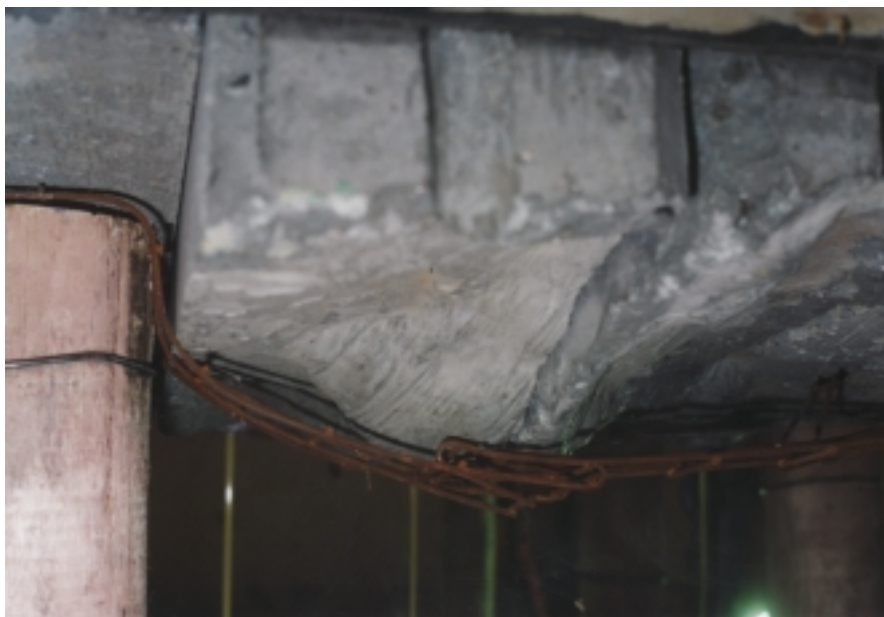
Photograph 5.14 Test # 7 showing close view of the overlap of the Samson strap at the southern end of the East beam.

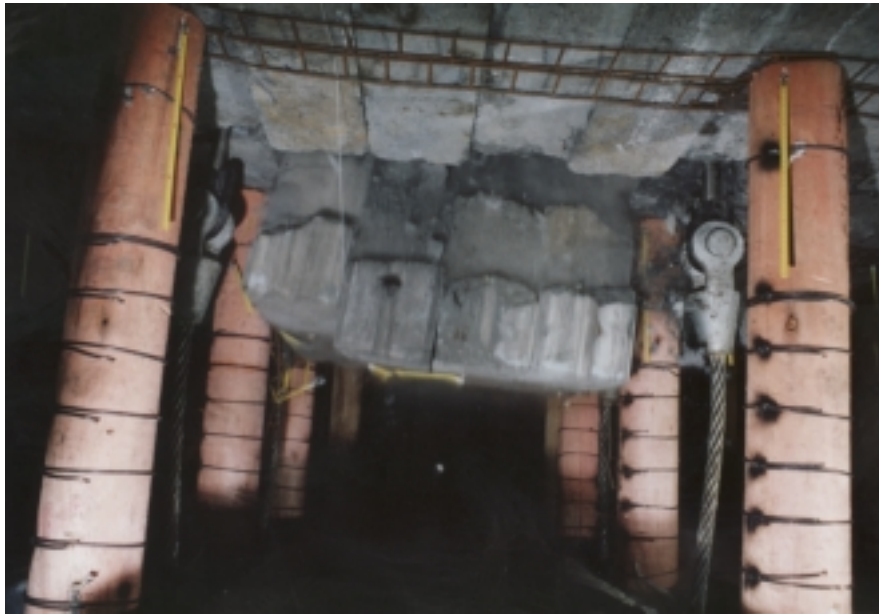
To confirm the above indication, in a further test of the same support elements and configuration, a single impulse of 147 kJ was imparted to the load-distribution pyramid of test # 8. The results of this impulse was that the straps failed and the four centre blocks were dramatically ejected – Photograph 5.15. It appears from a close examination of Photograph 5.16 that the Samson straps most probably pulled apart at their folded overlap as they can be seen draped down along the North and South elongates.

Photograph 5.15 Test # 8 some 200 milliseconds after impact of 147 kJ impulse at a velocity of 5,4 ms⁻¹.

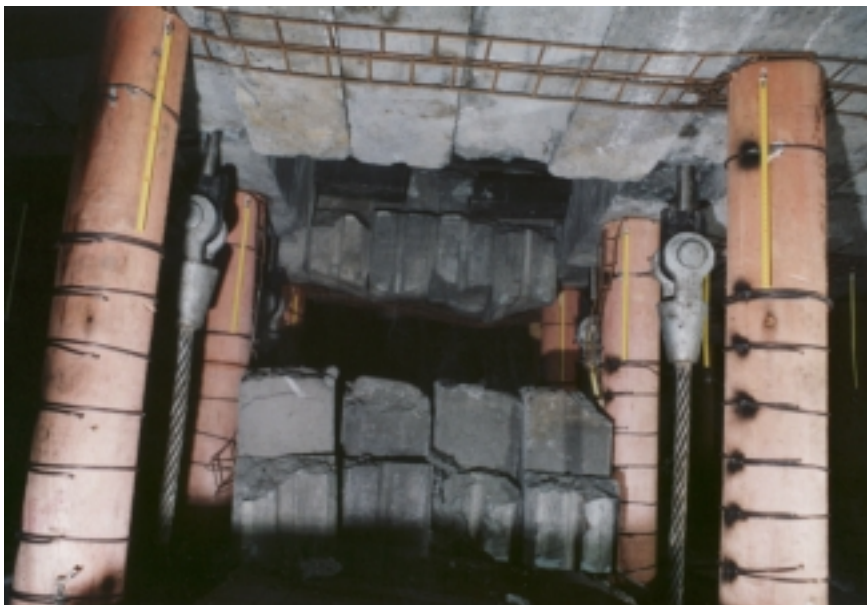
Photograph 5.16 Test # 8 indicating that Samson straps pulled apart at central overlap.

It appears from this comprehensive collapse that the energy losses accompanying the second and third impulses were greater than estimated and that the 'one-blow' equivalent of the 284 kJ total accumulated from the three impulses of test # 7 was, in fact, less than the 147 kJ imparted to test # 8 which caused the complete collapse.

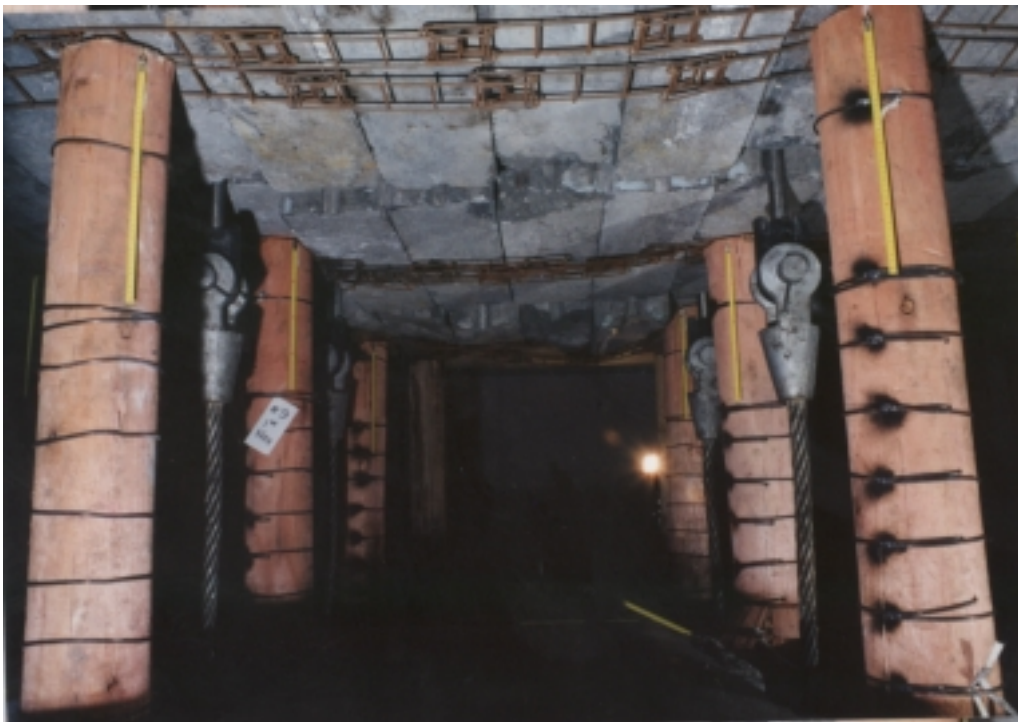
Photograph 5.17 shows that the first energy impulse of 83,5 kJ did not cause any unfolding of the overlap connection. Convergences of 28 mm and 64 mm resulted at the North and South elongates respectively with rather small step converges of about 40 mm and 20 mm respectively in the roof profile adjacent to the props.

Photograph 5.17 Test # 9 showing en masse movement of centre four blocks after the first impulse of 83,5 kJ with no visible unfolding of Samson strap overlap.

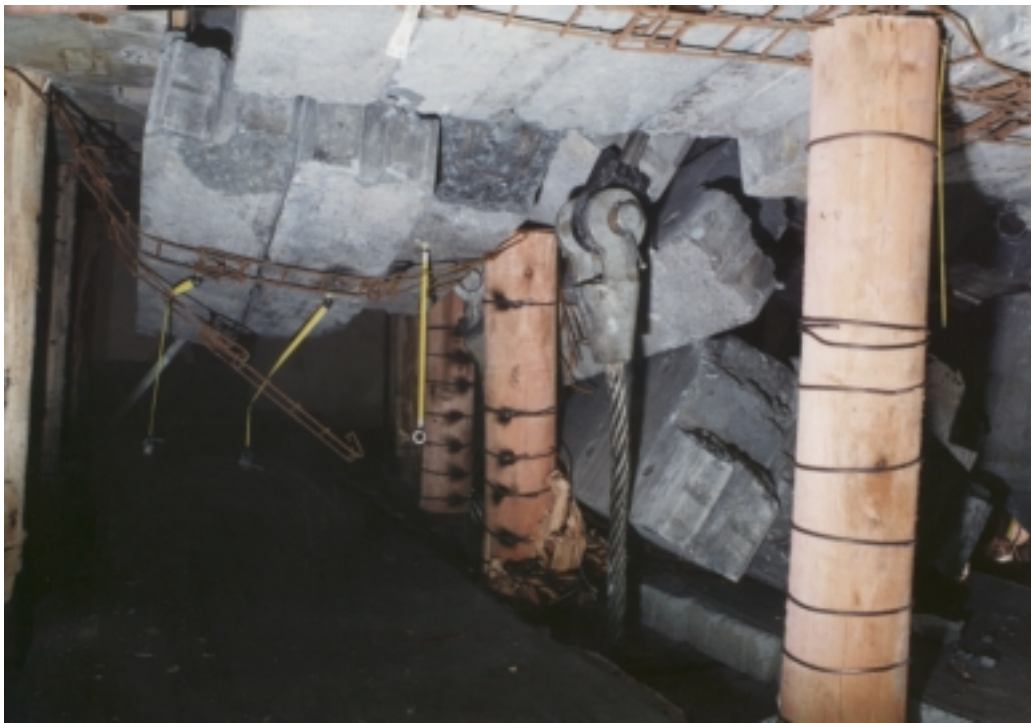
The second impulse of 196,4 kJ caused complete collapse of the four unsupported blocks and large displacements of the end blocks. Photograph 5.18 shows that blocks # 1, # 2 and # 3 experienced large step displacements, presumably when the clamping force dropped to zero. One of the Samson straps extending across the North end of the Voussoir beam to the elongate under the outer deck, has yielded partially but is supporting the weight of three blocks (about 7,5 kN). The other strap has pulled apart at the overlap and is hanging free.

Photograph 5.18 Test # 9, after the second impulse of 196,4 kJ at an impact velocity of $6,2 \text{ ms}^{-1}$. View of North elongate showing one Samson strap pulled open while the other appears to have helped support blocks 1, 2 and 3.

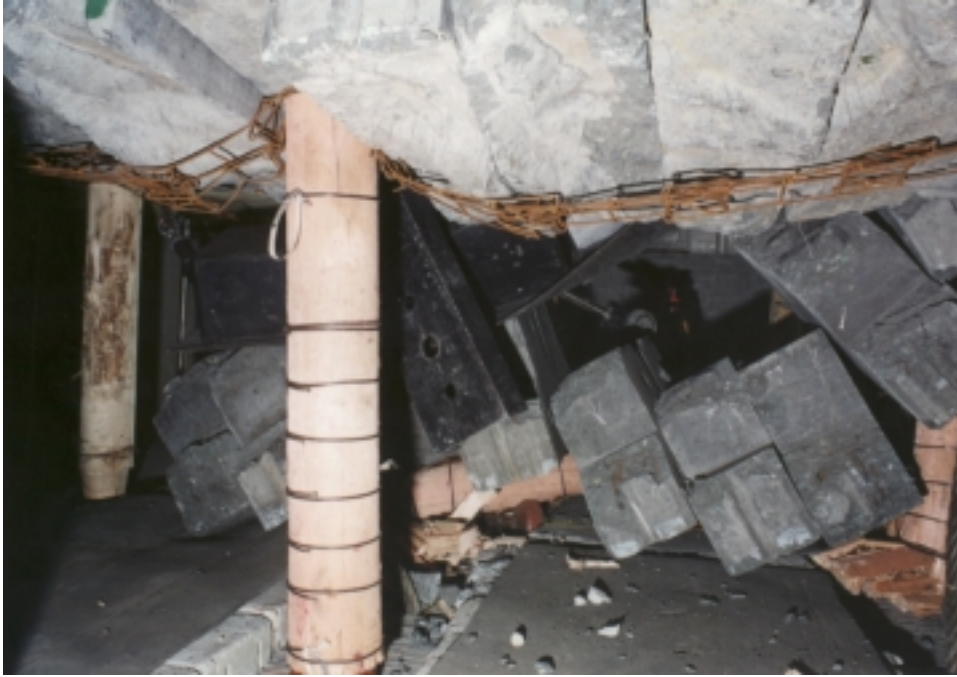
The reason for the complete collapse becomes evident from a study of Photograph 5.19. The yielding device at the base of the North elongate of the centre beam failed asymmetrically causing the elongate to lose its resistance abruptly and its top end to shift laterally towards the North. The southern elongate then toppled inwards to dramatically remove the last vestige of support. It is very probable that the Samson straps linking the North and South elongates and, importantly, those linking the South elongate to the fixed upper deck would have pulled apart early in this failure process.

The failure mode in this instance underlines the importance that all the support units in each strike-orientated line, must remain linked together throughout the convergence episode.

Photograph 5.19 Test # 9, after complete collapse resulted from asymmetrical ‘point-brush’ failure of base of North elongate.

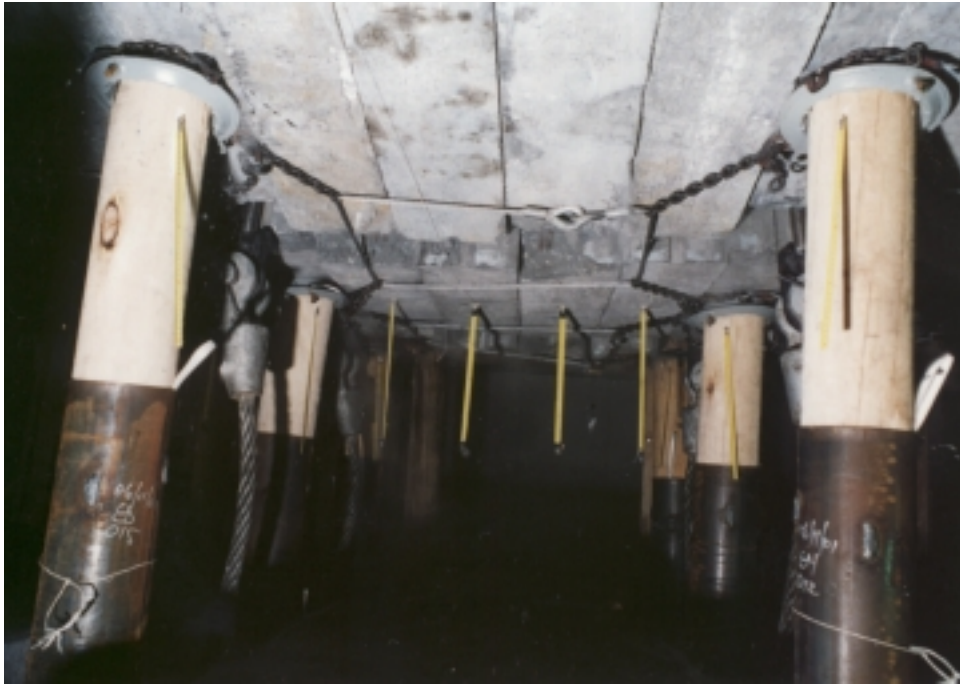
Photograph 5.20 Test # 10 shortly after impact of 88 kJ impulse at velocity of $4,2 \text{ ms}^{-1}$.

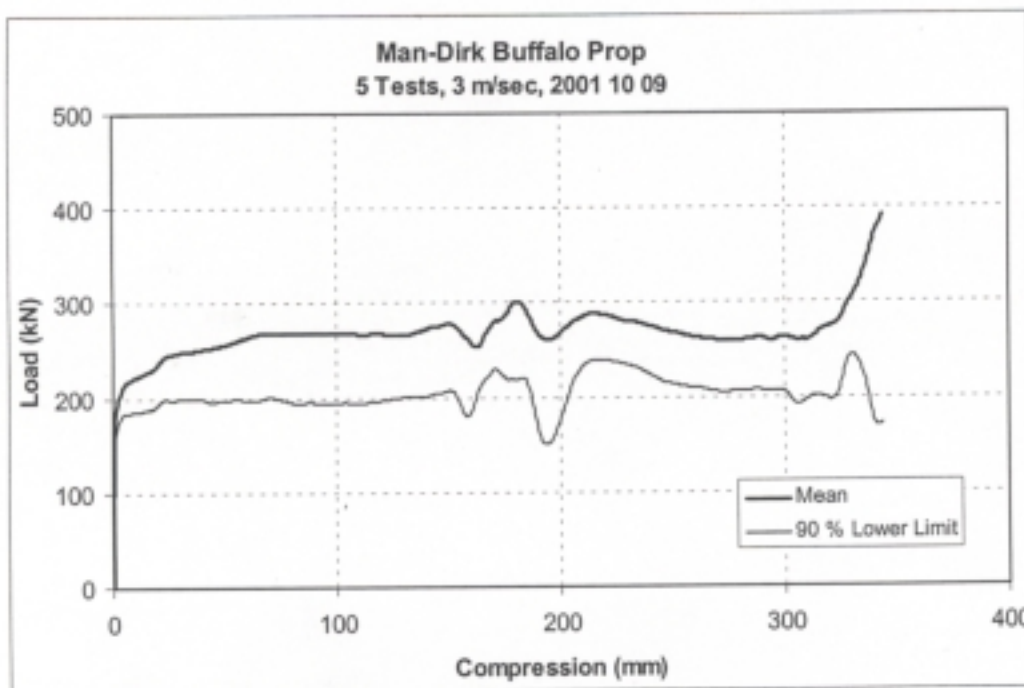
Convergences of 122 mm and 80 mm were caused in the North and South props by the first drop and 193 mm and 176 mm by the second drop, respectively. The corresponding absorbed energy amounts, determined from the manufacturers load-distribution curves (Figure 5.9), were 24 kJ and 15,8 kJ in the case of the first impulse and 38 kJ and 35 kJ in the case of the second impulse.

Figure 5.9 *Dynamic load characteristics of Buffalo timber elongate.*

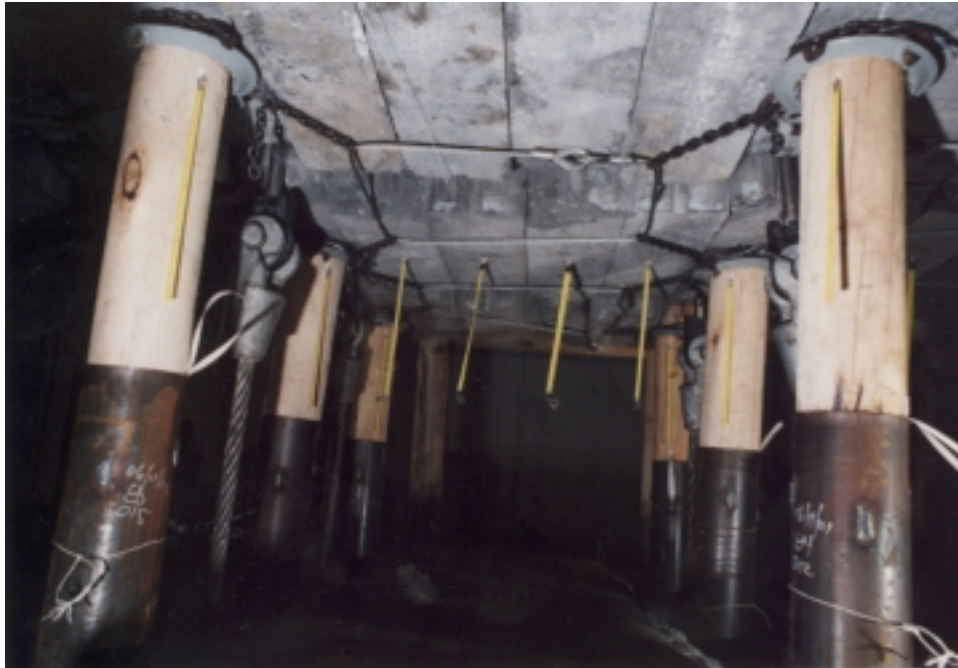
After the second impulse of 147,3 kJ (1,5 m drop height), the block displacements were again very similar, ranging between 207 mm and 234 mm and again only about 30 to 40 mm greater than the convergences on the adjacent timber elongates – Photograph 5.21.

Photograph 5.21 Test # 10, shortly after second impulse of 147 kJ impacted at velocity of 5,4 ms⁻¹.

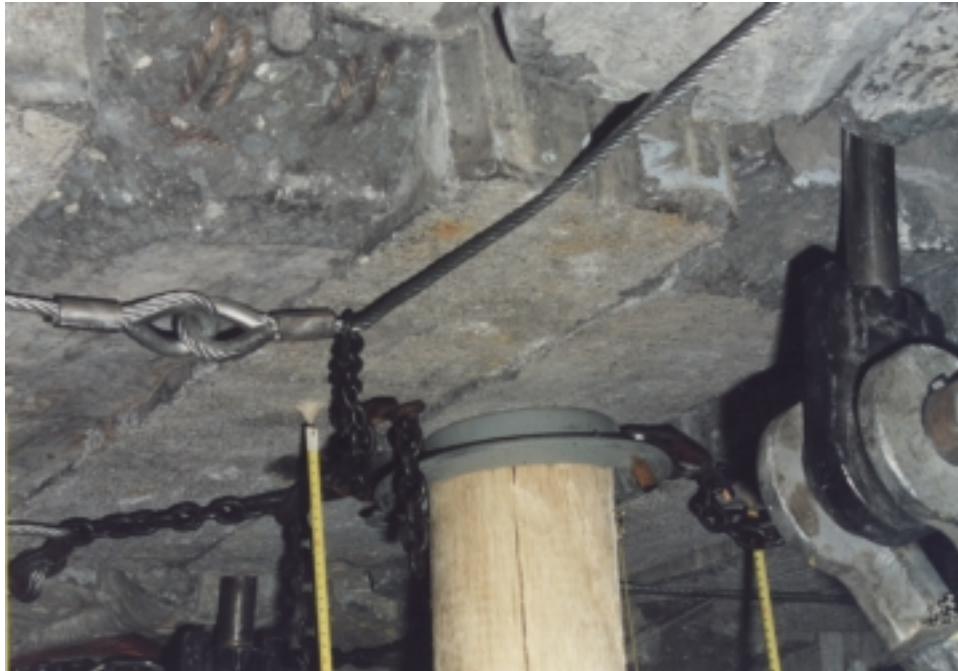
Although it seemed likely that the presence of the collar-and-web device had prevented collapse of the four centre hangingwall blocks, once again there was relatively little step displacement to impose significant strain on the various components of the linking device. The collar around the PSU of the North centre-beam prop had somehow become loose – Photograph 5.22. This had the effect of relaxing the adjacent webs, further reducing the straining of the linking device. This meant that its effective capacity was still undetermined.

Photograph 5.22 Test # 10 showing loosened collar around North prop.

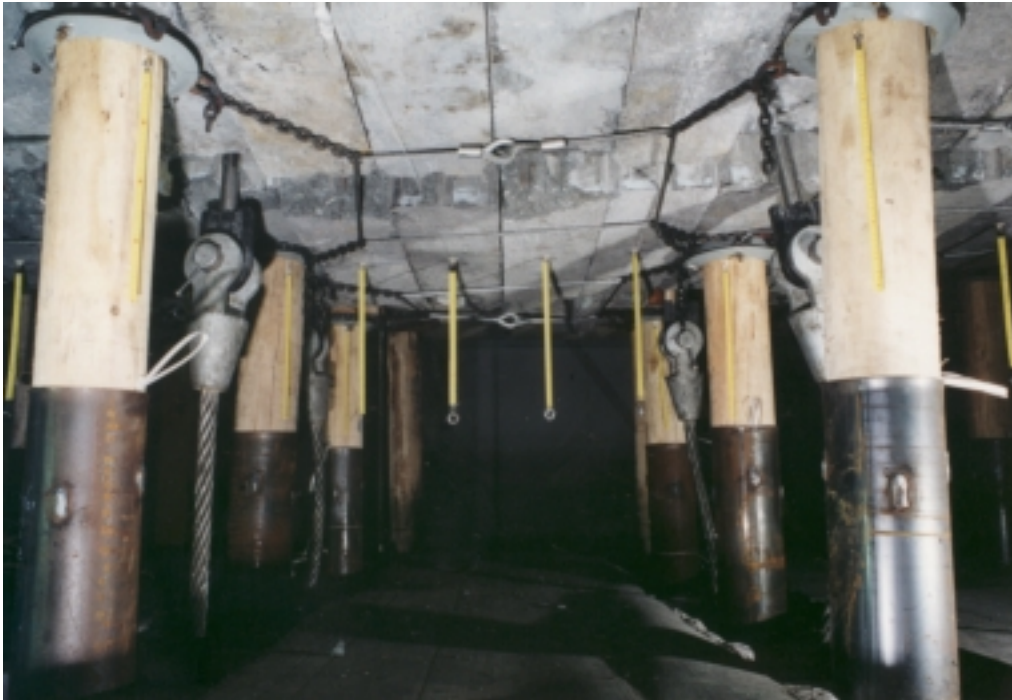
The displacements of the centre four blocks ranged from 149 mm to 183 mm which was 20 mm to 48 mm greater than the convergences of the adjacent elongates. Once more the step displacements were so small as to have exposed the chain linkages to relatively low amounts of straining. This is evident from Photograph 5.23, which is barely distinguishable from Photograph 5.21 of test # 10.

Photograph 5.23 Test # 11 after first impulse of 147 kJ at impact velocity of 5,4 ms⁻¹ showing small step displacements similar to those of test # 10 (Photograph 21).

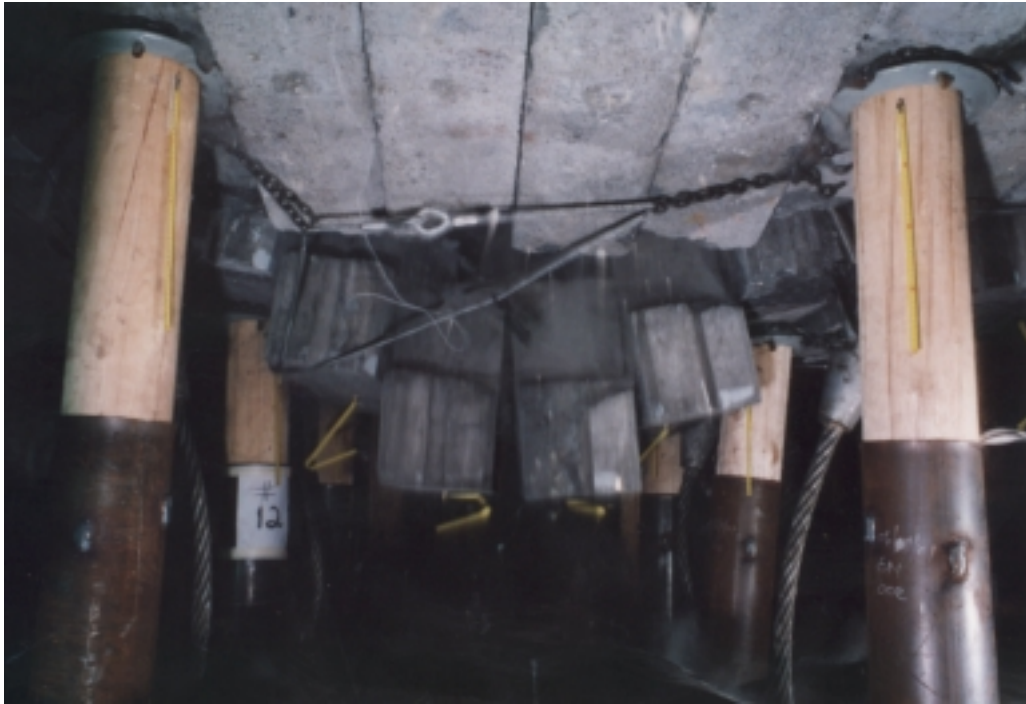
Photograph 5.24 Test # 12 shortly after impact of first impulse of 290 kJ at velocity of 7,5 ms⁻¹.
