Safety in Mines Research Advisory Committee

Final Project Report

Extended use of the Savuka dynamic test facility to improve material and analytical technology in deep-level stope support

Research agency : SRK Consulting
Project number : GAP 818
Date : November 2002

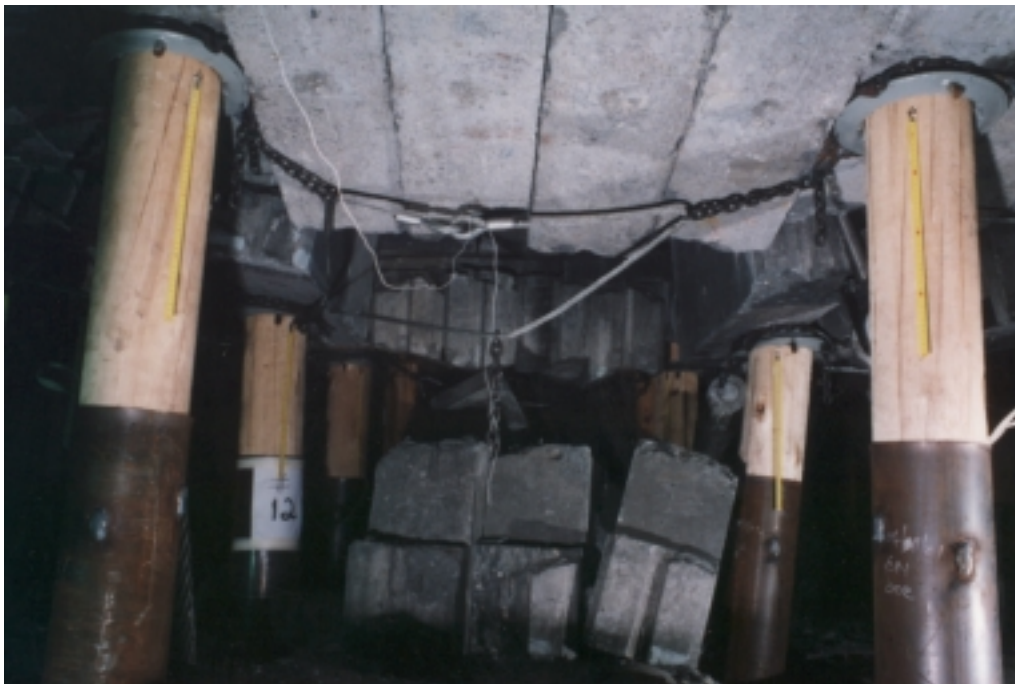
Photograph 5.25 shows that the chains and wire ropes of the 'web' portion of the prop-linking device were undamaged. Failure of the system was due to spreading of the 'button-hole' in the 6 mm thick steel latching segment of the collar – see Photograph 5.26. A minor change in configuration of this element would considerably increase the probability that even violent collapse of the rock between prop-type supports could be contained.

Photograph 5.25 Test # 12, showing collapse of four centre blocks after web link to SE collar pulled free from latch segment.

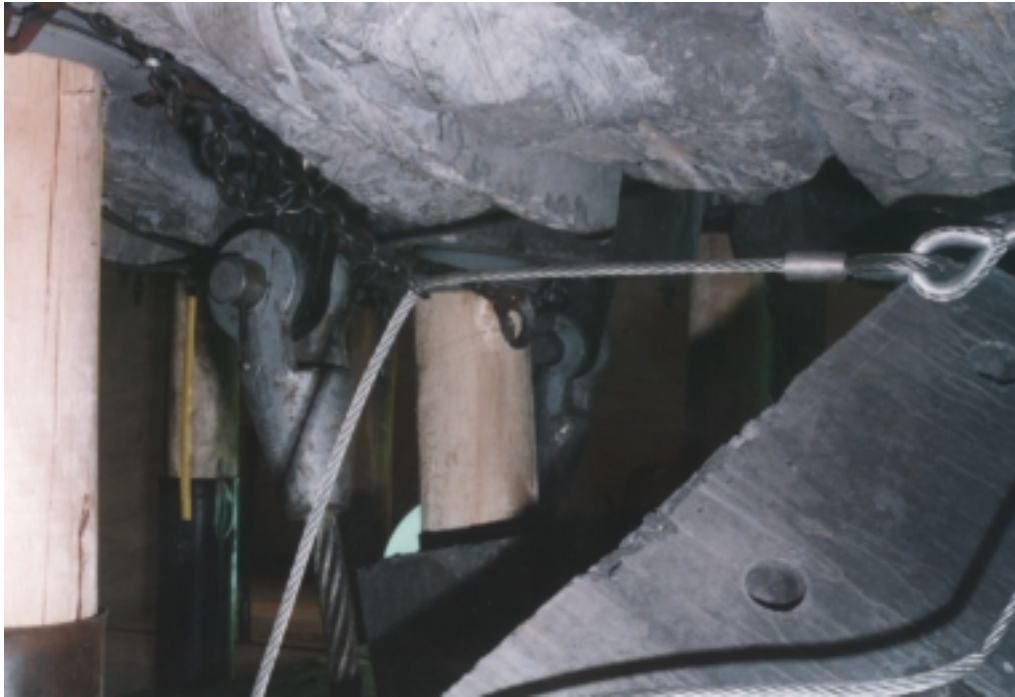
Photograph 5.26 Test # 12, close view of SE collar segment with 'button-hole' stretched open.

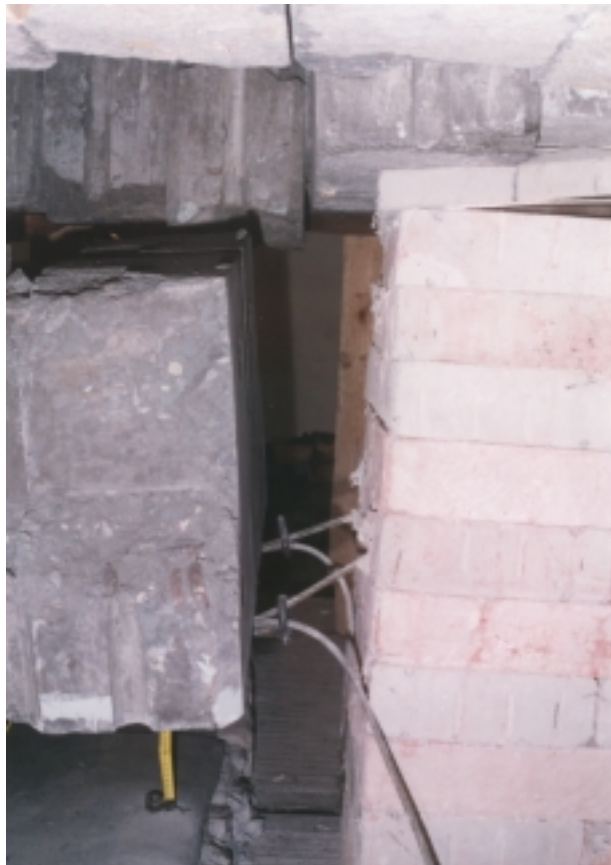
Photograph 5.27 Test # 13, showing tilted blocking layer of South pack.

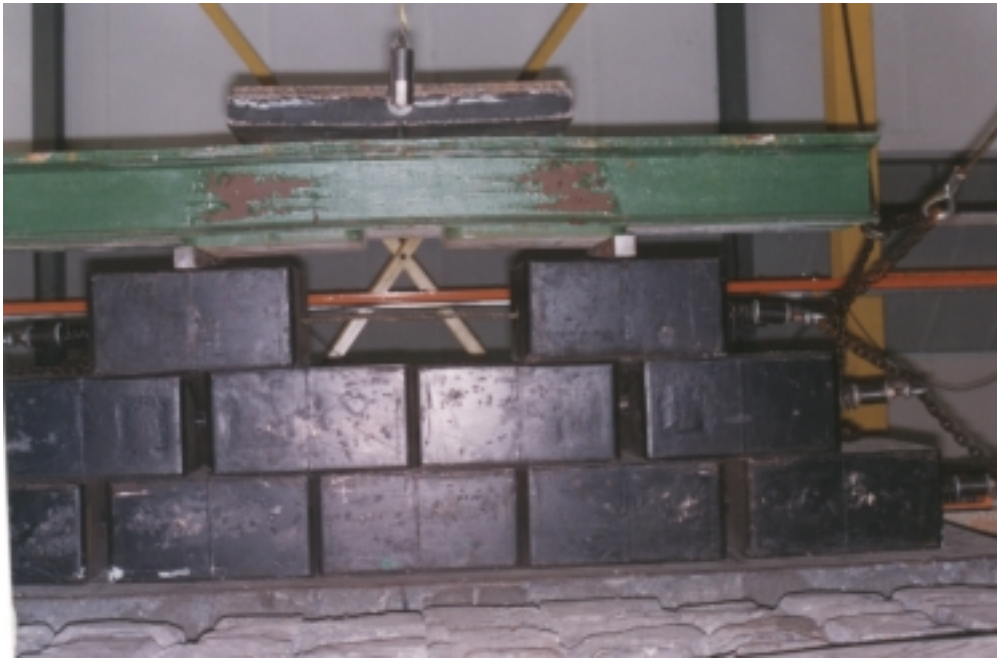
Photograph 5.28 Showing the two-dimensional load-distribution pyramid before impact.

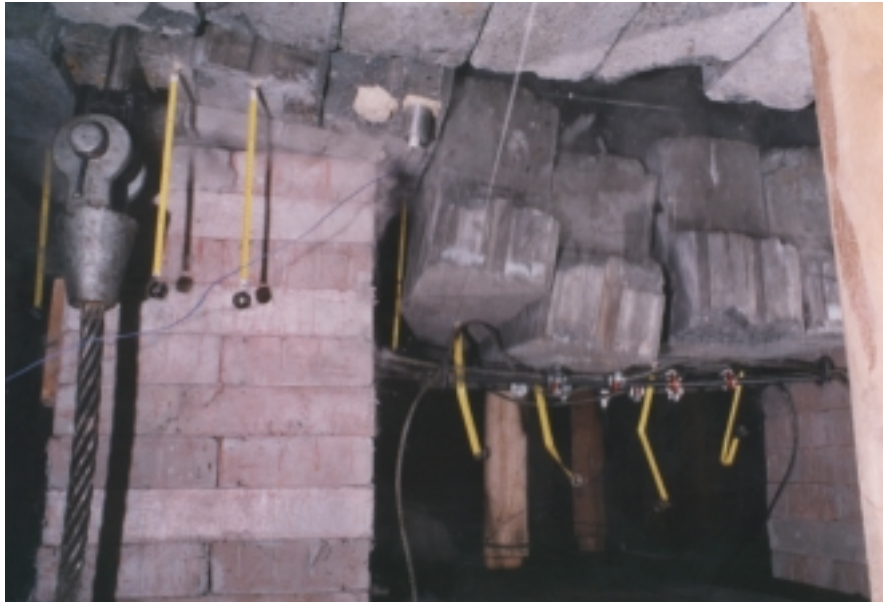
Photograph 5.29 Test # 13, shortly after impact of first impulse of 88,4 kJ at velocity of 4,2 ms⁻¹.

The first impulse of 88,4 kJ imparted to the load-distribution pyramid caused complete collapse of the four centre hangingwall blocks with the original clamping force of 230 kN dropping to zero. The crumpled tapes show that the hangingwall blocks are falling at a velocity significantly higher than that due to gravity, and are about to make contact with the arrester device. The blocks were brought to a stop after about 200 mm of further movement – Photograph 5.30 – with the arrester ropes cutting deeply into the seventh pack layer – Photograph 5.27. The extent of disarrangement of the pyramid as a result of the collapse of the roof-beam below is shown in Photograph 5.31.

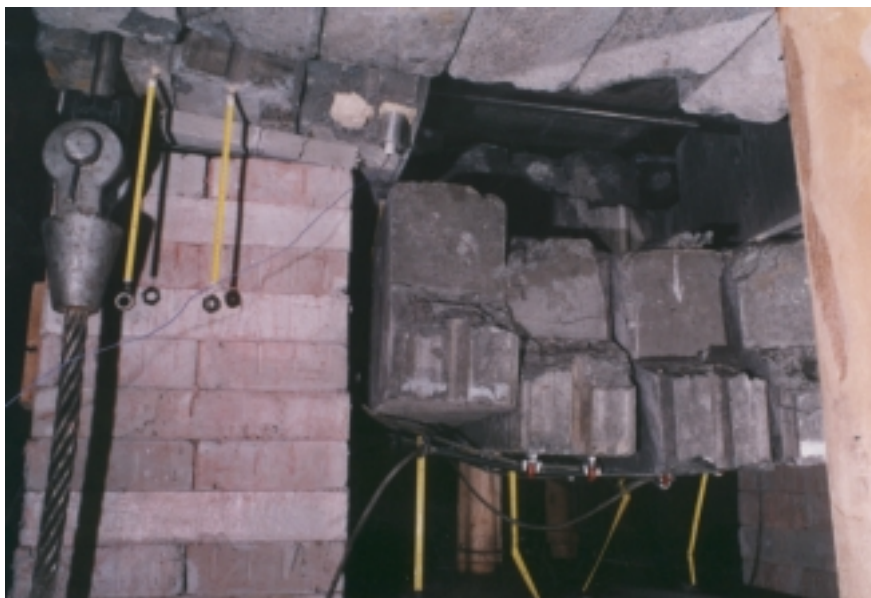
Photograph 5.30 Test # 13, showing arrested centre blocks.

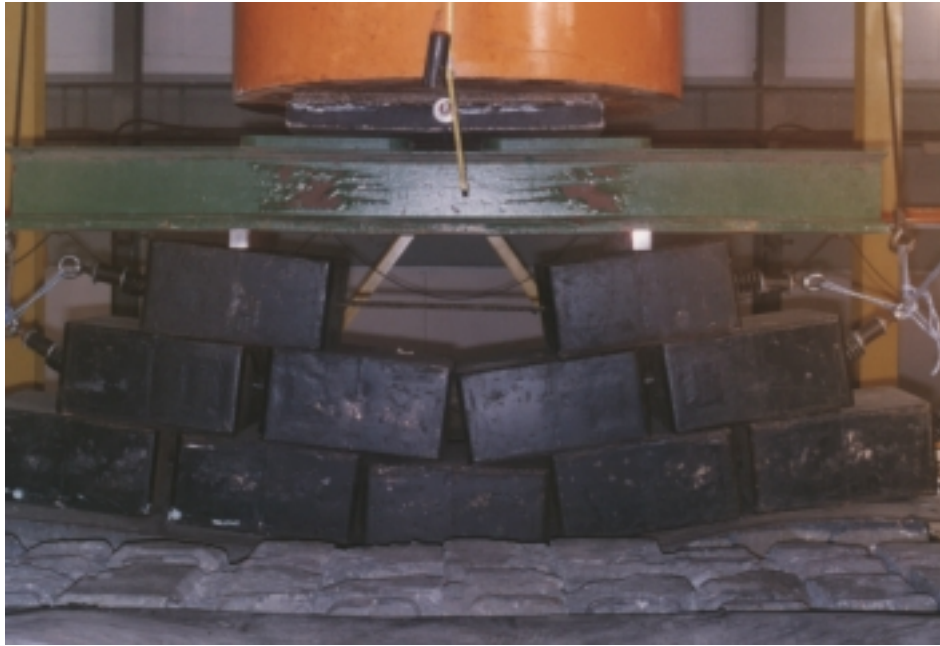
Photograph 5.31 Test # 13, showing disarrangement of two-dimensional pyramid after impact of 88,4 kJ.

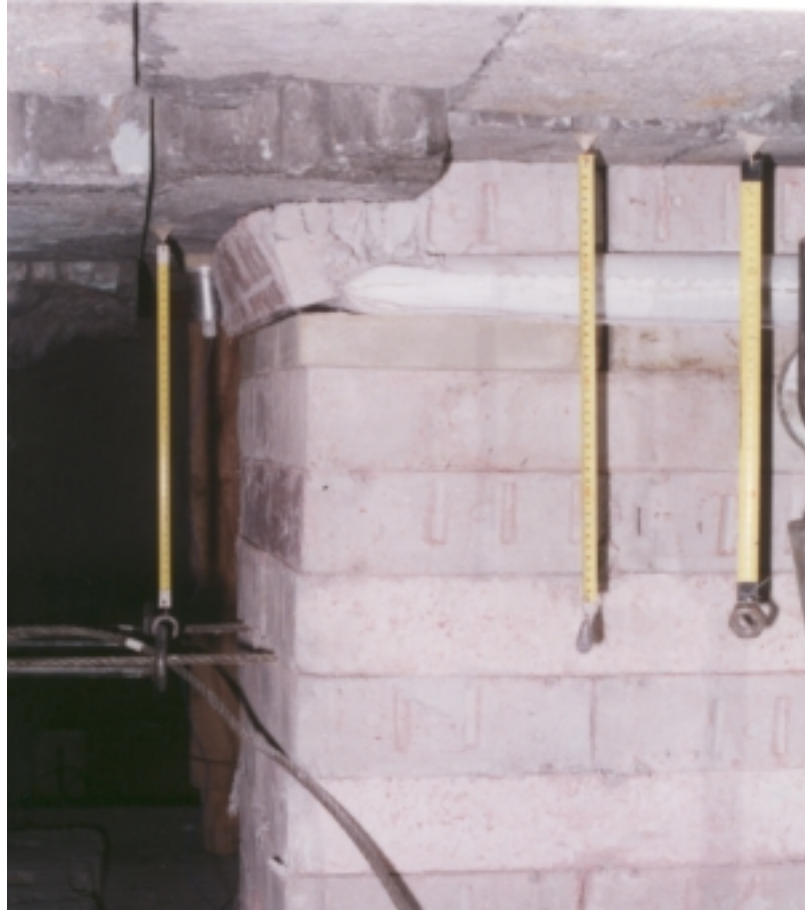
Photograph 5.32 Test # 14, showing no tilting at uppermost layer of South pack after first impulse of 88,4 kJ at a velocity of 4,2 ms⁻¹.

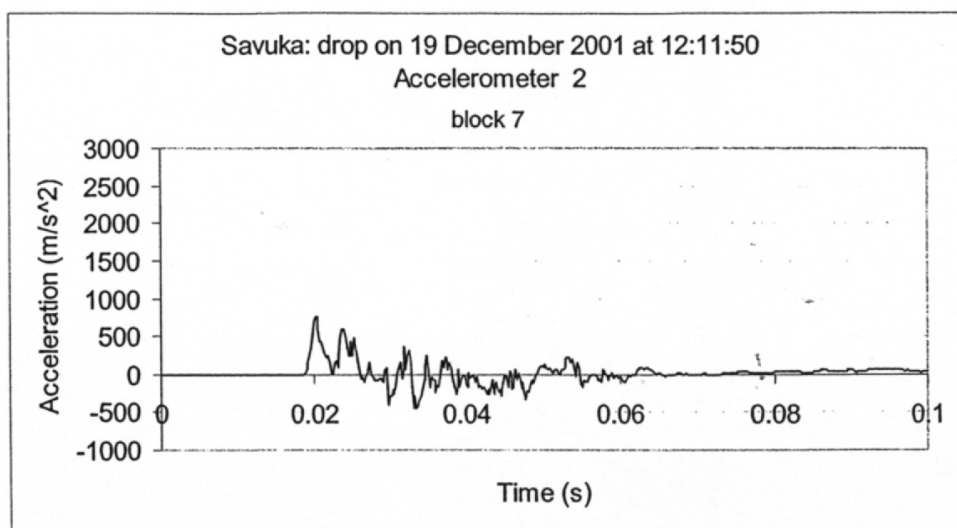
Figure 5.10 *Accelerogram recorded by A2 from drop # 1*

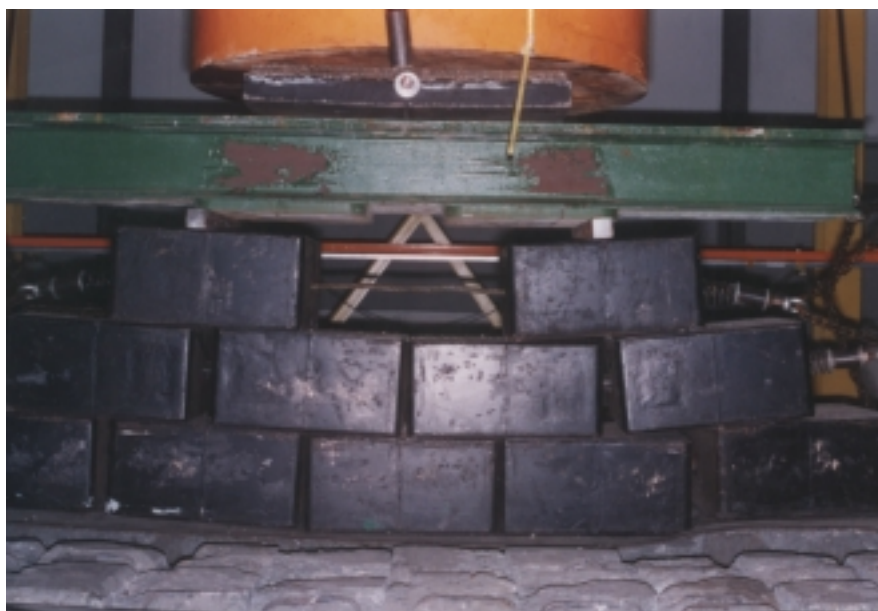
Photograph 5.33 *Test # 14, showing relatively little disarrangement of load distribution pyramid after first impulse.*

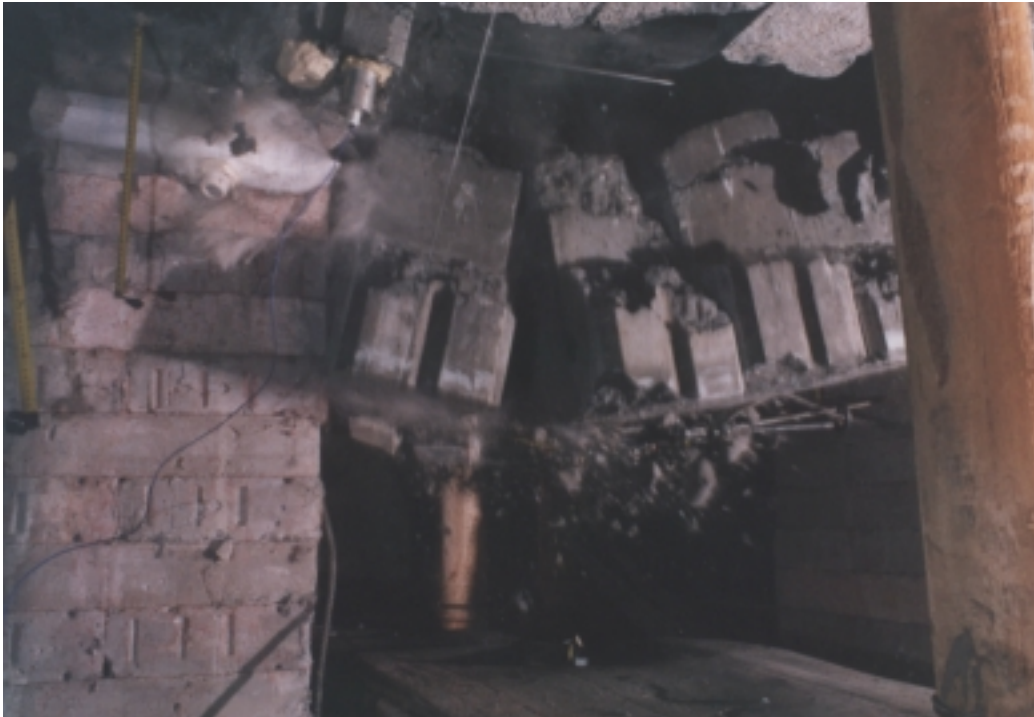
The second impulse of 147 kJ, impacting at a velocity of $5,4 \text{ ms}^{-1}$, caused the violent ejection of the four unsupported roof blocks (see Photograph 5.34) and further compression of the packs to total 66 mm at the North and 51 mm at the South. There was some indication that the second energy transfer through the pyramid was possibly more efficient than that following the first impulse, inasmuch as the three-fold increase in impulse energy produced a four-fold increase in energy dissipated in deformation of the support.

Photograph 5.34 Test # 14, shortly after impact of second impulse of 147,3 kJ at velocity of $5,4 \text{ ms}^{-1}$. Accelerometer visible on block 4 gave velocity estimate of $3,3 \text{ ms}^{-1}$.

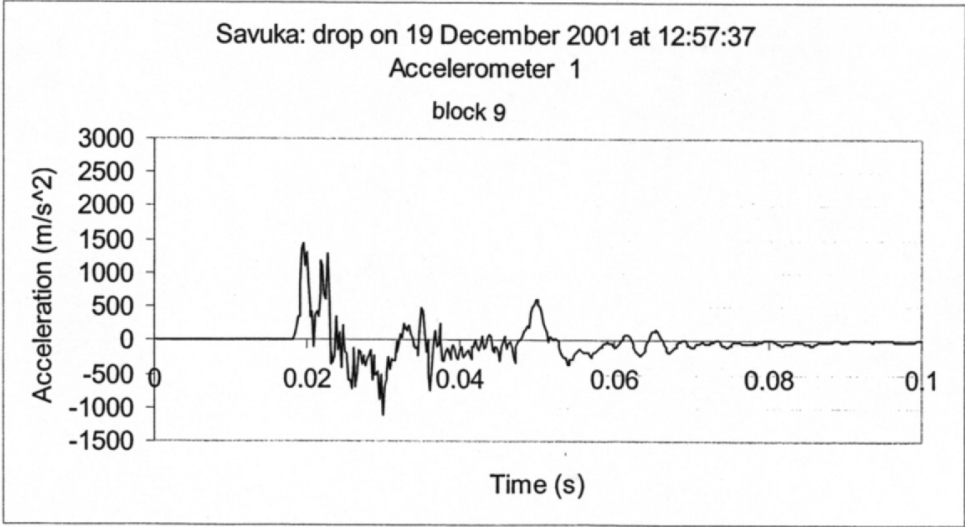
Figure 5.11 Accelerogram recorded by A1 from drop # 2.
