# **PROBLEMS EXPERIENCED WITH THE CONSTRUCTION OF CEMENT AND LIME STABILIZED LAYERS AND WORKING SOLUTIONS FOR THESE PROBLEMS**

P B Botha  
Transportek, CSIR, Republic of South Africa  
pbotha1@csir.co.za  
C J Semmelink  
Construction Problem Solutions cc, Republic of South Africa  
conprosol@lantic.net  
J Raubenheimer  
Raubex, Republic of South Africa  
raubex@roadworks.co.za

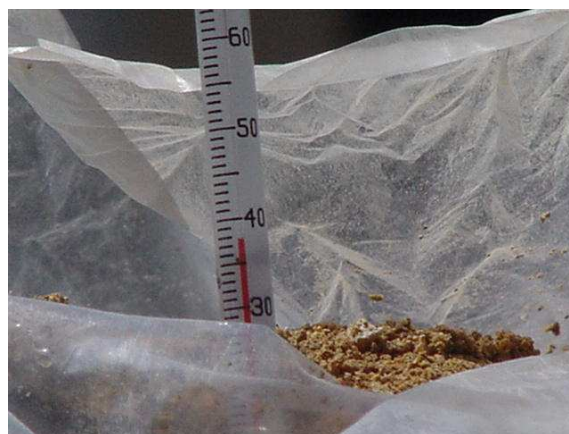
Photograph 1: temperature inside Builtcrete sample just before compaction

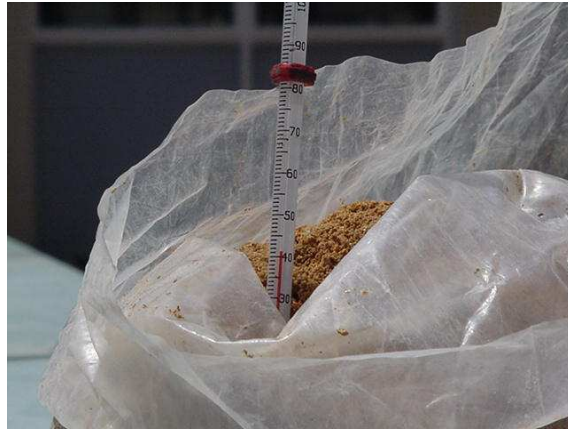
Photograph 2: Temperature inside lime/slag sample just before compaction  
The temperatures were very similar for both stabilized materials.

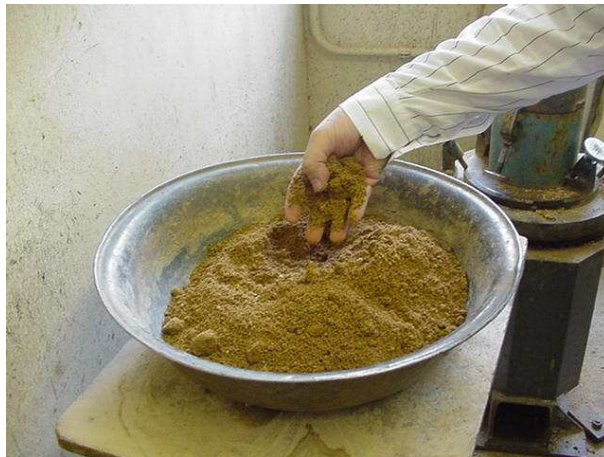
Photograph 3: Four hour lime/slag treated material just before compaction. Notice the loose texture.

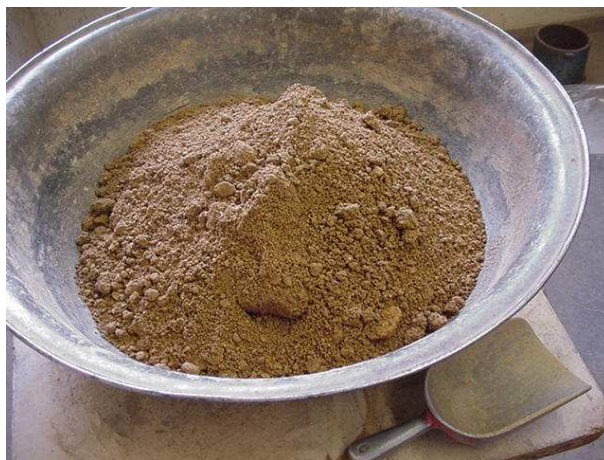
Photograph 4: Four hour Builtcrete treated material just before compaction. Notice more lumpy appearance.

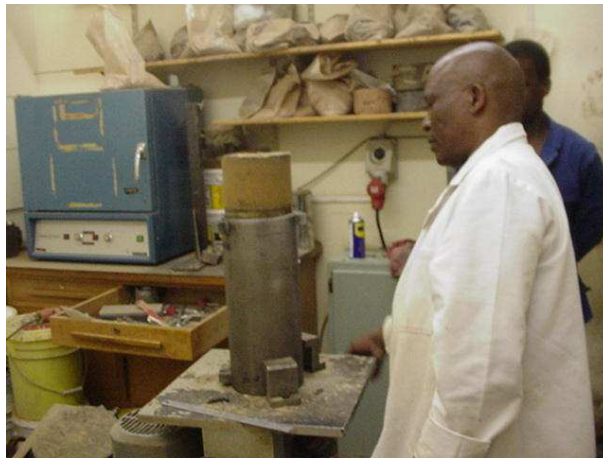
Photograph 5: Extruding the 4 hour Builtcrete sample after compaction on the vibratory compaction table.

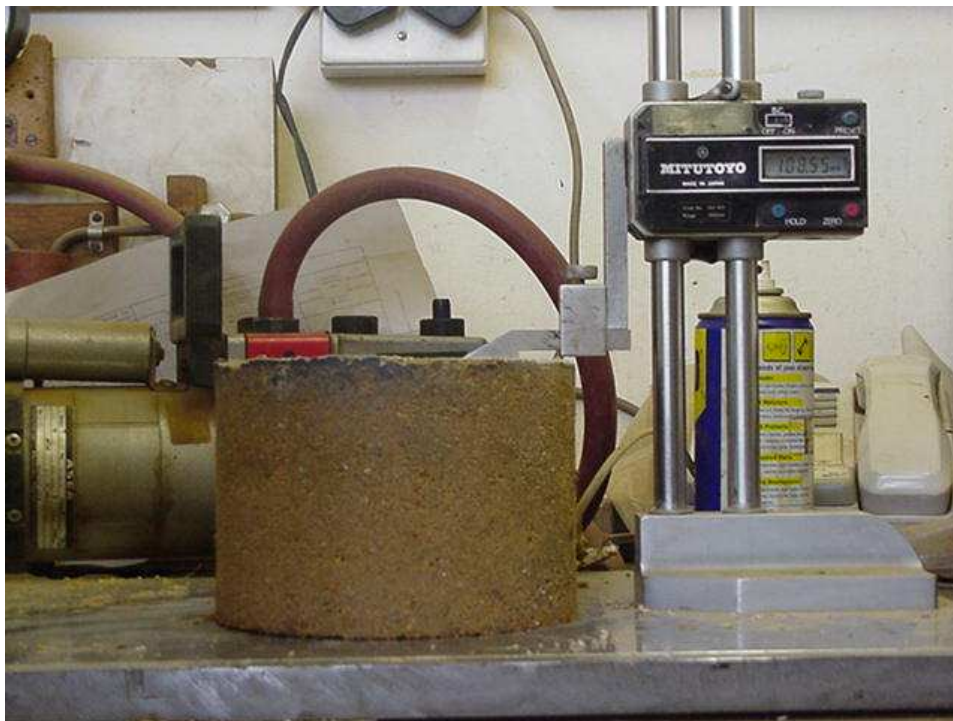
Photograph 6: Measuring height of four hour Builtcrete sample compacted on vibratory table. Notice height reading of 108.55 mm. Sample size was calculated to be approximately 100 mm high when compacted to 100% Mod.AASHTO

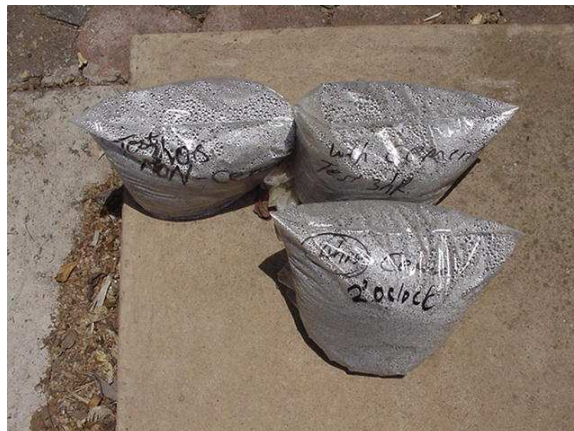
Photograph 7: Modified AASHTO samples exposed to site conditions before compaction

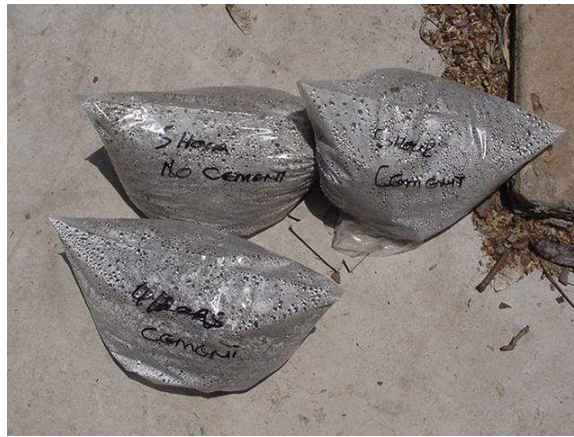
Photograph 8: Vibratory table samples exposed to site conditions before compaction

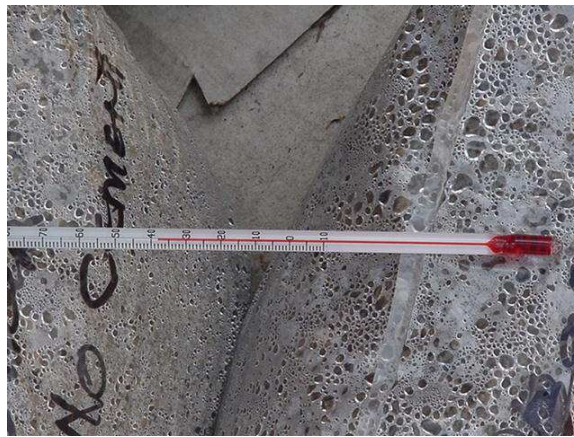
Photograph 9: Temperature measurement on top of samples showing temperature

The dry density of each of these samples was determined. During the time delay the samples were placed in the sun to simulate site conditions as close as possible. Temperature measurements were taken on top of these samples. These showed that although the air temperature was about 28 °C the temperature on the ground actually rose to nearly 40 °C (see Photographs 2 to 4).
