Report: DP-2004/25

**MOVING DYNAMIC LOADS CAUSED BY BRIDGE
DECK JOINT UNEVENNESS - A CASE STUDY**

Author: WJvdM Steyn

Reprinted from the proceedings of the
8th International Symposium on Heavy
Vehicles Weights and Dimensions,
Johannesburg, South Africa, March
2004.

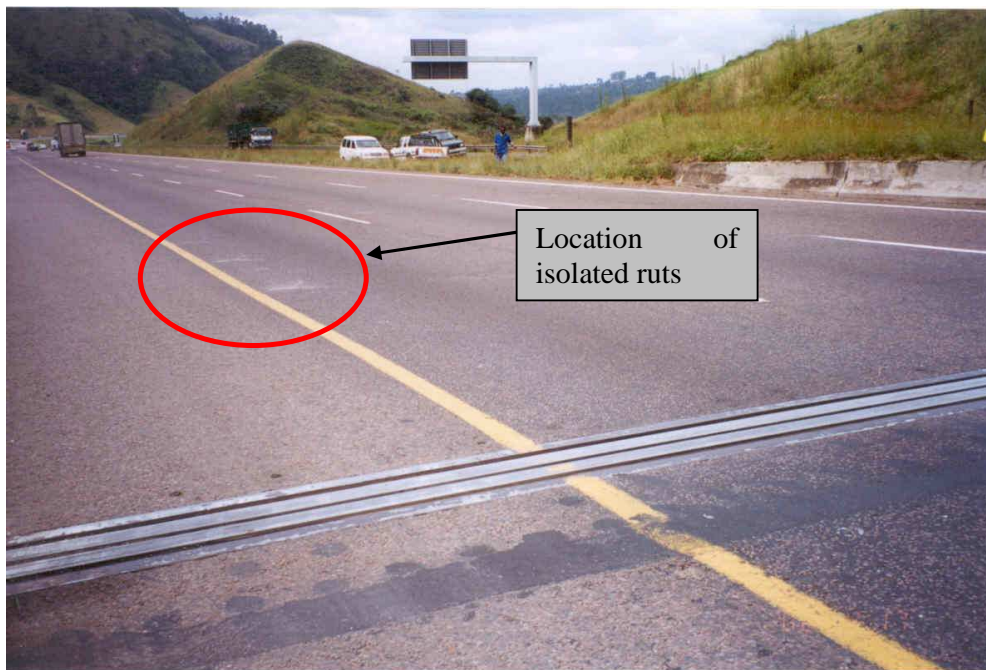
Figure 1: General view of pavement beyond Umthlatuzana South bridge in southern direction showing location of bridge deck joint and location of discrete ruts.

The initial observation of unusual deterioration of the pavement surfacing was made on the slow lane of the N3 South just after the Umthlatuzana South Bridge. In Figure 1 a view of the bridge, the bridge deck joint and the positions of the discrete ruts that developed are shown.

During the investigation the distance between the bridge deck joint and the discrete ruts were measured. It was observed that the distances between the bridge deck joint and the first rut was approximately 8 m, while the distance between the remaining 3 ruts were approximately 2,5 m in each case.

It clearly illustrates the potential increased damage due to “overloaded” conditions generated at specific locations due to the existence of a bridge deck joint standing proud of the surrounding pavement surface. This is an indication of the practical benefit of a good quality control system and workmanship during installation of such joints.

It was shown that a decrease in height of the joint from 10 mm to 5 mm result in a potential 30 per cent decrease in the “overloaded” condition at the location of maximum peak load. This is potentially a major improvement in the life of the pavement surfacing, mainly caused by improved installation of the bridge deck joint.

A further practical use of this information is that it will indicate to road maintenance authorities that maintenance of the rut developed on the pavement is only solving half the problem. In the case illustrated, the main cause of these types of localised ruts is to be found a distance before the physical ruts themselves, i.e. in this case the unevenness of the bridge deck joint.

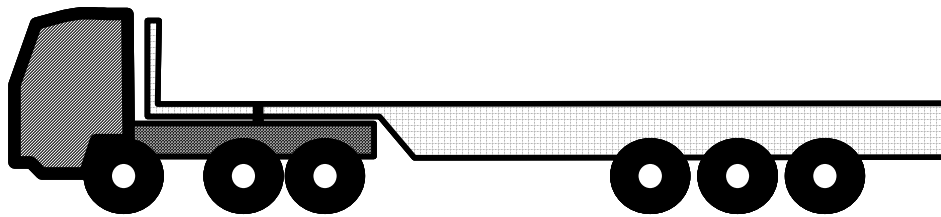
Articulated (123) vehicle

Figure 2: Schematic of vehicle used in TFP simulation.

Typically, the road is being used by articulated (truck-tractor and semi-trailer combination – 123 axles) and 1222 (interlink consisting of truck-tractor and two semi-trailers – 1222 axles) vehicles, and it was decided to model a typical 123 vehicle (Figure 2) as done previously in Steyn (2000). The main vehicle parameters used for the analysis are shown in Table 1 while the road was modelled as a level section of road (400 m long) with a 10 mm unevenness simulating the bridge deck joint.

The heavy vehicle data was simulated using the TFP software (TFP) to determine the moving variable load history of the vehicle. The Tyre Force Prediction Program (TFP) program is a typical program for the analysis of simple vehicle response simulations. TFP is an analytical model of a truck or truck-tractor and semi-trailer combination used to predict the forces that occur between the tyres of the vehicle and the road. In TFP, vehicle response is simulated at constant speed, and no turning or braking manoeuvres or roll effects can be simulated. It is only a two-dimensional vehicle model. TFP (and other similar programs) has been used for many studies available in the literature on vehicle-pavement interaction. Van Niekerk (1992) evaluated TFP for use in simulations of variable vehicle loading and it was found to provide satisfactory results. TFP results were compared with measured variable load data and it gave a reasonable indication of the overall trend of the dynamic axle masses. The output from this analysis is shown in Figures 3 and 4.

Each axle of the in suspension system in TFP is modelled as an independent 2-spring suspension connected to the unsprung mass of the axle, wheels, and wheel support hardware. Also included in the model are viscous damping and coulomb damping.

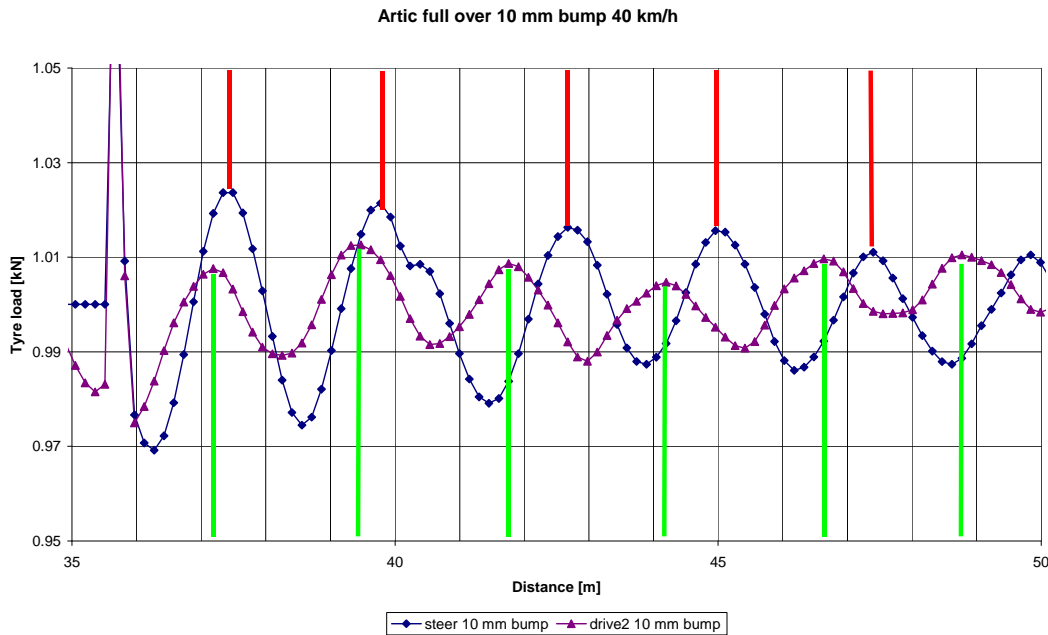
Figure 3: Variable loads generated in steer and drive axle of 123 vehicle after passing over a 10 mm bump at 40 km/h.

In Figure 3 the dynamic response from the steer and drive axles are shown. The interval between peak loads is between 2 m and 3 m. This relates comparatively well with the measured intervals between the ruts on the road of approximately 2,5 m. In Figure 4 the dynamic response from the trailer axles are shown. The interval between these peak loads is approximately 15 m. Due to the heavier loads carried on these axles the lower frequency may be expected. The 15 m peak loads may still correspond to some of the ruts observed on the road.

The output from the analysis indicates that the simulation software predicts the locations of the maximum moving dynamic loads for the steer and drive axles as being closely correlated with the locations of the discrete ruts on the road beyond the bridge deck joint. The fact that the initial

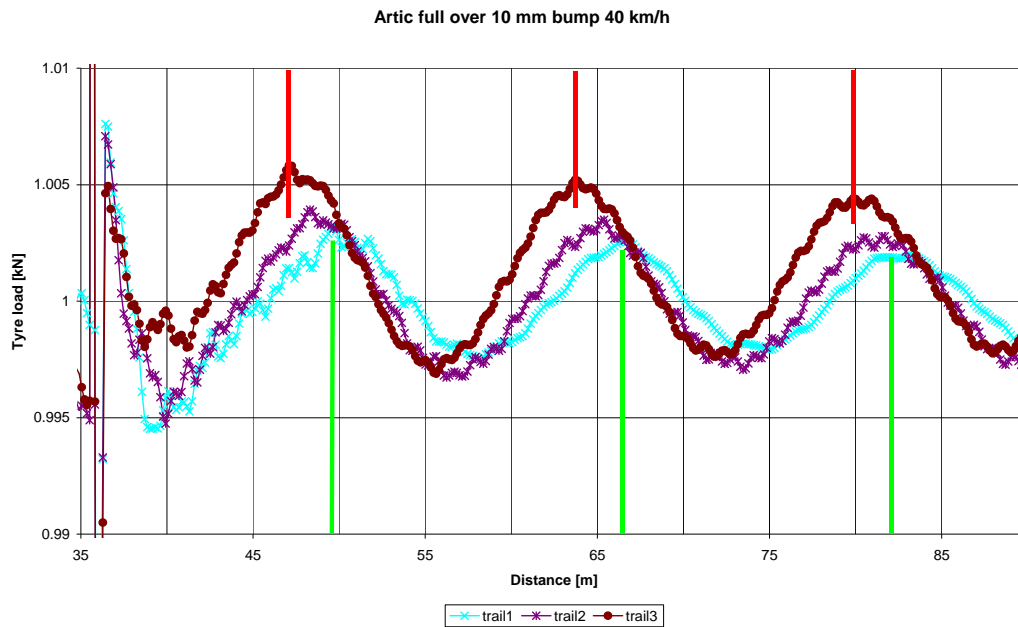
Figure 4: Variable load responses from trailer axles after passing over a 10 mm bump at a speed of 40 km/h.
