SURVEY OF SEPTEMBER 1987 NATAL FLOODS

SOUTH AFRICAN NATIONAL SCIENTIFIC PROGRAMMES REPORT NO. 164 - 1989

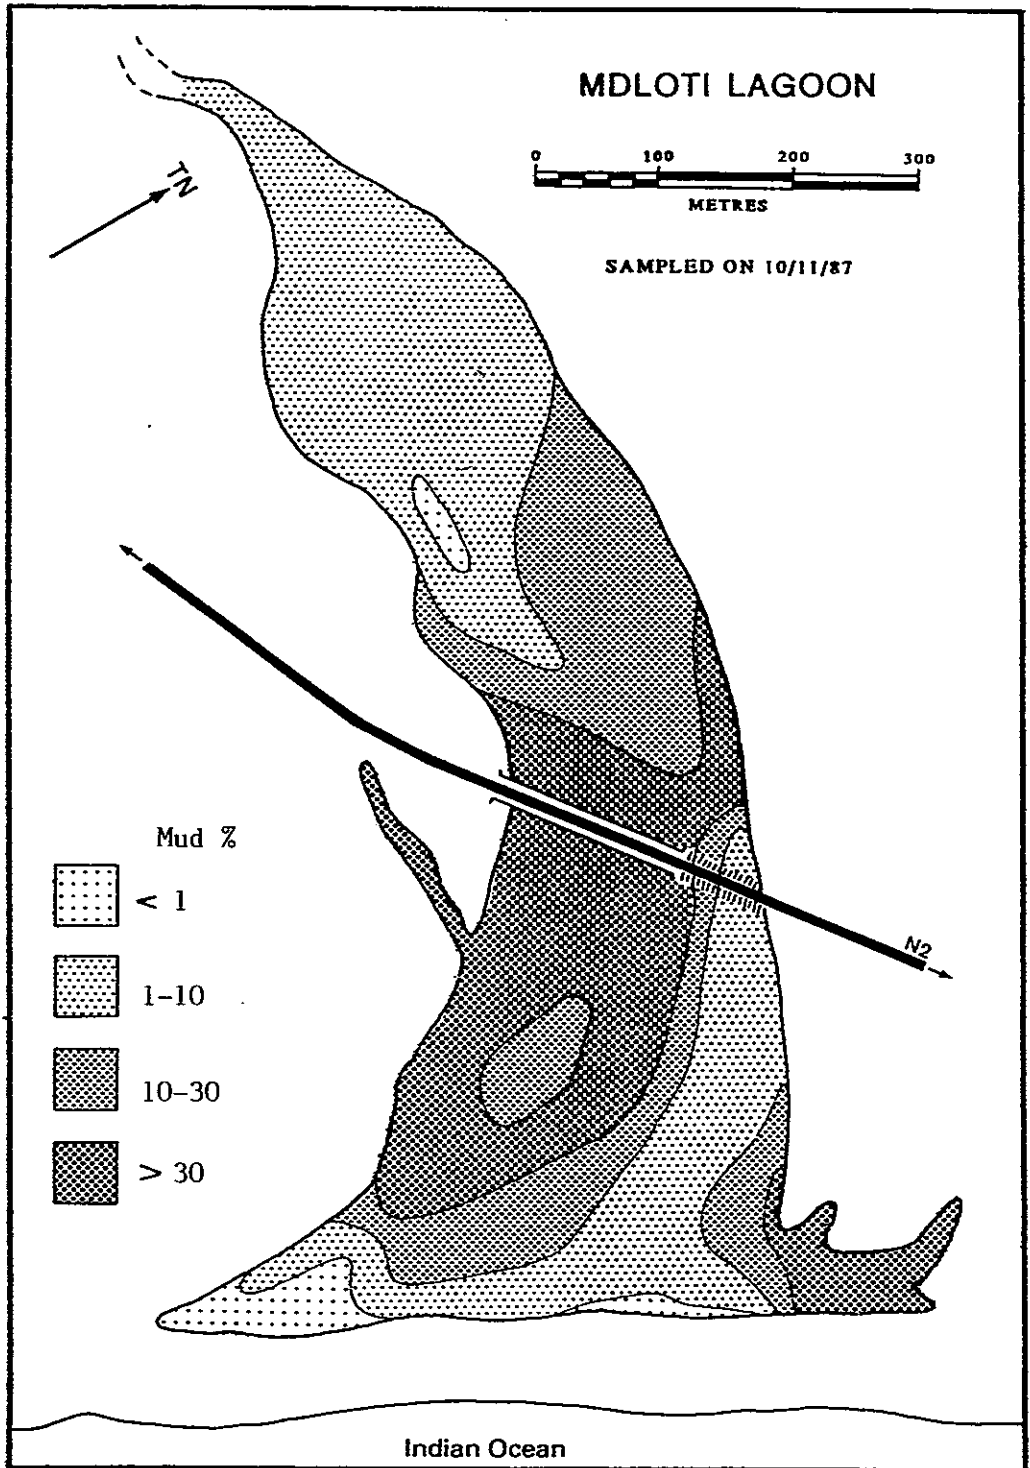
FIGURE 8

Mud distribution for samples collected at the sediment surface; Post-flood.

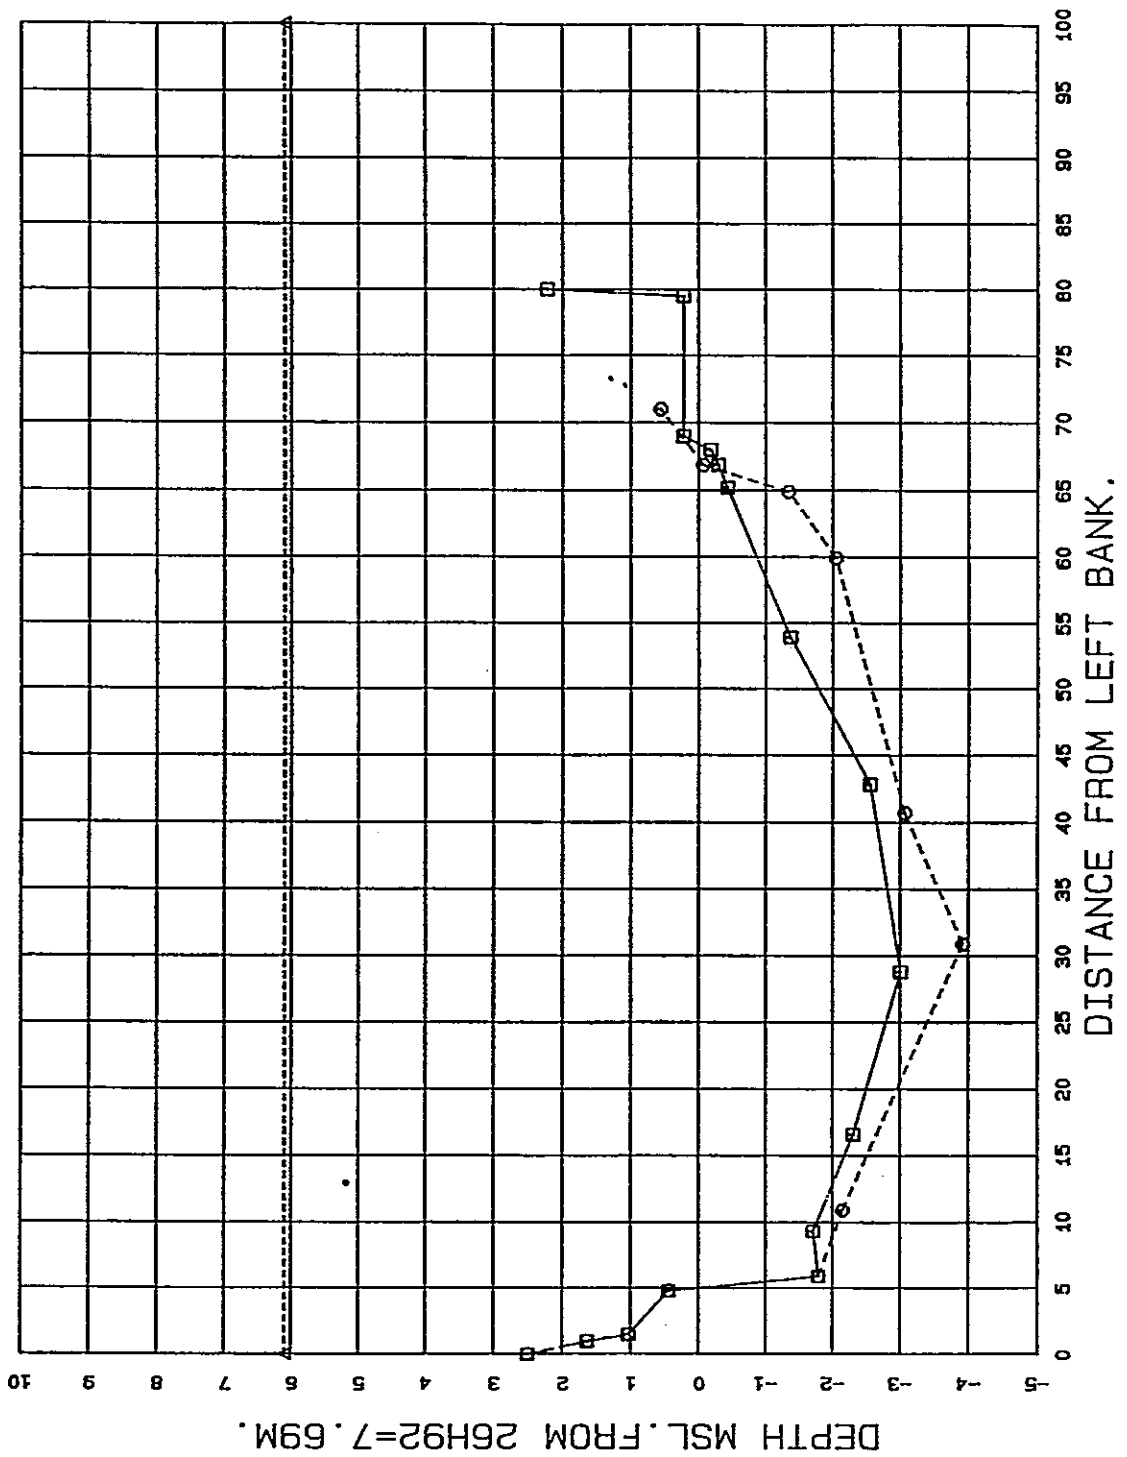
FIGURE
 5

SEDIMENTATION RATES OF NATAL ESTUARIES
 PROFILE OF MLALAZI RIVER BED.

At Profile 4 (Figure 5) the highest water level in September 1987 was 6,1m. There has been degradation of about 1 m since the previous survey of 24 March 1987. Near this position a dredger that was taking sediment from the river to be used for the new N2 freeway had capsized during the flood and traces of oil from its bunker tank were observed.

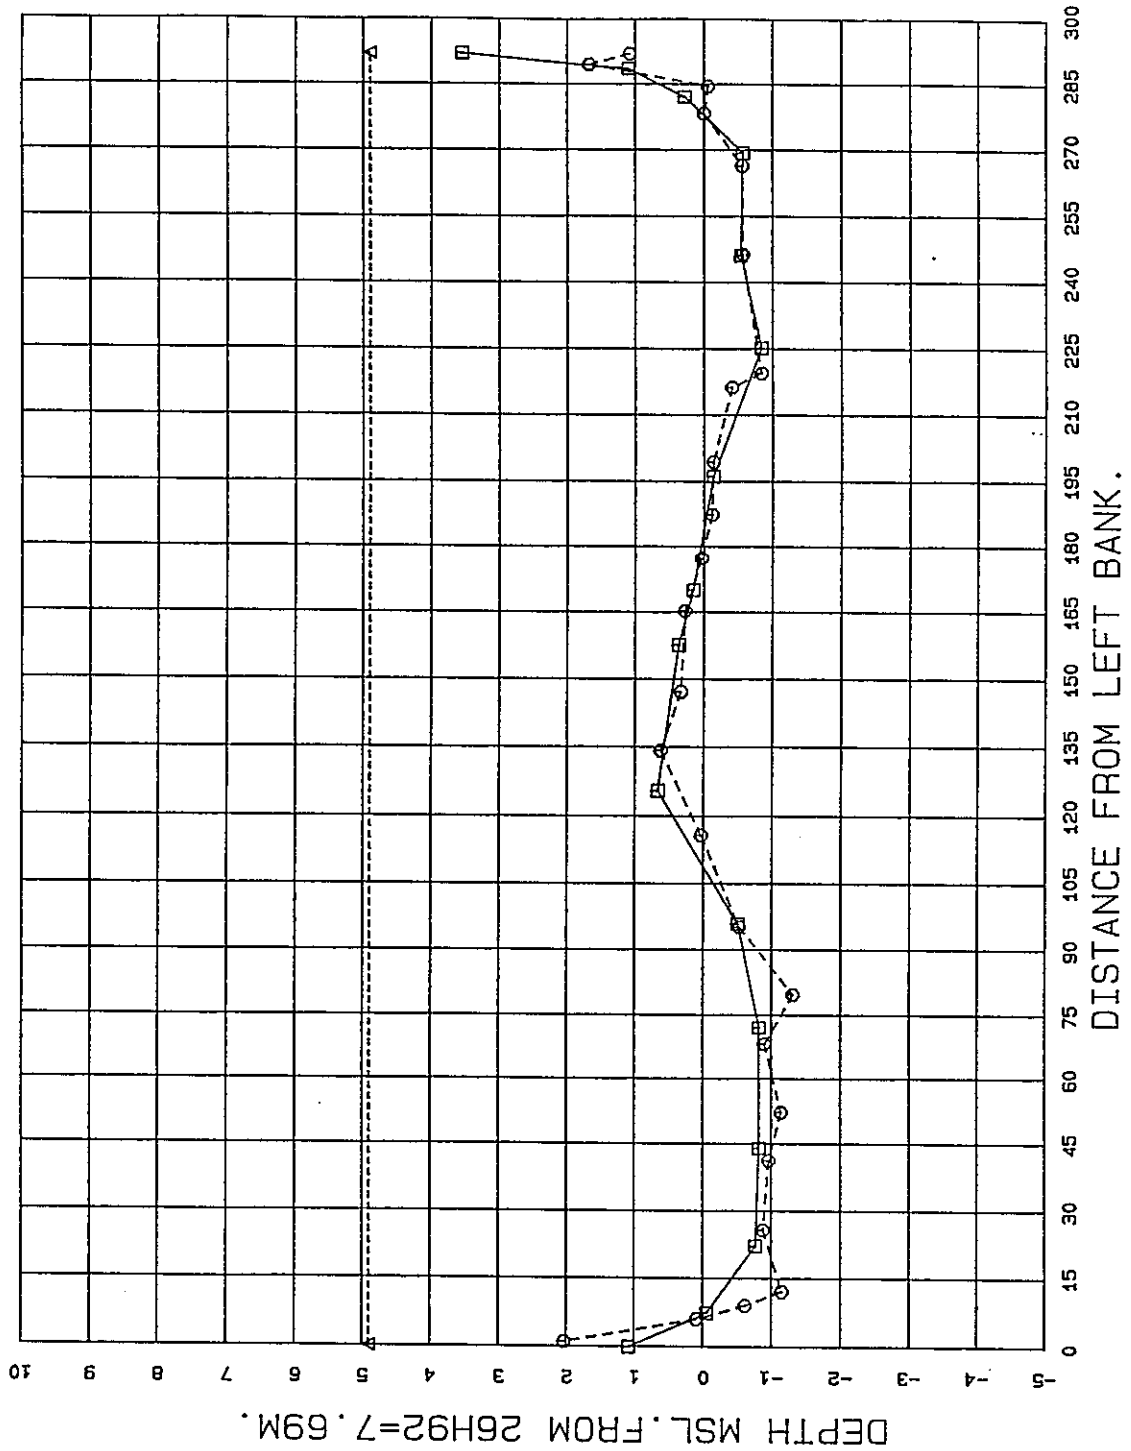
FIGURE
 8

SEDIMENTATION RATES OF NATAL ESTUARIES
 PROFILE OF MLALAZI RIVER BED.

Relatively small changes in the depth of the river bed occurred at the last profile, Profile 7 (Figure 8). Except for the thatched sunshades along the picnic/area that were swept away there was no visible damage to the ablution block on the right bank near Profile 7. The debris line in the trees on the left bank was 4,9 m for the September 1987 flood.

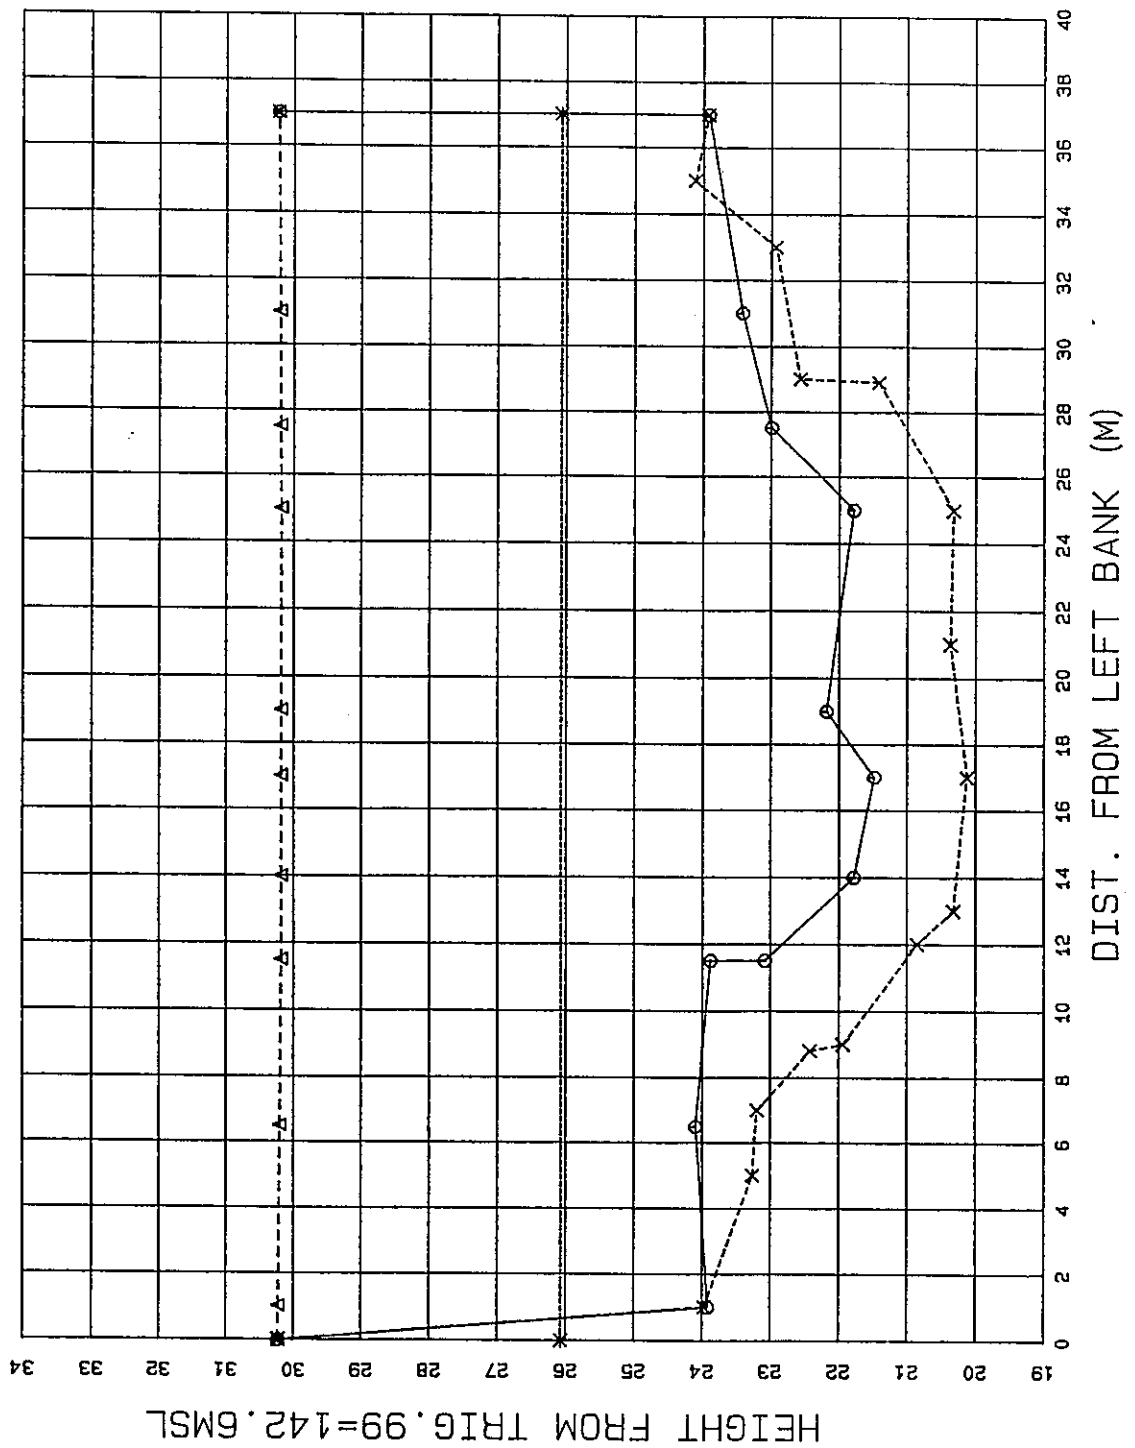
FIGURE
 10

SEDIMENTATION RATES OF NATAL ESTUARIES
 PROFILE OF ZINKWAZI N2 BRIDGE.

The positions of the profiles taken in the Zinkwasi River are shown in Figure 9. Profile 1 at the Zinkwasi N2 bridge lies upstream of any estuarine influence. This profile (Figure 10) shows degradation of about 1,5 m under the bridge.

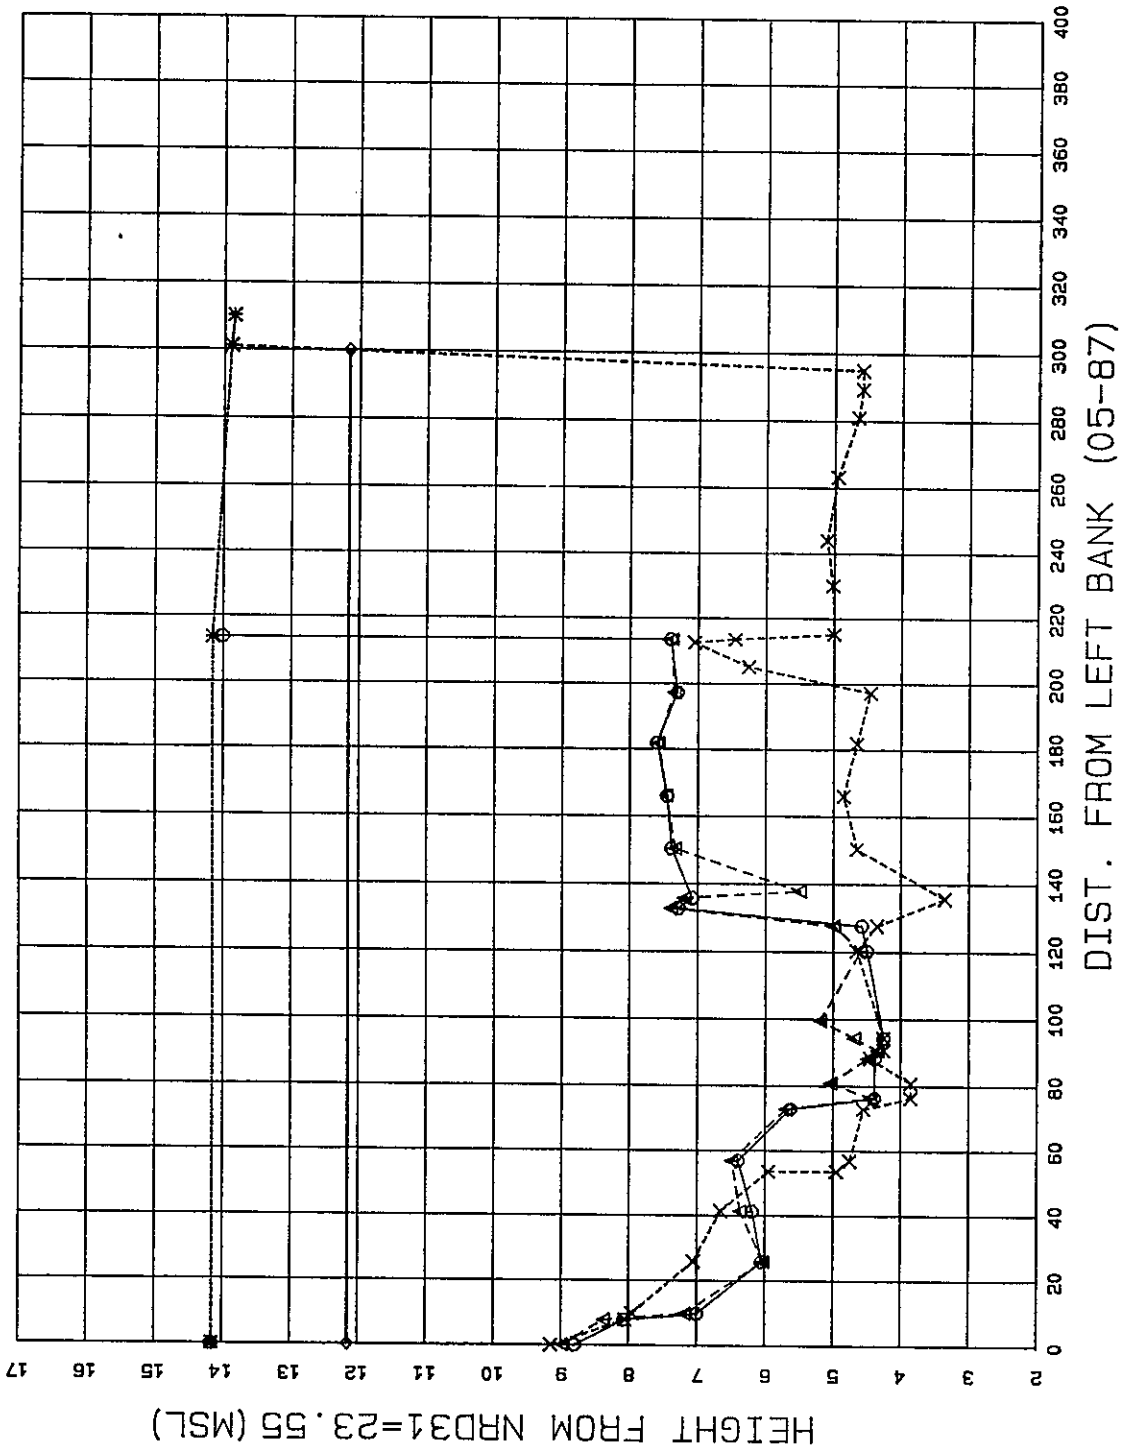
FIGURE
 16

SEDIMENTATION RATES OF NATAL ESTUARIES
 PROFILE OF MVOTI (N2) BRIDGE.

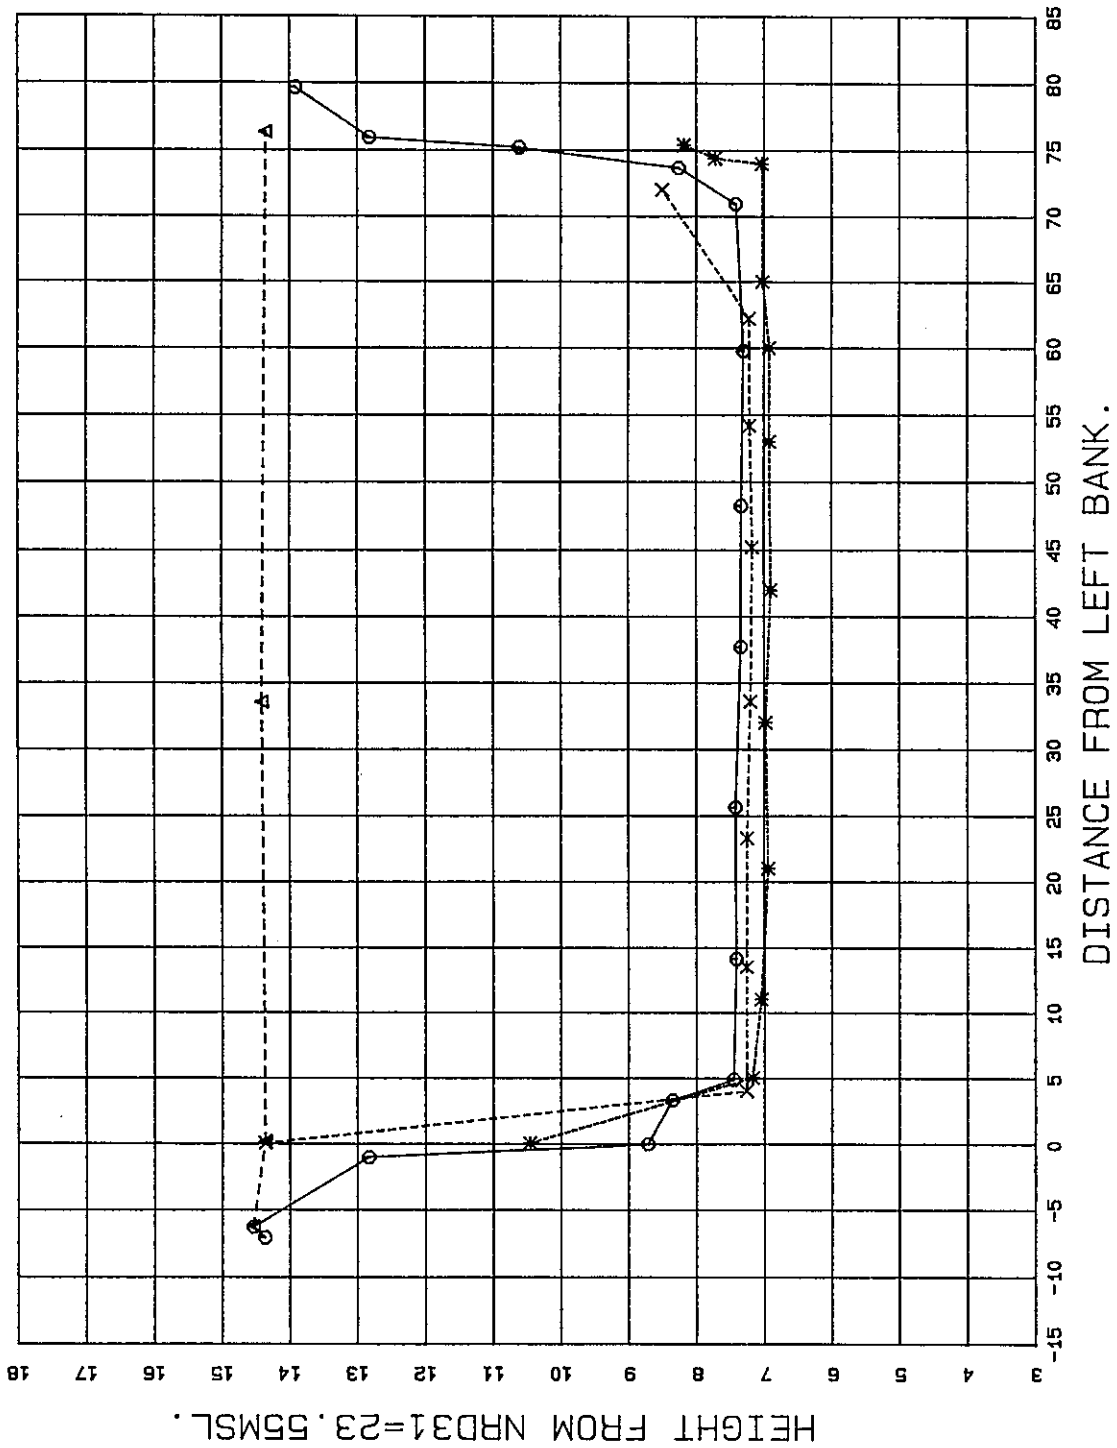
FIGURE
 22

SEDIMENTATION RATES OF NATAL ESTUARIES
 OLD MZUMBE STEEL BRIDGE.

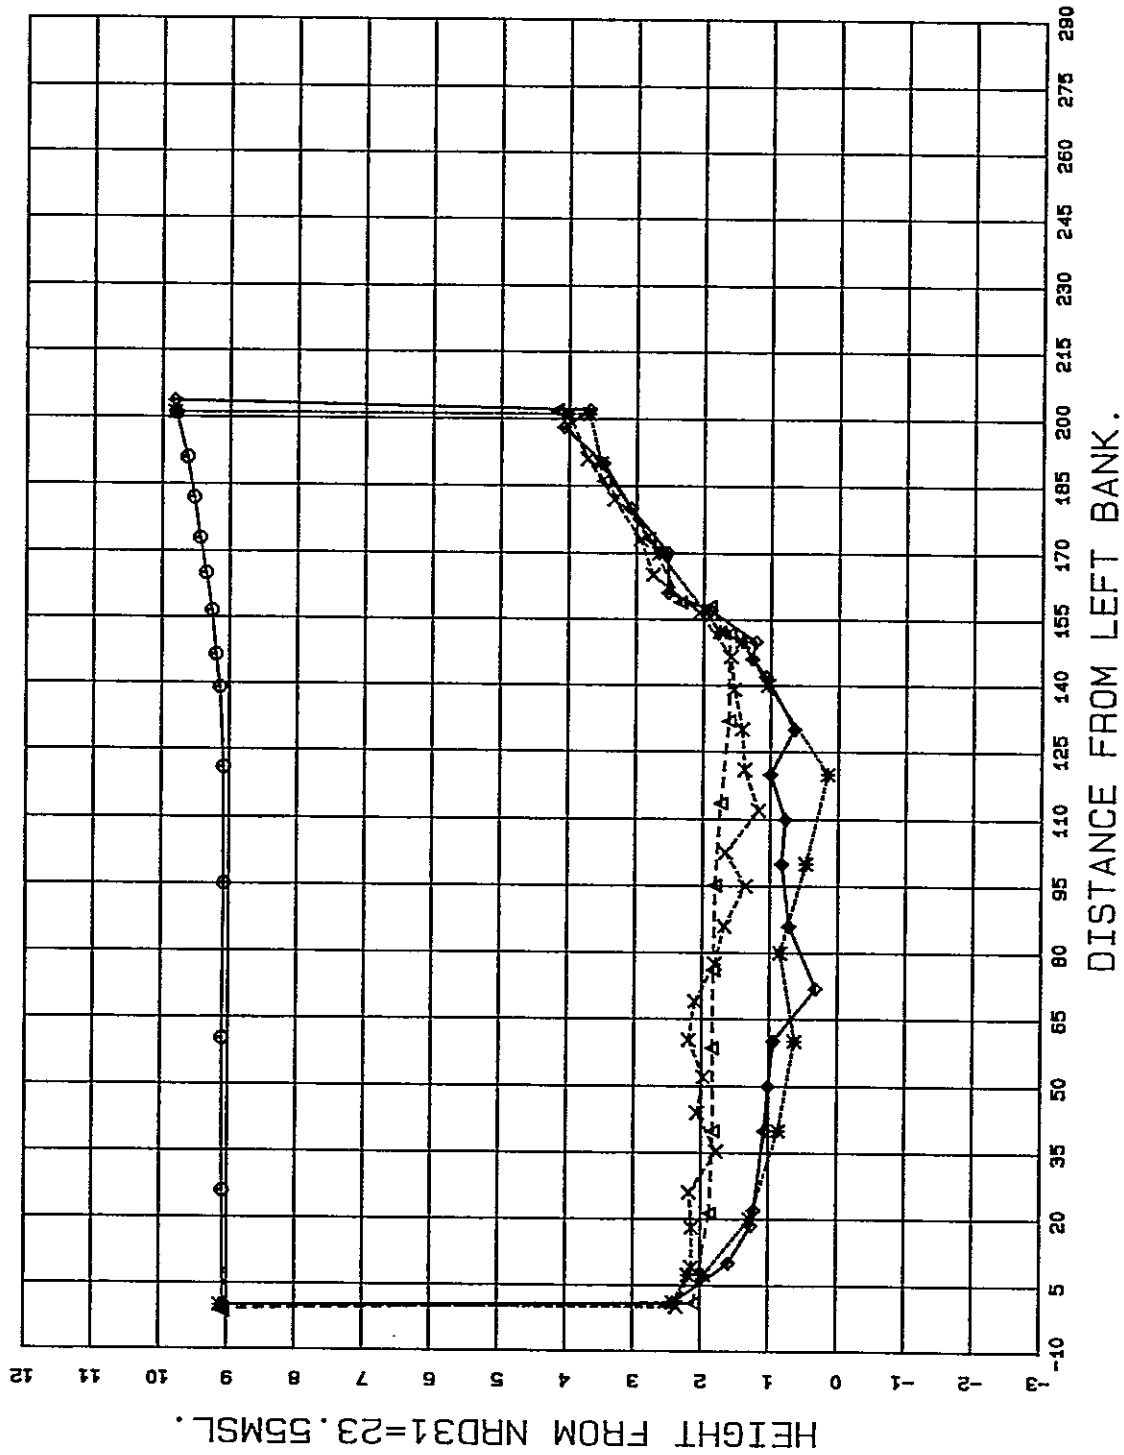
FIGURE
 25

SEDIMENTATION RATES OF NATAL ESTUARIES
 EXISTING MZUMBE N2 BRIDGE PROFILE

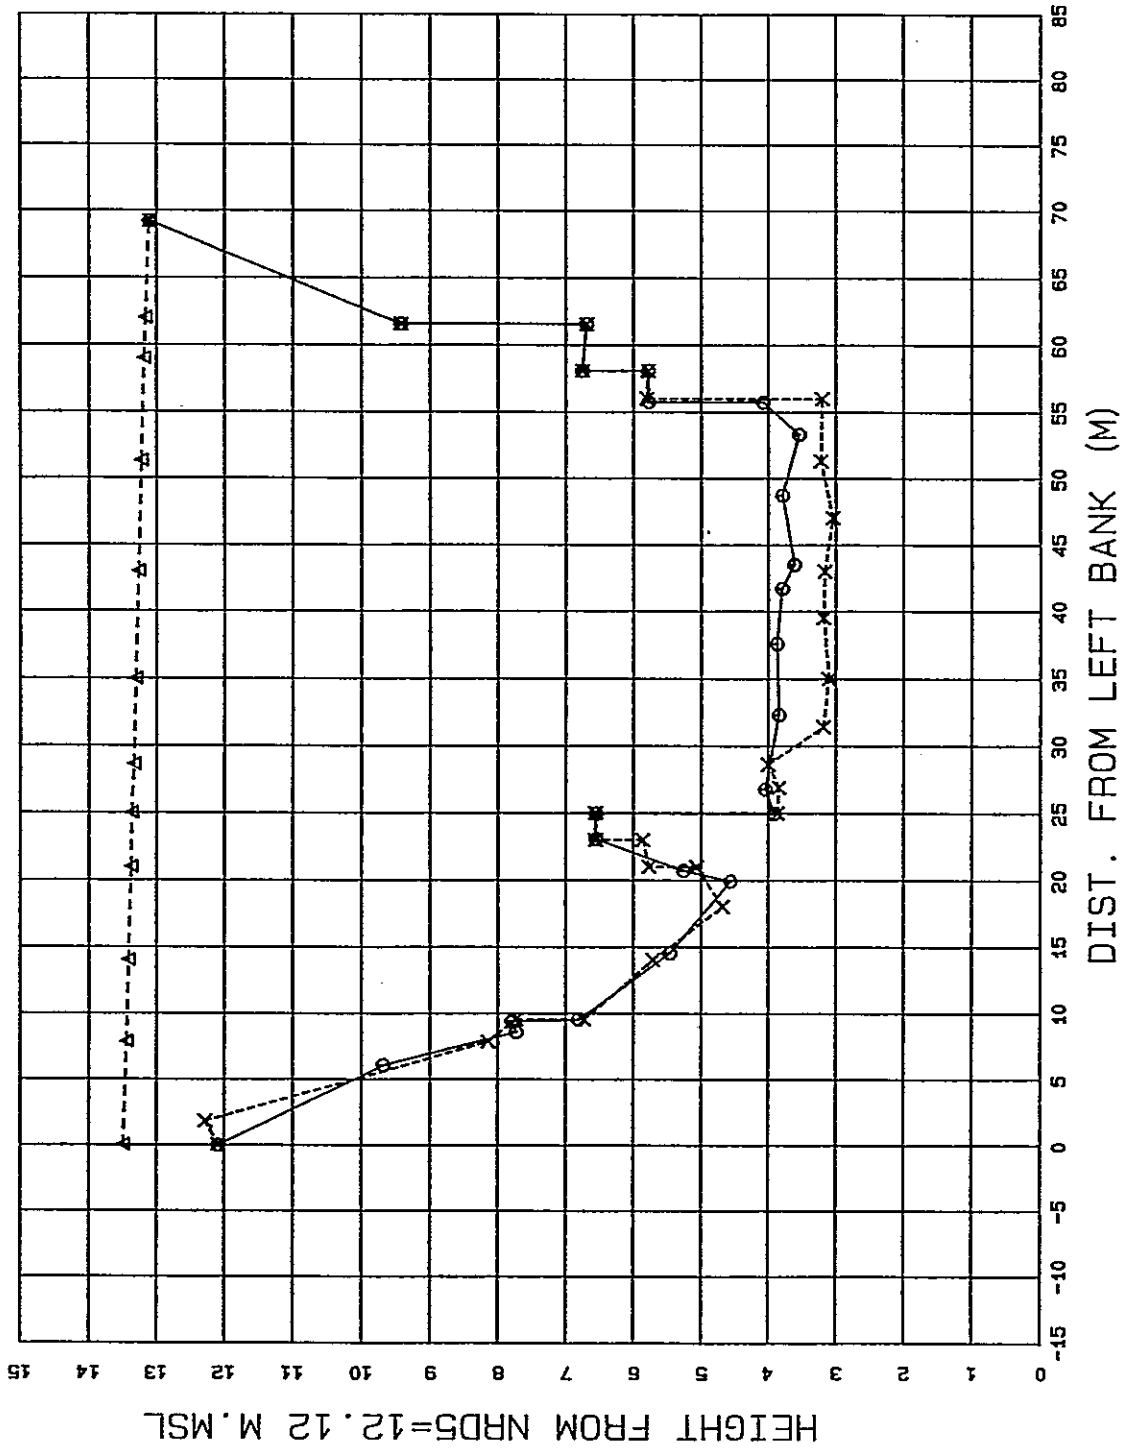
FIGURE
 27

SEDIMENTATION RATES OF NATAL ESTUARIES
 PROFILE OF NEW MBIZANA BRIDGE.

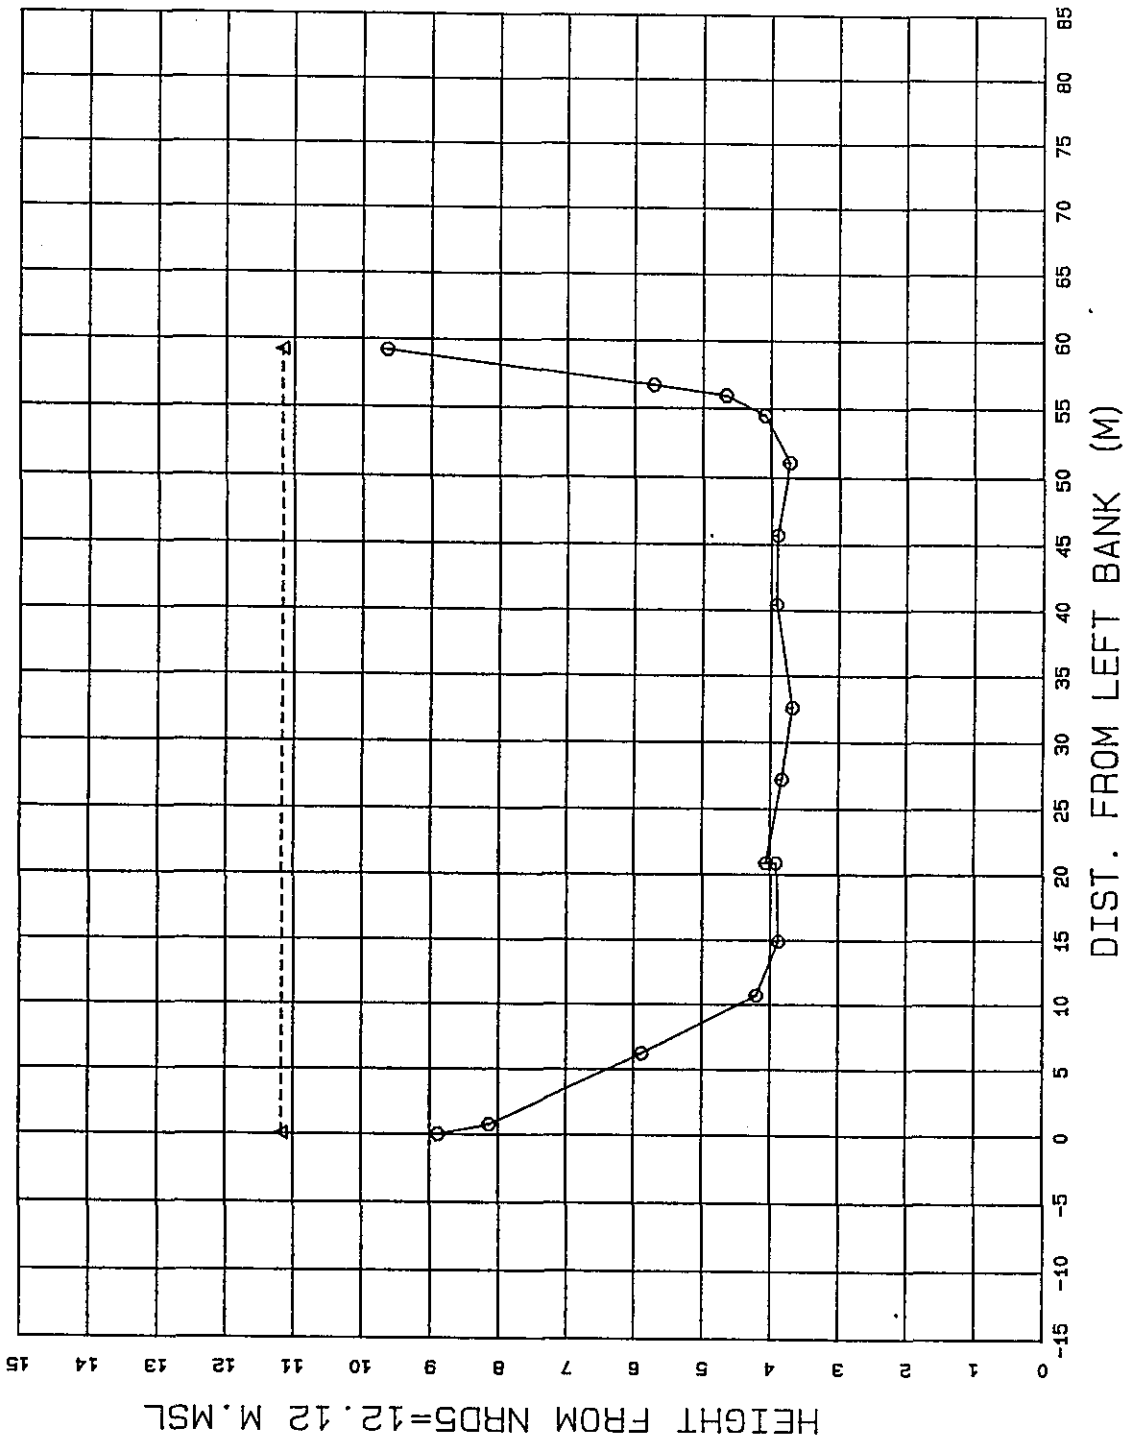
FIGURE
 28

SEDIMENTATION RATES OF NATAL ESTUARIES
 PROFILE OF OLD MBIZANA BRIDGE.
