REPORT NO. 29
HOUT BAY (CW 27)

REPORT NO. 29: HOUT BAY (CW 27)

BY: S A GRINDLEY

ESTUARINE AND COASTAL RESEARCH UNIT – ECRU
DIVISION OF EARTH, MARINE AND ATMOSPHERIC SCIENCE AND TECHNOLOGY
COUNCIL FOR SCIENTIFIC AND INDUSTRIAL RESEARCH

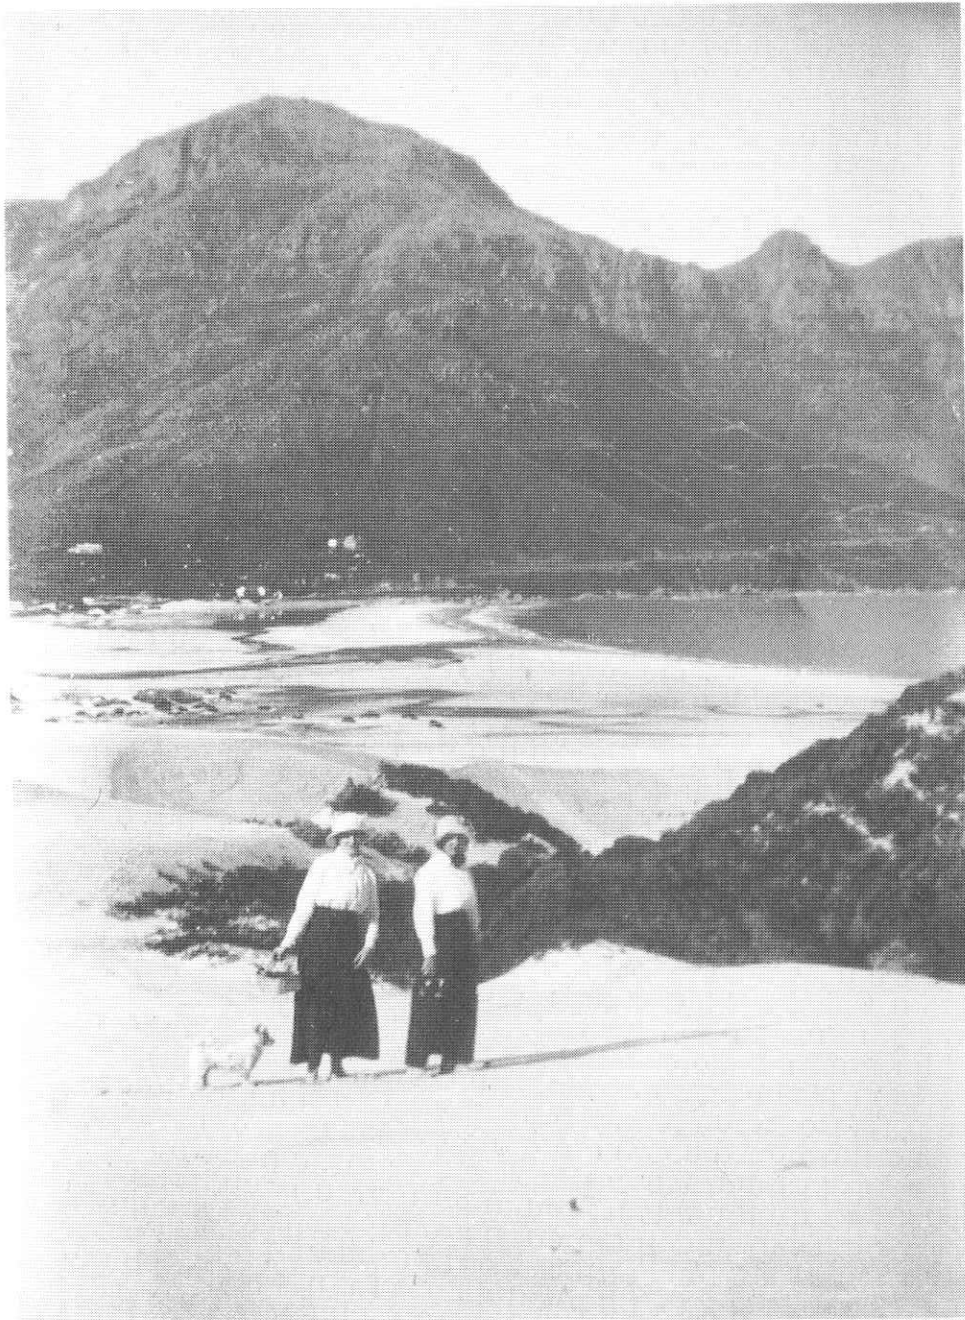
FIG. 3: Hout Bay beachfront in the early part of this century looking Eastwards across the wide sandy beach, backshore lagoon and meandering estuary, towards Constantiaberg and Chapmans Peak Drive. (Photo: Hout Bay Museum).

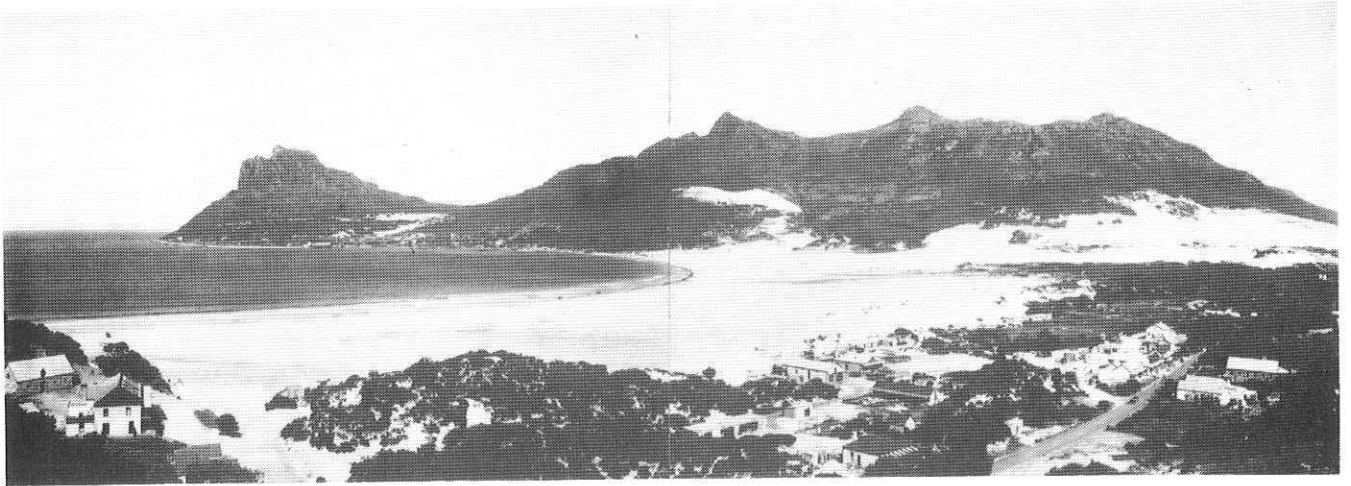
FIG. 4: A view of the bay and beach in 1903 looking west with the Sentinel and Karbonkelberg in the background. The sand corridor linking Hout Bay beach and Sandy Bay can be seen in the right of the picture. (Photo: Hout Bay Museum).

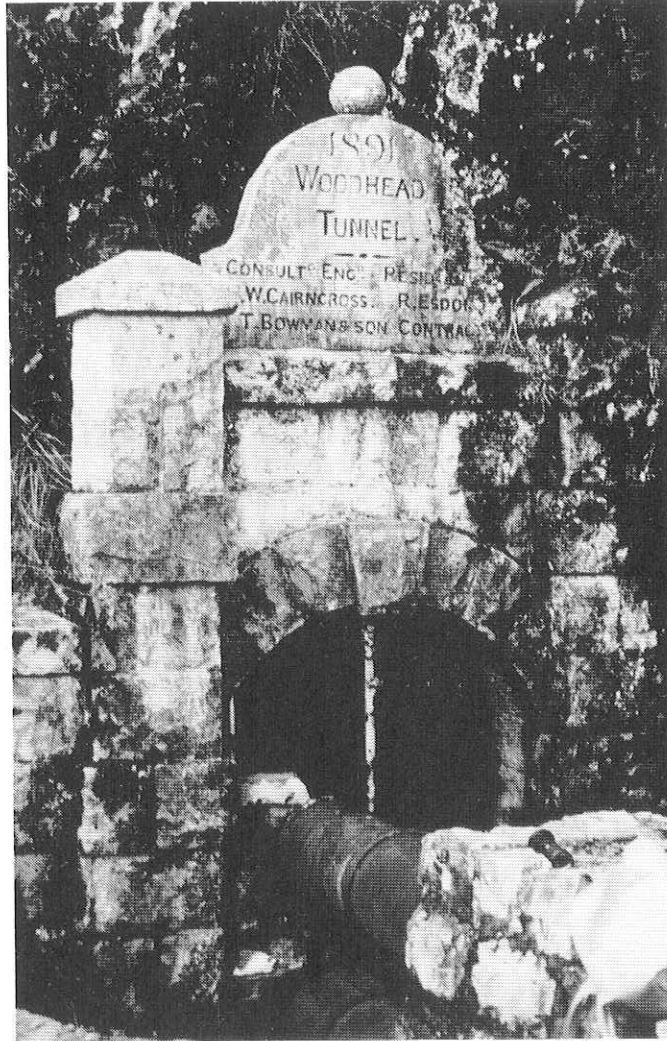
FIG. 9: In 1891 the Woodhead tunnel was completed; this 640m long tunnel led water from Disa stream through the mountain to Slangolie Ravine south of Camps Bay, providing Cape Town with a supply of potable water (Photo: Hout Bay Museum).

The exploitation of the water supply from the upper catchment began late last century when the Wynberg Water Supply Act (Act 34 (Cape Colony) of 1887) and the Cape Town Municipality Additional Water Supply Act (Act 35 (Cape Colony) of 1887) vested these two municipalities with far reaching rights to use, divert and impound "all the water of the upper source and the tributary of the Hout Bay River, known as the Back Stream ..." (Cape of Good Hope Acts of Parliament 1884-1888). These rights were exercised initially by the construction of the Woodhead Tunnel in 1888 which led water from the Disa Stream through the mountain to Slangolie Ravine above Camps Bay.

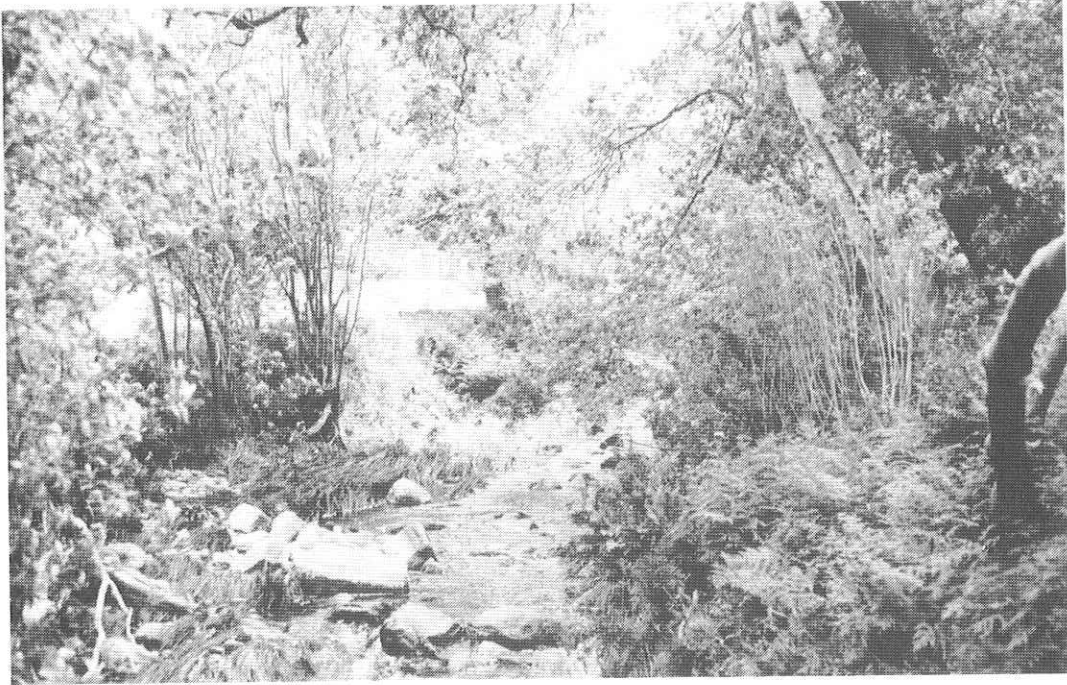
FIG. 12: The upper catchment: in this zone the steep, fast flowing stream has a rocky bed and predominantly indigenous vegetation line the banks. (Photo: S Grindley, 1983).

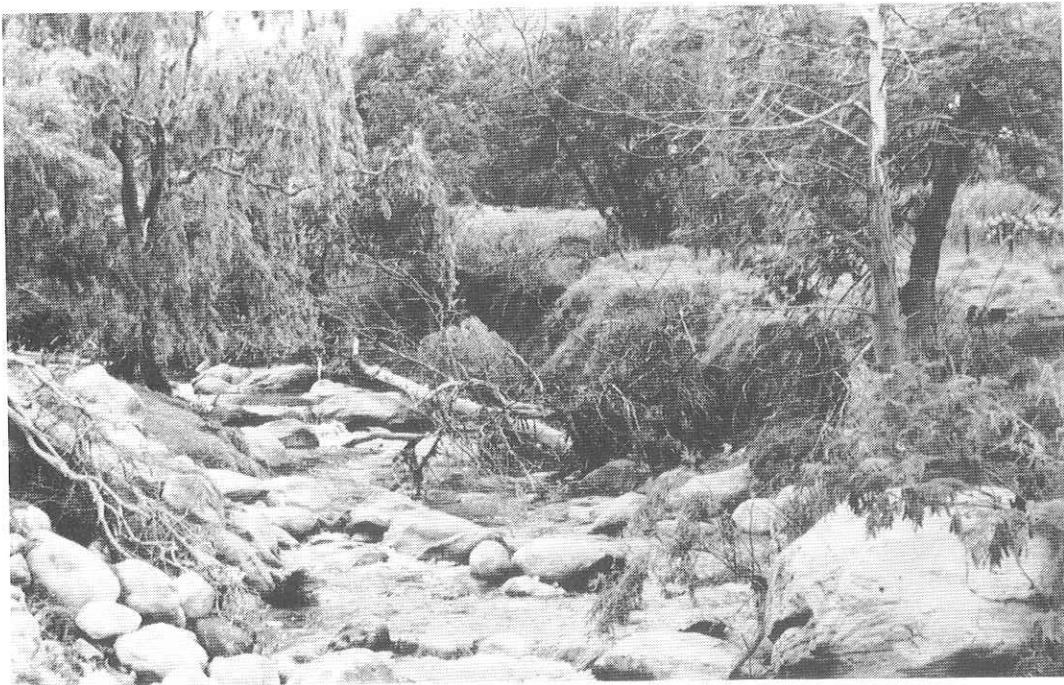
FIG. 13: The erosion zone: both bed and bank erosion have degraded this section of the river. (Photo: S Grindley, 1983).

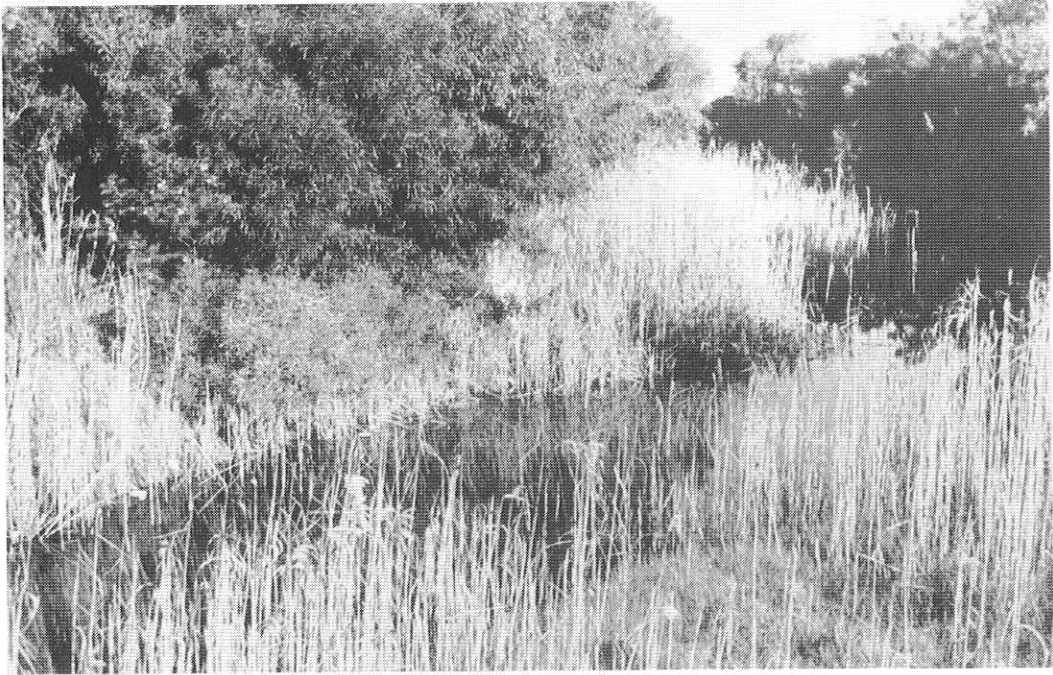
FIG 14: The siltation zone: the flatter gradient of this section of the river results in extensive silt deposition from upstream erosion. Alien vegetation has colonized the levees of dredge spoil and reeds encroach into the shallow river channel. (Photo: Hout Bay Museum).

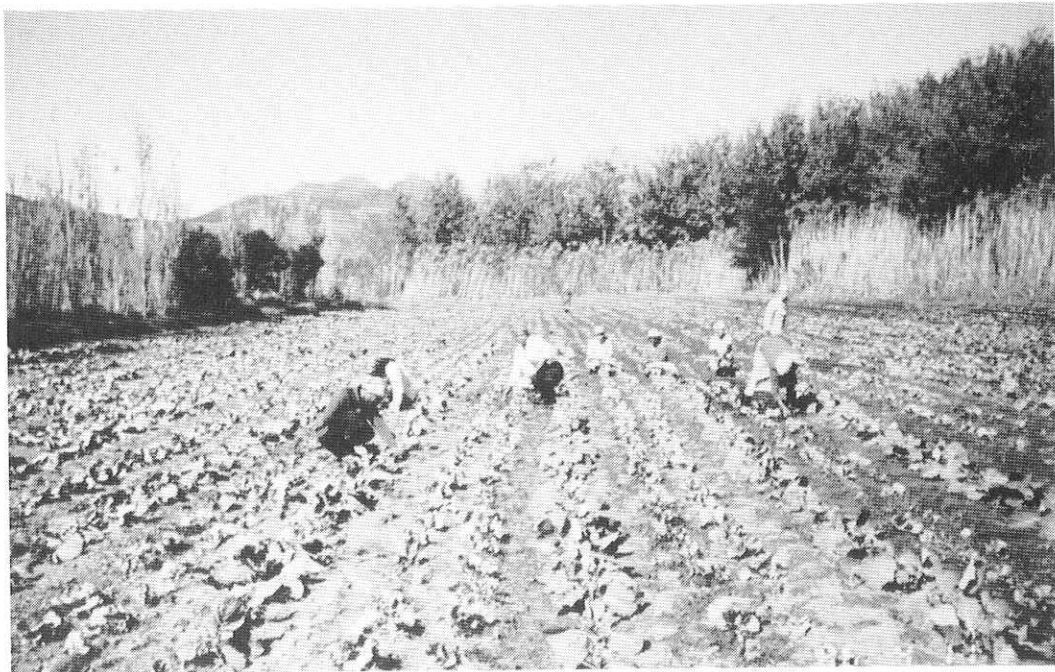
FIG 20: Market gardening below Victoria Road Bridge. (Photo: WCRSC).

As a result of the agricultural zoning of the valley floor, for most of the length of the river, riparian plots are in excess of 8000m². This allows for a semi-rural lifestyle with paddocks, cultivated fields and livestock (particularly horses) being a pleasant feature of the area. Market gardening, on a large scale, takes place on one remaining farm situated below Victoria Road (Figure 20).

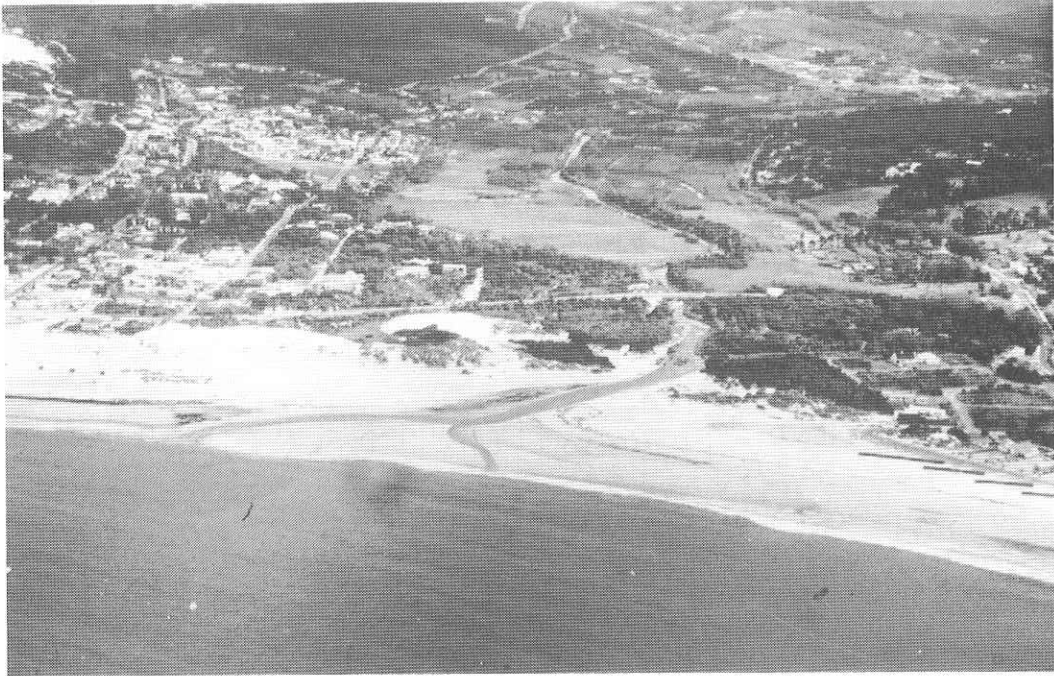
FIG. 21: A view of the beach front showing the estuary flowing out through two channels. The movement of the mouth is constrained by a sea-wall and hardened parking area to the west. Reed-beds flank the lower reaches of the river. (Photo: ECRU, 79-10-23, altitude 250m).

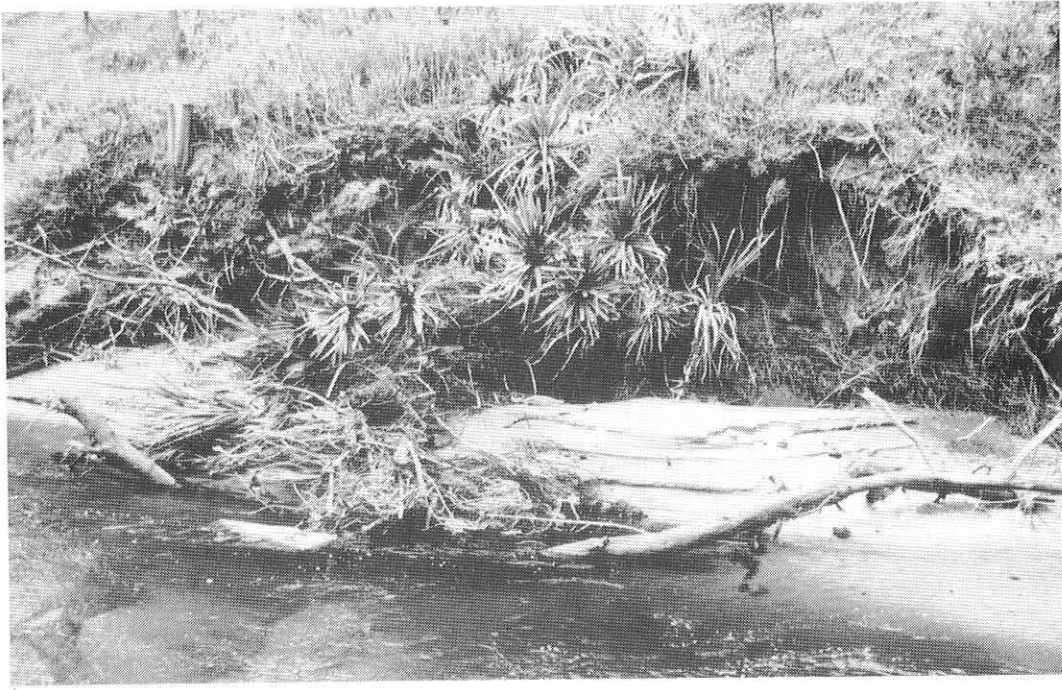
FIG. 32: Palmiet (*Prionium serratum*): little now remains along the river banks.
(Photo: S Grindley, Nov. 1979).

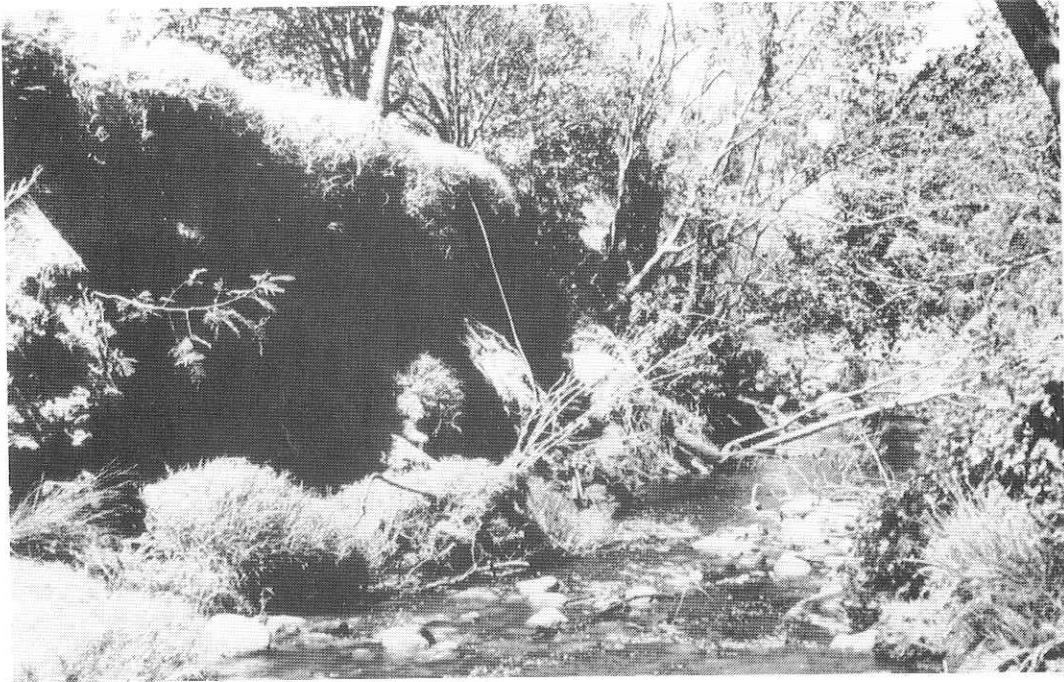
FIG. 33: Shallow-rooted trees, particularly alien *Acacia* spp., give little protection to the river banks and are often uprooted during spates.
(Photo: WCRSC).

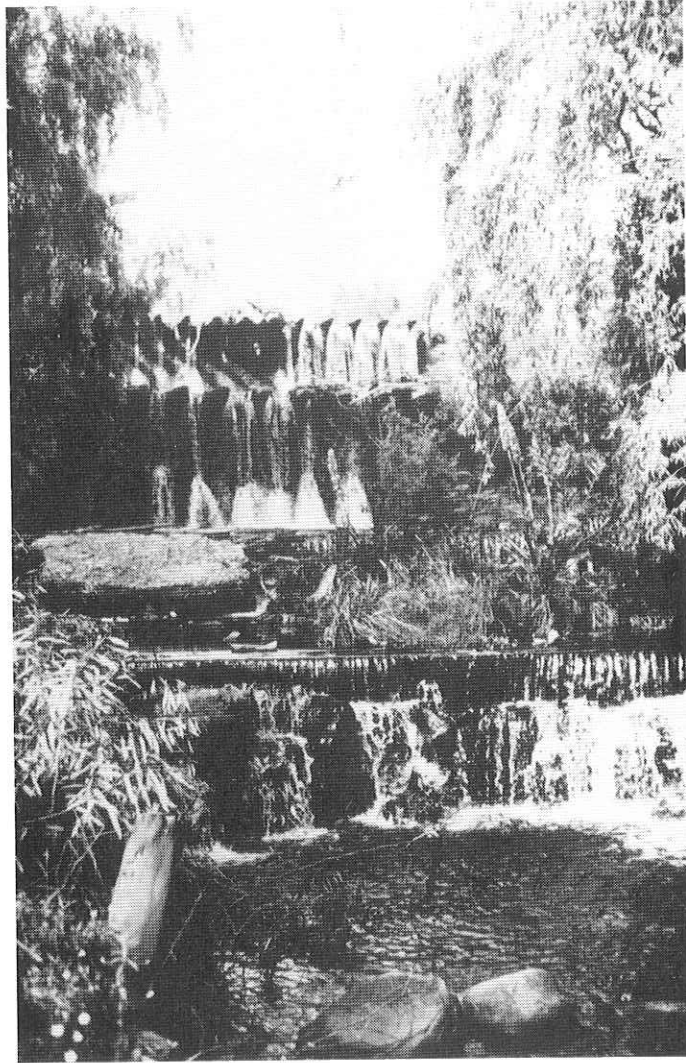
FIG. 34: The Longkloof spillway. (Photo: Hout Bay Museum, Oct. 1981).

The Longkloof spillway was damaged during the 1983 spate when flood water, bypassing the bridge, swept around the eastern side of the spillway seriously undermining it. Repair work has since been undertaken by the local authority.

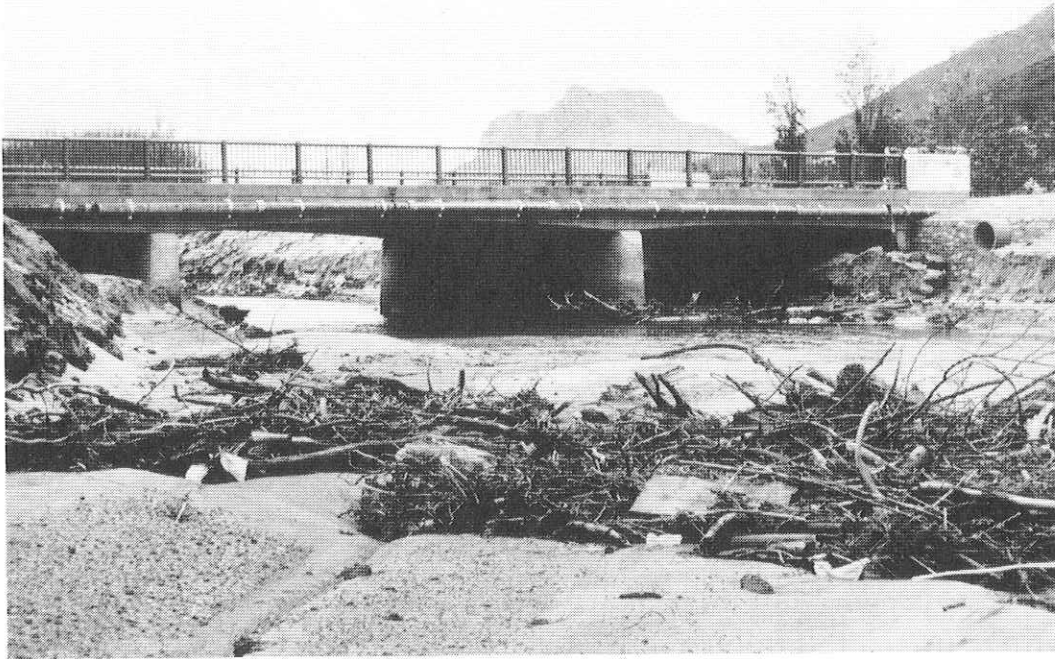
FIG. 35: Silt and debris deposited under Victoria Road bridge after the flood in June 1983. (Photo: S Grindley).

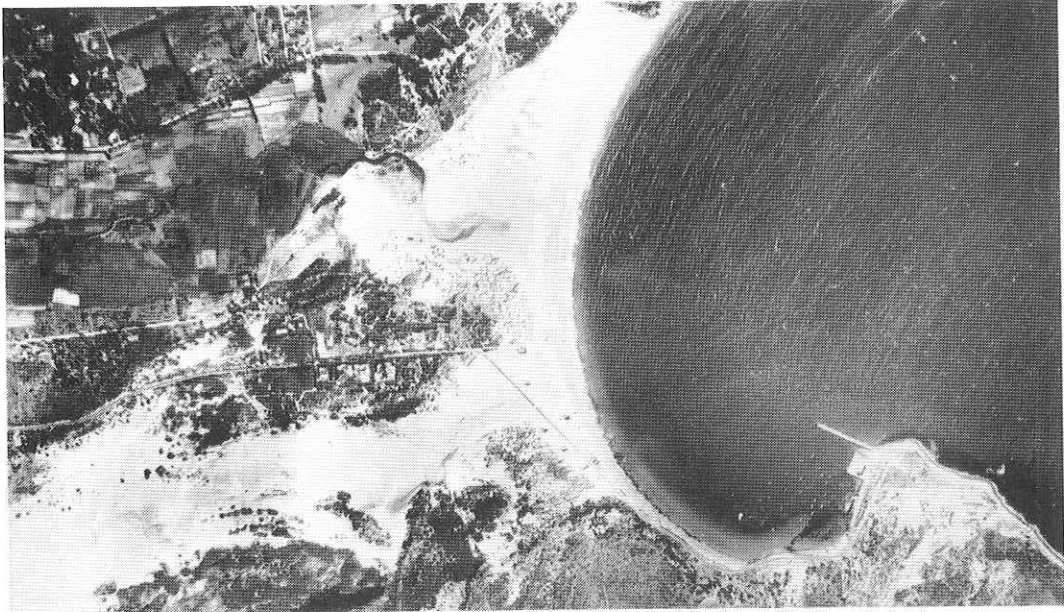
FIG. 37: Aerial view of Hout Bay Valley, 1944 (Photo: Directorate of Surveys and Mapping).

The earliest available aerial photographs, taken in 1944, show that there was a large open triangular sandy embayment at the river mouth which extended over half a kilometre upstream to what is now known as the Princess Road bridge. The river mouth periodically shifted across this sandy plain over a distance of 400m (Hout Bay beachfront, 1980; Hill Kaplan Scott Inc., 1984).

From 1944 to the present this natural and highly dynamic buffer zone between the sea, the river and the hinterland was confined by artificial embankments to an unnaturally narrow strip of beach. In its natural state (1944) Hout Bay beach had an unhindered connection to a large strait of driftsand running across the Karbonkelberg ridge to Sandy Bay on the Atlantic coast (Section 3.2.3).

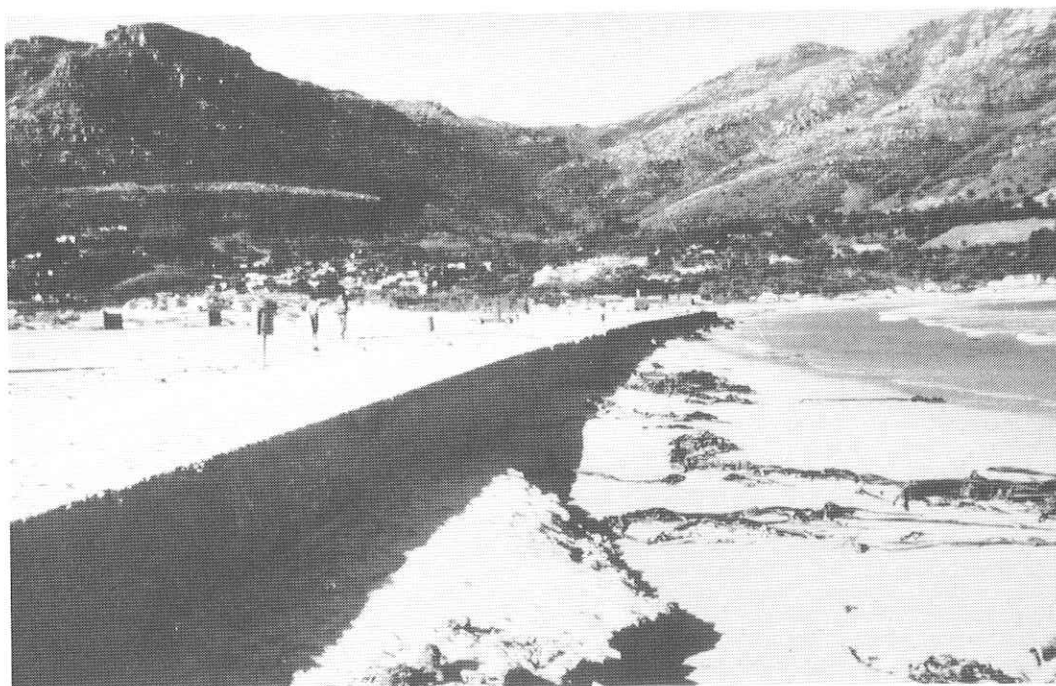
FIG. 40: Sea-wall west of the river mouth with an artificially hardened parking area behind it. (Photo: ECRU, 82-04-19).

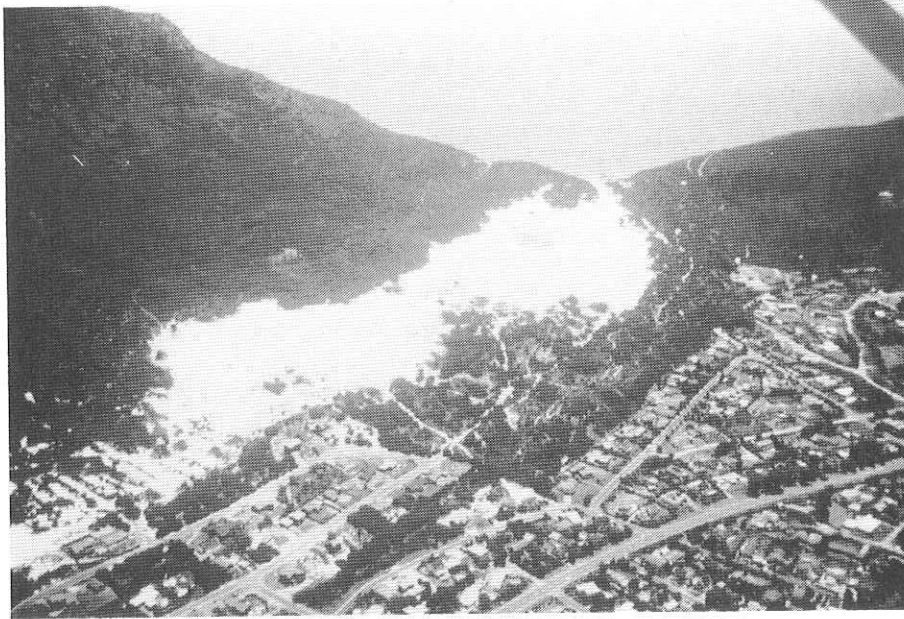
FIG. 43: The remnant of the driftsand strait on the northeastern slopes of the Karbonkelberg between Hout Bay and Sandy Bay (Photo: ECRU 87-11-01).

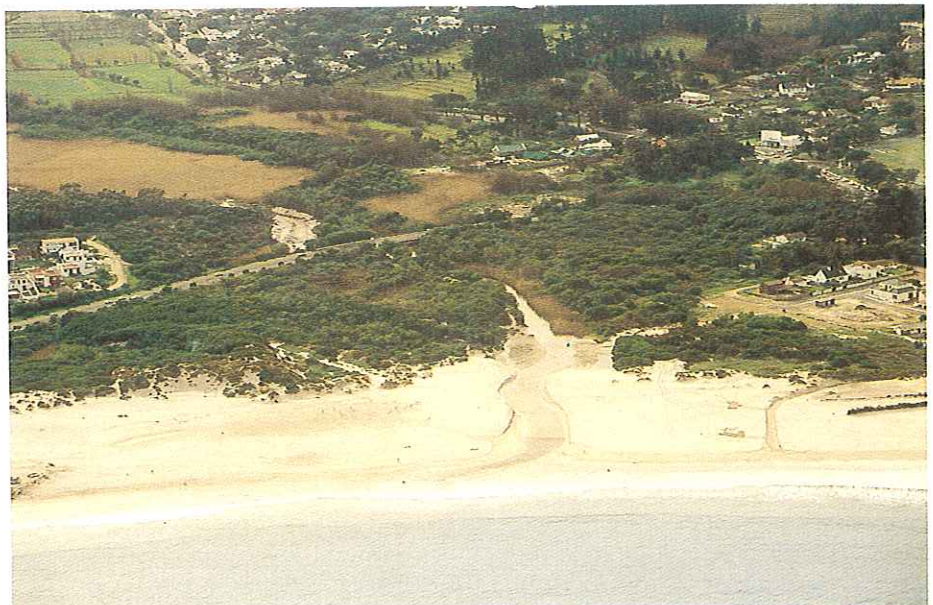
PLATE III:

The shallow lower reaches of the Hout Bay River meandering across the broad beach. Note the *Phragmites* reed-beds in the left background. (Photo: ECRU 88-05-31).
