# ESTUARIES OF THE CAPE

## PART II: SYNOPSES OF AVAILABLE INFORMATION ON INDIVIDUAL SYSTEMS

### REPORT NO. 11: HARTENBOS (CMS1)

COMPILED BY: I B BICKERTON

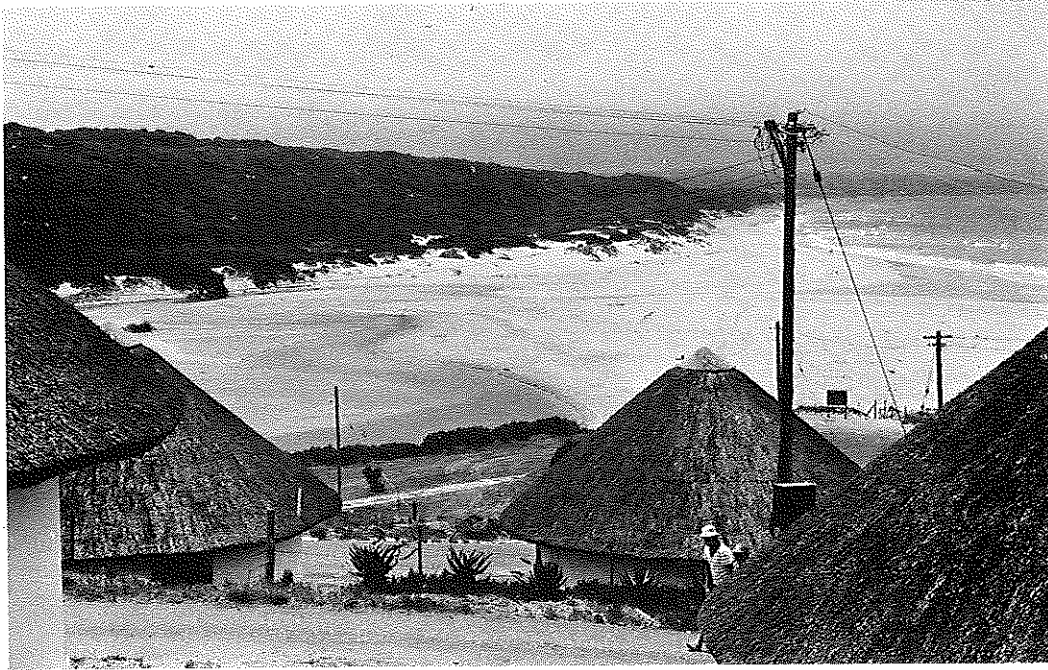
FIG. 5: Mouth of the Hartenbos Estuary just after closure at the end of 1981 (ECRU 81-12-05)

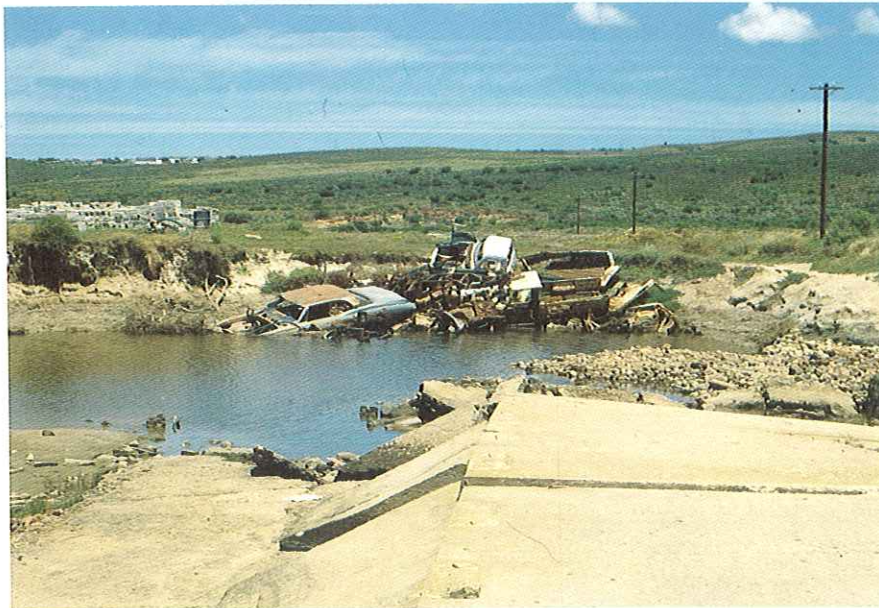
PLATE III: Northern drift in the upper reaches of the estuary (Grid Ref 0707) showing flood damage and attempts to prevent erosion using derelict vehicles. The proposed sewage effluent outfall is to be sited just downstream of this point. (ECRU 81-11-11)

In the upper reaches of the estuary, approximately 2,5 km from the mouth (Grid Refs 0704 and 0707) road causeways cross the two main watercourses of the Hartenbos. The southern causeway is a low-lying concrete structure with several pipe culverts for the passage of water. At the time of the ECRU survey, this causeway had recently been damaged (probably during the 1981 floods) and repaired. The northern causeway (Plate III) had been completely washed away on its southern side and could no longer be traversed by vehicles at the time of the ECRU survey. The banks of the channel on the southern side of the causeway had also been badly eroded by floodwaters. Attempts to curb this have been made by filling in the eroded part with derelict vehicles (Plate III).
