ESTUARIES OF THE CAPE

SYNOPSIS OF AVAILABLE INFORMATION
ON INDIVIDUAL SYSTEMS

REPORT NO. 12

BUFFELS (WES) (CSW 1), ELSIES (CSW 2)
SIR LOWRY'S PASS (CSW 8), STEENBRAS (CSW 9)
and BUFFELS (OOS) (CSW 11)

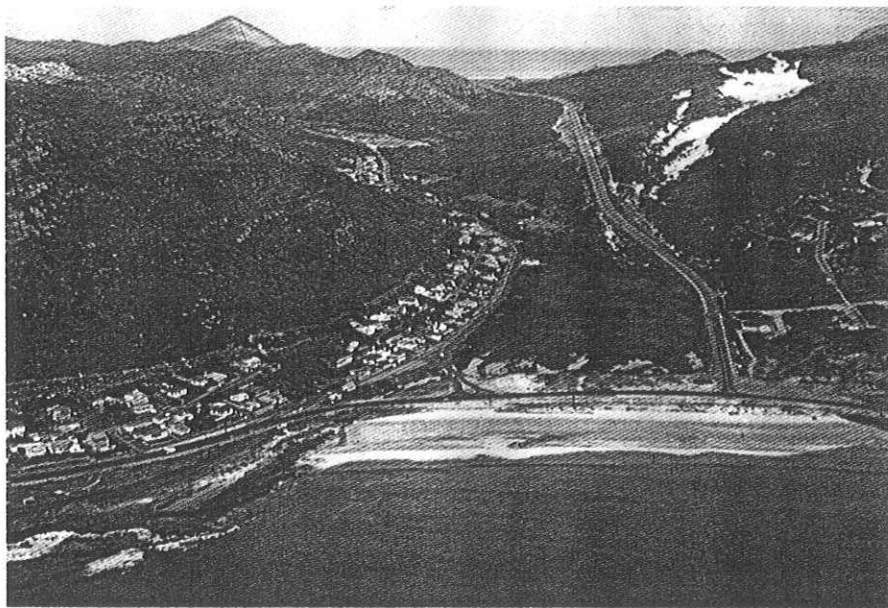
PLATE II: The Elsie's River mouth, showing to what extent the roads and railway line dominate the lower part of the estuary. Open water can be seen in the Vlei and the remnants of the original bare dune belt are visible on the top right-hand corner of the photograph. The Glencairn township is on the left with the new subdivision of Glencairn Heights on the right (ECRU 79-10-23).

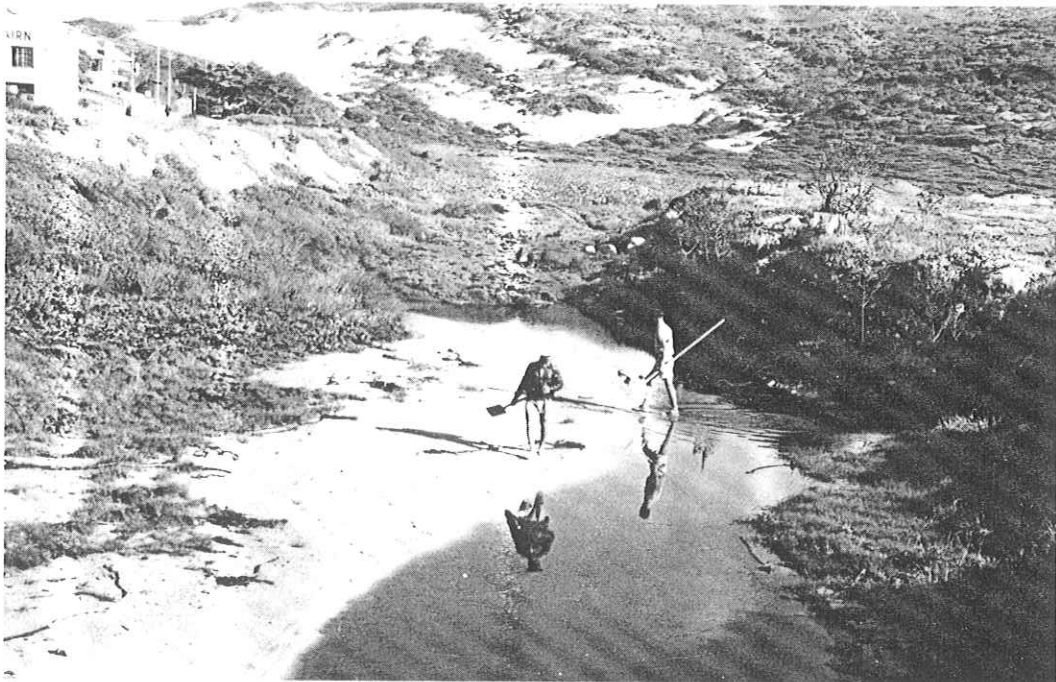
FIG. 1: The Elsie River estuary upstream of the main road bridge on 59-10-21 (GF van Wyk).

In 1912 most of the upper catchment of the river was acquired by the Simonstown Municipality when they bought the farm "Brooklands". This was to ensure a permanent water supply for the town (Burman, 1962). In October 1959 GF van Wyk surveyed the estuary and his sketch map and a photograph of the estuary shows an open stretch of water just above the first road bridge approximately 10 m wide (GF van Wyk, unpublished field notes), (see Figure 1).

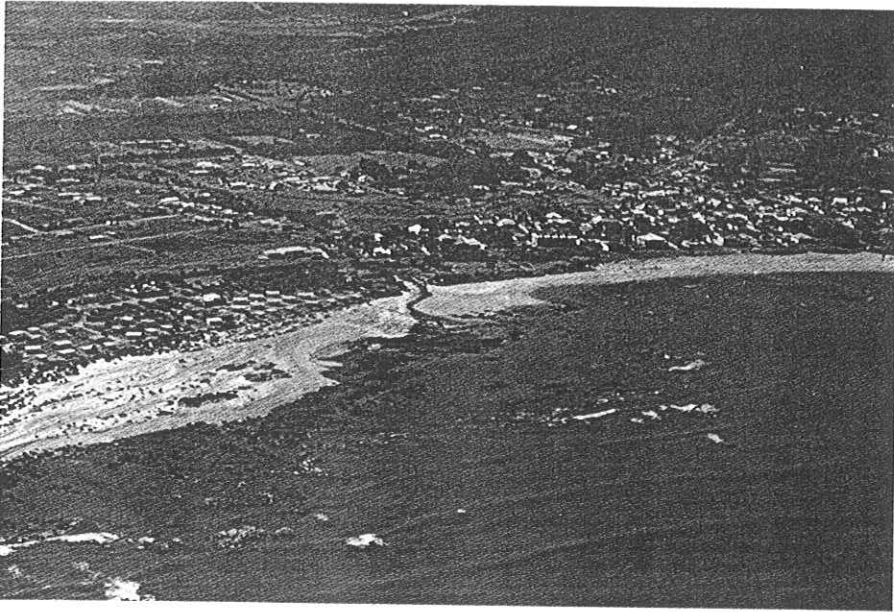
PLATE III:

The Sir Lowry's Pass Estuary taken from an altitude of 150 m. Note the channel meandering across the sandy beach behind the rocky infratidal zone (ECRU 79-08-15).
