SURFACE CONTACT FATIGUE FAILURES IN GEARS

P. J. L. FERNANDES and C. McDULING

Advanced Engineering and Testing Services, CSIR, Private Bag X28, Auckland Park 2006, South Africa

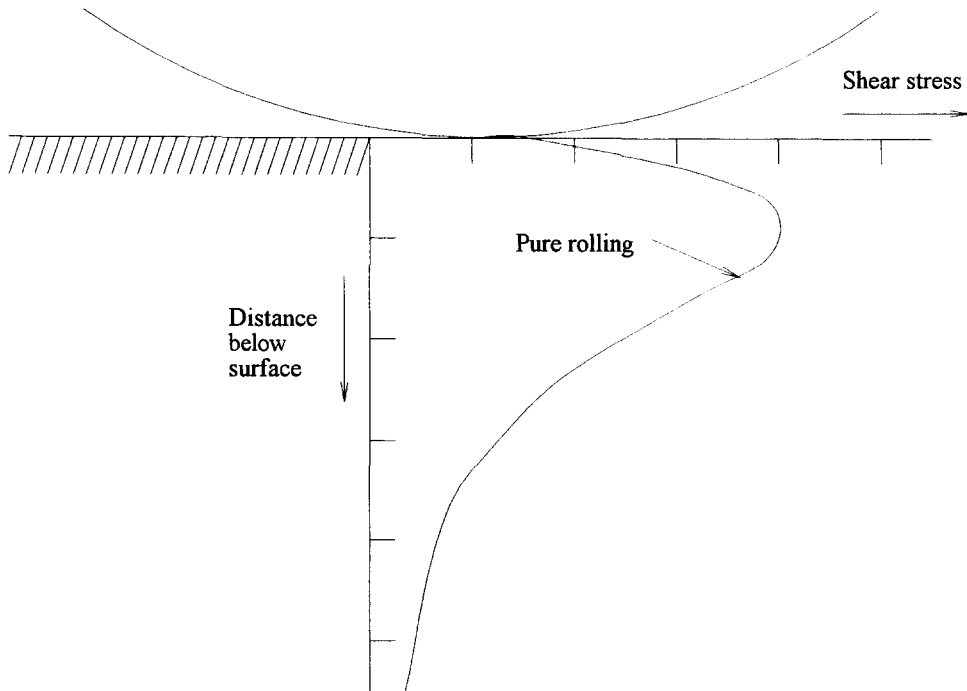
Fig. 1. Stress distribution at and near two contacting surfaces under pure rolling.

The stress distribution resulting from pure rolling conditions prevalent at the pitch-line is shown in Fig. 1. The maximum shear stress occurs at some distance, usually 0.18–0.3 mm [3], below the surface, and just ahead of the contact point. Cracks initiate at the point of maximum stress, and propagate essentially parallel to the surface. Continued rolling may cause the cracks to deviate up towards the contact surface, resulting in the removal of metal from the surface. The pits formed in this manner initially have sides perpendicular to the contact surface, as illustrated schematically in Fig. 2. Continued operation of the pitted surface, however, may cause a breakdown in the pit shape.

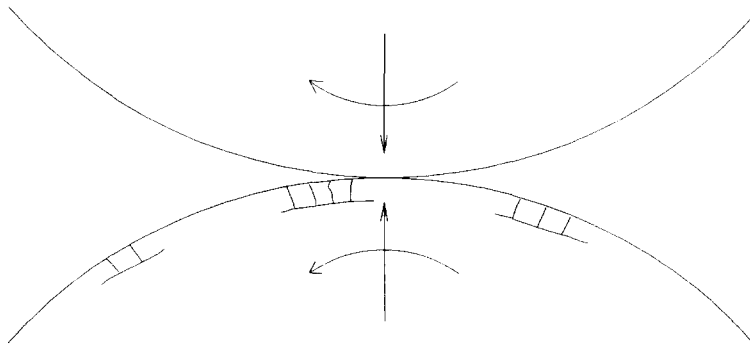
Fig. 2. Location and orientation of subsurface cracks under pure rolling conditions.

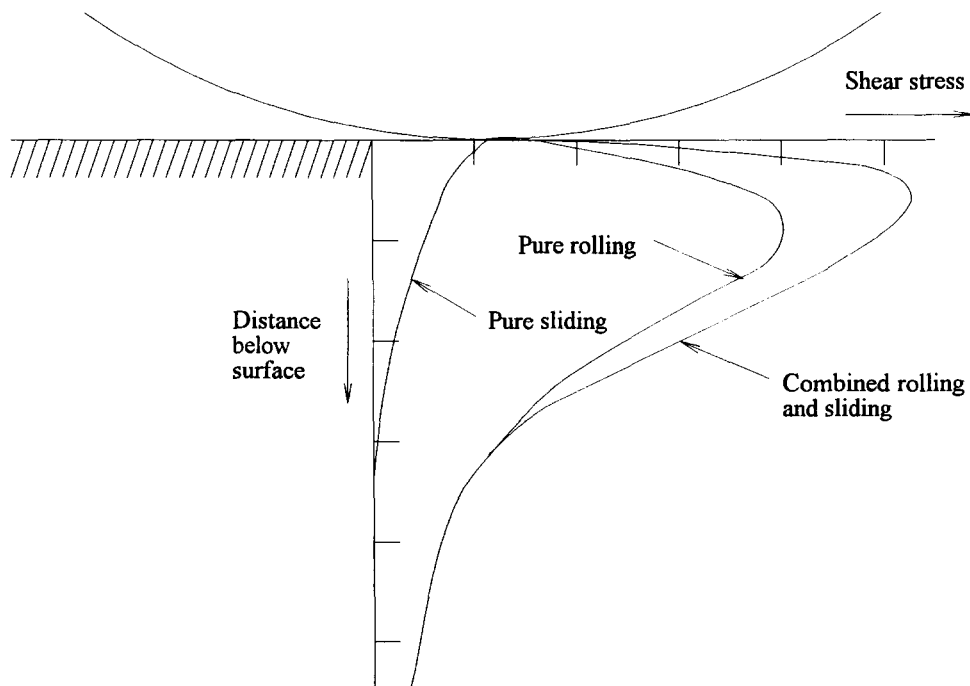
Pure rolling conditions prevail when the surface velocities of two contacting curved bodies are the same. However, if these velocities are different, an element of sliding is introduced which significantly alters the stress distribution in the surface and near-surface material. Depending on the relative velocities of the contacting bodies, rolling and sliding may occur in the same direction*—*positive sliding*—or in opposite directions—*negative sliding*. The effect of the latter is that the surface material is rolled in one direction, and pushed (sliding) in another, therefore resulting in higher stresses than those encountered in positive sliding [4]. The modified stress distribution in the surface and near-surface material resulting from combined rolling and sliding is shown in Fig. 3. The position of maximum shear stress is moved closer to the contacting interface, and crack initiation therefore occurs at the surface.

Fig. 3. Stress distribution at and near two contacting surfaces under sliding–rolling conditions.

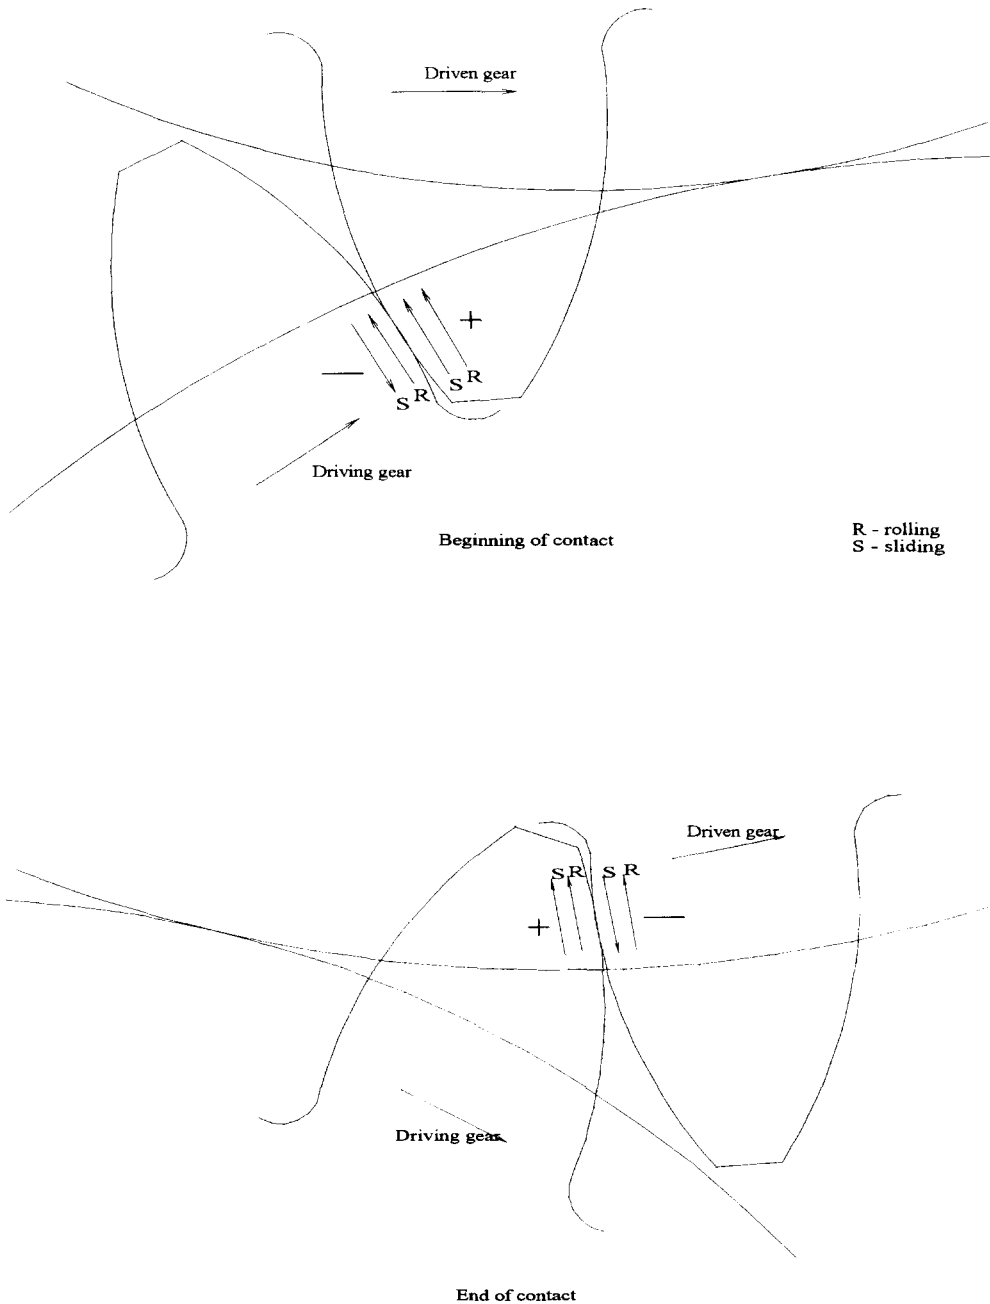
Gear teeth have complex combinations of sliding and rolling, which vary along the profile of each tooth, as illustrated in Fig. 4. In the addendum, the direction of rolling and sliding is the same, and positive sliding conditions therefore prevail. In the dedendum, however, the direction of rolling is opposite to that of sliding, and negative sliding conditions exist. Contact fatigue is therefore more likely to initiate in the dedendum, and pitting in this region is usually very severe, and often acts as a precursor to tooth bending fatigue [1].

Fig. 4. Combination of sliding and rolling in gear teeth.
