# SIMRAC

## Final Project Report

**Title:** DETERMINE THE NEED TO RESEARCH THE TIME-RELATED STABILITY DECAY OF BORD AND PILLAR SYSTEMS

**Project No:** COL 439

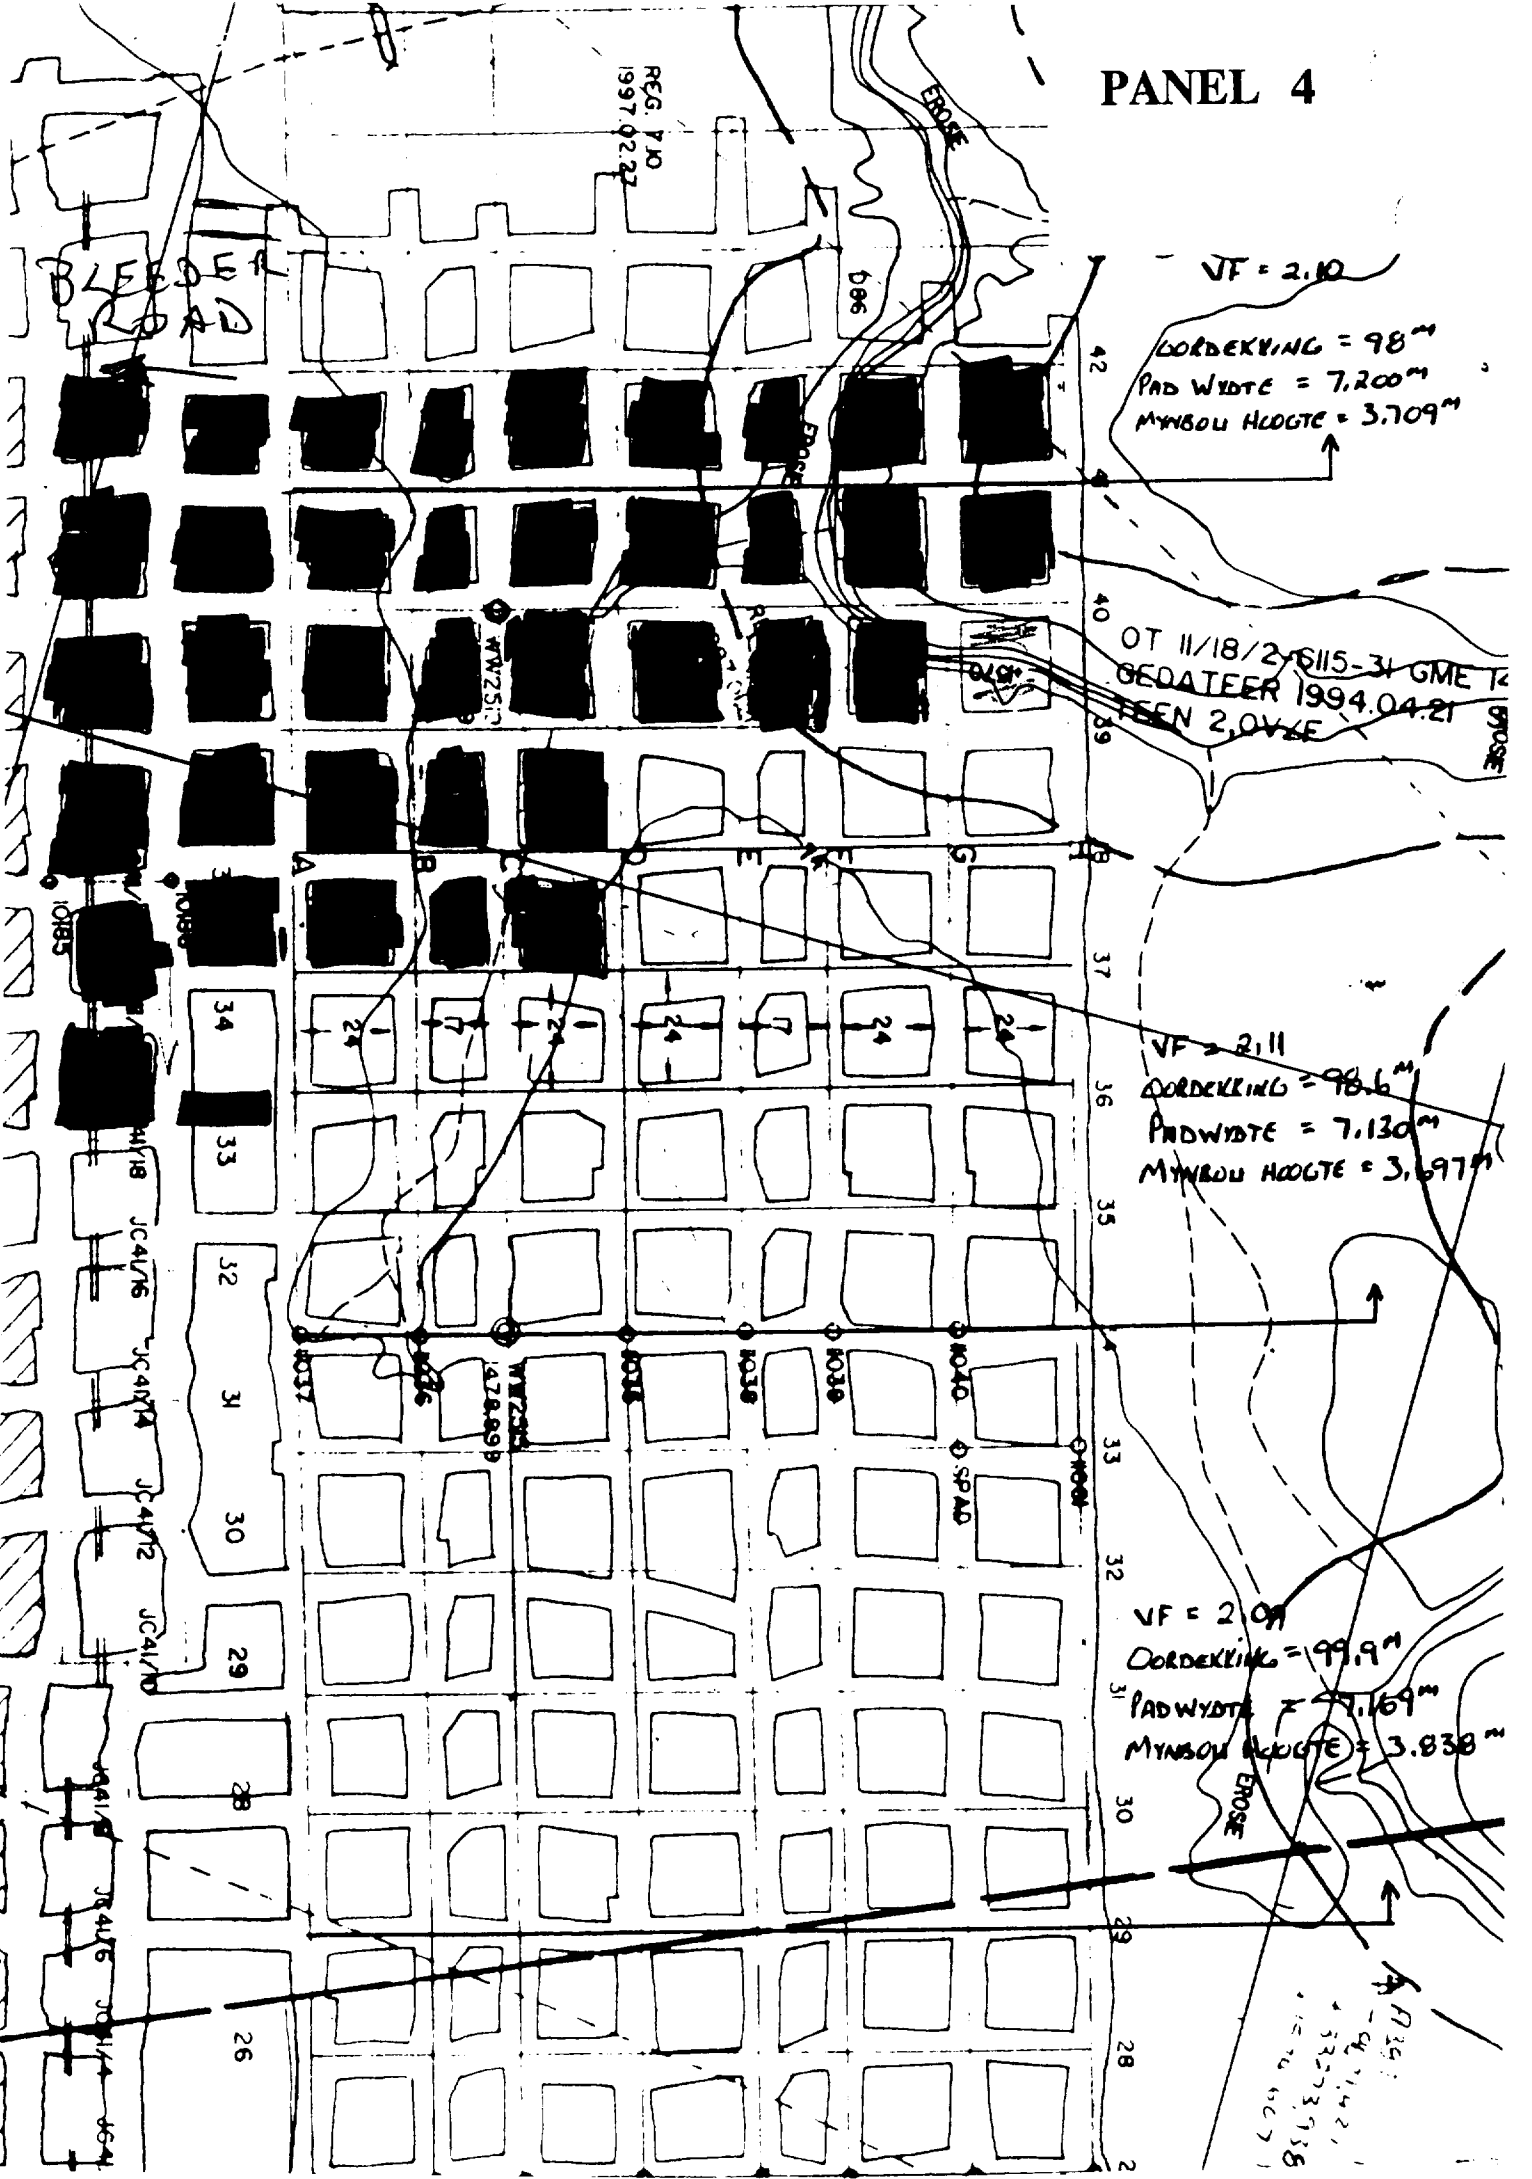
# PANEL 4

No scaling was observed of the pillar sidewalls or corners either near the goaf line or further back. The roof also showed no deterioration at that stage.

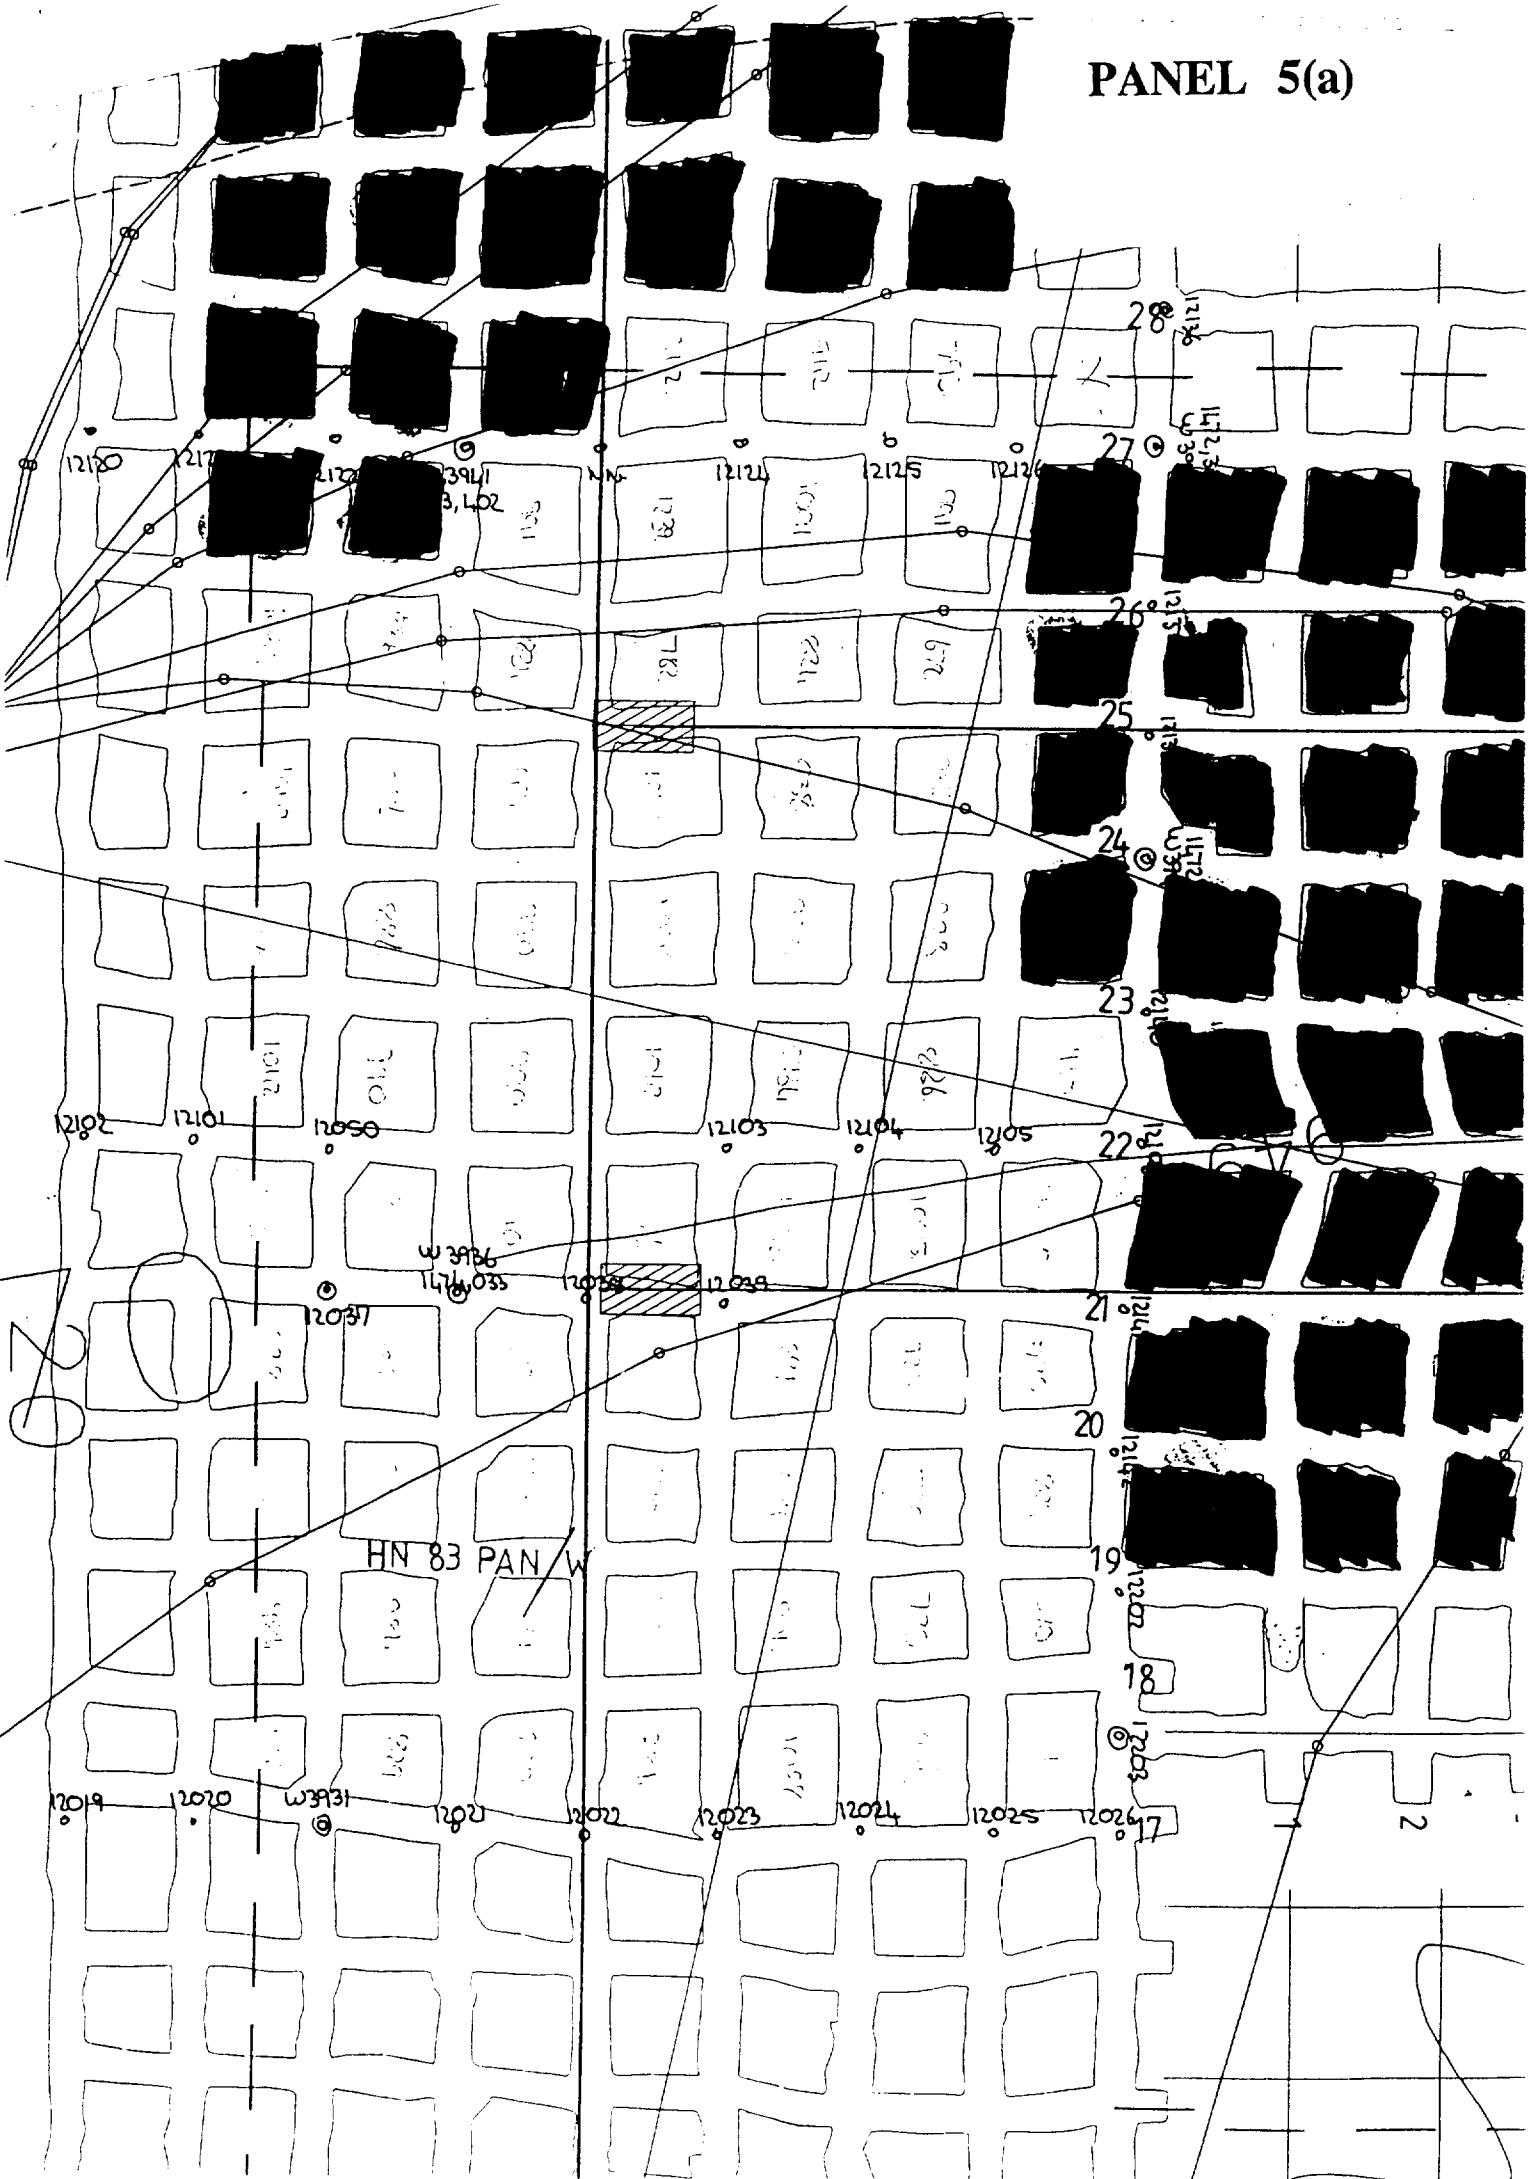
PANEL 5(a)

The significance and danger of critical pillar sizes which defines the safety factor was well illustrated by the pillar behaviour of this panel. The stress distribution on the pillars rapidly reduced from the first to the second line of pillars from the goaf.

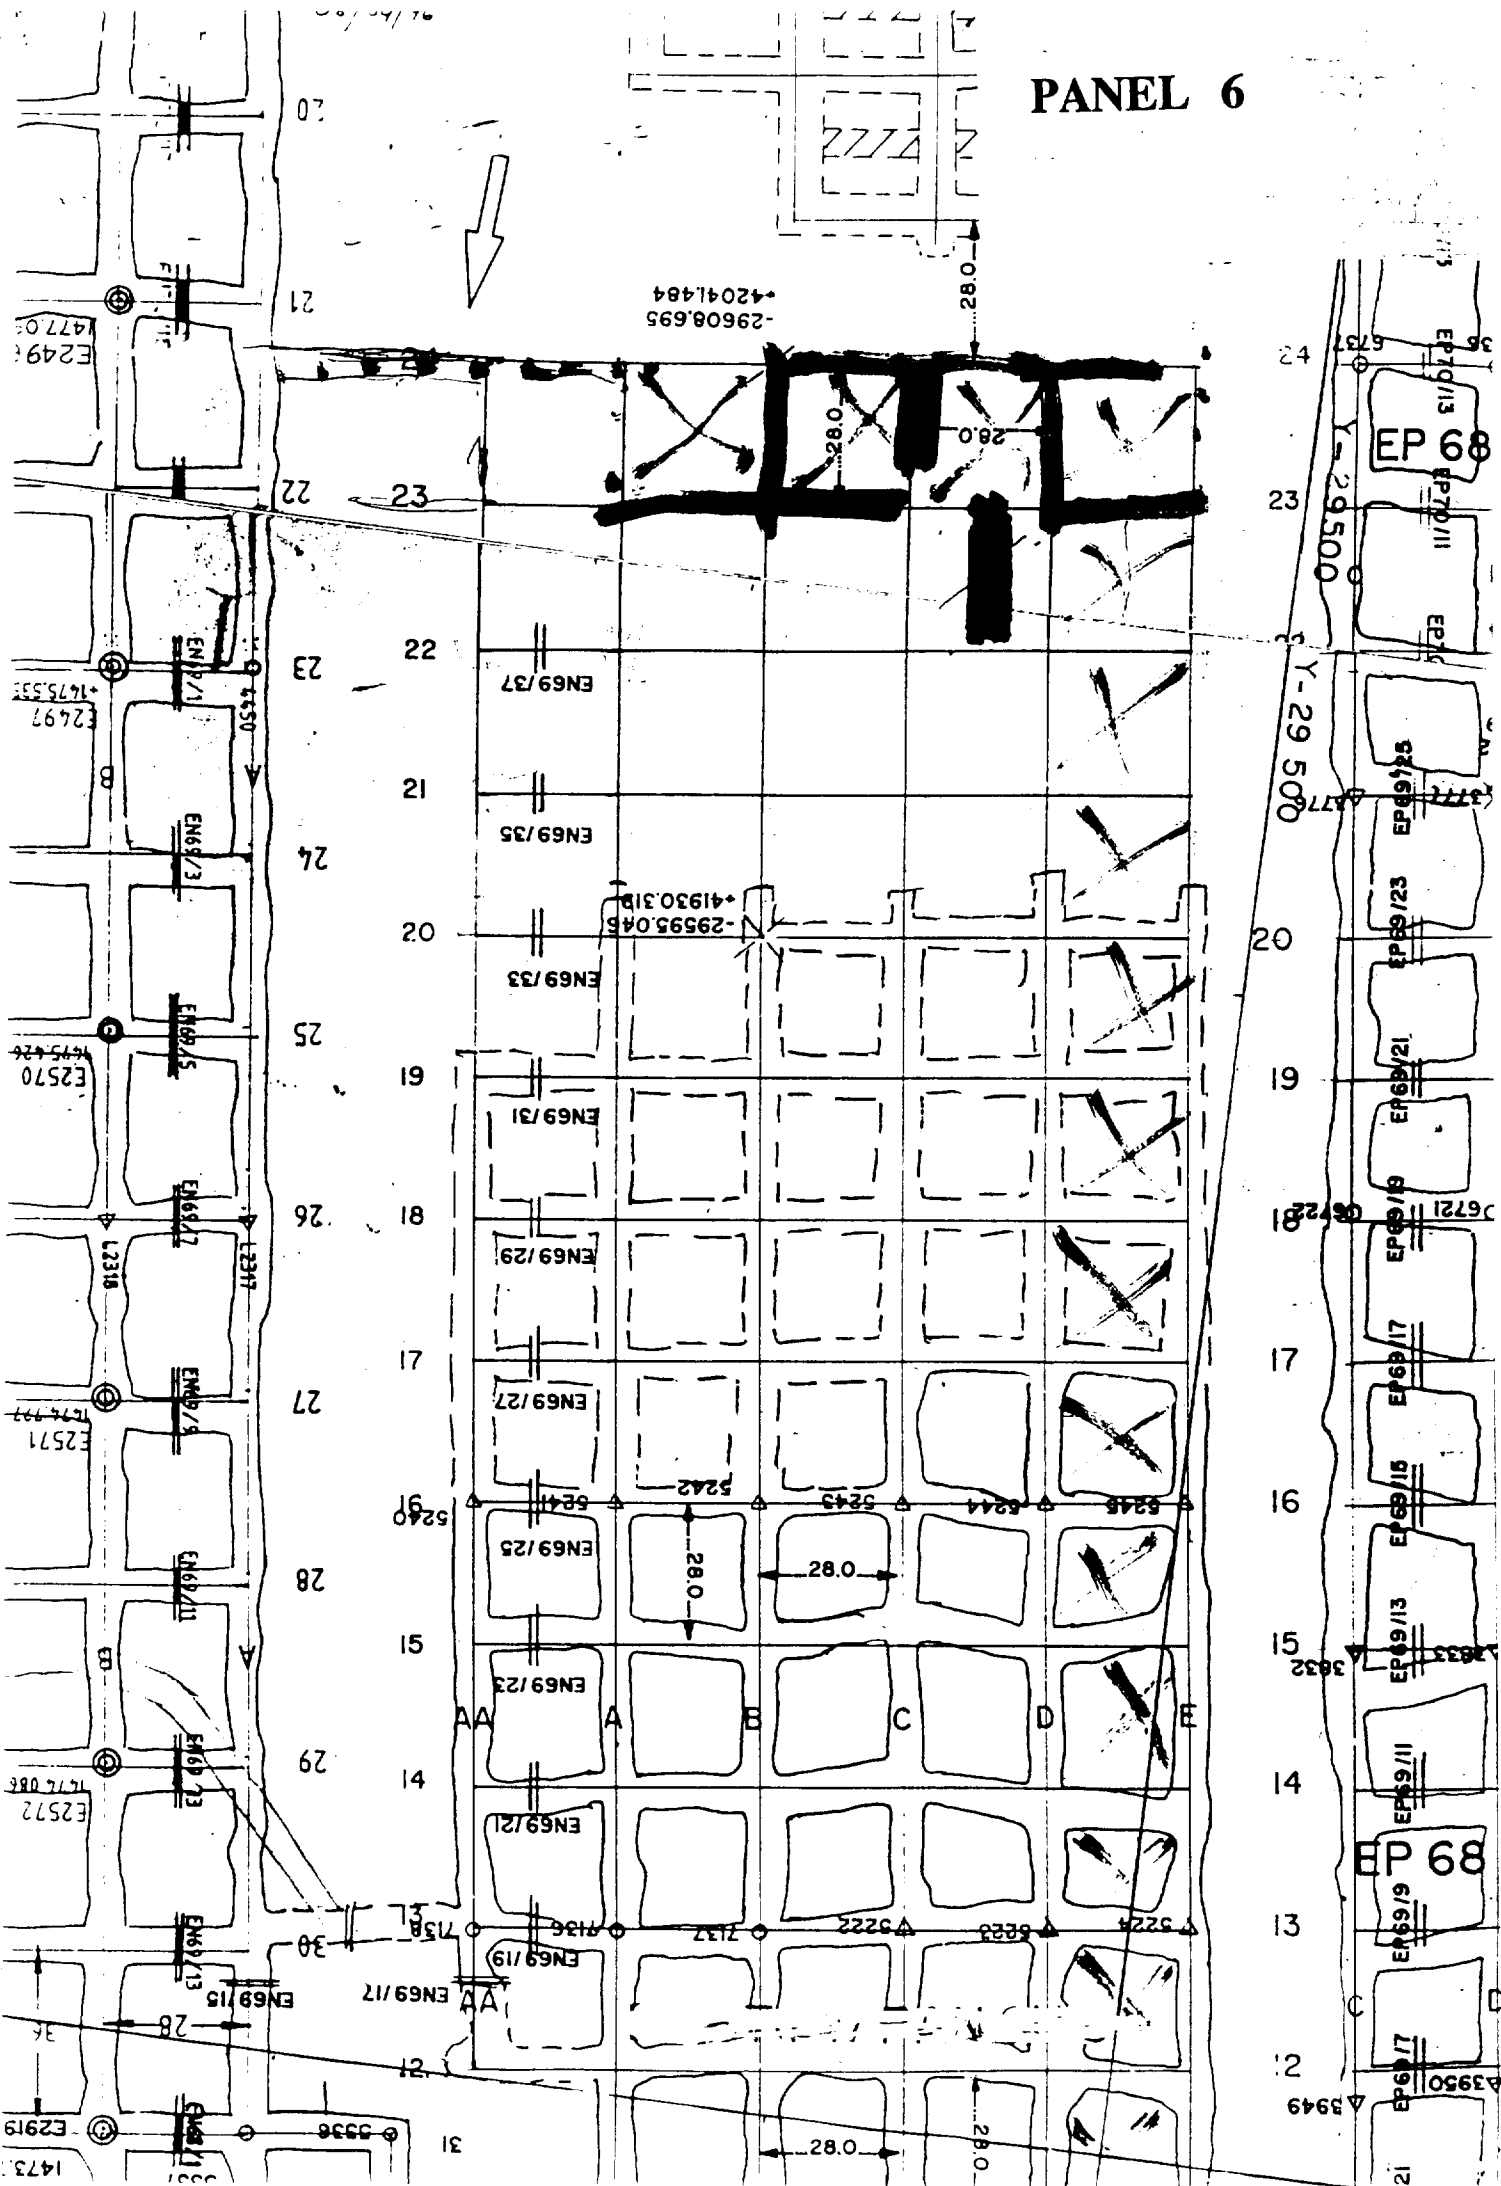
PANEL 6

As a result of the limited seam height no coal was left in the roof during mining. The immediate roof consisted of  $\pm$  20cm shaly sandstone which tend to dislodge in places. This could cause some problems during pillar extraction. At places lateral cracks were also formed in the centre of the roads which would require additional roofbolts and barring.

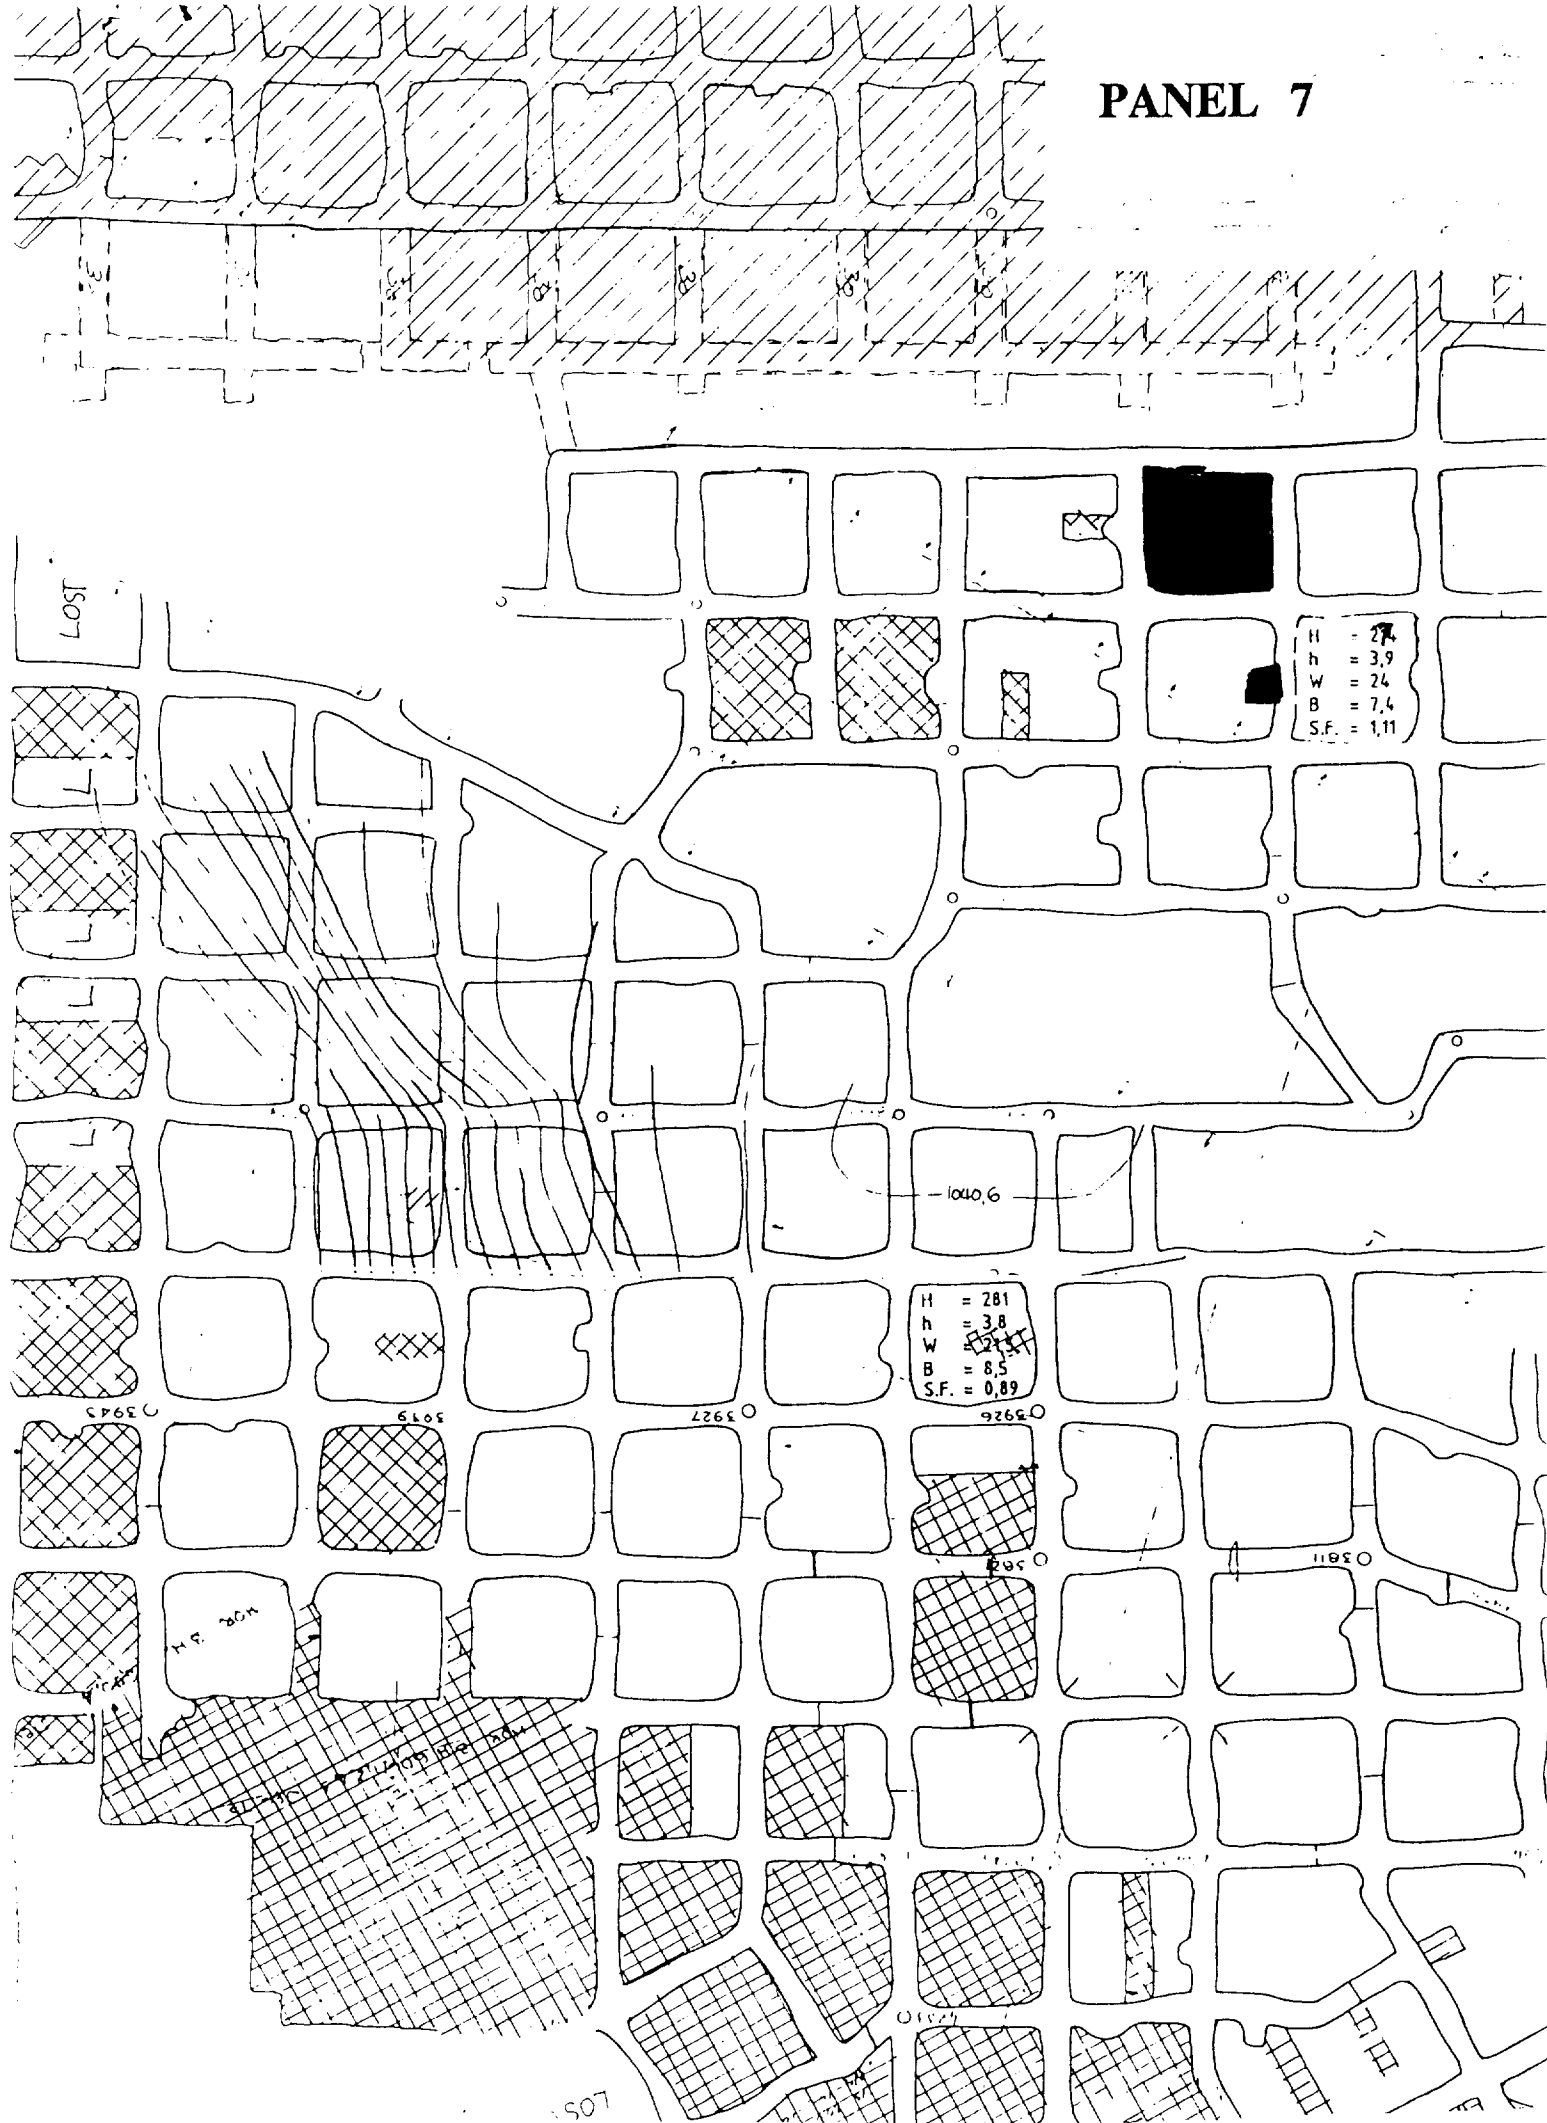
PANEL 7

The condition of the pillars in this panel illustrated the possible consequences of marginal safety factors and not allowing for possible additional abutment stresses.

H = 27  
 h = 3,9  
 W = 24  
 B = 7,4  
 S.F. = 1,11

H = 281  
 h = 3,8  
 W = 2,4  
 B = 8,5  
 S.F. = 0,89

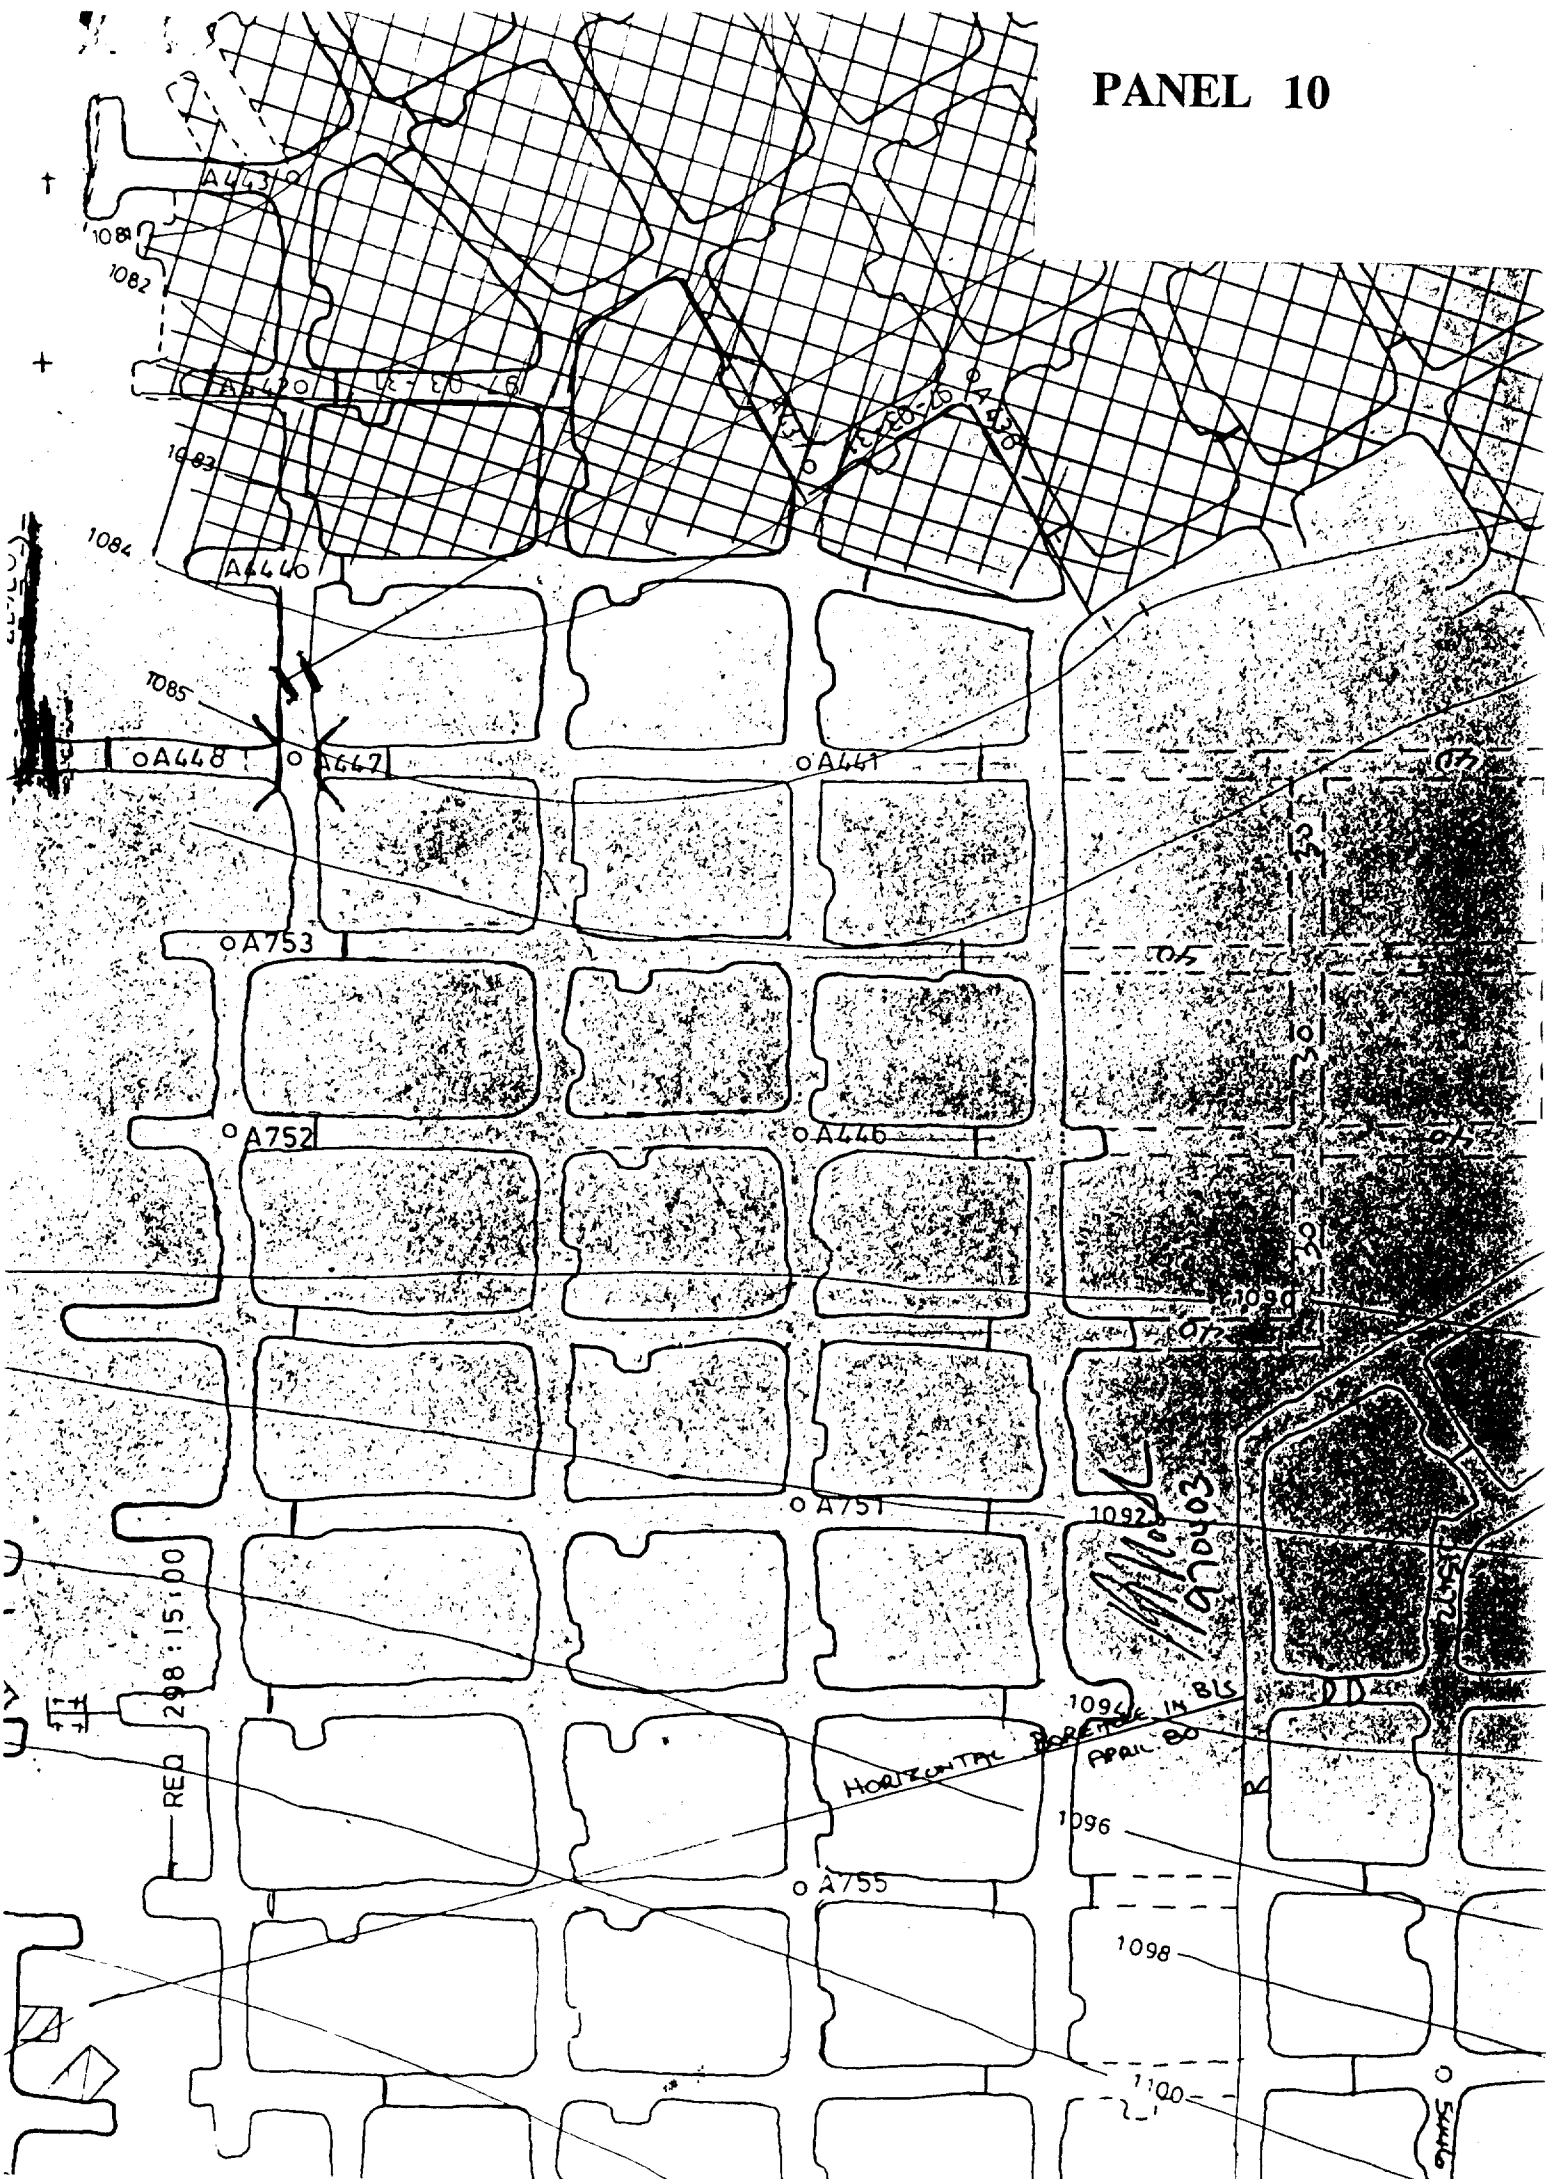
PANEL 10

Further back the conditions were as mined with occasional minor sidewall scaling

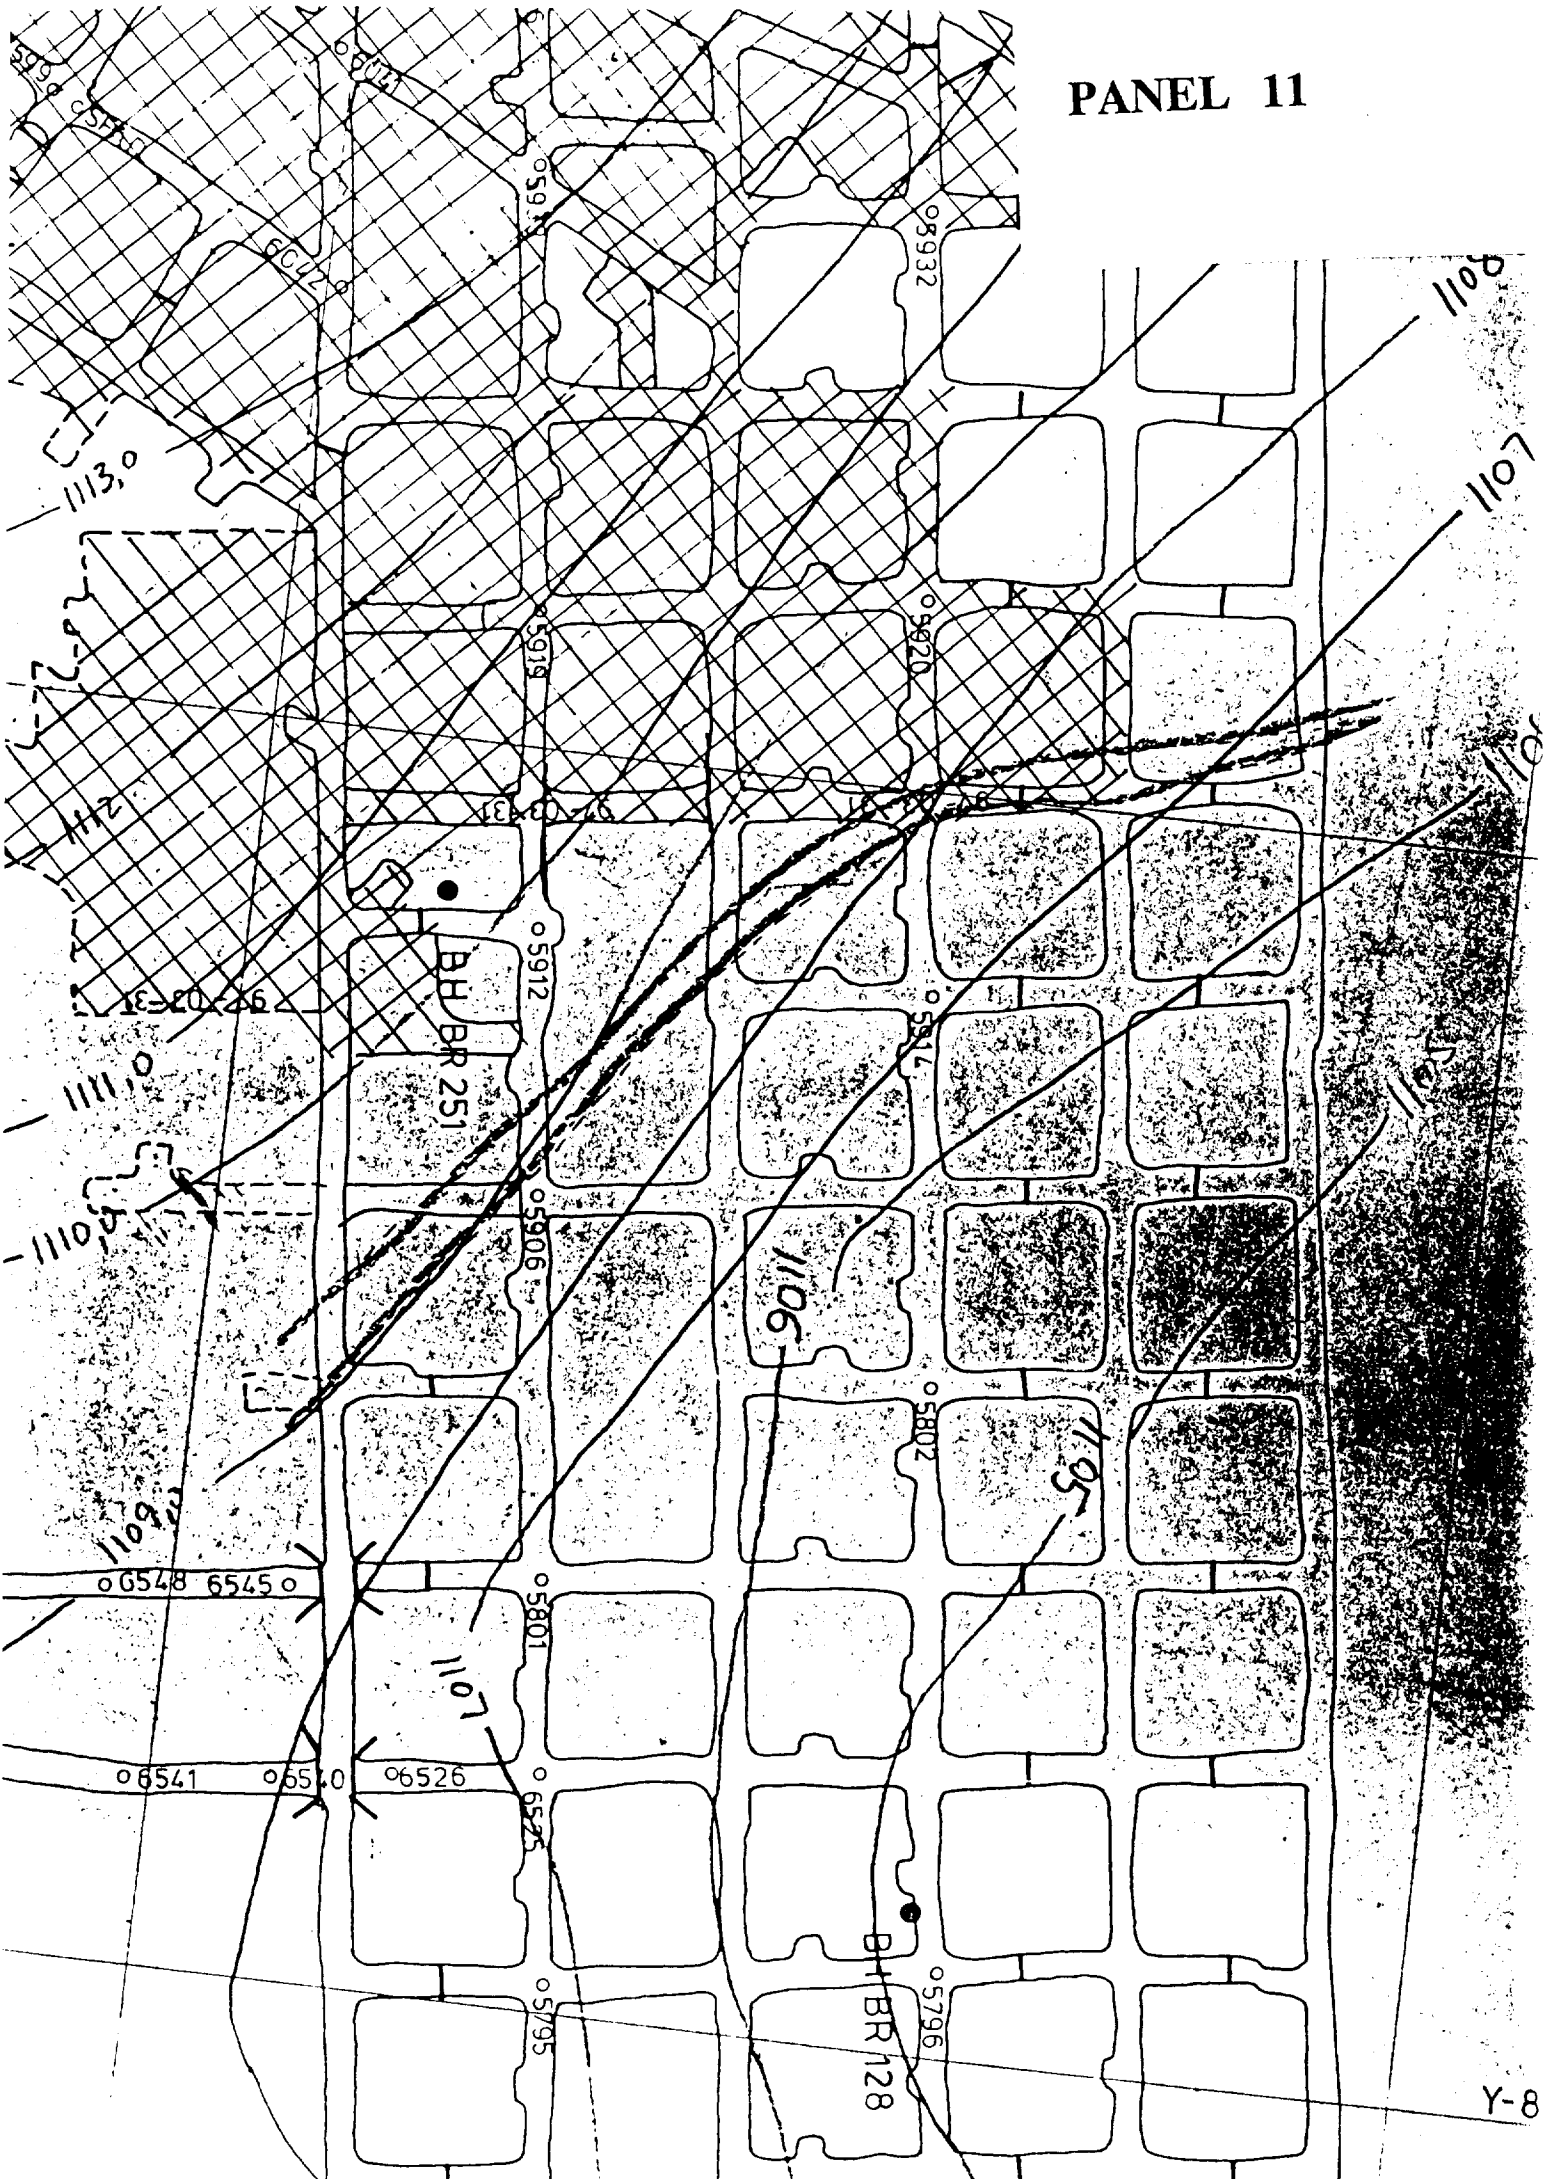
PANEL 11

Further back the pillars were as mined and unaffected by the stooping operations in front.
