# SIMRAC

## Final Project Report

**Title:** DETERMINE THE NEED TO RESEARCH THE TIME-RELATED STABILITY DECAY OF BORD AND PILLAR SYSTEMS

**Project No:** COL 439

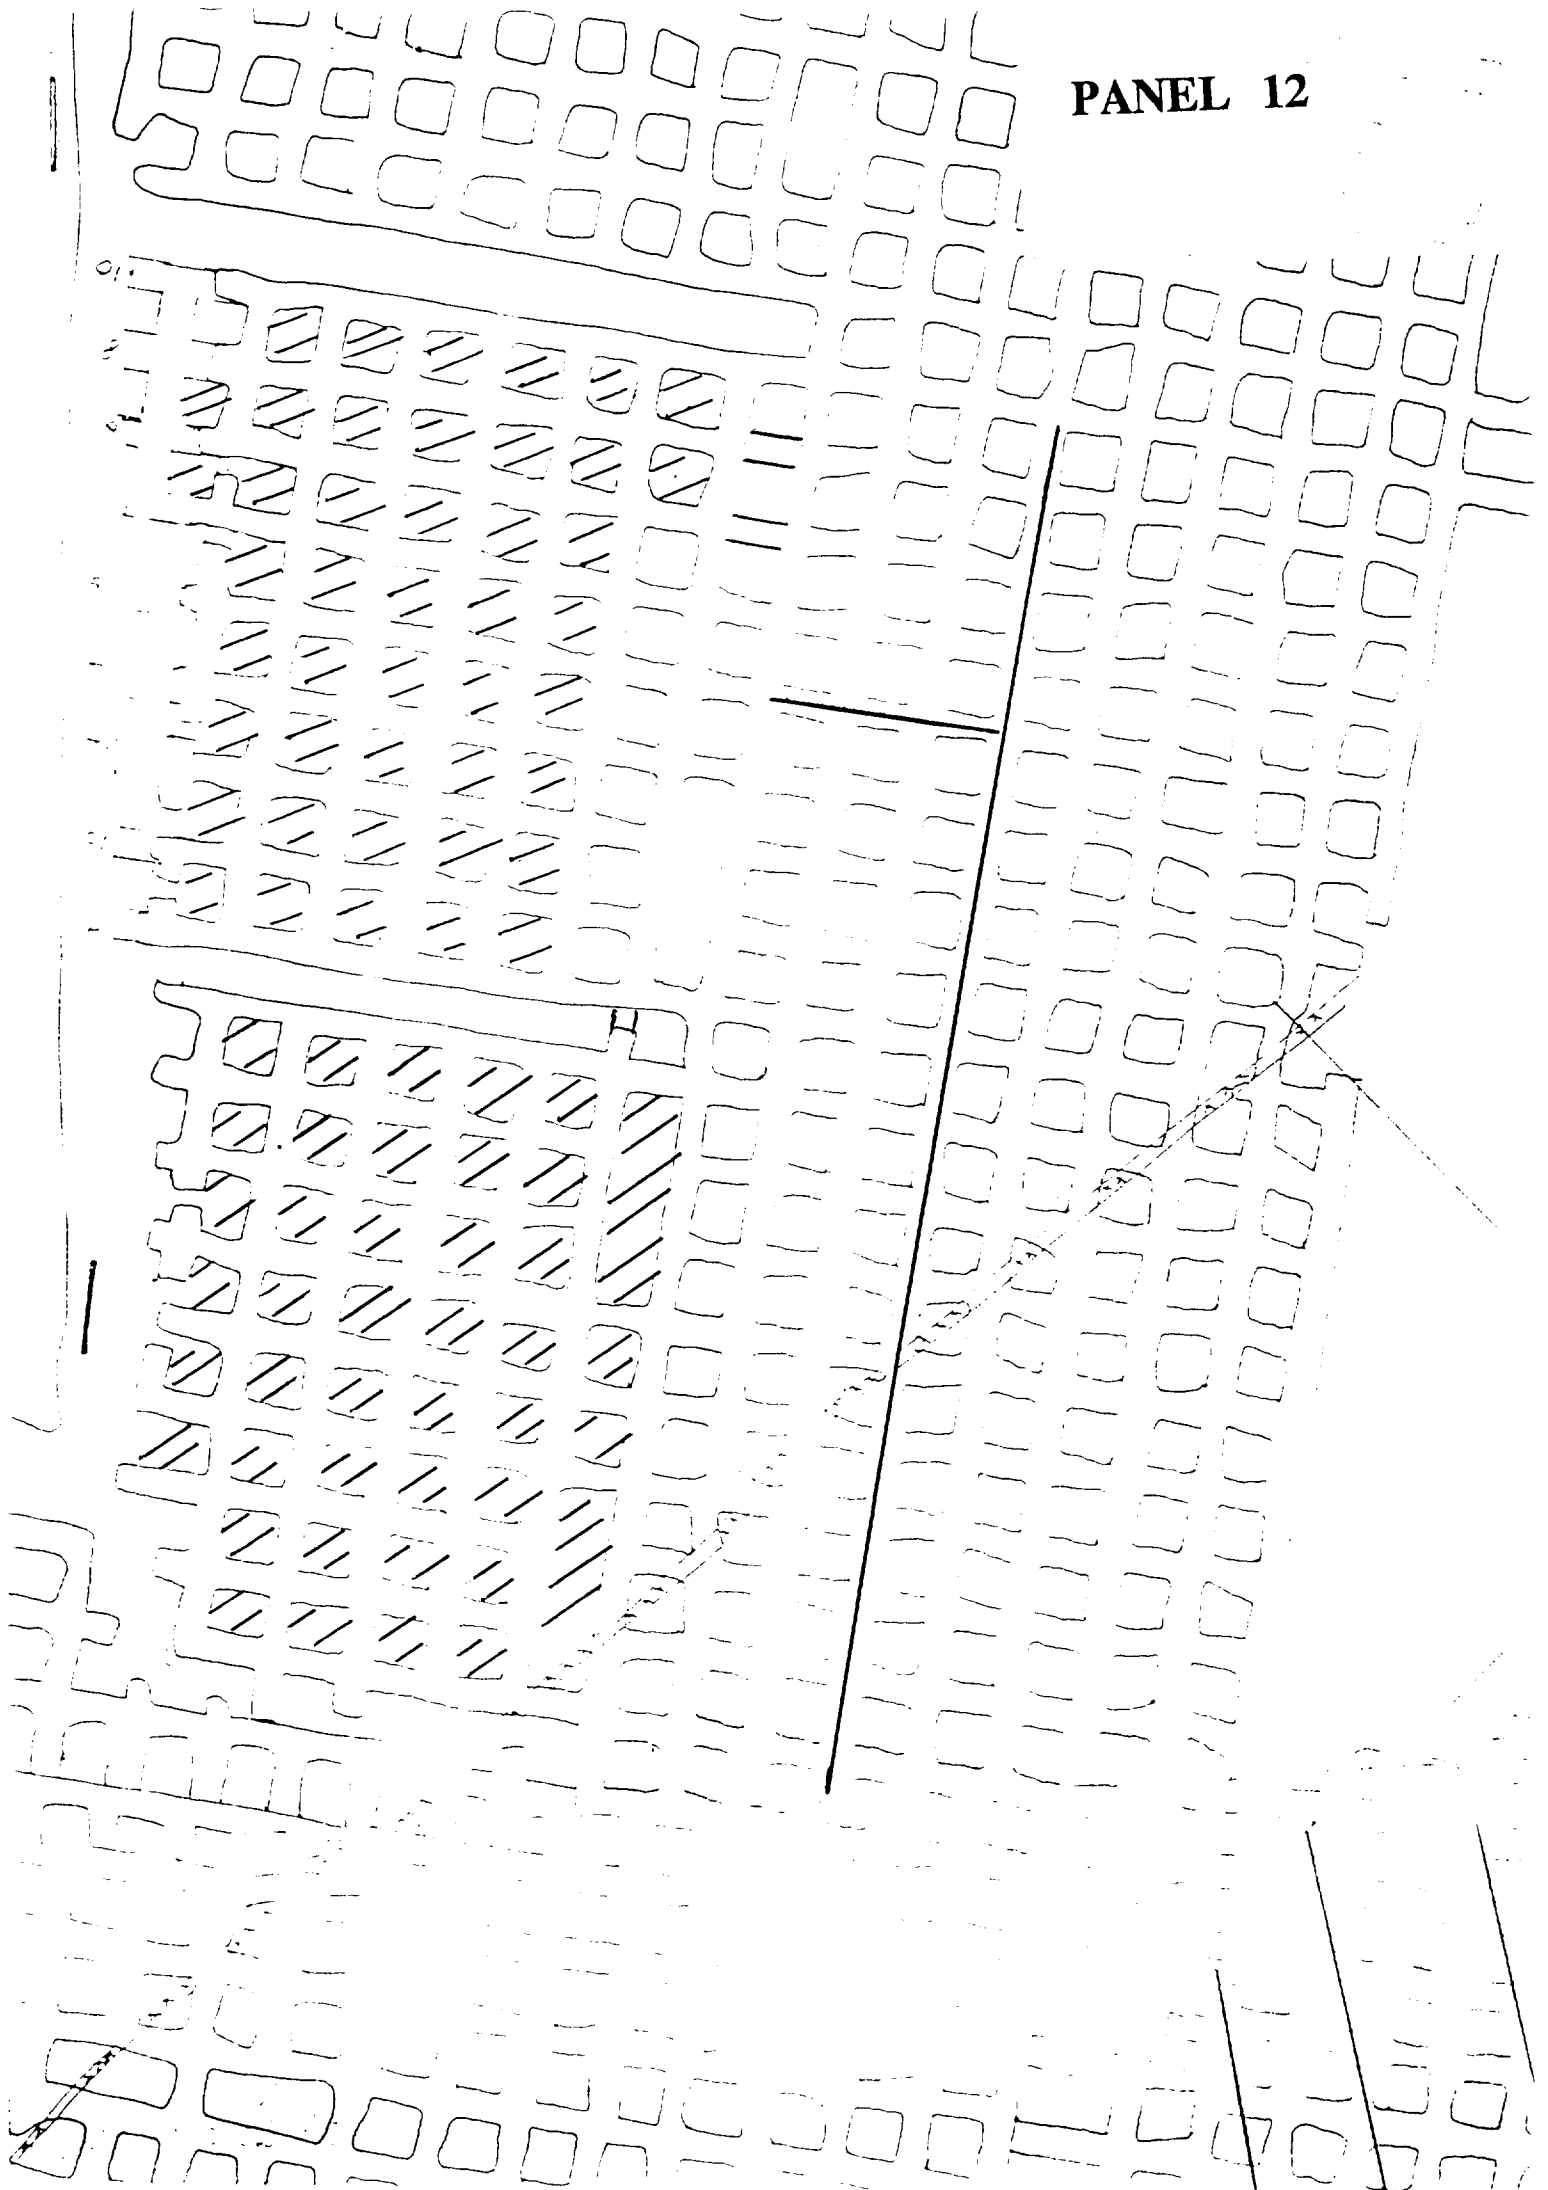
PANEL 12

Further back the condition of the pillars were good with no scaling observed.

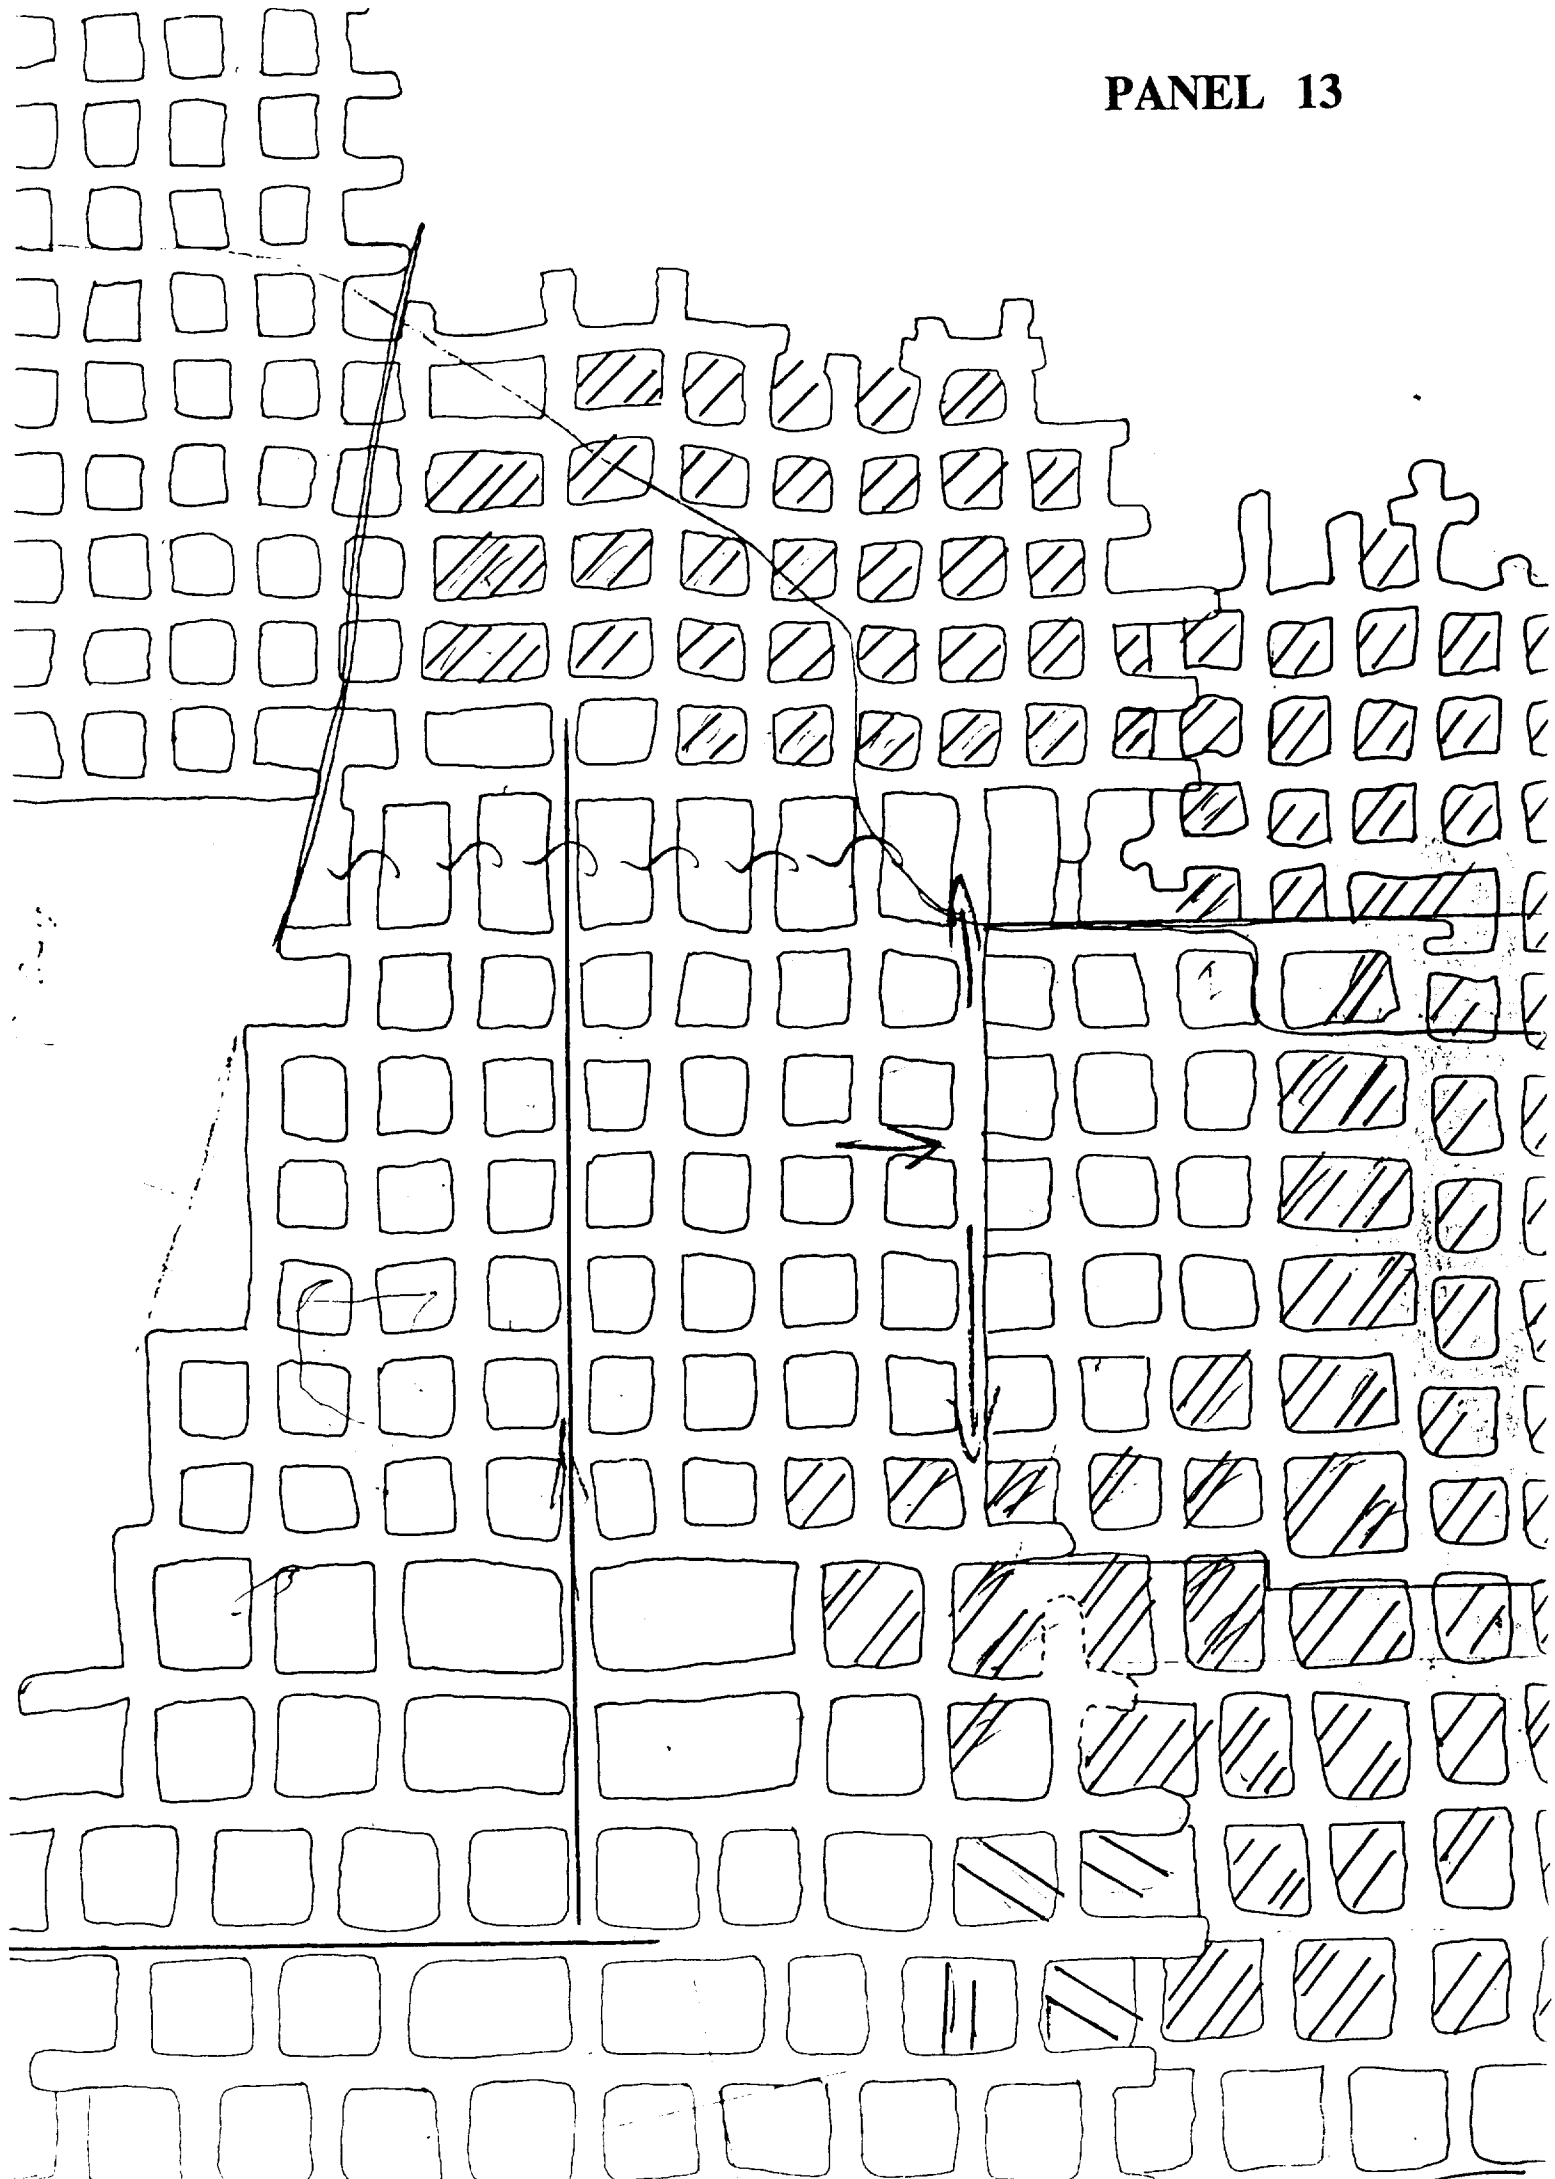
The pillars adjacent to the secondary mining were visually unaffected by the reduced sizes of pillars. No scaling of pillar sidewalls, corners or roof was observed.

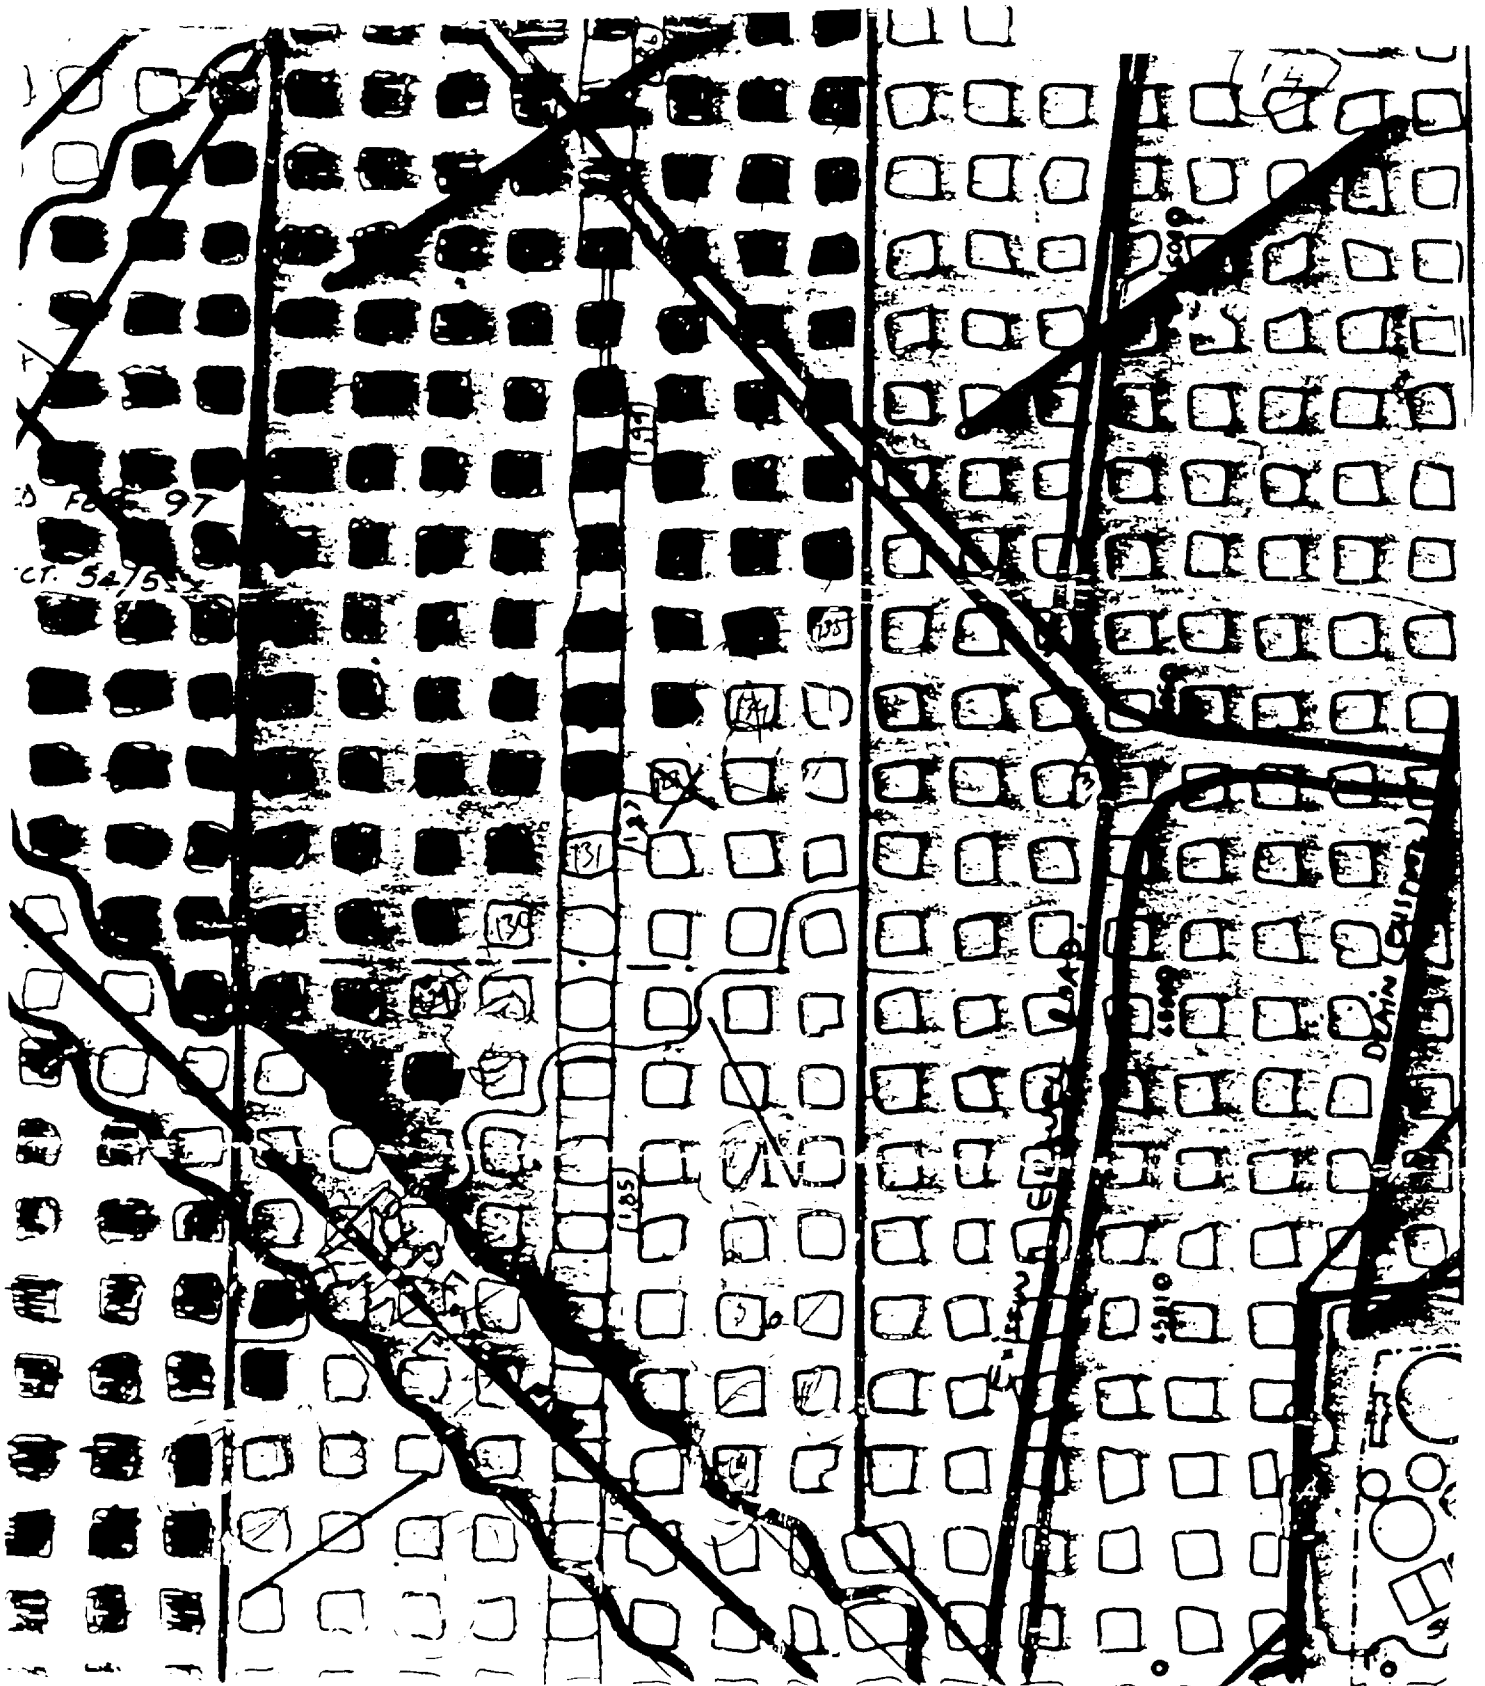
mined. Along the roof occasional scaling of a  $\pm 100$  mm false layer was observed.

Further back the conditions were observed to be similar with no scaling of the pillar sidewalls and corners but still some slight scaling of the roof. As far as could be seen with the limited vision no scaling occurred at the pillars left to protect the pipeline.
