EXAMINATION OF A FAILED FIFTH WHEEL COUPLING

P. J. L. FERNANDES

Abstract—Examination of a fifth wheel coupling which had failed in service showed that it had been modified and that the operating handle had been moved from its original design position. This modification completely eliminated the safety device designed to prevent inadvertent opening of the coupling locking mechanism. No alternative safety device was employed to ensure the safety of the modified design. Furthermore, the rubbing plate on the pup-trailer was significantly smaller than that on the fifth wheel, with the result that the load transfer conditions were not optimal. This may have resulted in excessive damage to the wearing components such as the locking jaw, the locking bar and the king pin. © 1998 Elsevier Science Ltd. All rights reserved.

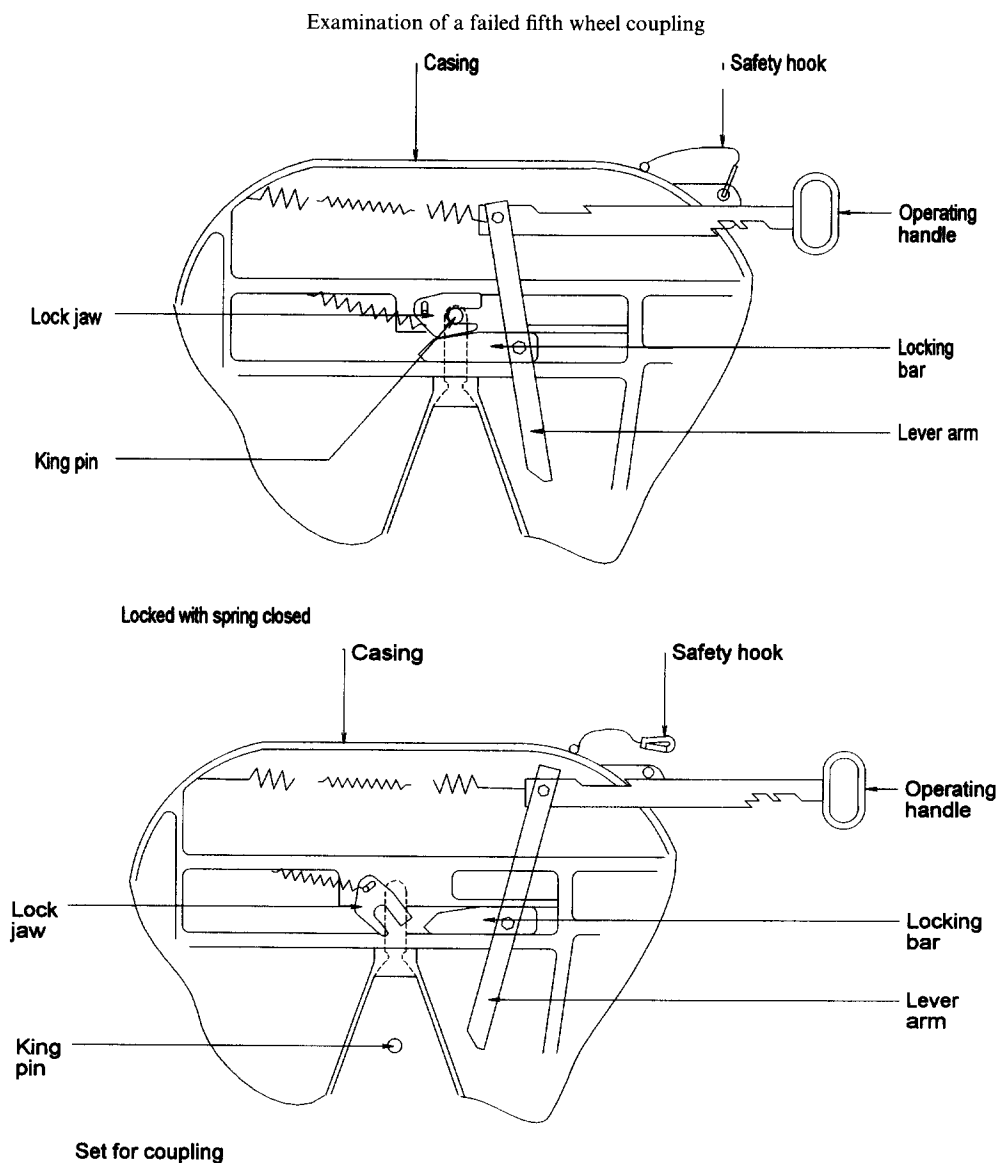
Fig. 2. A schematic diagram of the locking mechanism in a typical fifth wheel. (a) Locked with spring closed, and (b) set for coupling.

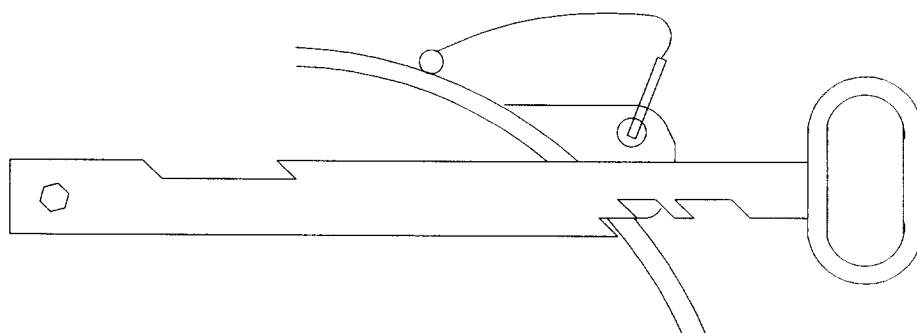
Fig. 3. A schematic diagram of the spring loaded hook arrangement which prevents the operating handle from opening.

Furthermore, it is also evident that in the modified condition there was no locking mechanism to prevent the operating handle-lever arm combination from moving and possibly opening the lock jaw during operation. Thus, the spring loaded safety device which had been rendered useless by the modification had not been substituted by a device performing an equivalent function in the modified design. The importance of this safety device was discussed in detail in the previous section, and, as such, this modification can be expected to seriously reduce the safety and integrity of the coupling system.
