Safety in Mines Research Advisory Committee

DRAFT FINAL REPORT

**Improvement of worker safety through
the investigation of the site response
to rockbursts**

Research agency : CSIR: Division of Mining Technology

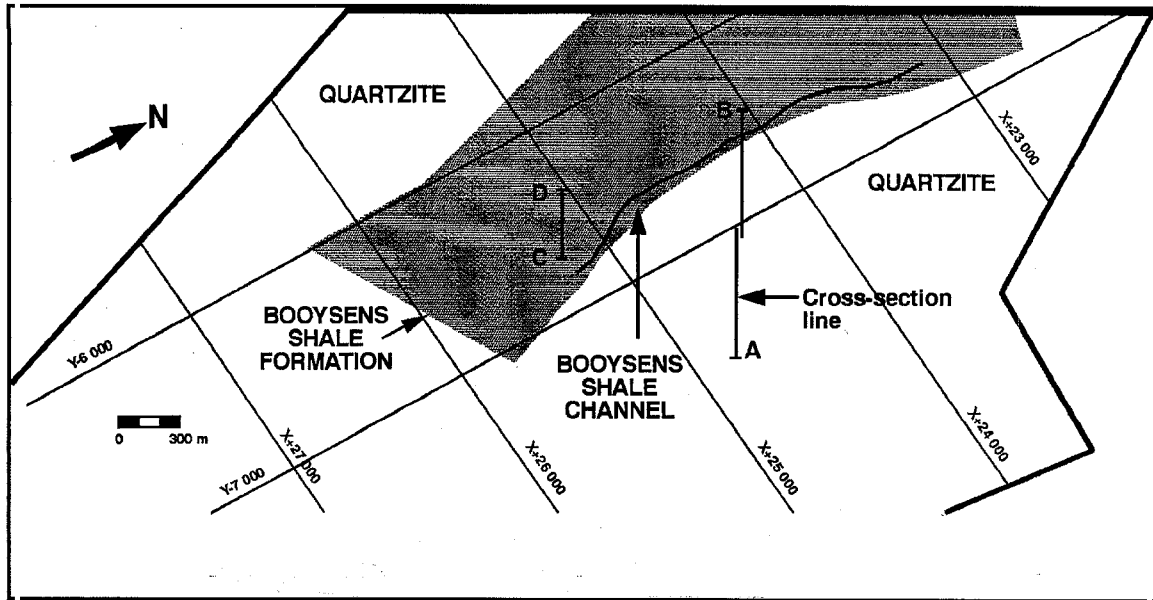
Figure B.1(a) Map of Leeudoorn Gold Mine showing the sub-outcrop of the Booyens Shale Formations and the locations of the cross-sections used to construct the composite cross-section shown in Figure B.1 (b).

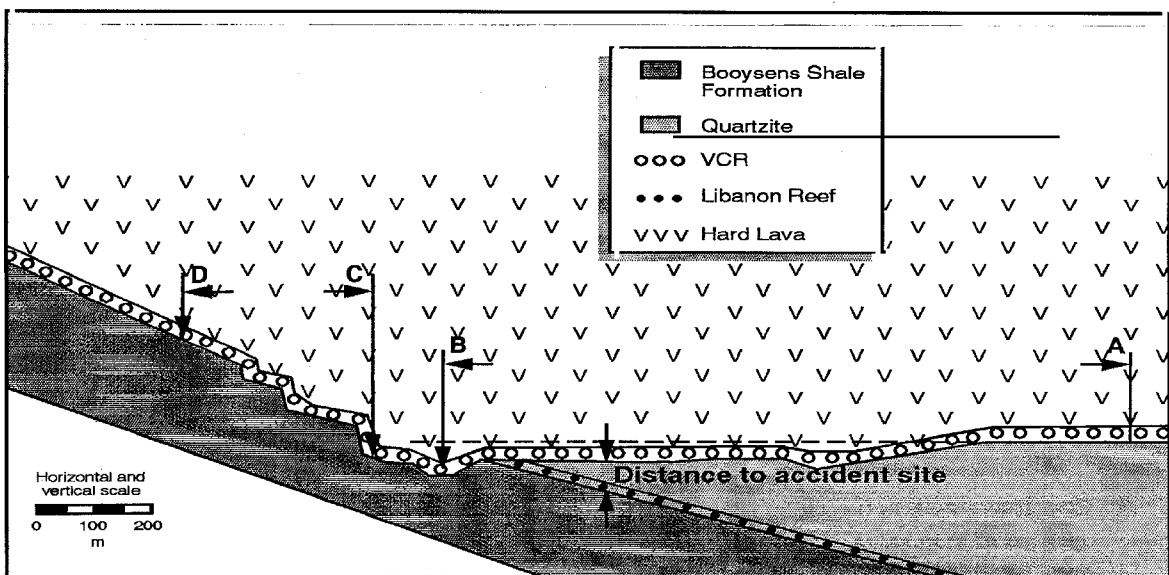
Figure B.1 (b) Composite geological cross-section of Leeudoorn Gold Mine. The VCR slope in which the accident occurred is situated about 80 m above the quartzite/shale contact.

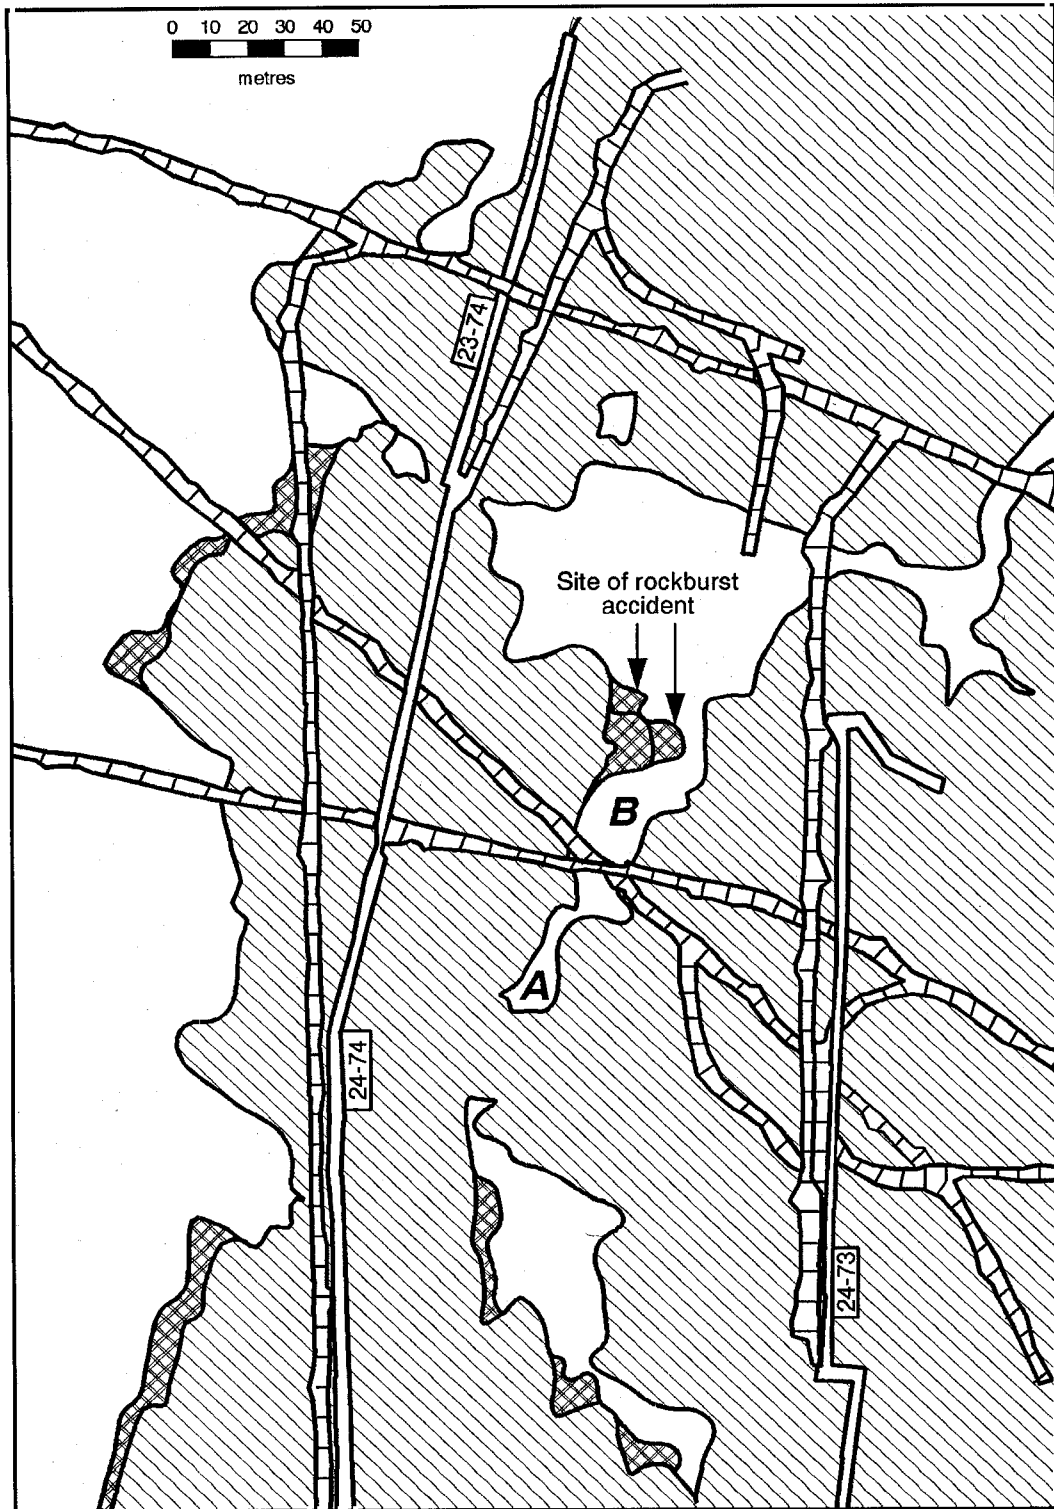
Figure B.2 Map showing the site of the rockburst on 10 January 1994 damaging the 24-74 stope, Leeudoorn Gold Mine. Mined out areas are indicated by diagonal lines. Areas of active mining are cross-hatched.

A rockburst occurred several months earlier in the same remnant, 50 m to the south of the current fatality site. The site of this rockburst is labelled A in Figure B.2. Failure of this part of the pillar would have increased the load on the remaining 600 m² area of the remnant (area B in Figure B.2).

It is believed that the hazard posed by the remnant (pillar B in Figure B.2) was not recognised.

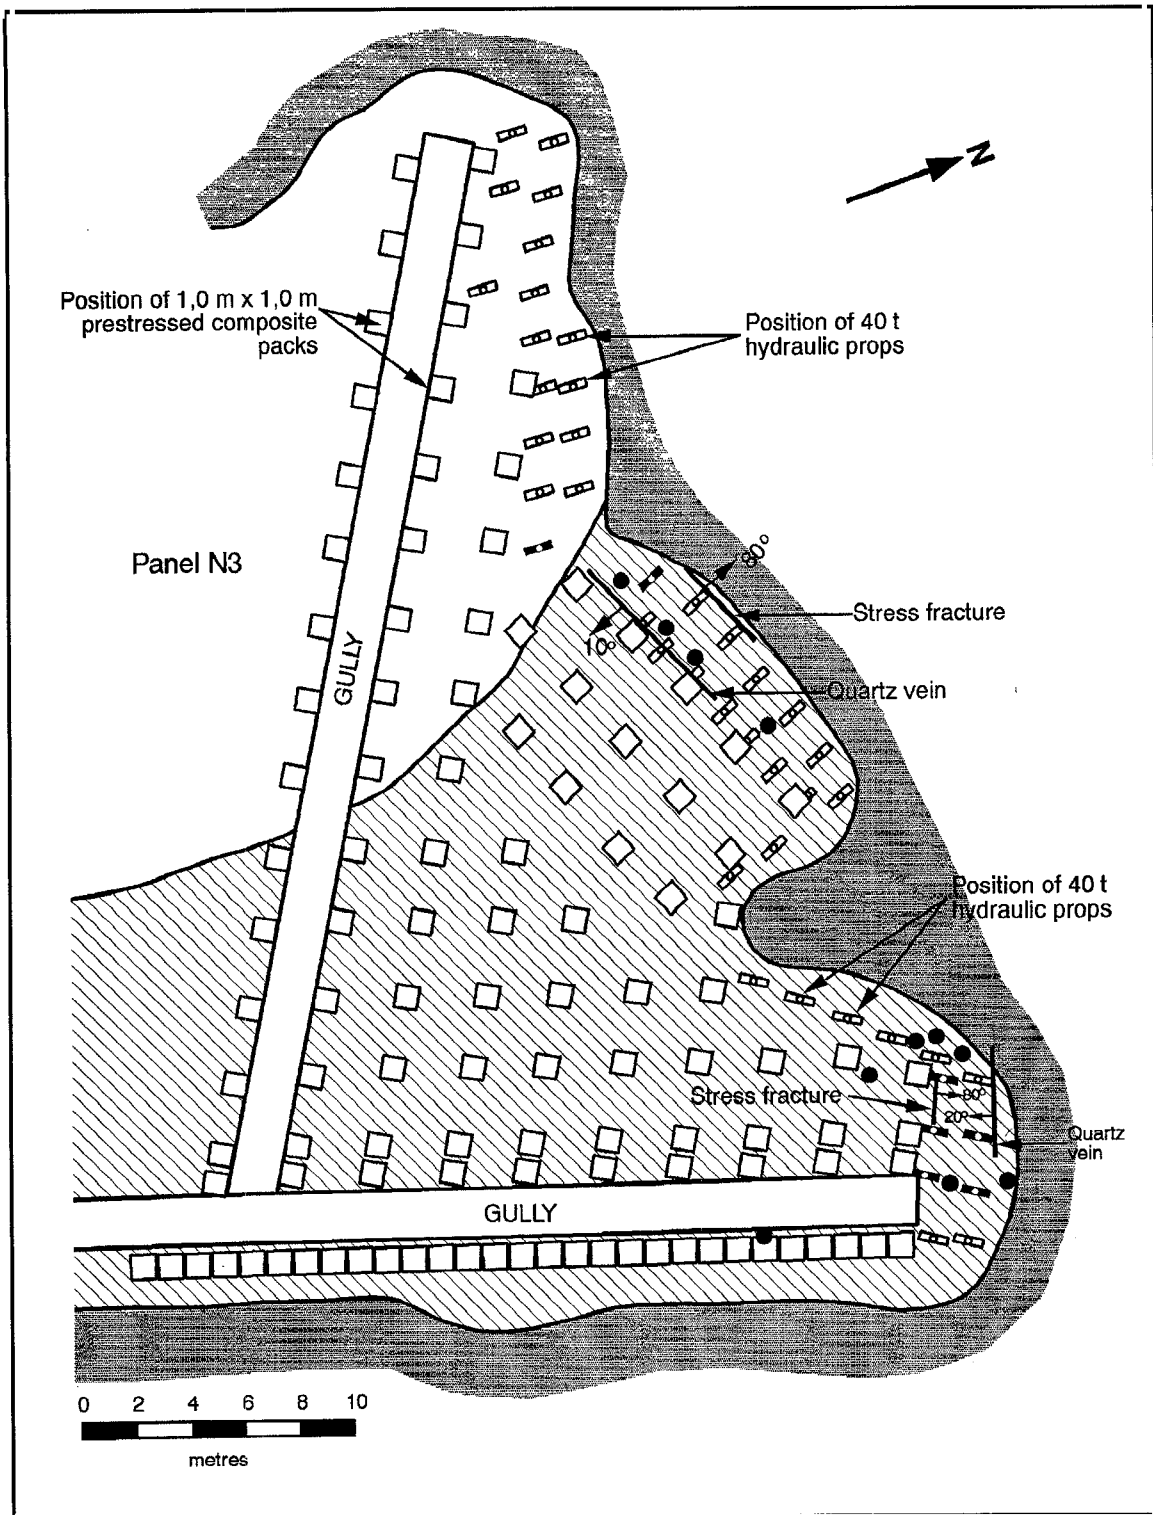
Figure B.4 Plan showing stope support. Solid circles indicate the positions of the fatalities.

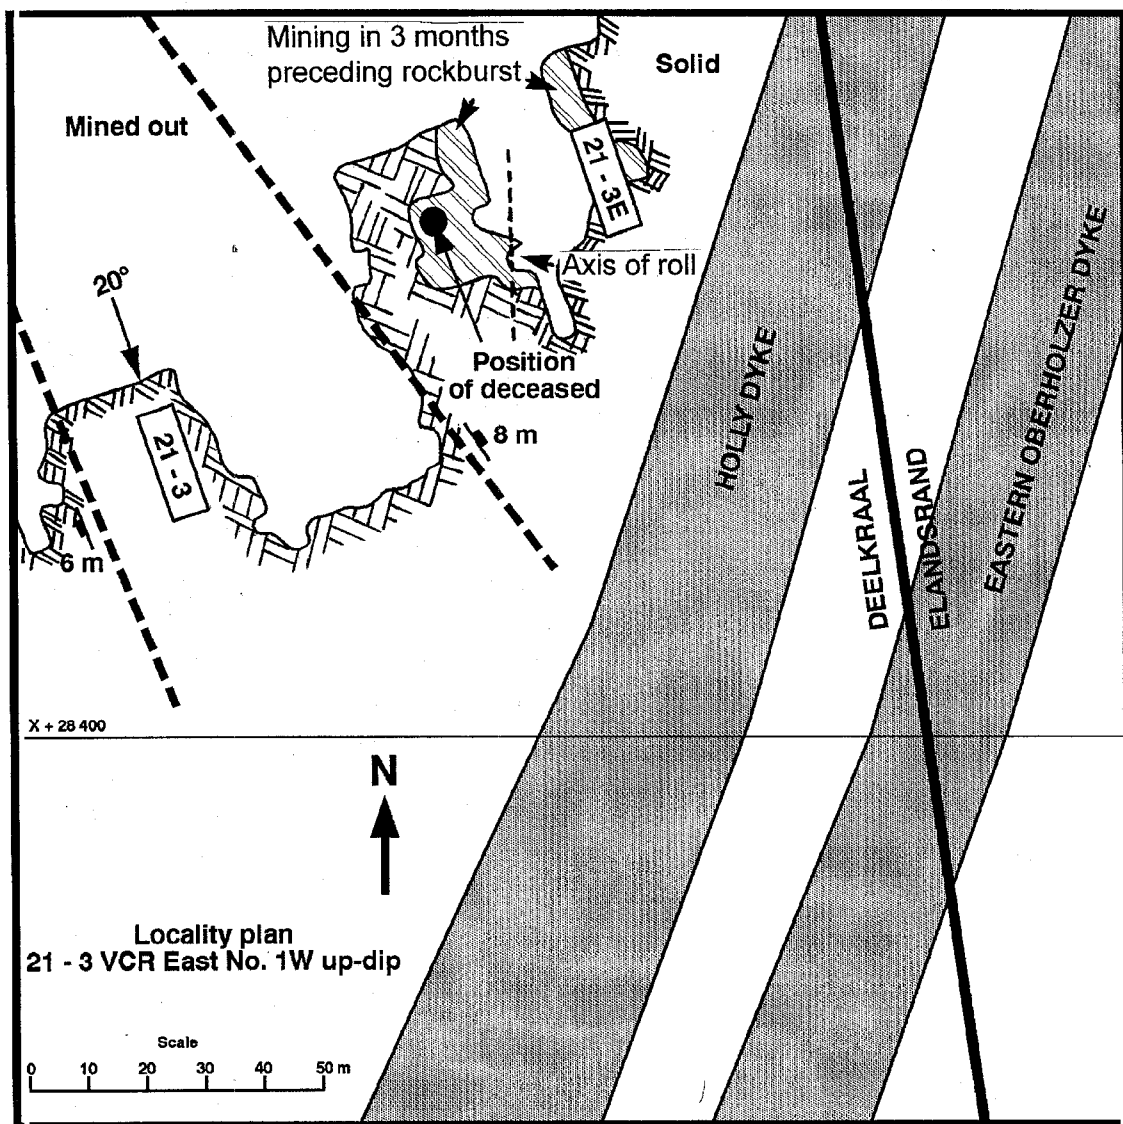
On 4 May 1994 a rockburst occurred at Deelkraal Gold Mine, damaging the 21-3E VCR stope and fatally injuring four workers in the 1W up-dip working place, 2294 m below surface (Figure B.5). The seismic network recorded a single seismic event at 09h49 with a local magnitude $M_L = 2,1$. At the request of Mr D. Bakker of the Department of Minerals and Energy, a team was mobilized to investigate the rock engineering aspects of the rockburst. The aim of the investigation was to determine the causes of the rockburst in order to prevent future occurrences. The site was visited on 9 May and 20 May 1994. The site was undisturbed apart from the rescue activities.

Figure B.5 Map of a portion of Deelkraal Gold Mine showing the site of the rockburst of 4 May 1994 and major geological features. Stopping in the 3 months preceding the accident is indicated by diagonal hatching. The 1W up-dip working place where the fatalities occurred is 2294 m below the surface.

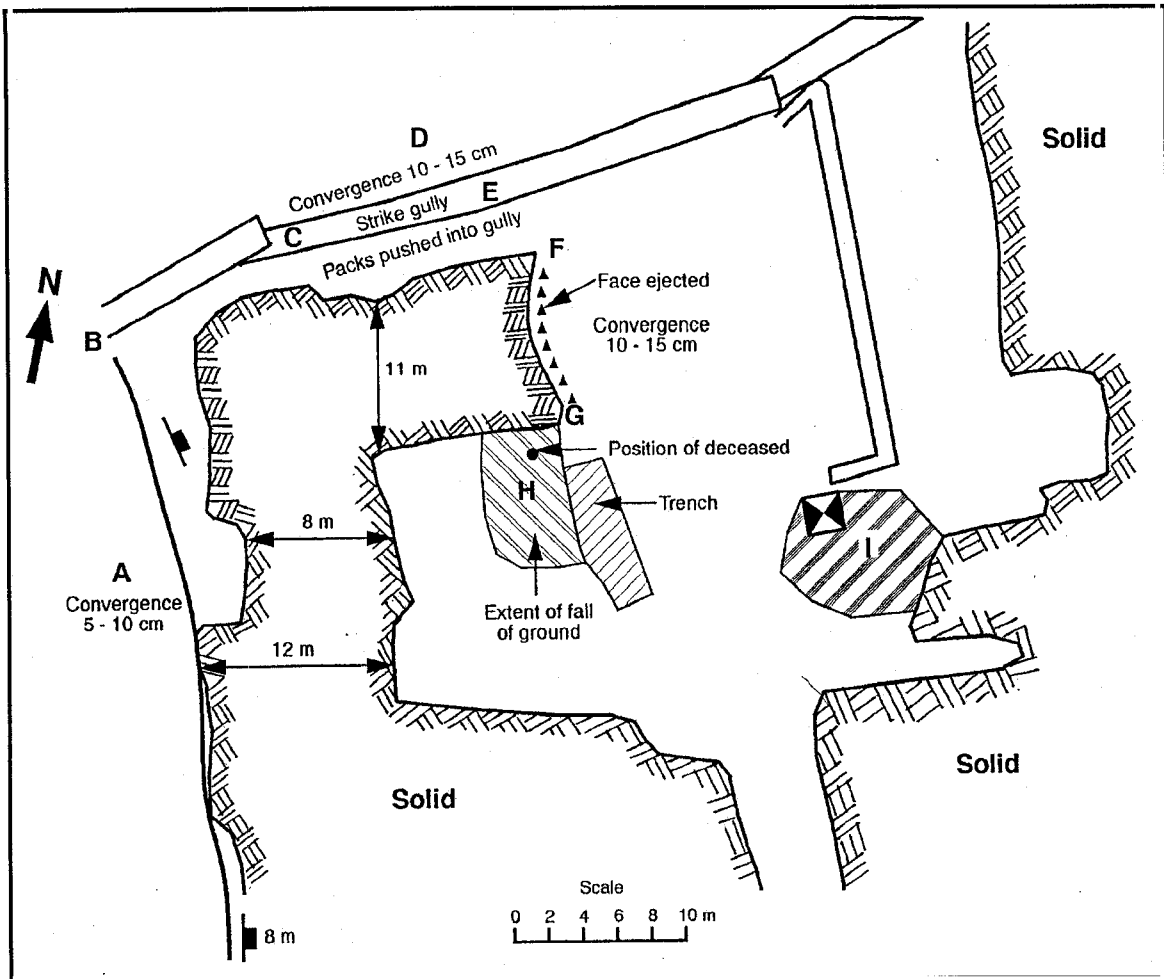
Figure B.8 Plan of the 21-3E VCR stope showing the positions of observations made during the inspection of the rockburst site.

The stoping layout resulted in an L-shaped peninsular remnant. At the time of the rockburst the width of the remnant ranged from 8-12 m (see Figure B.8). If the strength of one limb of the remnant was exceeded, it is likely that the entire remnant would have failed simultaneously. In contrast, a stoping layout giving rise to a triangular-shaped remnant would tend to fail at the apices of the triangle, with the core remaining intact.

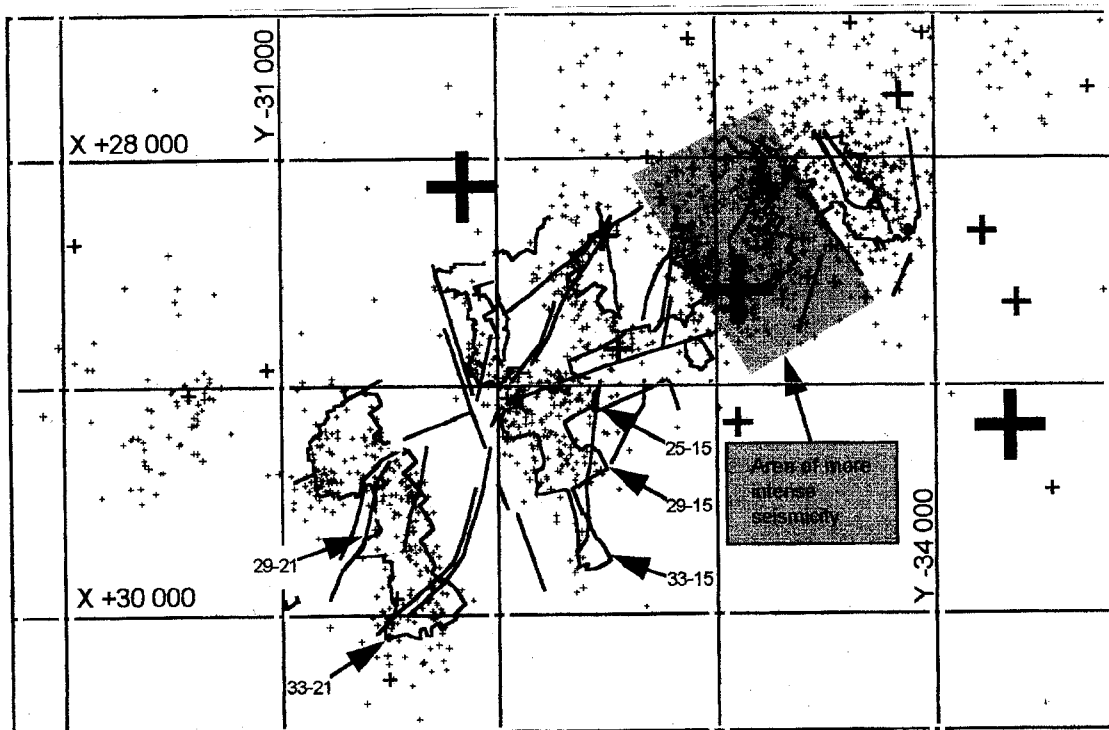
Seismic monitoring results were available over the mining lease area of Deelkraal Gold Mine covering the period from the beginning of 1984 to the time of the rockburst in May 1994 (Figure B.11). Fairly detailed seismic coverage only commenced in 1987, and continuous cover exists only from the start of 1989. The seismic network in its present state comprises some sixteen geophone sites. The reported magnitudes of some 14 larger events were compared with results published by the Council for Geoscience in Pretoria from the national seismic network. Although the scatter in the differences was appreciable ($\pm 0,53$), the average difference is insignificant ($-0,07$), and the Deelkraal magnitudes were accepted at face value.

Figure B.11 Spatial distribution of all seismic events with $M_L \geq 1$ recorded at Deelkraal Gold Mine during the period 1984 to 1994. The size of the symbols is proportional to magnitude, the largest event in the area displayed having $M_L=3,9$.

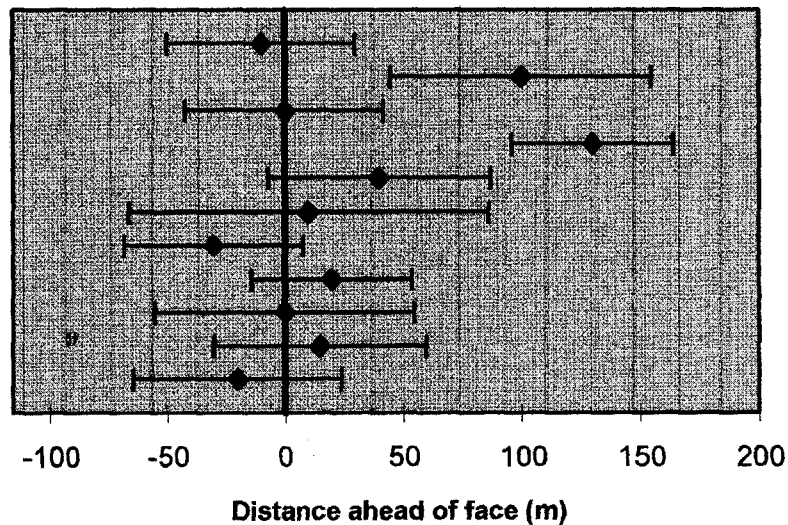
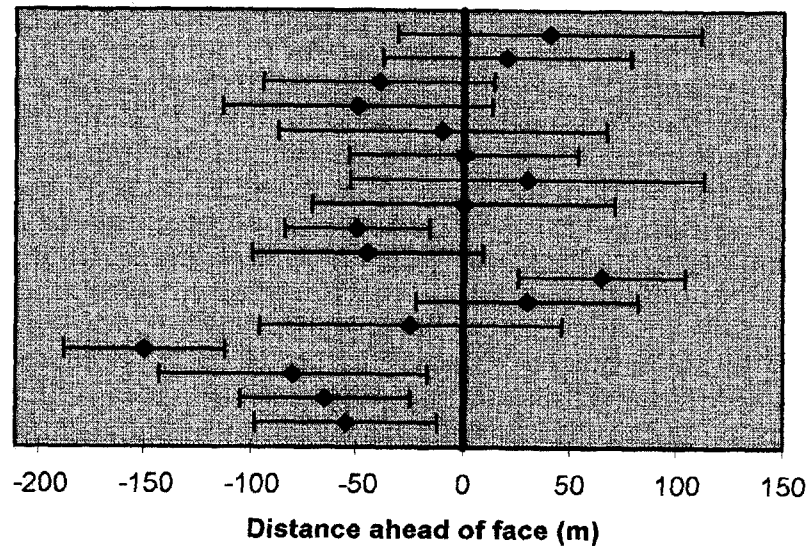
The location of seismic events with respect to face positions at the time was also investigated (Figures B.12 (a) and B.12 (b)). Location error varies from as little as 30 m, to more than 100 m, which seldom allows for unambiguous identification of causative structures. The prospect of positively identifying geological seismic hazards is therefore not good. In the area of 29-21 and 33-21 longwalls the majority of events tend to cluster at the stope face with some events ahead of the face, while in the area of 25-15, 29-15 and 33-15 longwalls there appears a tendency for the seismic events to locate in the immediate back area of the stopes.

Figure B.12 (a) Location of events with $M \geq 2$ in relation to face positions in the areas of 29-21 and 33-21 longwalls. The horizontal error bars indicate location error. Negative distances indicate the back area.

Figure B.12 (b) Location of events with $M_L \geq 2$ in relation to face positions in the areas of 25-15, 29-15 and 33-15 longwalls. Location error is indicated by the horizontal error bars. Negative distances indicate the back area.

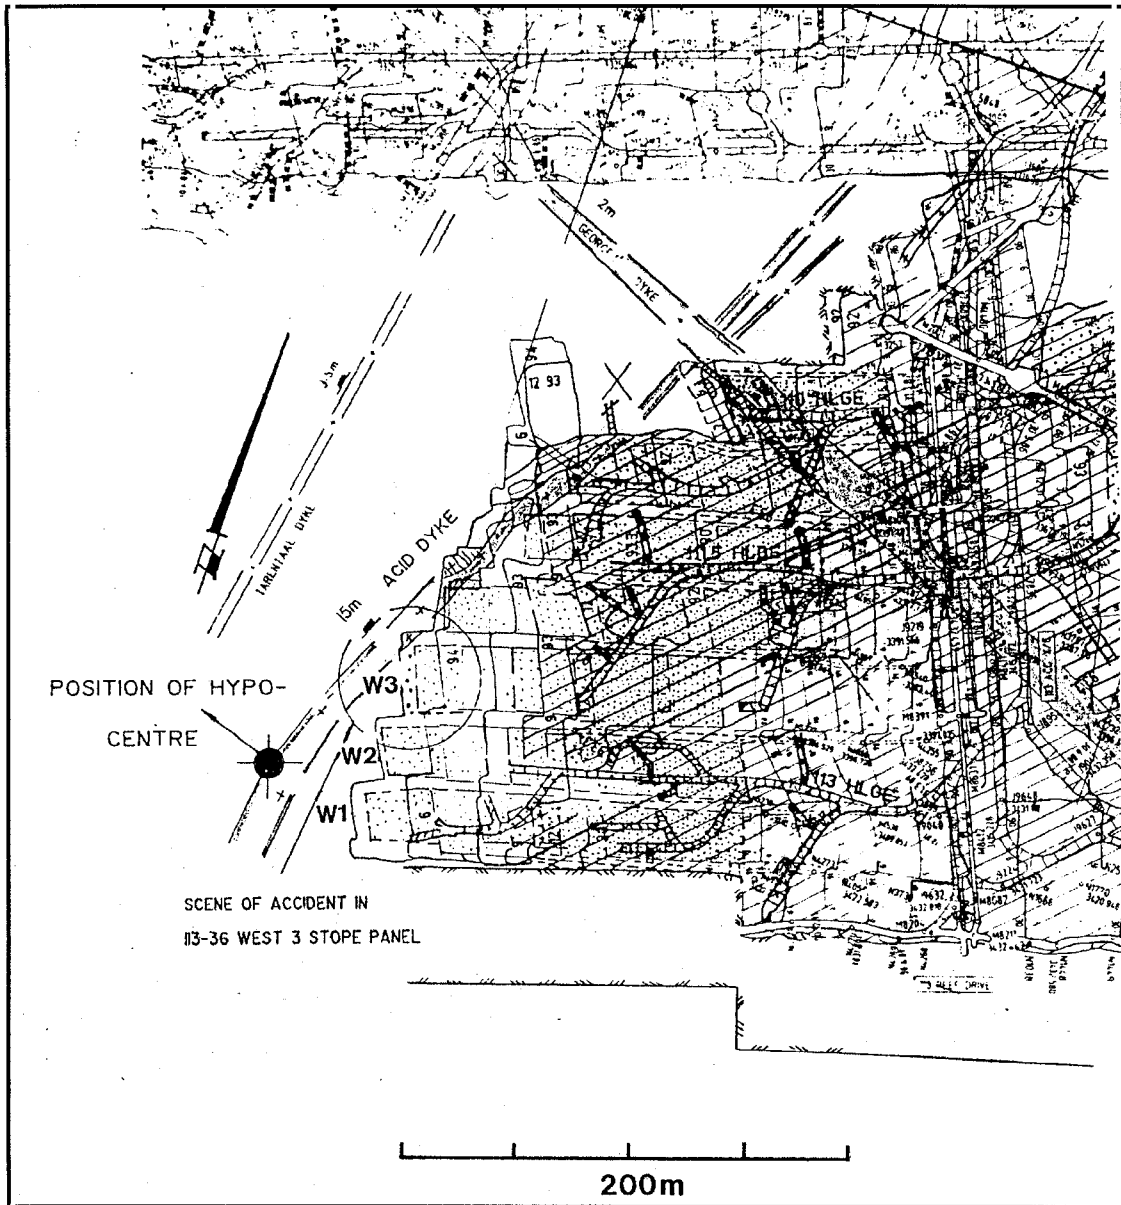
Figure B.13 Plan showing the location of the rockburst at Western Deep Levels (Ltd.) West Mine on 3 November 1994 damaging the 113-36 West 3 Carbon Leader panel.

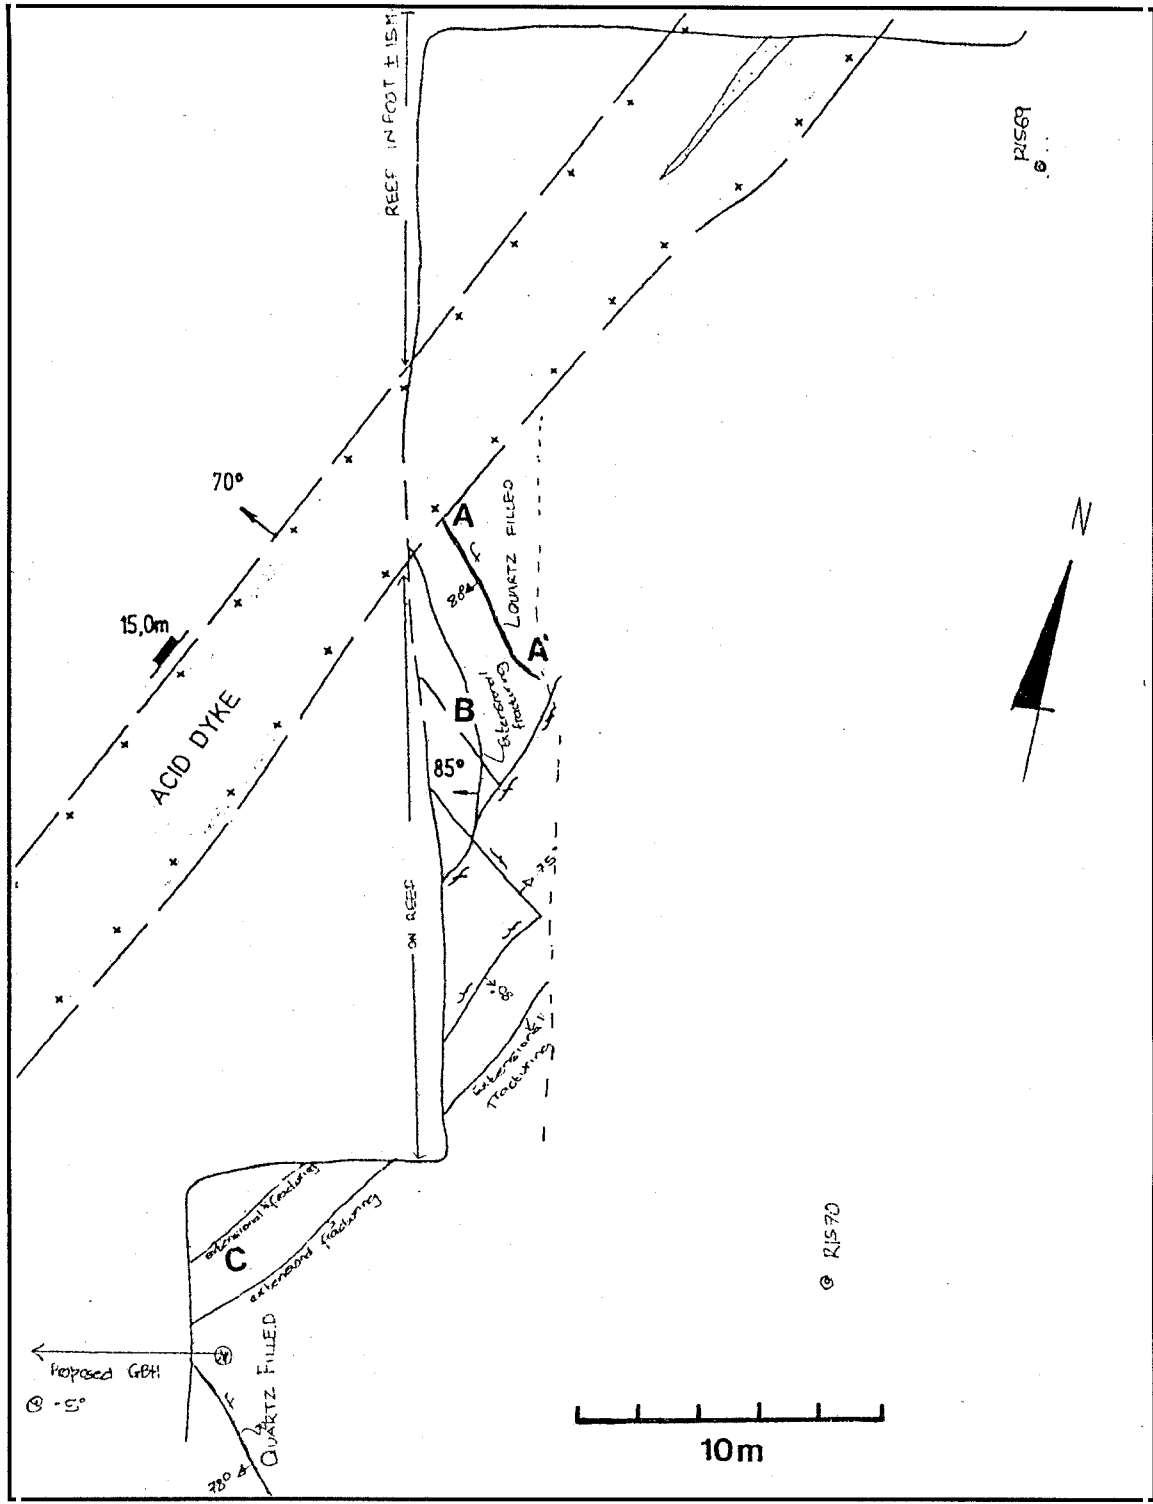
Figure B.16 Plan showing major fractures and joints in the 113-36 West 3 Carbon Leader panel (mapped by S. Reddy, Senior Geologist, Western Deep Levels (Ltd) West Mine).

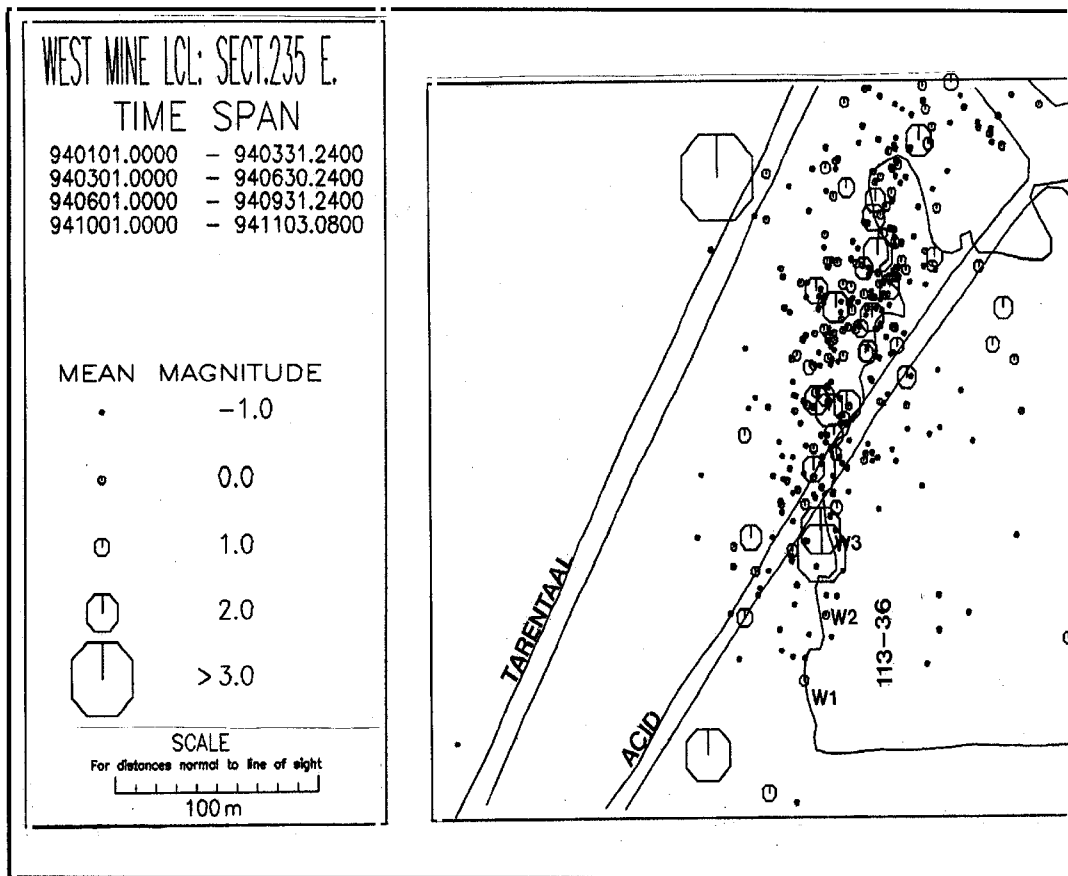
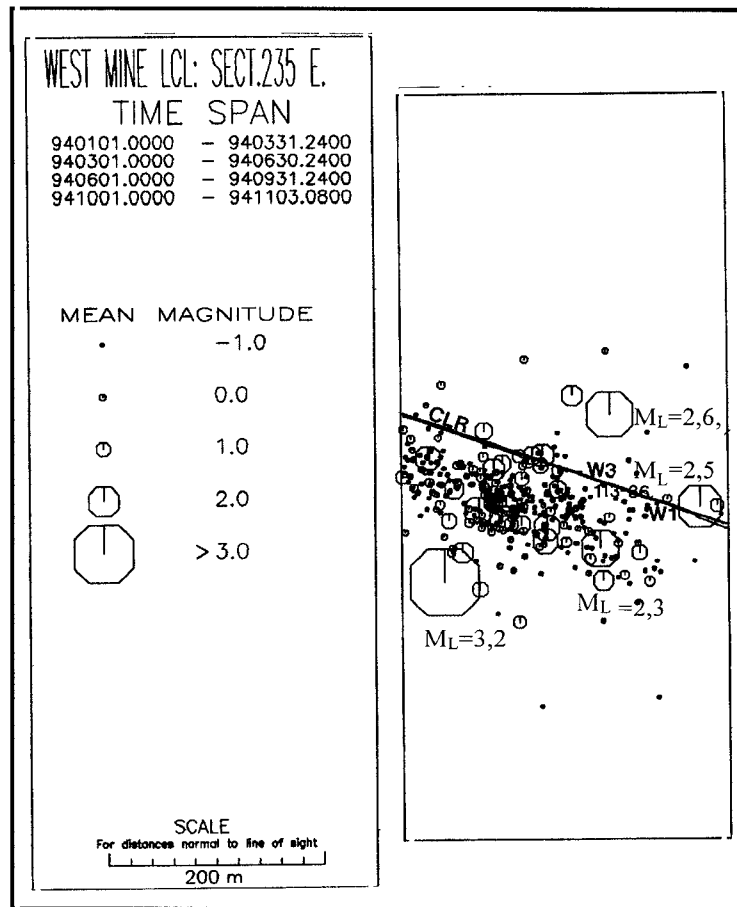
Figure B.17(a) Plan and section showing seismicity for the period 1/1/94 to 3/11/94 in the vicinity of the 113-36 Carbon Leader longwall. Face positions as at June 1994. Data provided by A. G. Butler (Senior Seismologist, Western Deep Levels (Ltd) West Mine). Note the $M_L=2,3$ and $M_L=2,6$ events close to the position of the W3 panel, and the $M_L=3,2$ event close to the Tarentaal dyke; (a) plan; (b) section.

Figure B.17(b) Section from Figure B.17 (a) showing seismicity in the vicinity of the 113-36 Carbon Leader longwall.

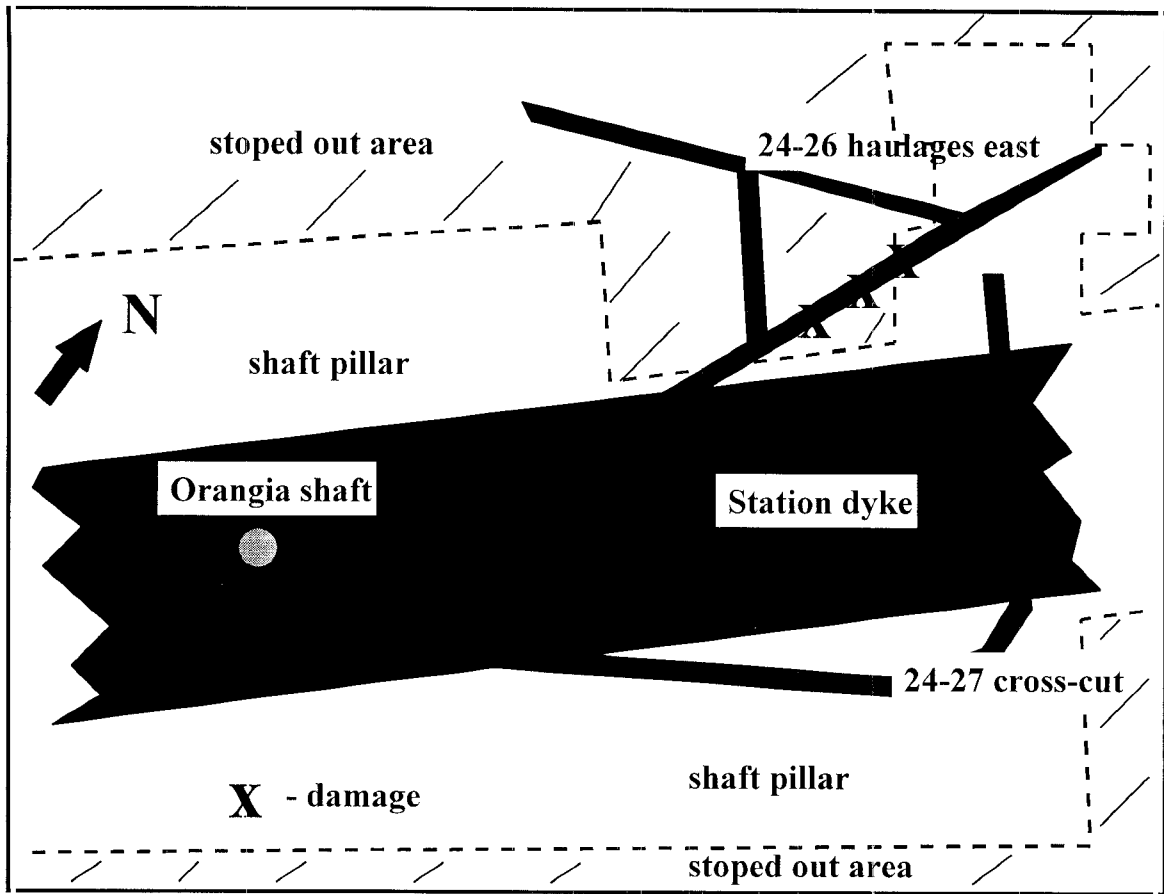
Figure B.18 Schematic plan of 24 level tunnels, Orangia Shaft, Buffelsfontein Gold Mine, damaged by the $M_L=3,4$ rockburst on 4 July 1995.

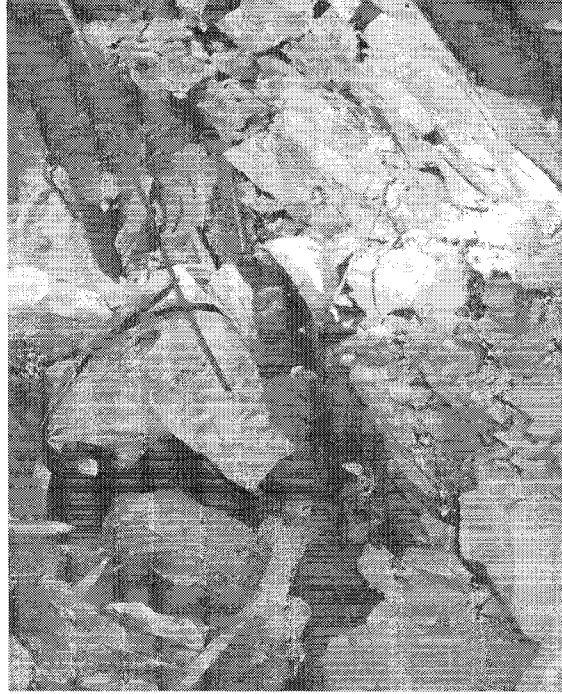
Figure B.23 View south along 24-26 haulage east at end of area of hangingwall collapse showing the highly fractured nature of the immediate hangingwall rock mass, and remaining rock bolt reinforcement.

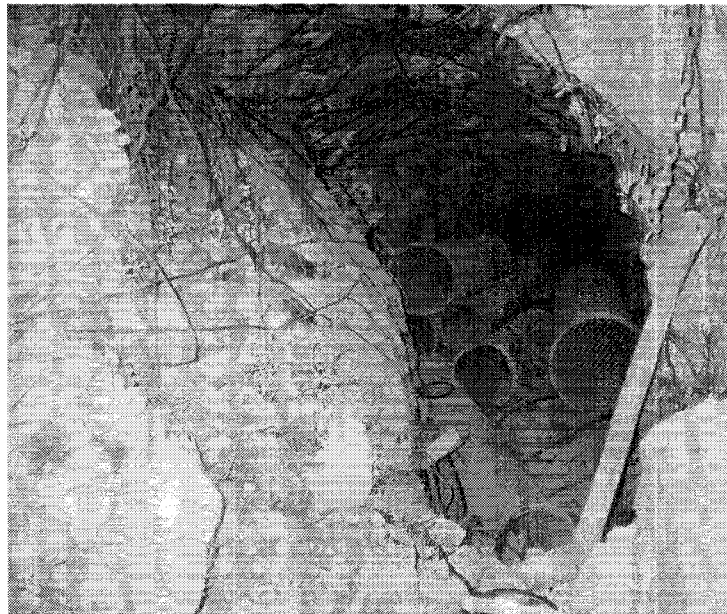
Figure B.24 View north-west along 24-27 cross-cut showing large deformation of the south-west sidewall of the tunnel.

It was noted the deformation was greatest in the lower part of the sidewall. This may be owing to the presence of dominant sub-horizontal bedding planes and the lack of lower sidewall support. The presence of hangingwall support, together with the general upward inclination of the upper sidewall support, creates a more competent reinforced rock mass structure and thus constrains the upper part of the sidewall more effectively.

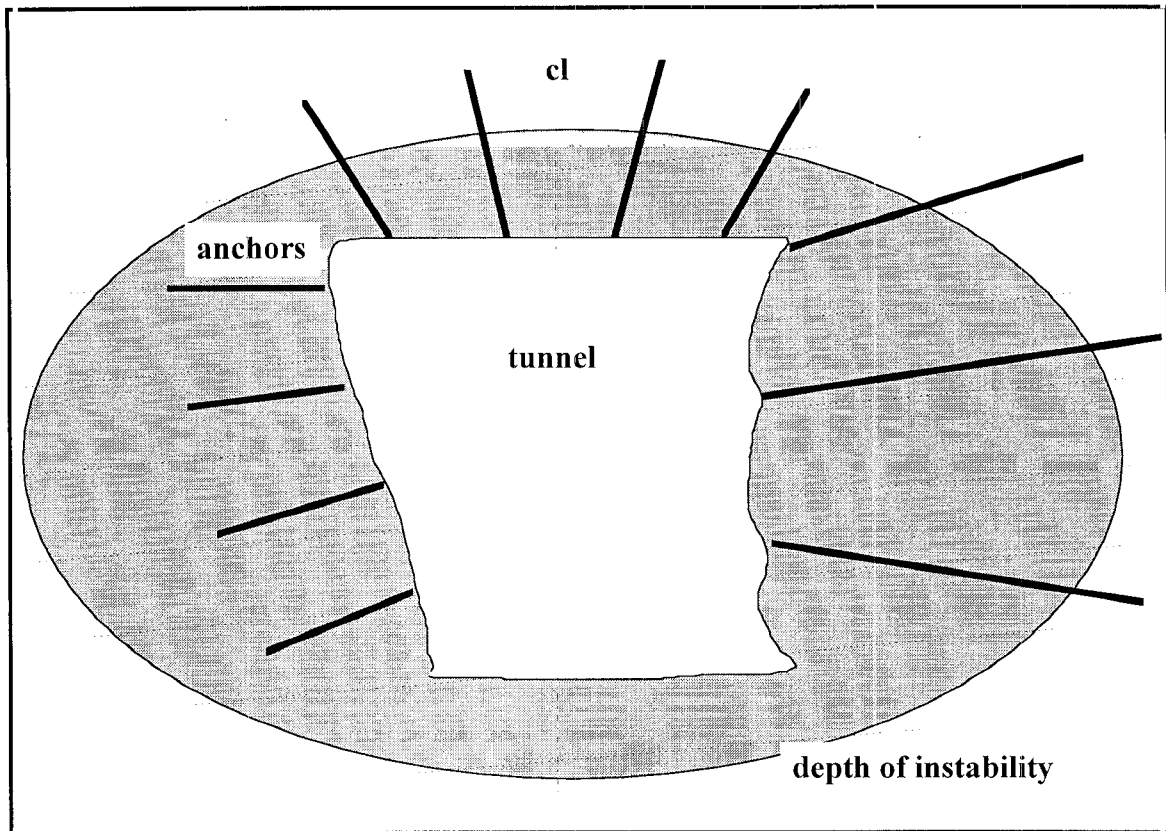
This uniform deformation profile is in contrast to that exhibited by a stiff support system anchored in stable ground, which generally shows greater differential deformation and bulking over the sidewall profile (Figure B.25). With regard to safety, a more uniform deformation of the sidewall rock mass structure is preferable, as the general integrity of the support system and peripheral rock mass is more likely to be maintained.

Figure B.25 *Diagram showing conceptual mechanisms of excavation deformation as a function of support interaction with the rock mass. Within the South African gold mining environment the vertical virgin stress level is approximately twice that of the horizontal, and induced stresses are generally sub-vertical, the depth of failure within the sidewalls of the excavations is substantially greater than in the hangingwall or footwall. The tendons on the left hand side of the tunnel are anchored within the zone of instability, hence the entire sidewall is displaced inwards owing to bulking of the unstable rock mass. A similar effect will be observed if the tendons snap or debond. In contrast, the tendons on the right hand side of the tunnel remain anchored in solid rock, hence the sidewall bulks between the tendons.*

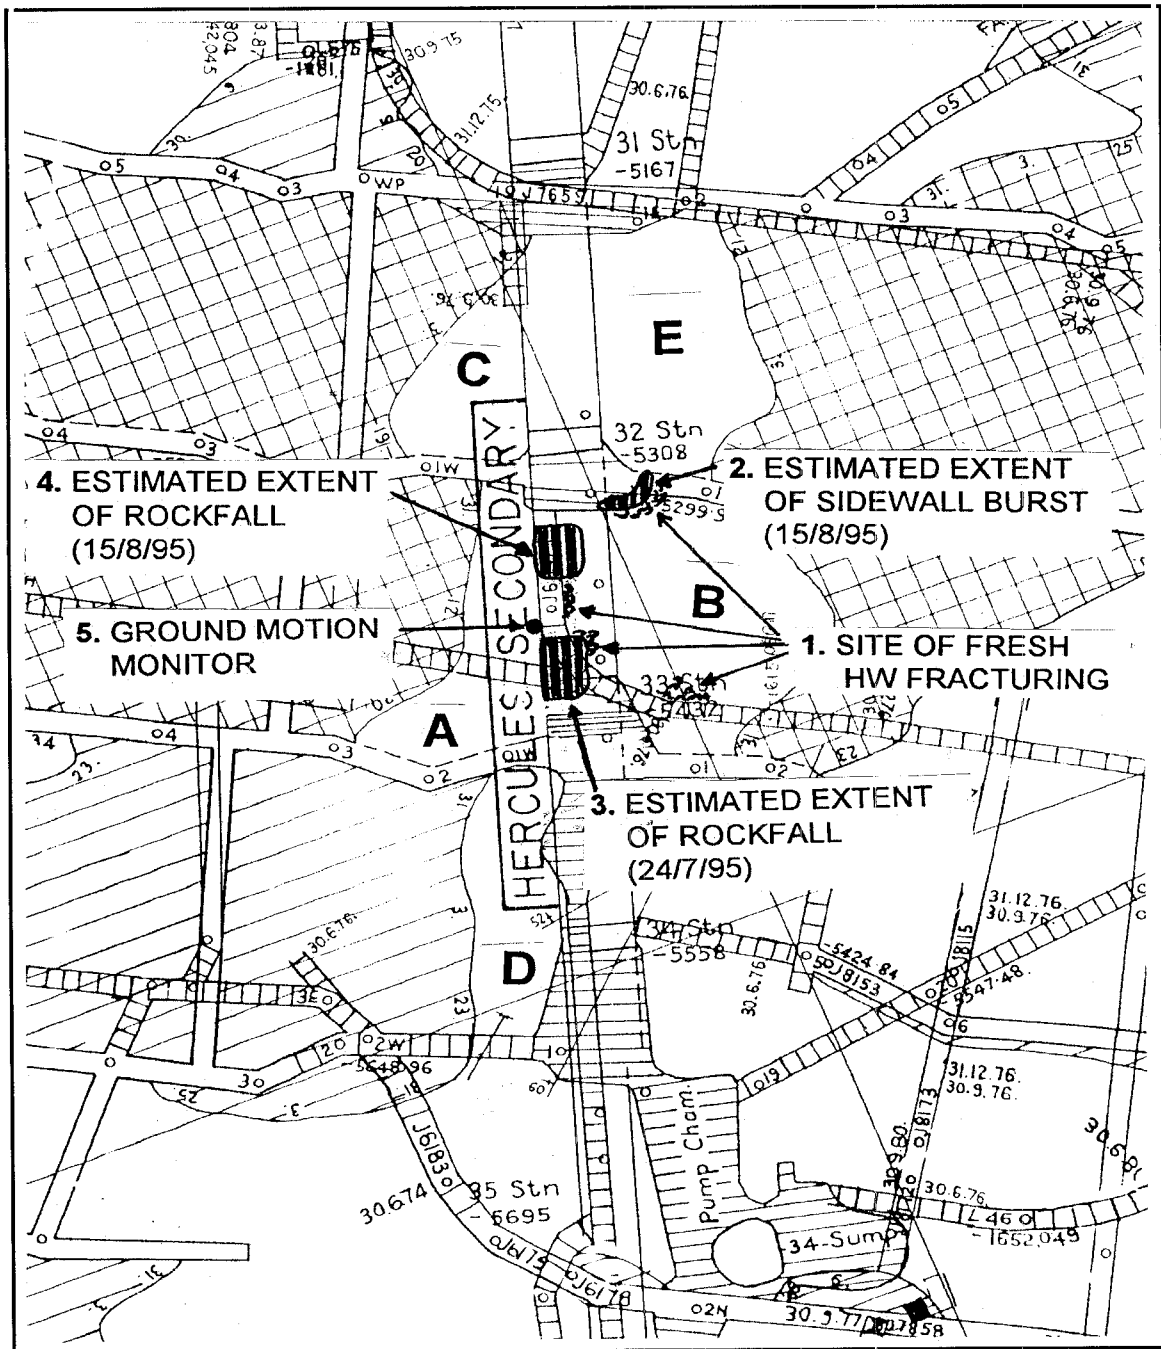
Figure B.26 Plan showing the location of the rockfalls at ERPM on 24 July and 15 August 1995 damaging the Hercules secondary incline shaft between 32- and 33-level.

The second rockfall (on 15 August 1995) and the seismicity recorded by the ground motion monitor indicate continuation of the failure of the narrow pillar to the west of the incline shaft (pillar **A** in Figure B.26). The sidewall burst of pillar **B** east of the incline (at **2** in Figure B.26) is further evidence that stress was being transferred to the pillars to the east of the incline shaft.

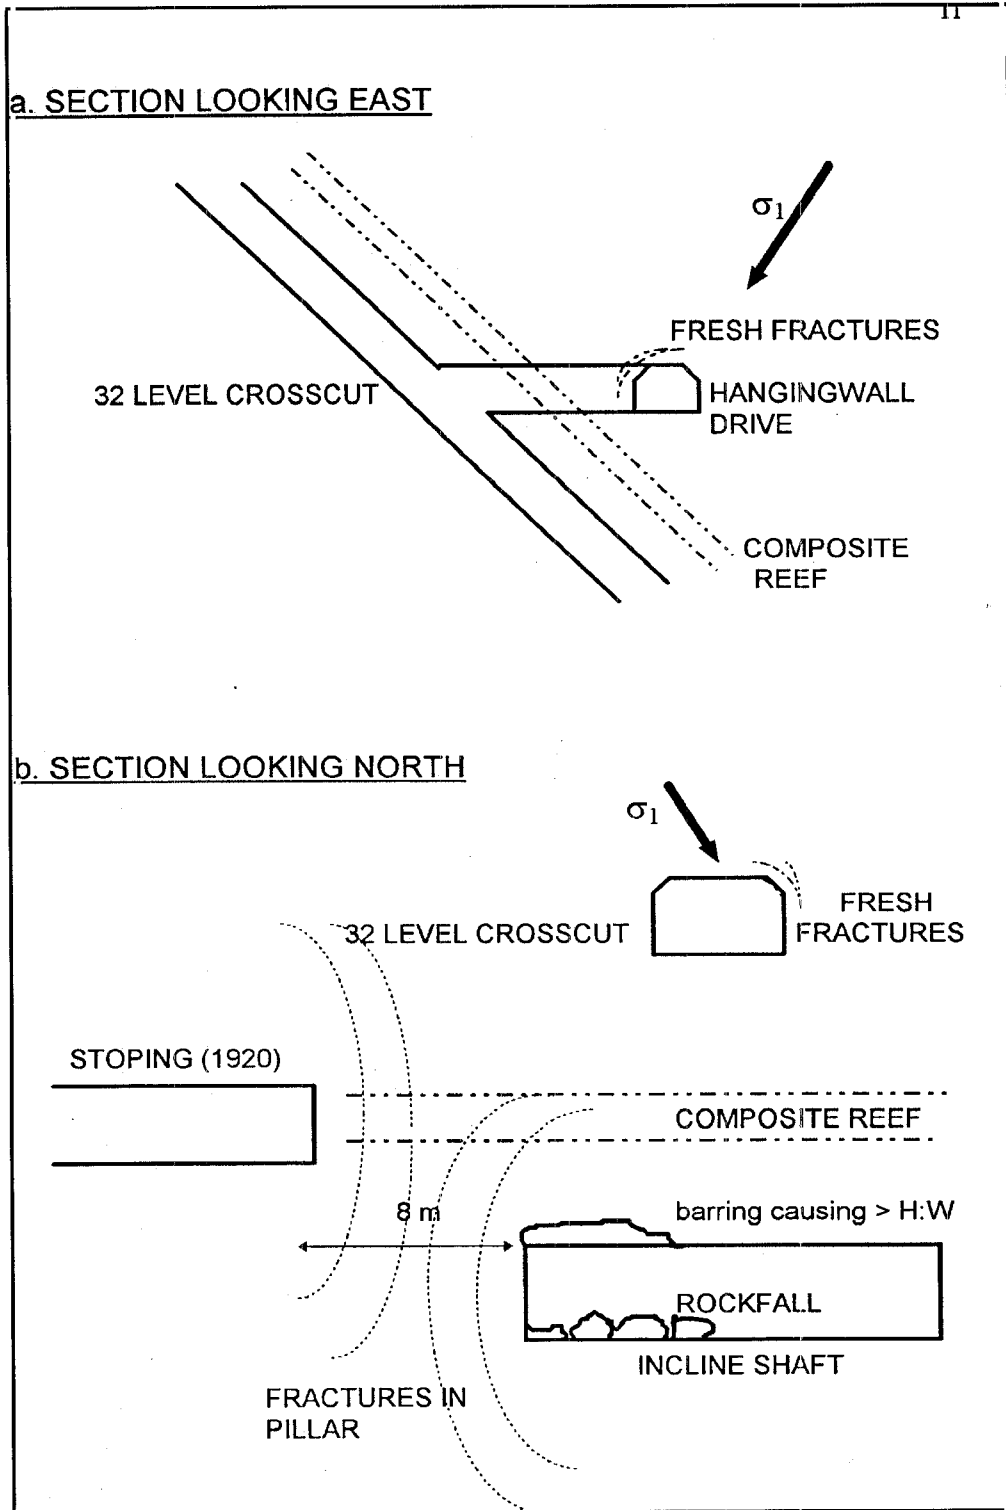
The progressive failure of pillar **A** resulted in the horizontal dilation of both the hangingwall and in the footwall of adjacent strata, causing the hangingwall beam of the incline shaft to buckle and ultimately to collapse. It is possible that the collapse was triggered by a small seismic event with magnitude $M_L < 0,5$. A similar phenomenon had previously been noted by M.K.C.Roberts (CSIR Mining Technology) in bord and pillar workings, where underdesigned pillars progressively failed and dilated, causing the hangingwall to deflect and collapse into the bord.

Figure B.27 Diagram showing the interpreted mechanism of the rockbursts on 24 July and 15 August 1995 damaging the Hercules secondary incline shaft between 32- and 33-level.
