Safety in Mines Research Advisory Committee

DRAFT FINAL REPORT

**Improvement of worker safety through
the investigation of the site response
to rockbursts**

Research agency : CSIR: Division of Mining Technology

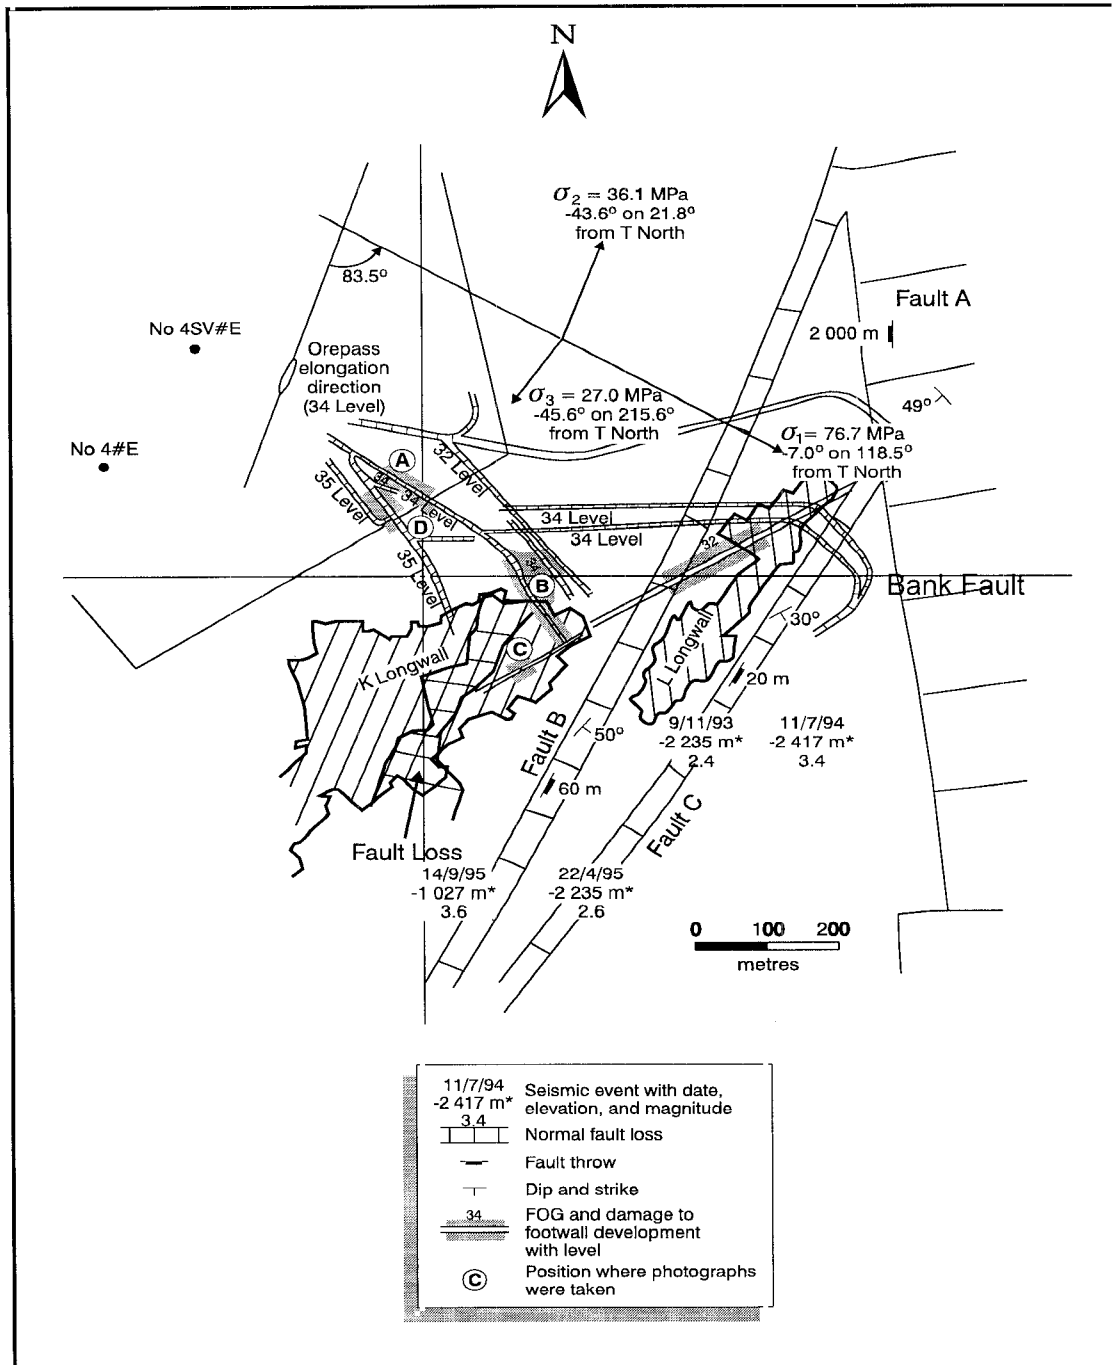
The seismic event affected excavations from 31 to 36 Levels over a wide area east of No. 4 Shaft. The damage was confined mainly to cross-cuts and drives that provide access to the K- and L longwalls situated to the south-east of No. 4 Shaft. This area has a history of large seismic events, many of which have caused damage to the access development, with stoping being less severely affected. This strongly suggests that the seismic events are related to geological structures remote from the stopes. Candidates include the Bank Fault, the Skelm Fault (which is exposed in the northern part of the K longwall), eastwards downthrow faulting both east and west of the L longwall, and the many other structures associated with the folding and thrusting in the area (Vermaakt et al., 1989). All recorded seismic events with $M_L>2,0$ for the period September 1993 to September 1995, together with the most prominent geological structures, are plotted in Figure B.28.

Figure B.28 Plan showing damage to tunnels serving No. 4 Shaft, East Driefontein Gold Mine, by a $M_L=3.6$ seismic event on 14 September 1995. The locations of all seismic events with $M_L>2$ which occurred in the preceding two year period are shown. Falls of ground (FOG) and damaged sections of tunnels are indicated by shading.

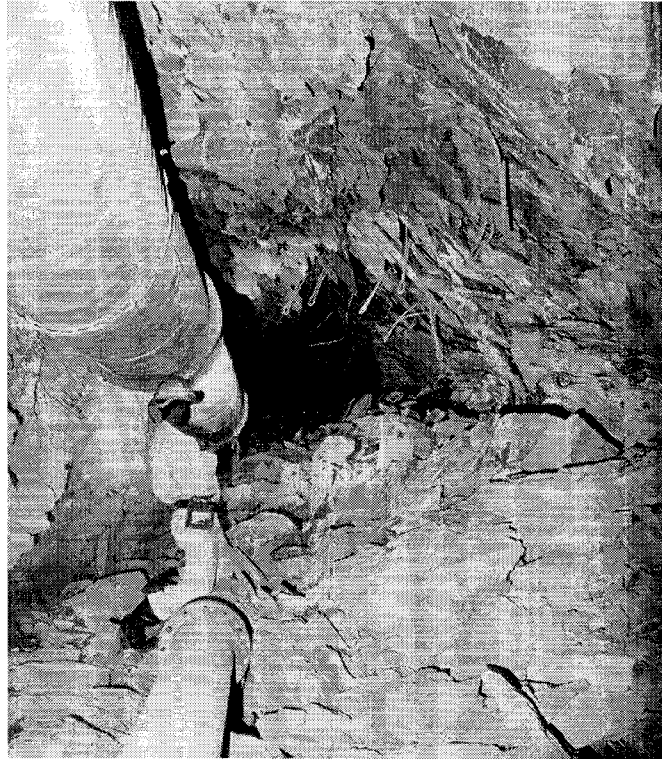
Damage was therefore generally associated with the up-dip side of excavation. This could be owing to the more inherently unstable orientation of the bedding relative to the sidewall of the excavation, and that the up-dip sidewall of the excavation is significantly higher owing to the geology and excavation technique, resulting in a more unstable structural configuration.

Figure B.29 Damage to 34K footwall drive at Site A showing falls of ground between grouted shepherd's crook rebars. Mesh and lacing had not yet been installed in this section of the tunnel. In this area the south-western (right hand) side of the drive was most severely damaged. The view is taken looking to the south-east, away from the shaft.

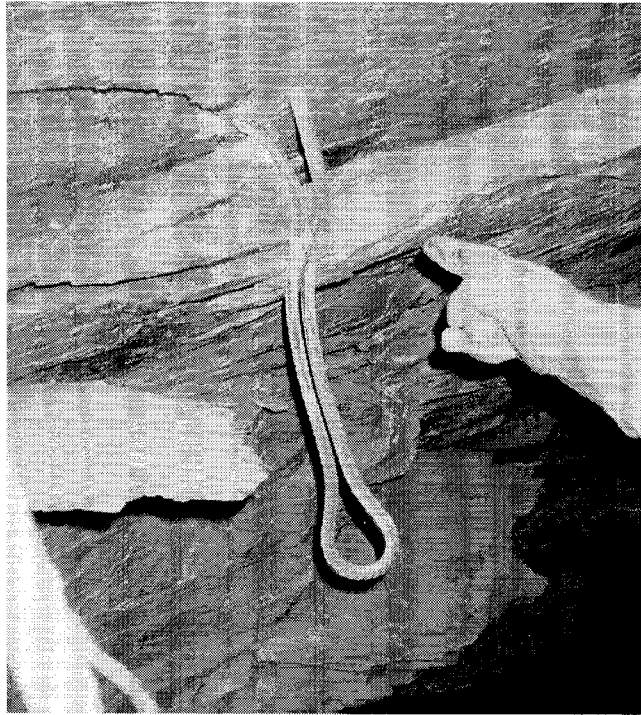
Failure of the support system was owing to either direct tensile or shear failure of the shepherd crook rebar rock bolts. The most of the failure was fresh and was probably associated with the seismic event, however one example of an old failure (rusted failure surface) was exposed by the collapse of the rock mass. Direct shear failure of the bolts was predominantly associated with hangingwall of the excavation at the position of clearly

defined bedding planes, where clean guillotining of the bolts had occurred in the down dip direction (Figure B.32). Within the sidewall of the excavation, tensile failure of the bolts was generally observed. The majority of the bolts, however, indicated some degree of plastic bending prior to failure, which suggests some component of shear movement.

Figure B.32 Kinked shepherd's crook rebar observed in the hangingwall of the 34K footwall drive between Sites B and C. Some bars had been sheared by the movement along bedding planes.

Long term excavations, that are expected to be subjected to seismicity sometime in the future, should be supported by pre-stressed yielding units that can accommodate shear deformations (grouted rope anchors, or cone bolts) integrated with mesh and lacing. In areas where severe damage is expected, these support units should be supplemented with shotcrete.

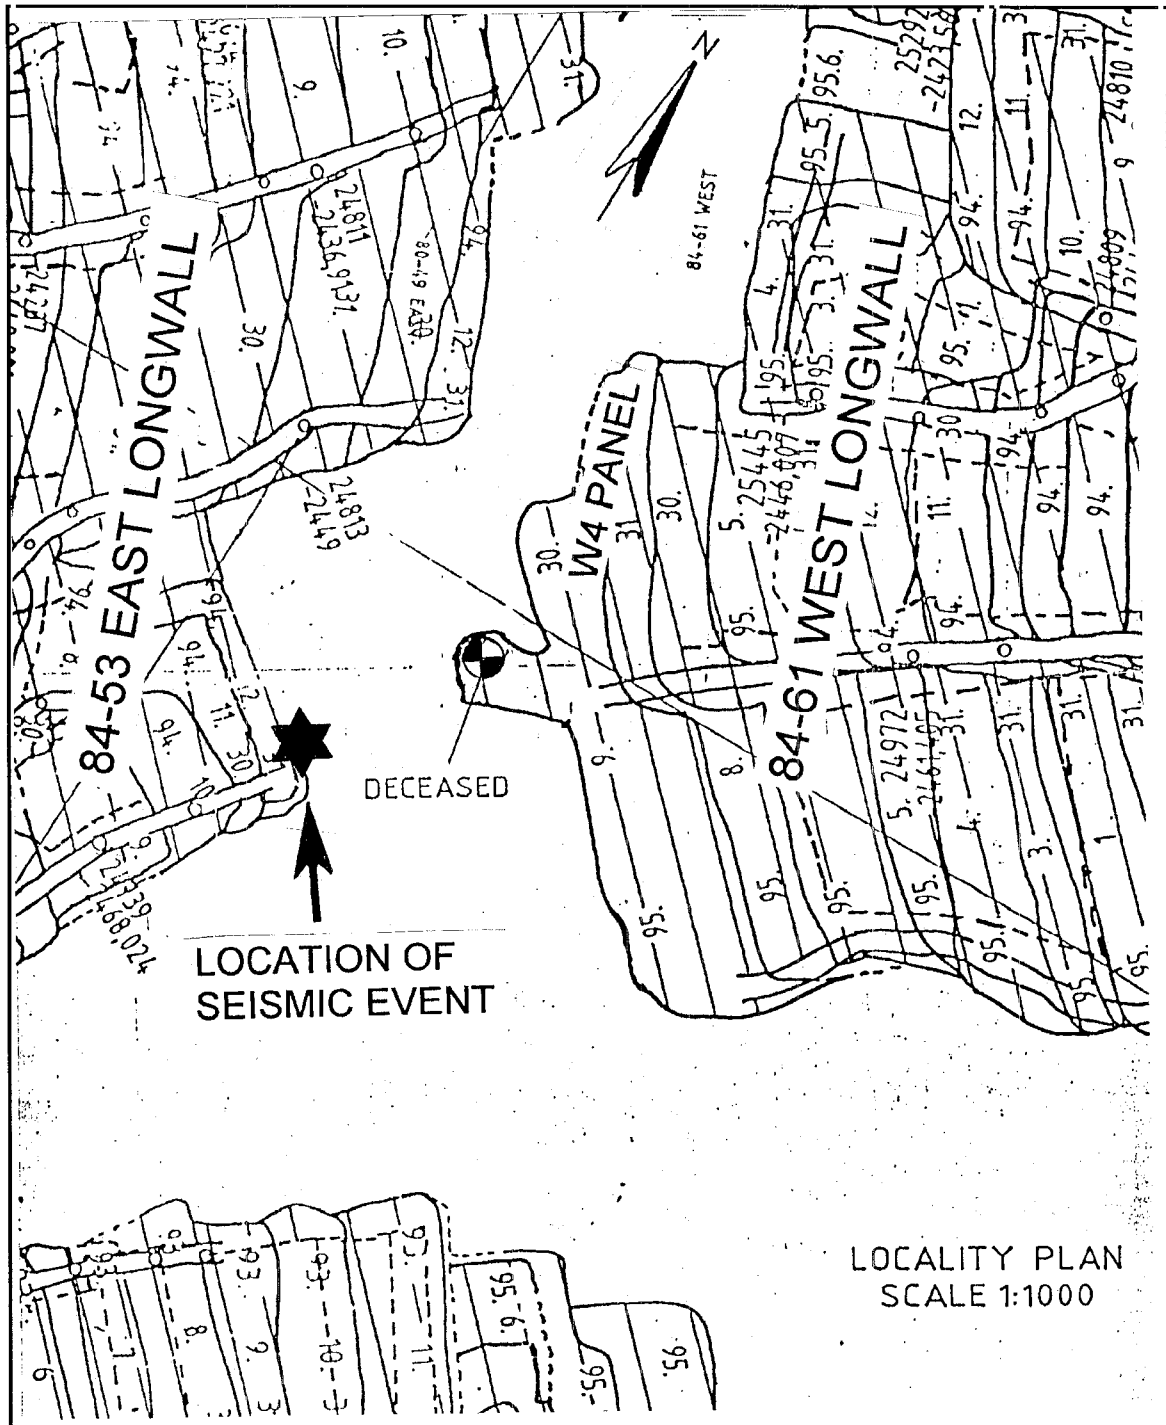
Figure B.33 Plan showing the location of the rockburst at Western Deep Levels South Mine on 18 September 1995 damaging the 84-61 West 4 VCR panel.

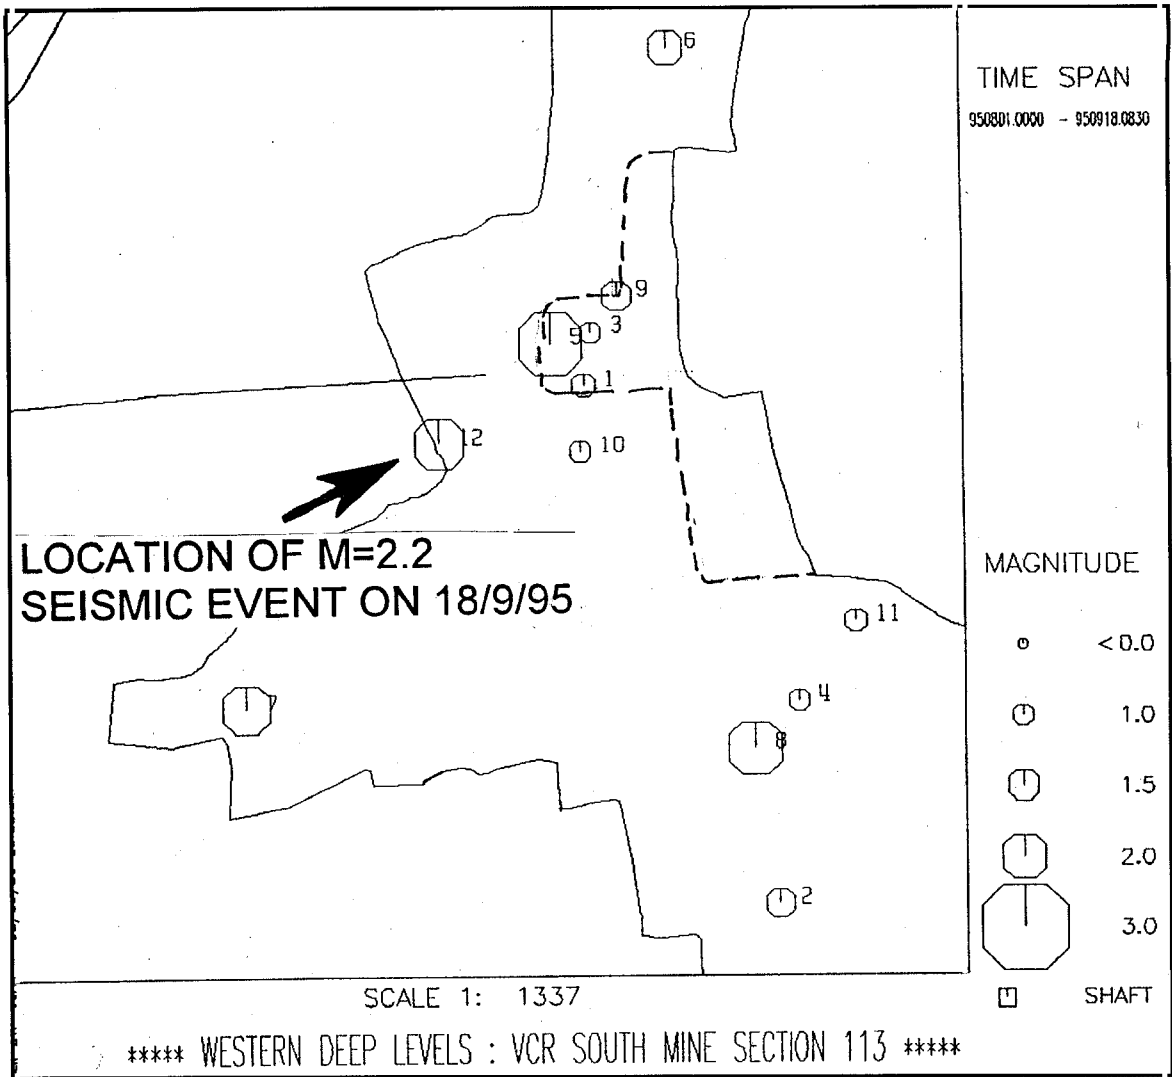
Figure B.35 Plan showing the seismicity (events with $M > 1$) in the vicinity of the 84-61 West longwall for the period 1 August - 18 September 1995. The approximate face position on 18 September is indicated by a dashed line. Data provided by F. Naude (Senior Seismologist, Western Deep Levels (Ltd) South Mine).

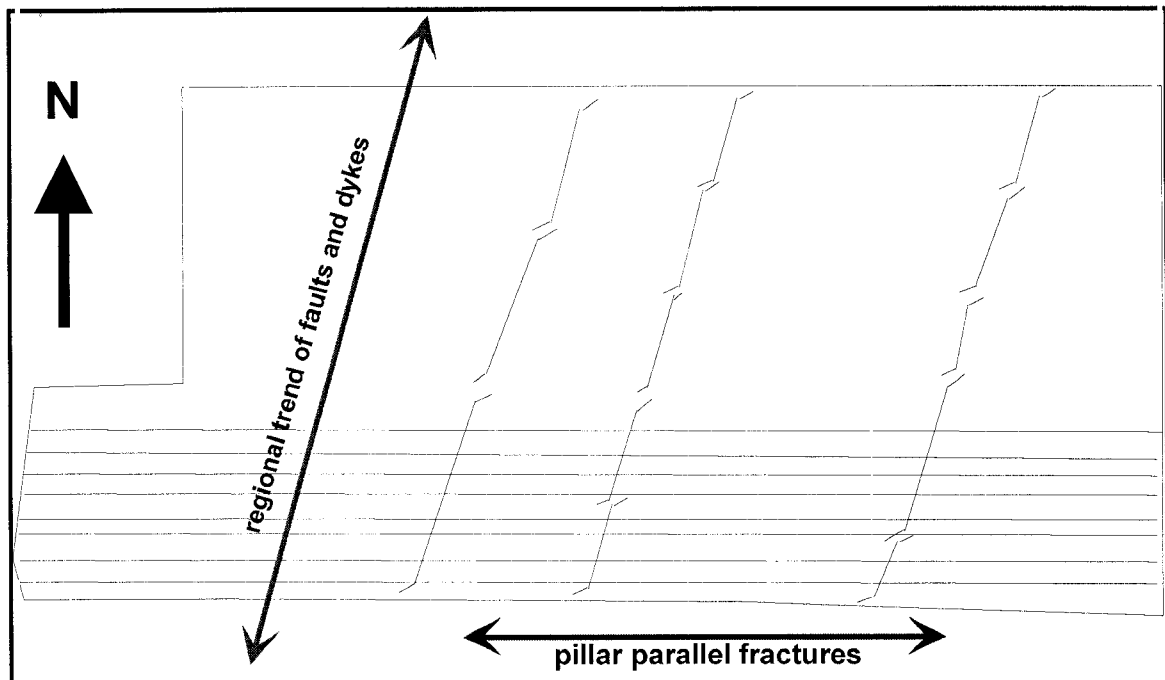
Figure B.42 Sketch plan of the lower portion of the pillar showing the orientation and position of the two major fracture sets that have controlled size of the falls of ground. Note that the lower gully is positioned within the zone of intense pillar-parallel fractures.

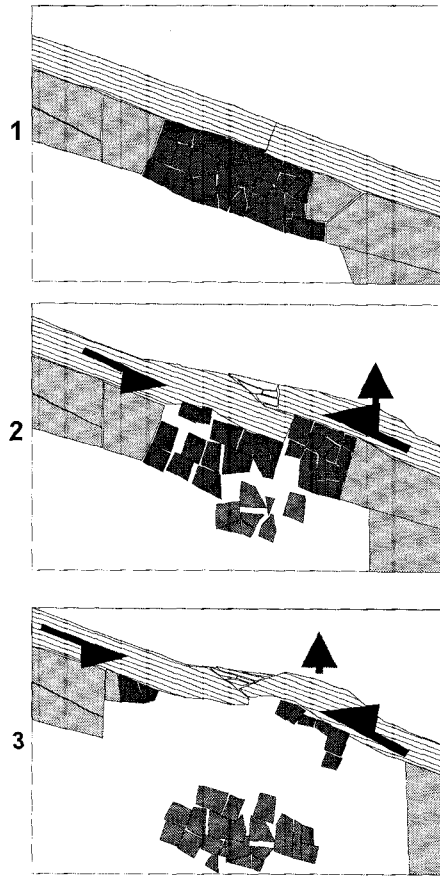
Figure B.44 (b) Sketch diagram showing the possible mechanism of rockburst damage to a Carbon Leader Reef gully. Prior to damage, note the region of intense pillar-parallel fractures (dark shading); slip on the Green Bar (direction is shown by arrows) causes buckling and underthrusting of the Green Bar. The underthrusting causes fallout of the hangingwall quartzite below the Green Bar. Continued thrusting and buckling causes extensive falls of both hangingwall quartzite and Green Bar.

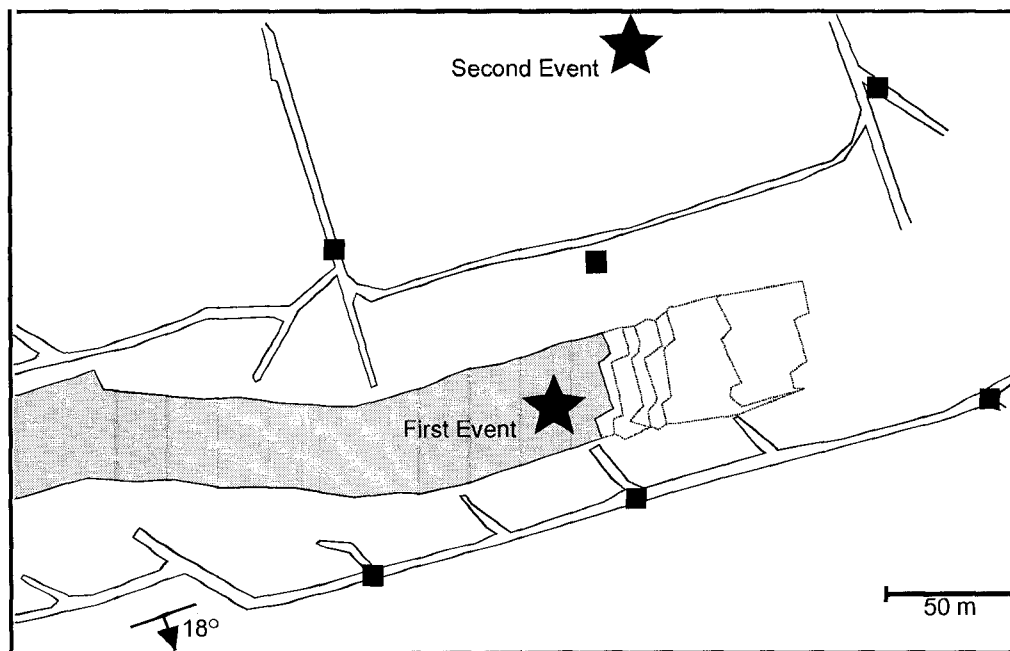
Figure B.45 Plan showing the locations, as determined from the research seismic network records, of the $M_L=2,2$ and $M_L=2,3$ seismic events which occurred on 30 January 1996 damaging the 17-24W stope, Blyvooruitzicht Gold Mine.

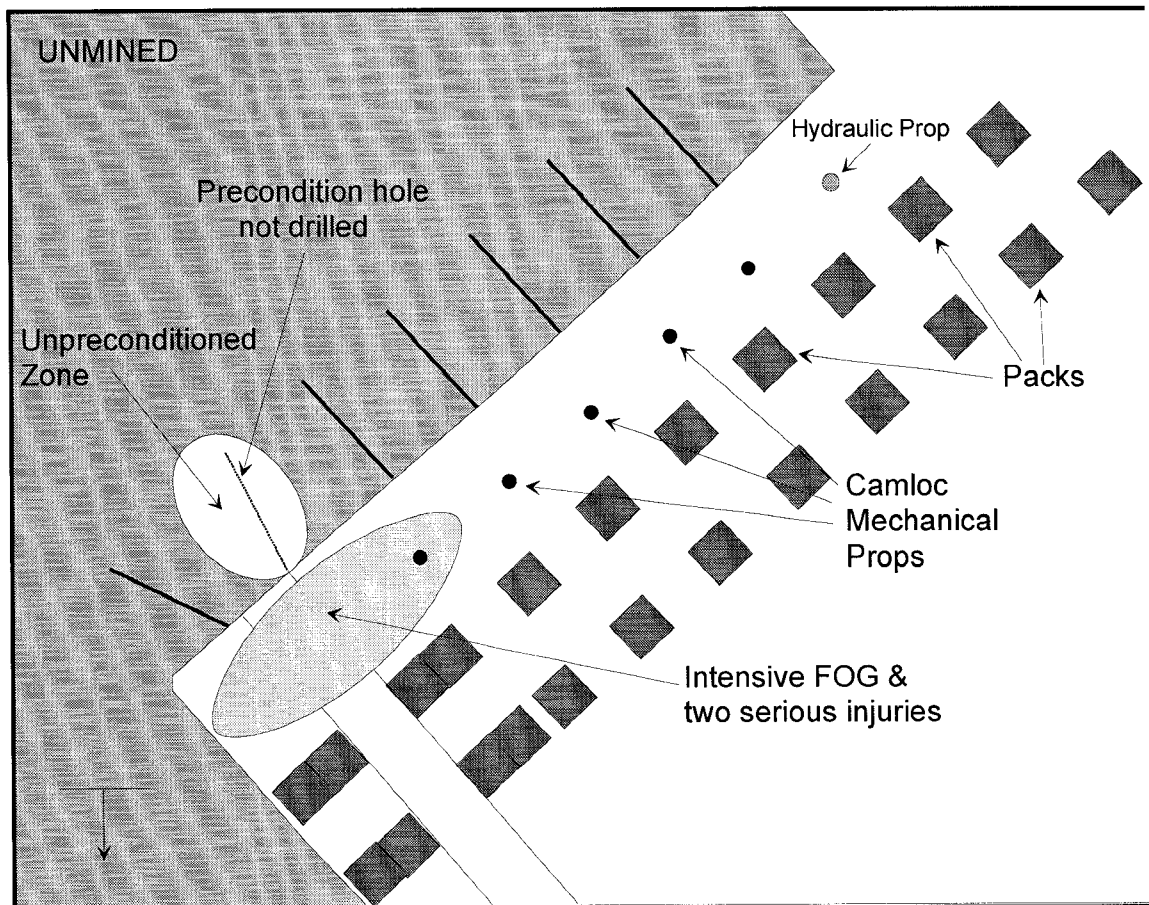
On 15 February 1996, a rockburst occurred at Western Deep Levels South Mine, causing damage to the West 2 (W2) panel of the 87-49 stope, about 2500 m below surface (Figure B.46). The rockburst, which caused five injuries, took place at 07h56. A seismic event with magnitude $M_L=1,8$ was recorded by the mine's seismic network at that time. A preconditioning experiment was being conducted in this stope by a team from CSIR Mining Technology. Consequently the rockburst was of great interest and relevance, and a detailed investigation into the incident was conducted. The team visited the site on 16 February 1996.

Figure B.46 Schematic plan of West 2 (Diagonal) panel (Not to scale).

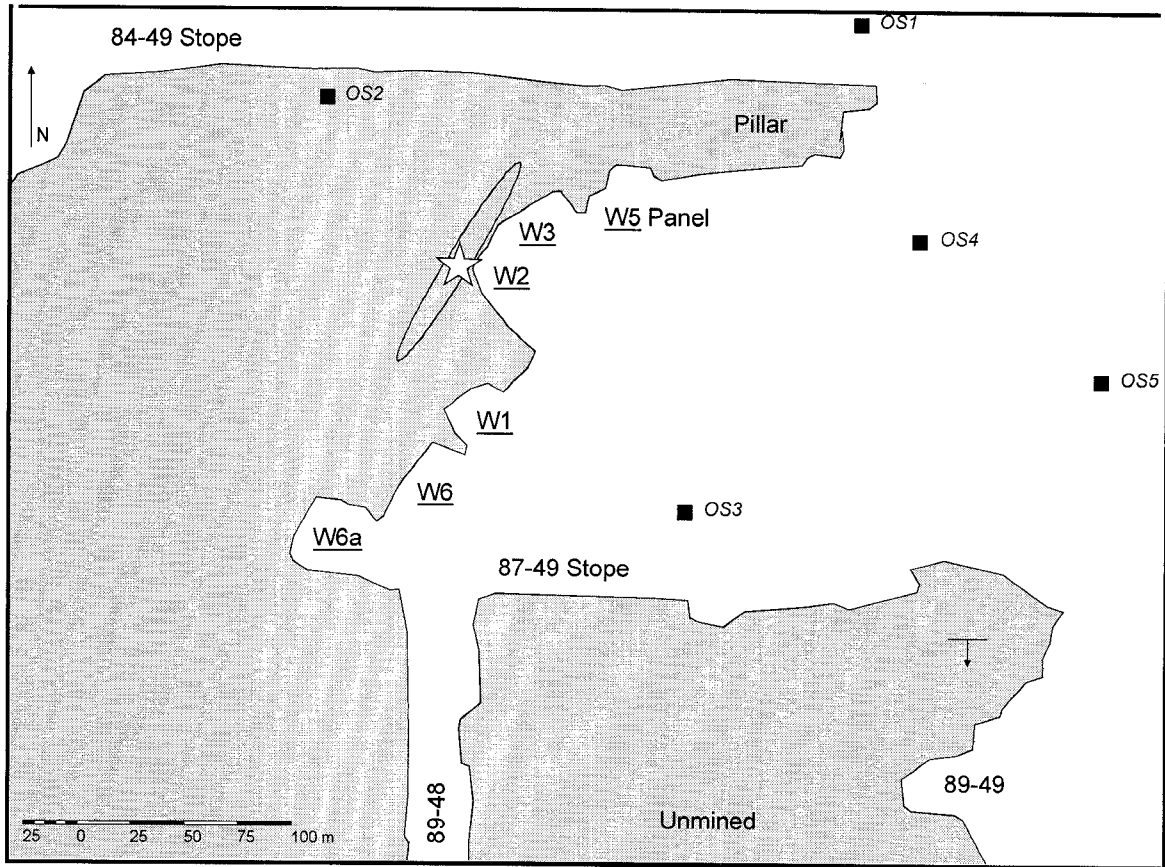
In the three months before the rockburst on 15 February, some 33 seismic events of magnitude $M_L > 1,0$ were recorded from the vicinity of the 87-49W stope faces by the PSS. The majority of these events were located close to the stope faces (within 40 m of the faces). Fortunately, most the events took place during or shortly after blasting time (only six events took place separately from the blast-induced seismicity). The large events tended to cluster in the vicinity of the faces of panels W5 (seven events), W6 (nine events) and W2 (seven events). One interesting feature of the clustering is that, while the large events tended to locate ahead of the faces in the case of panels W5 and W6, the events located exclusively in the vicinity of the siding or (as in the case of the rockburst event) in the vicinity of the angle between the siding and the face in the case of W2 panel.

This was brought about, no doubt, by the long lead-lag situation which had developed behind W2 panel.

Figure B.49 Plan of WDLs 87-49 stope, showing the location of the rockburst seismic event (star) as determined from the PSS recording. The ellipse around the star indicates the possible source region as given by the Brune model of the seismic source, assuming slip on a steeply dipping plane oriented parallel to the large seismically induced shear zones observed underground. The positions of the PSS recording sites are shown by the labelled squares.

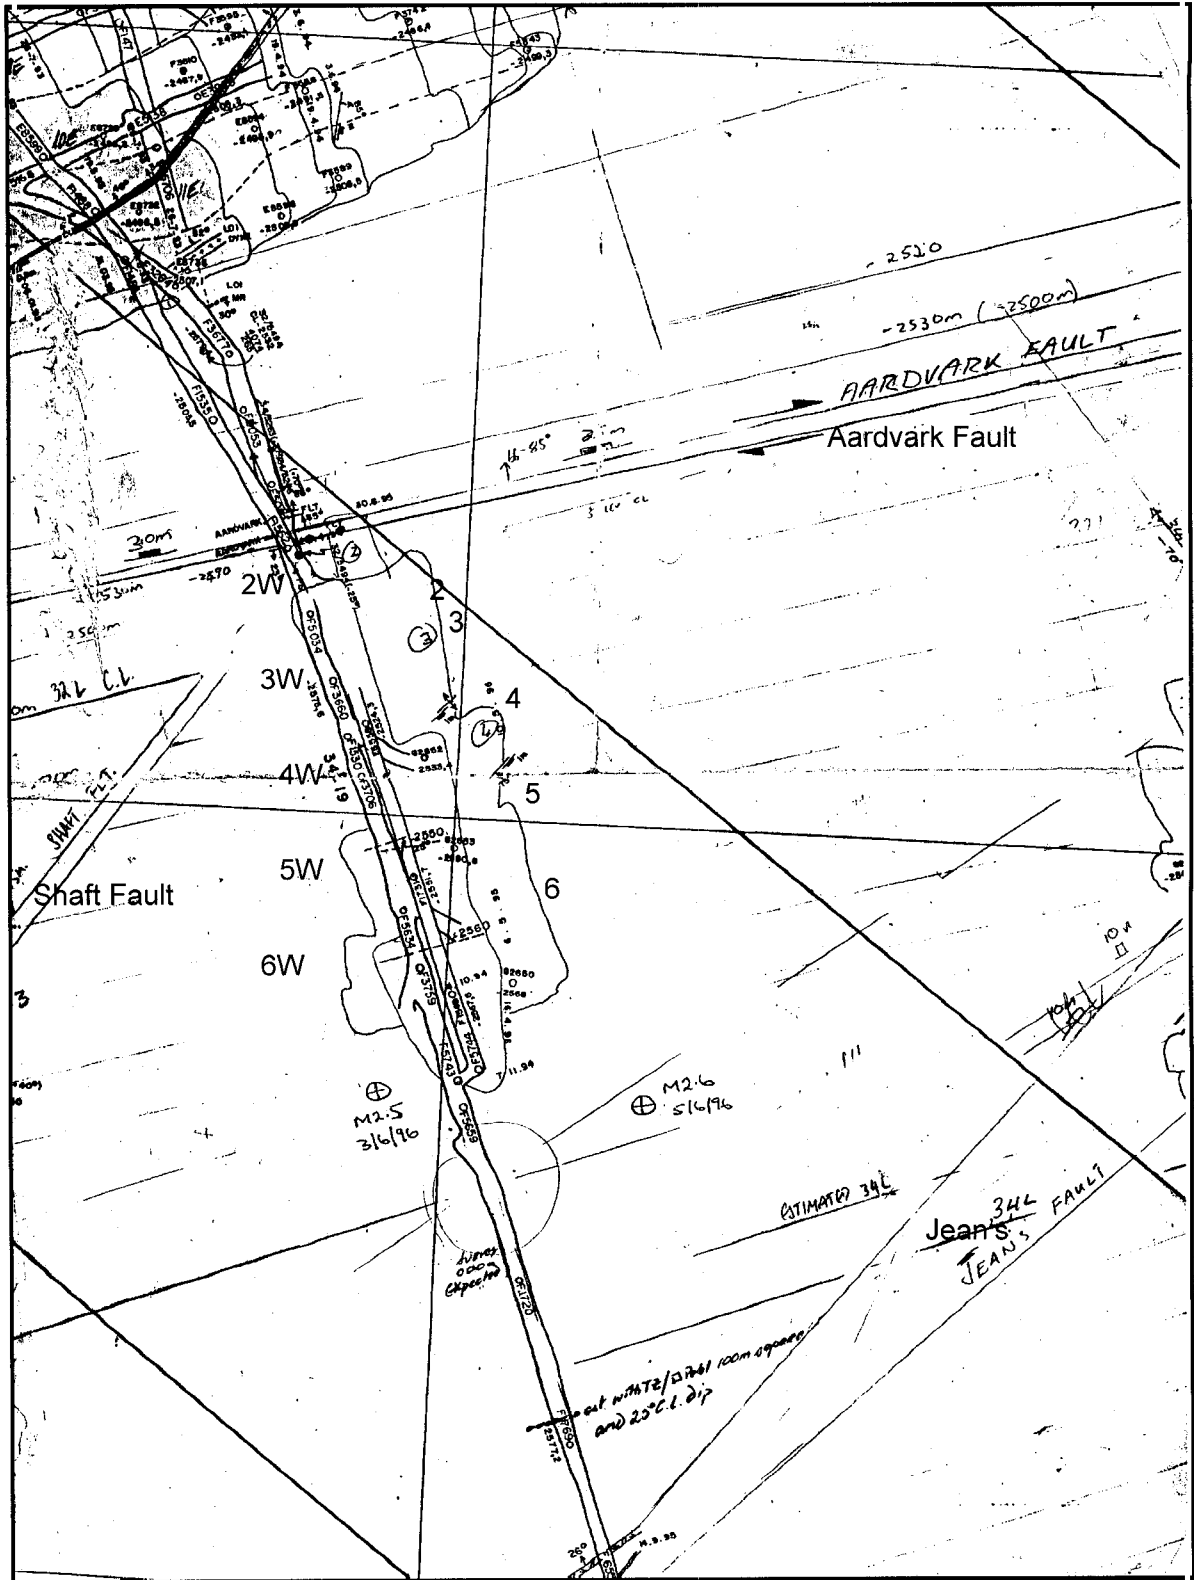
Figure B.50 Plan showing the 34-19 Carbon Leader stope, No. 1 Shaft, East Driefontein Gold Mine, damaged by a $M_L=2,7$ rockburst on 5 June 1996.

Damage in the stope largely consisted a scattered falls of ground in the face area where the face to support distance exceeded 3 m, and falls of ground between packs in the back areas. There was no evidence of crushing or ejection of the face. Co-seismic closure was estimated from the bending of Camlock props to be about 150 mm at the bottom of panel 6E. The Rocprops generally performed well in supporting the hangingwall, although the distortion of their headboards is cause for concern as their ability to provide areal support in a subsequent rockburst is probably diminished.

Substantial damage occurred in the 34-level cross-cut near the reef intersection owing to bulking of the eastern sidewall and footwall, causing the sets to topple.

Rockburst resistant support such as rapid yielding hydraulic props or Rocprops must be installed in the face area. Owing to the highly fractured nature of the hangingwall, good areal coverage is essential and headboards should be used. This is especially critical in the highly stressed regions at the top and bottom of the panels. Mechanical props (such as Camlocks) and mine poles have little value in rockburst conditions and should not be used.

The use of shorter panels is recommended to limit the magnitude of ruptures on face-parallel shears, and the extent of damage.

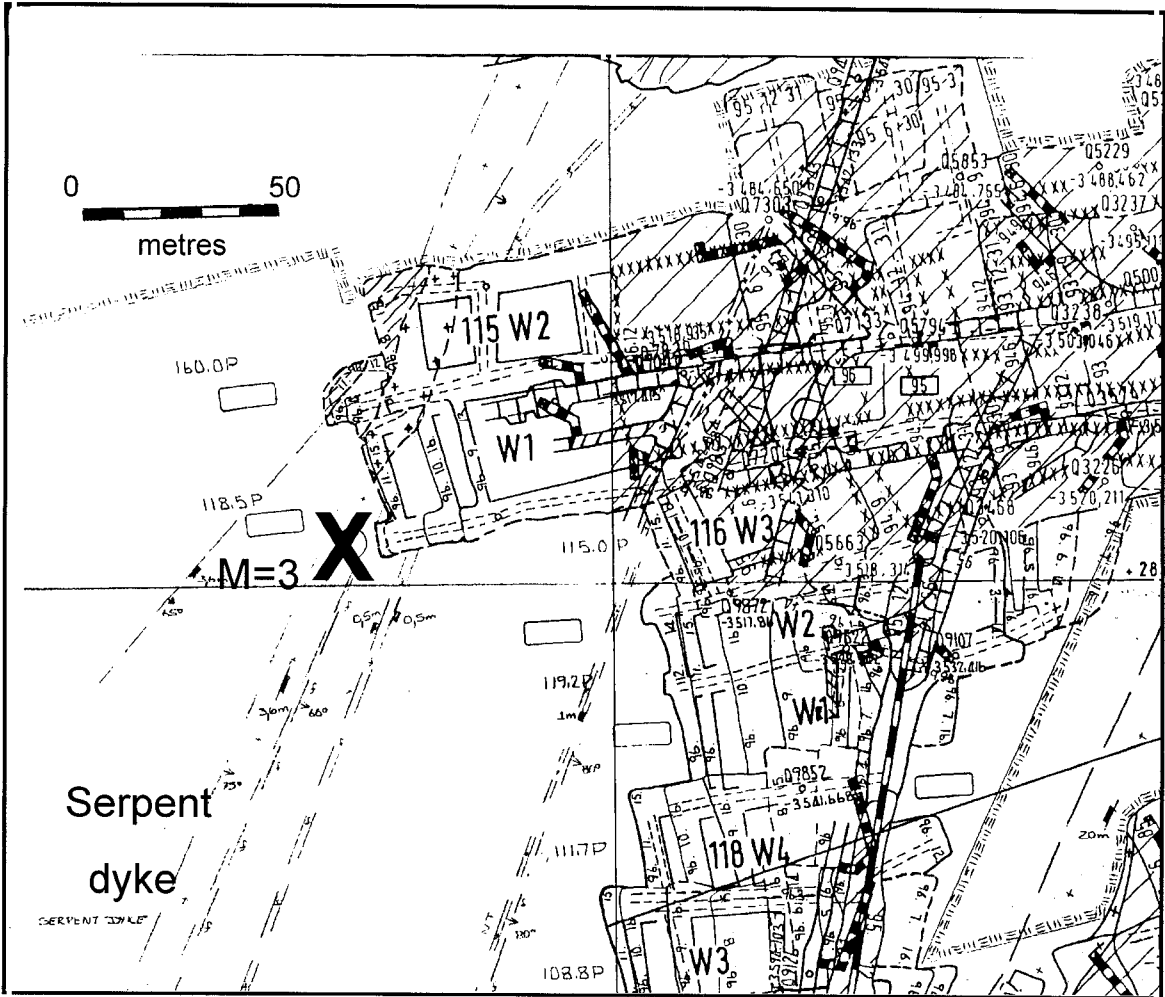
A rockburst occurred at Western Deep Levels East Mine on 18 November 1996, causing severe damage to the strike gullies serving the 115 W1 and 115 W2 Carbon Leader panels, about 3300 m below surface (Figure B.53). A seismic event with a local magnitude $M_L=3,0$ was recorded at 9h10 by the mine-wide seismic network. A worker installing sets in the lower (115 W1) gully was fatally injured. A further 15 workers were trapped in the face area of the 115 W1 panel. They were extricated by 18h00 on the same day by rescuers digging through the collapsed ground in the upper (115 W2) gully. One of the trapped workers suffered lacerations caused by falling rock, while all the

Several geological structures are present in the environs of the 115 W1 Carbon Leader panel, notably the Serpent Dyke and the Serpent Dyke Offshoot, and minor sympathetic faulting associated with these features (Figure B.53). The Serpent Dyke is about 10 m thick and dips to the south-east at approximately 70°. It was exposed in the upper half of the W1 panel, while the W2 panel had already mined through it. Quartz veins were noted close to the dyke/country rock contact. In this area the Rice Pebble quartzite, which forms the hangingwall of the Carbon Leader Reef, is about 1,8 m thick. The Green Bar shale horizon lies above the Rice Pebble quartzite. The parting at the base of the Green Bar is particularly prone to separation.

Figure B.53 Plan showing the stopping layout and epicentre of the $M_L=3,0$ seismic event which occurred on 18 November 1996 damaging the 115 W1 lower strike gully, Western Deep Levels East Mine. Areas which sustained rockburst damage are shaded.

The rockburst damage in the 115 W1 gully was briefly inspected by the team. The 115 W1 panel was leading the 116 W3 panel by some 60 m. It was reported that hangingwall collapses extended for much of this distance, with the exception of about 10 m near the face. The fallout generally extended to the base of the Green Bar horizon (about 1,8 m), and in some instances included the Green Bar itself, creating caverns up to 6 m high. Ground conditions in the face area of the gully were reasonable.

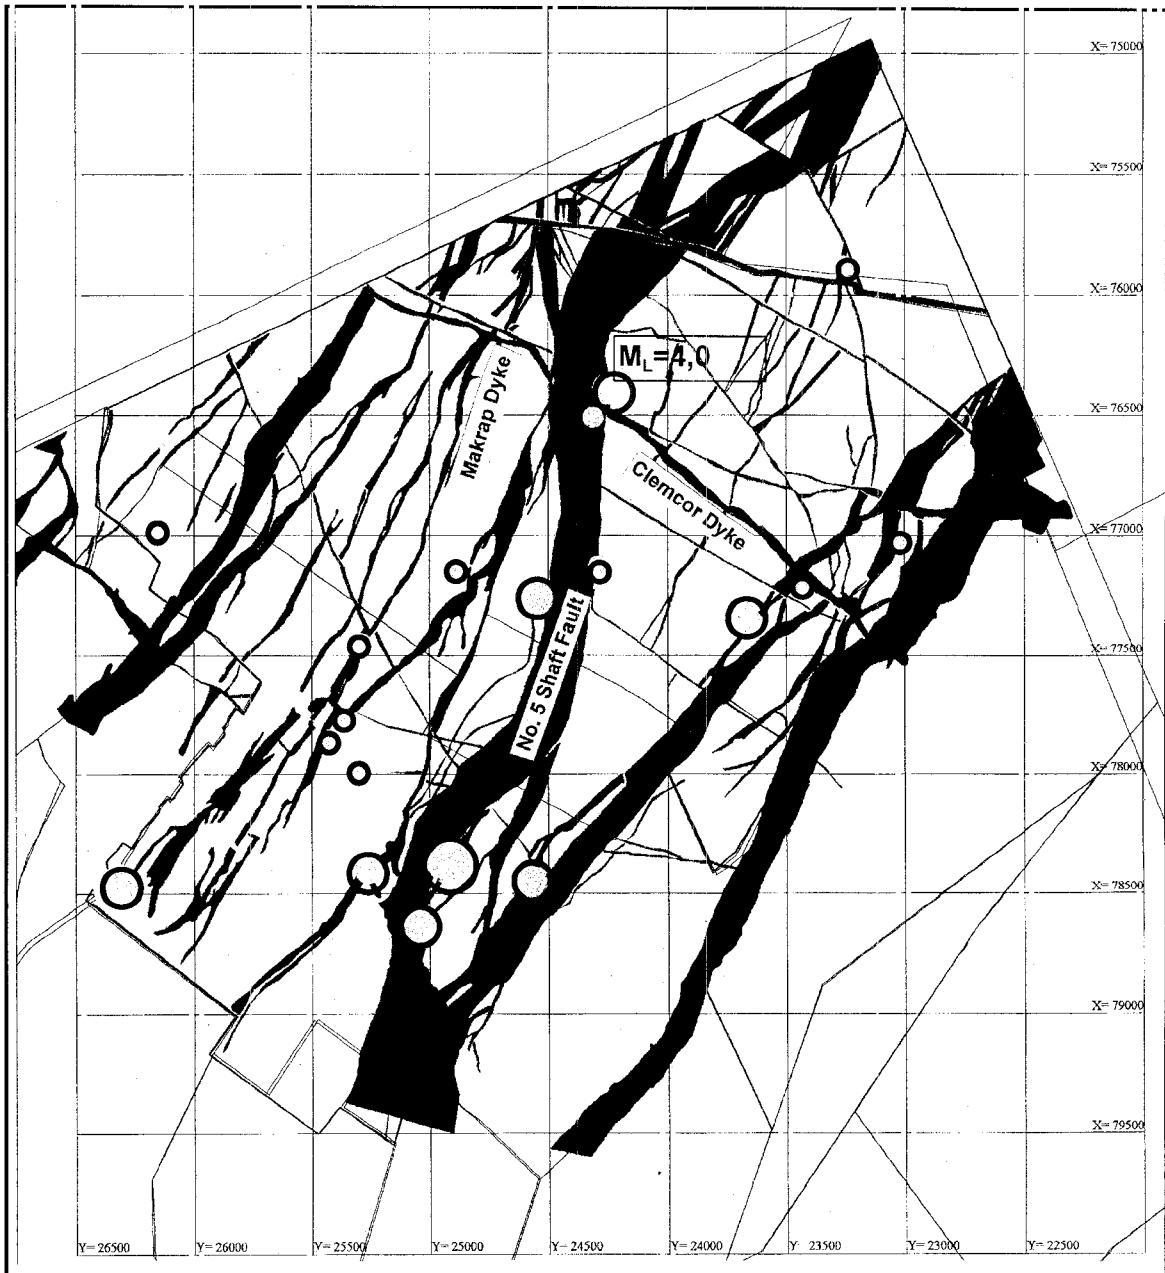
Figure B.55 Plan showing the epicentre of the $M_L=4,0$ seismic event which occurred on 10 February 1996, damaging the haulages on 50-50 and 62 levels, No. 5 Shaft, Vaal Reefs Gold Mine. Major geological structures and the location of 19 other events with $M_L \geq 3,9$ occurring since 1972 are also shown.

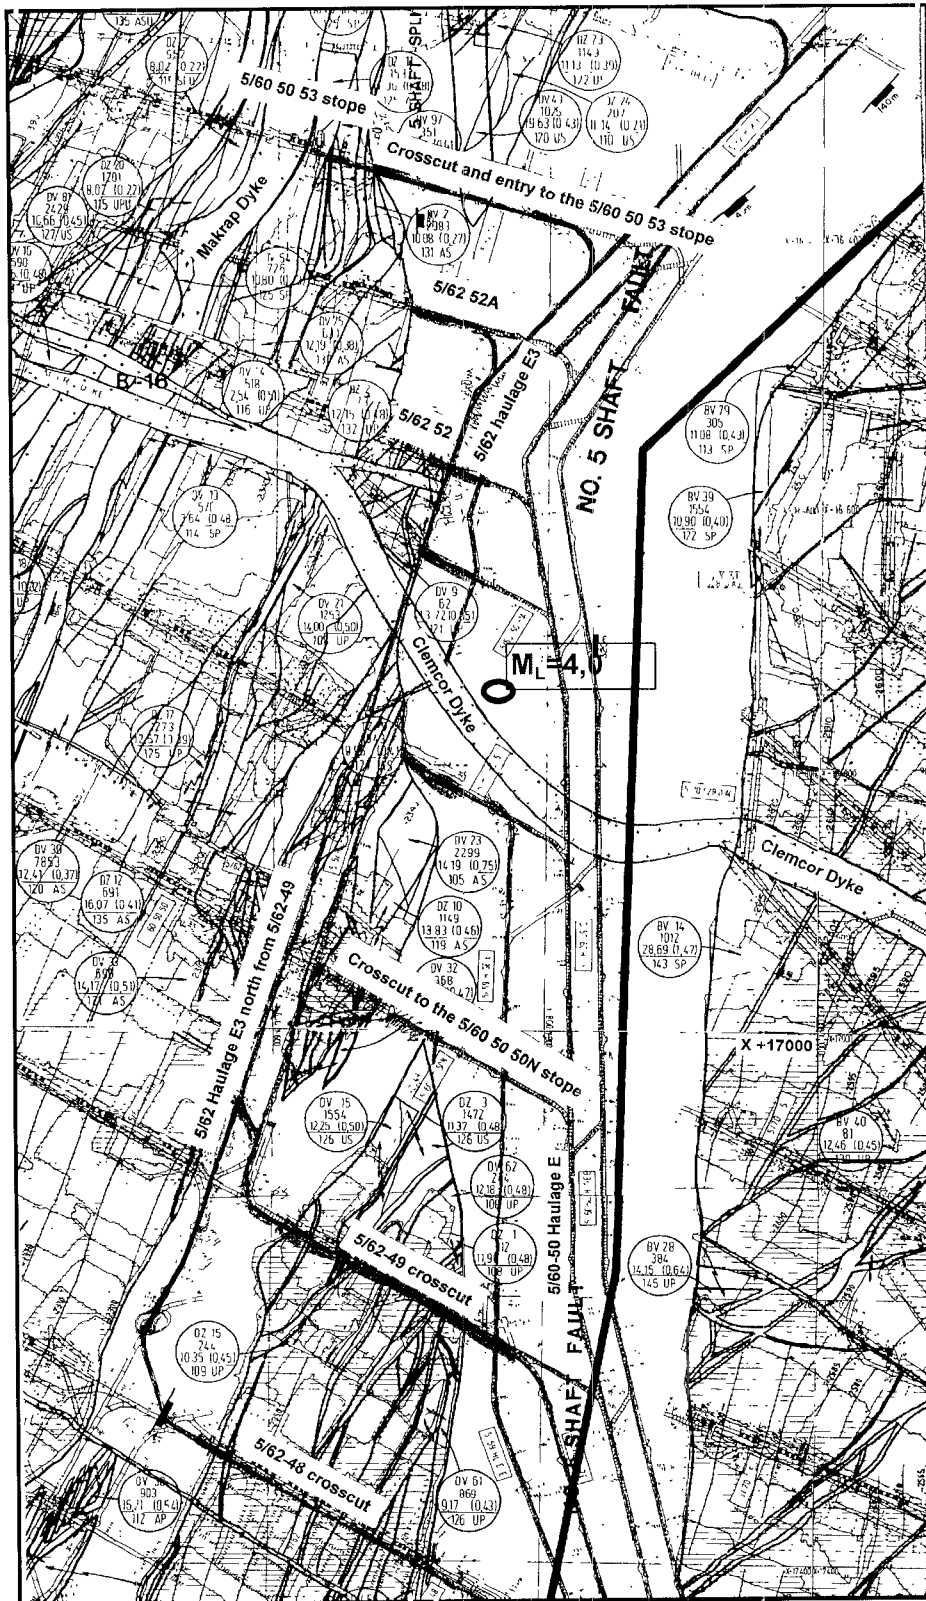
The in situ investigation commenced at the 60-50 level (see Figure B.56). There was little damage to the 5/60-50 main haulage. Most damage was found in cross-cuts passing from solid to over-stoped ground, especially in the vicinity of the dyke which was intruded close to the fault surface.

Figure B.56 Plan showing tunnels damaged by the $M_L=4,0$ seismic event which occurred on 10 February 1996, No. 5 Shaft, Vaal Reefs Gold Mine.

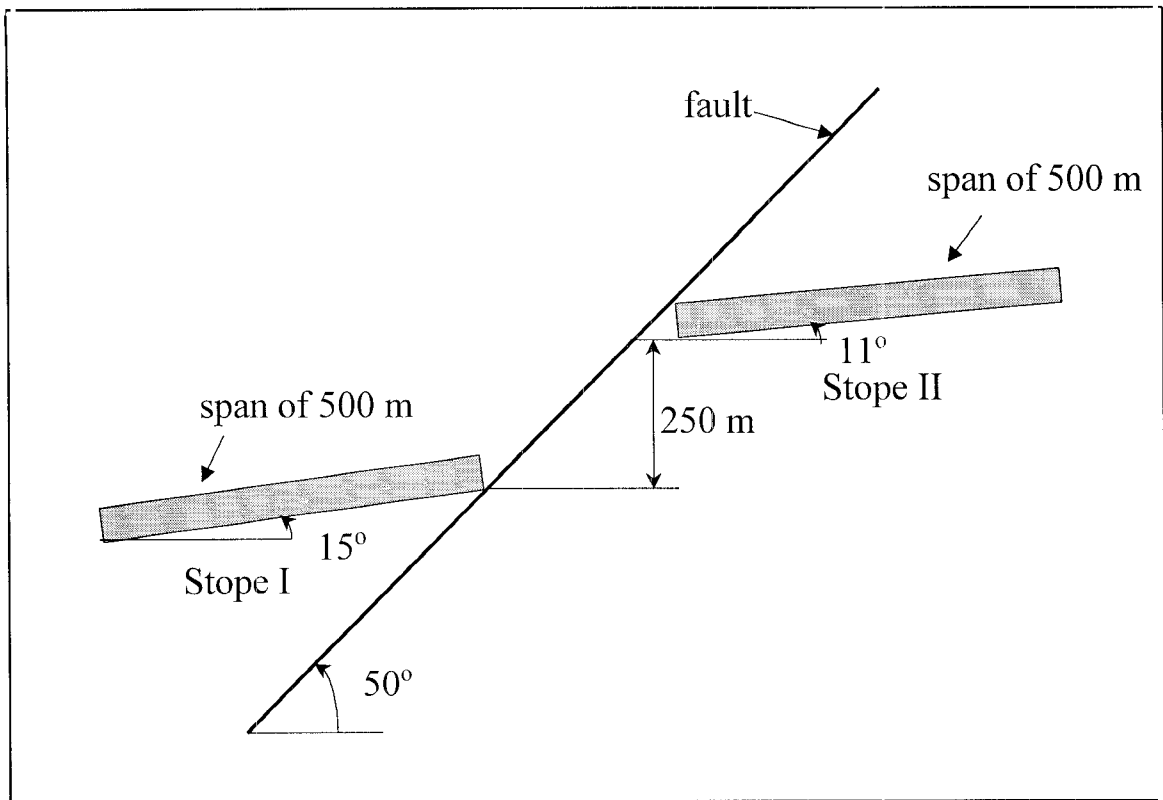
Figure B.57 Cross-section of seismic event area where mining is approaching the fault from both sides

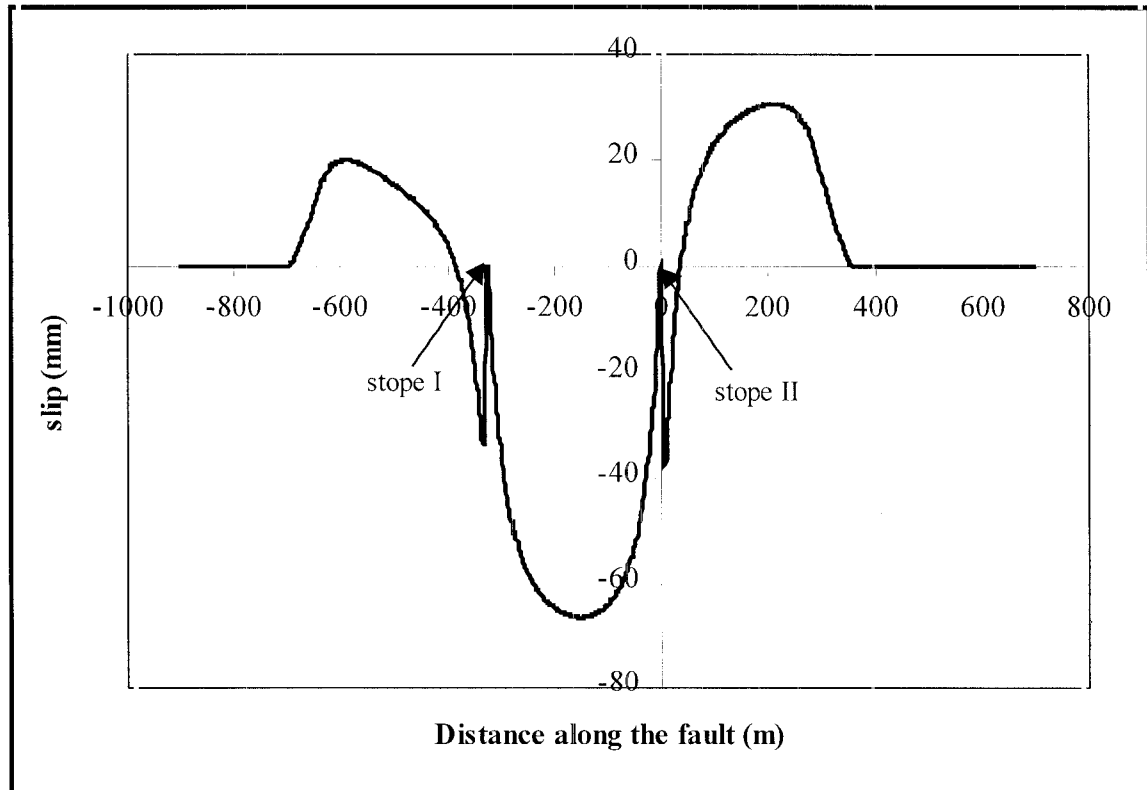
The distribution of slip provided by the plane strain model was numerically integrated over the (dip) length of the discontinuity undergoing slip, and the average slip was calculated by dividing the integrated slip value by the dip length undergoing slip. The area of the circle was calculated and multiplied by the average slip. This can be thought of as the *volume* of slip. The seismic moment based on the above procedure was found to be $1,59 \times 10^{15}$ Nm.

Figure B.58 Slip profile on the fault

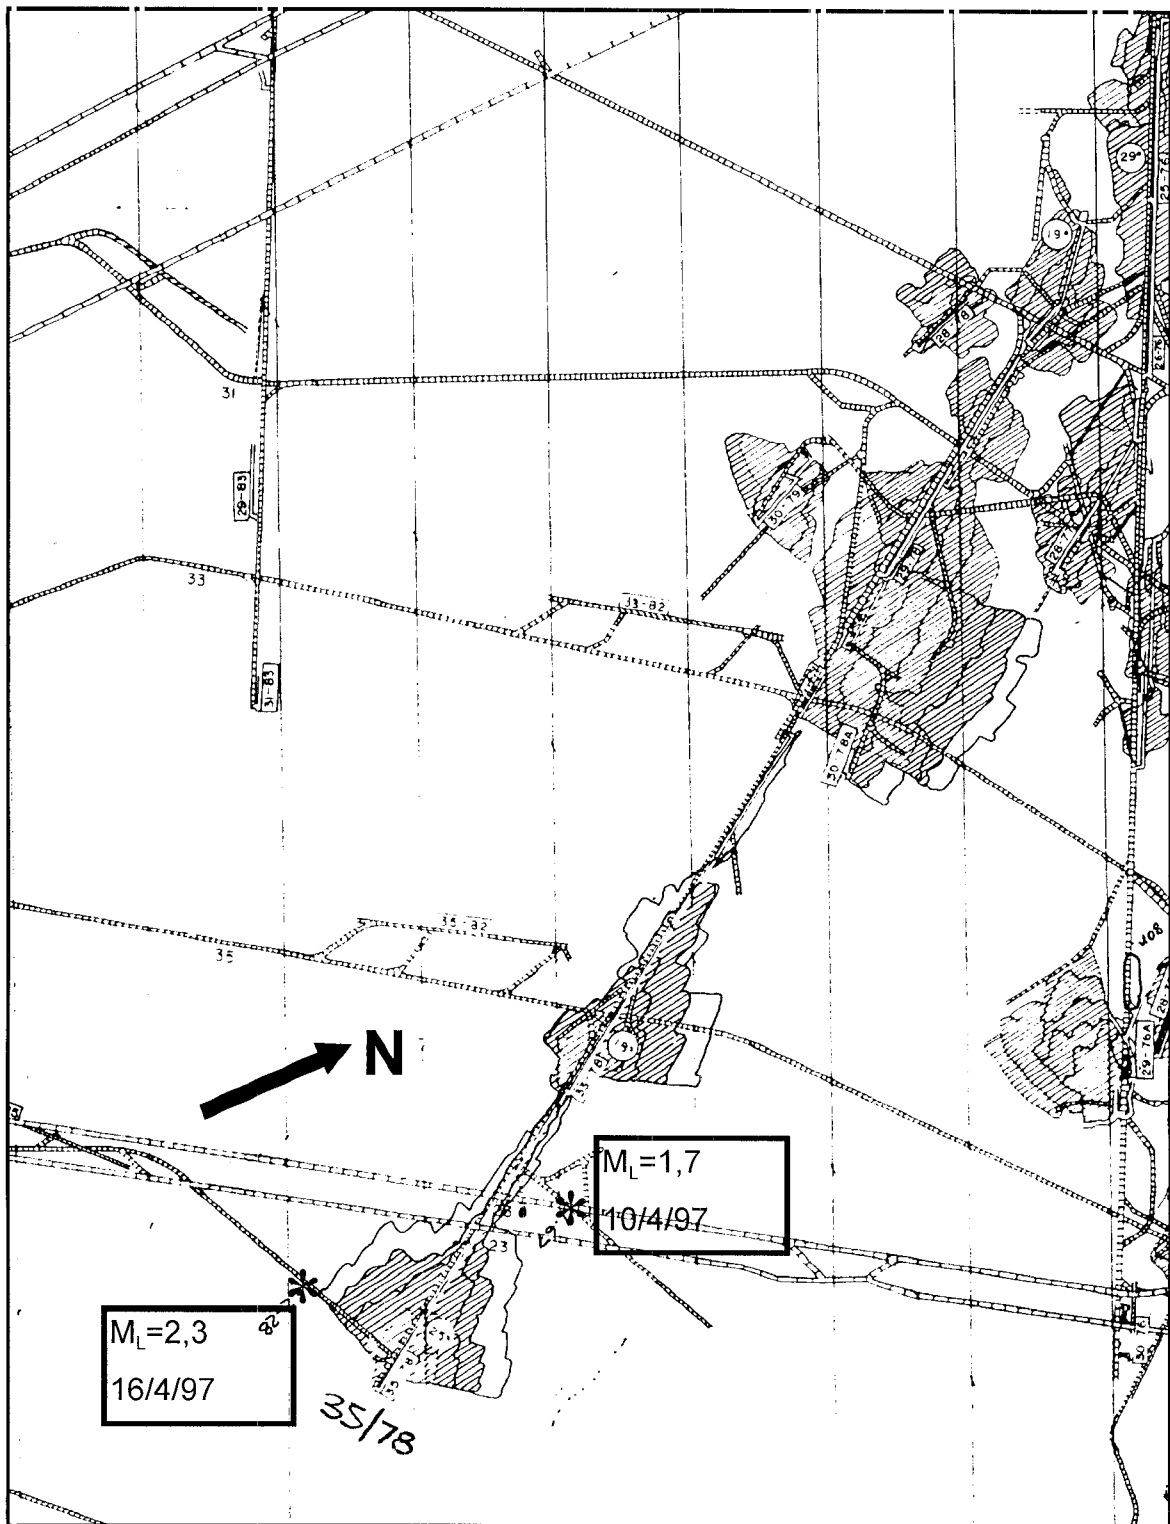
Stopping on the VCR horizon was conventional breast mining with approximately 30 m panels with small leads, creating an overall overhand face configuration. The extent of mining, on a regional basis, in this area was very limited (see Figure B.59). The large lead of the panel immediately down dip of the $M_L=1,7$ event increased the stress concentration on the lagging face position. This, however, did not seem to contribute to an instability of this lower portion of the panel on which the hangingwall collapse occurred. Overall the general stope face configuration on the VCR, is considered to comply to standard rock engineering practice.

Figure B.59 Regional mining plan showing the stoping layout in the vicinity of the 35 Level 78 Line, Leeudoorn Division of Kloof Gold Mine, which experienced damage owing to a $M_L=1,7$ seismic event on 10 April 1997 and a $M_L=2,3$ seismic event on 16 April 1997.
