Safety in Mines Research Advisory Committee

DRAFT FINAL REPORT

**Improvement of worker safety through
the investigation of the site response
to rockbursts**

Research agency : CSIR: Division of Mining Technology

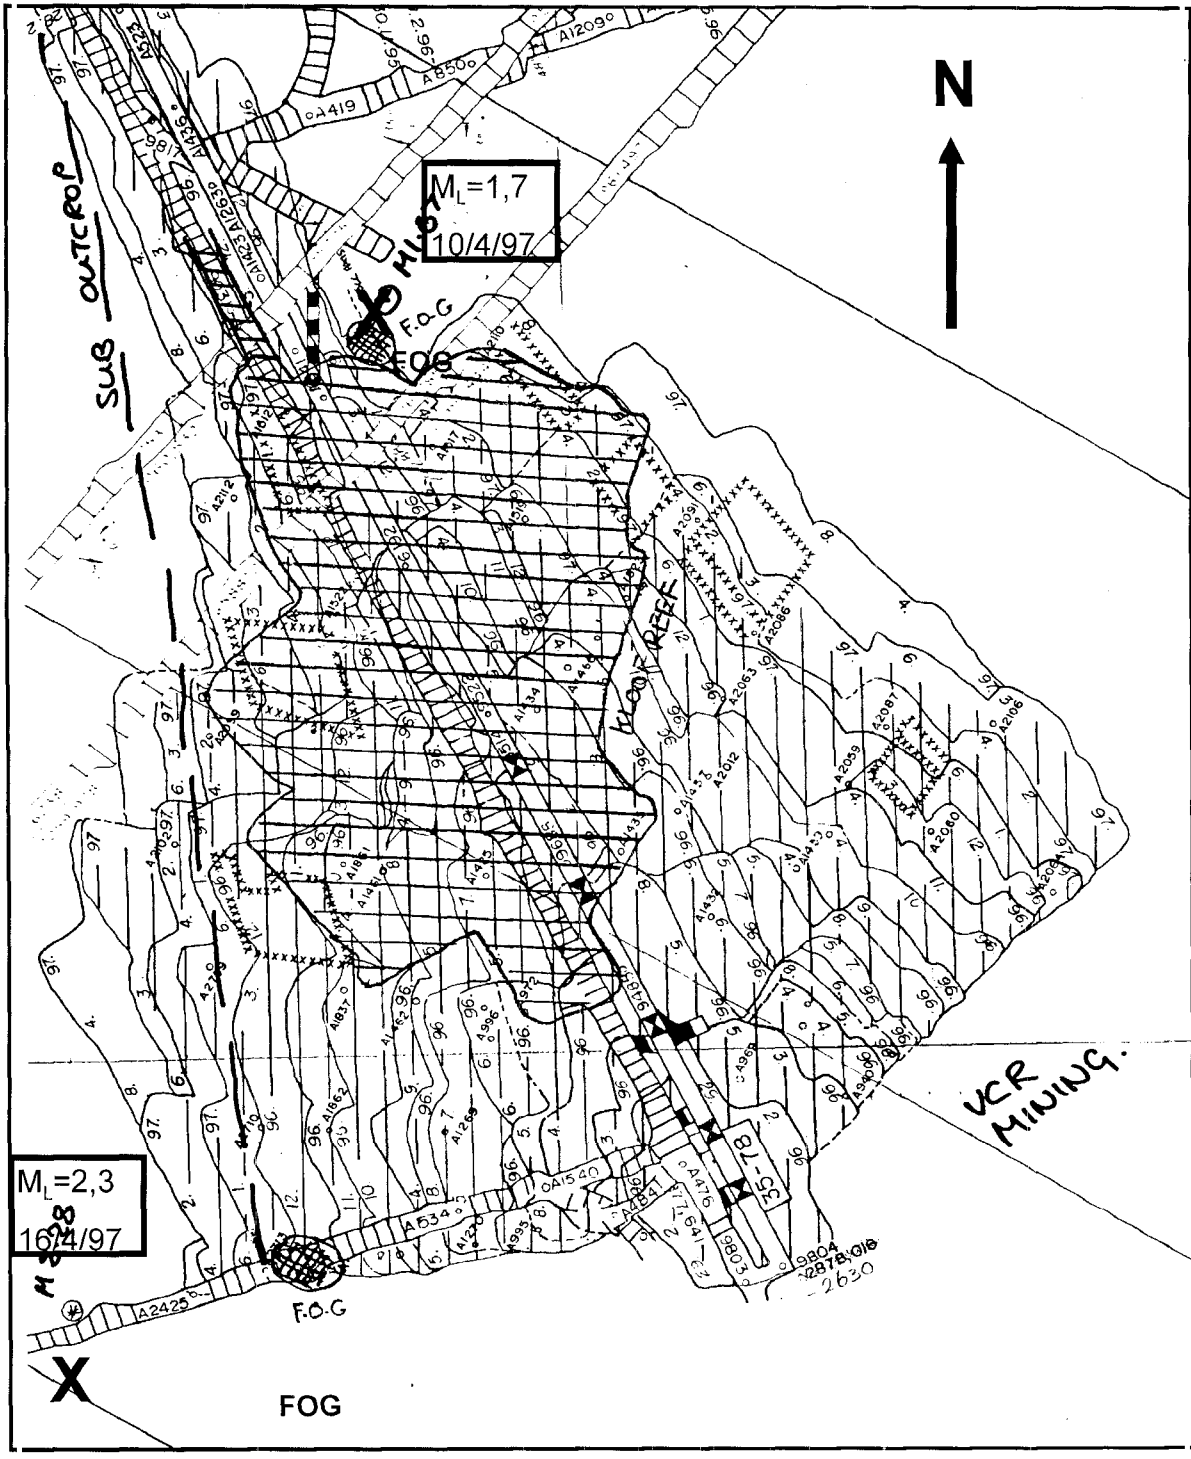
Figure B.60 Local mining plan showing the locations of the $M_L=1,7$ seismic event on 10 April 1997 and a $M_L=2,3$ seismic event on 16 April 1997 and the distribution of damage in the 35/78 VCR stope, Leeudoorn Division of Kloof Gold Mine. The stope area of the VCR and the sub-cropping Kloof reef are shown by vertical and horizontal hatching, respectively.

The negotiation of the roll in the reef at the site of the $M_L=1,7$ event had necessitated trenching at the mining face in order to expose the reef horizon at the lower elevation. This would have resulted in the exposure of the hangingwall lava at the face position and a higher than normal unconfined face dimension.

The rockburst damage at this location is considered to be a function of both the seismic event and the local rock mass characteristics. The highly disturbed nature of the stope hangingwall in this area is considered to be owing to small scale thrust faulting of the VCR in a zone striking sub-parallel to the VCR strike in this vicinity, in addition to the disruption of the hangingwall integrity owing to the presence of the VCR roll. This complex geotechnical environment is considered to lead to a highly friable hangingwall rock mass condition, which would be abnormal to anticipated hangingwall conditions and prone to collapse under dynamic loading.

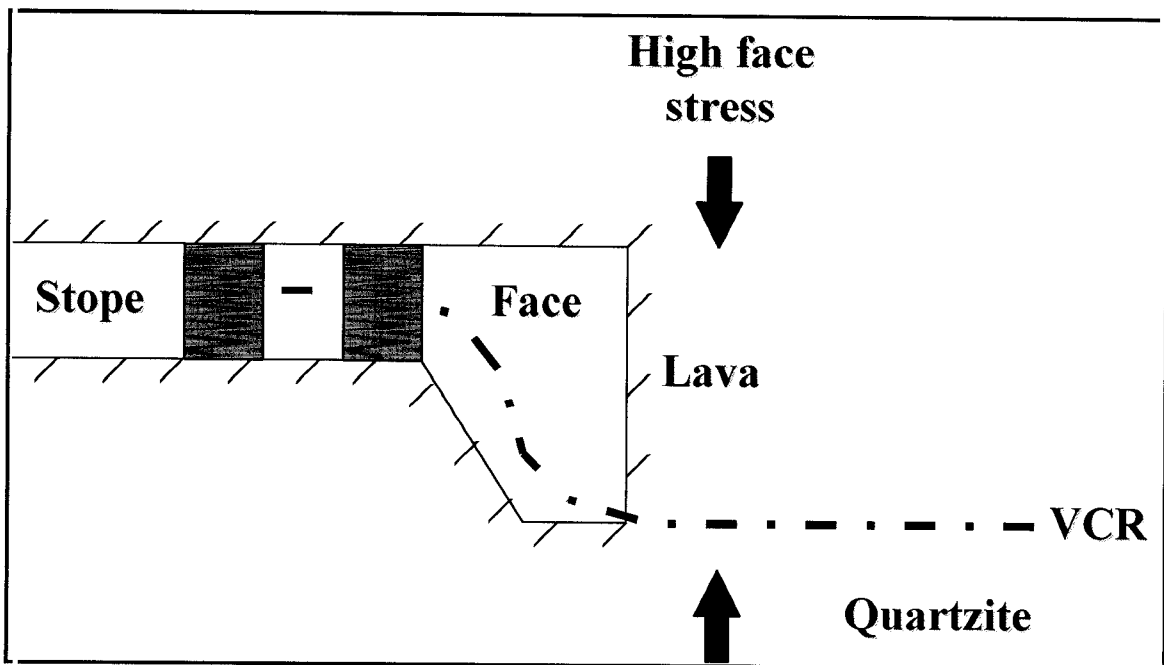
Figure B.61 Possible source mechanism of face burst owing to lava in face, and high face dimension

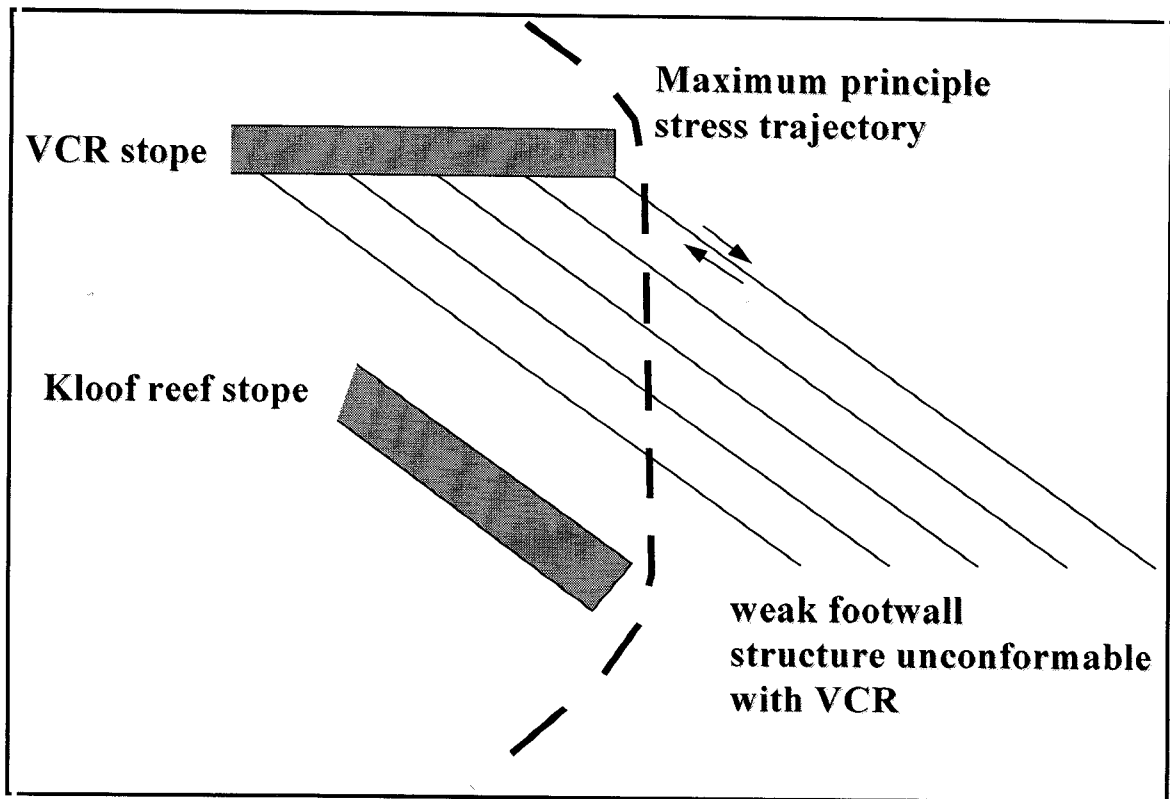
An alternative seismic mechanism may be related to the location of the Kloof reef undermining relative to the VCR horizon. The position of the Kloof reef north face is almost directly below that of the VCR, with an approximate middling of 35 m. This may cause a more adverse orientation of the maximum principle stress relative to the unconformable VCR footwall stratigraphy, with resultant potential shear failure (Figure B.62). This mechanism is discussed in more detail below, with regard to the $M_L=2,3$ event.

Figure B.62 Possible seismic mechanism owing to relative position of Kloof reef under-mining.

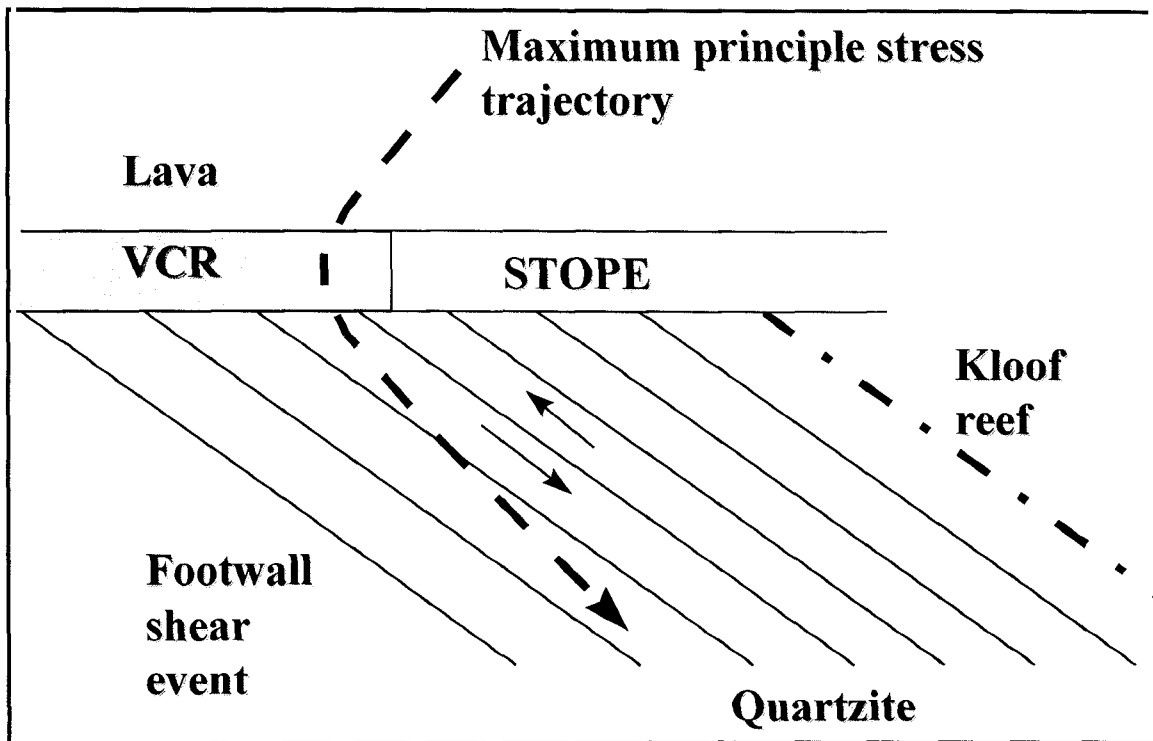
A $M_L=2,3$ seismic event occurring in advance of the stope face would generally be associated with a weak geological structure such as a fault or dyke. No such structure was known to exist on the VCR horizon. It is postulated that the event was related to the presence and orientation of the weak bedding planes associated with the unconformable footwall stratigraphy. The trajectory of the maximum principle stress, refracted by the mined out VCR stope, was adversely orientated relative to the footwall stratigraphy. As a result, violent shear movement occurred on weak planes within the footwall rock mass once the stress reached a critical level (Figure B.63).

Figure B.63 Proposed mechanism of footwall shear owing to unconformable footwall stratigraphy (north-south section, up dip view)

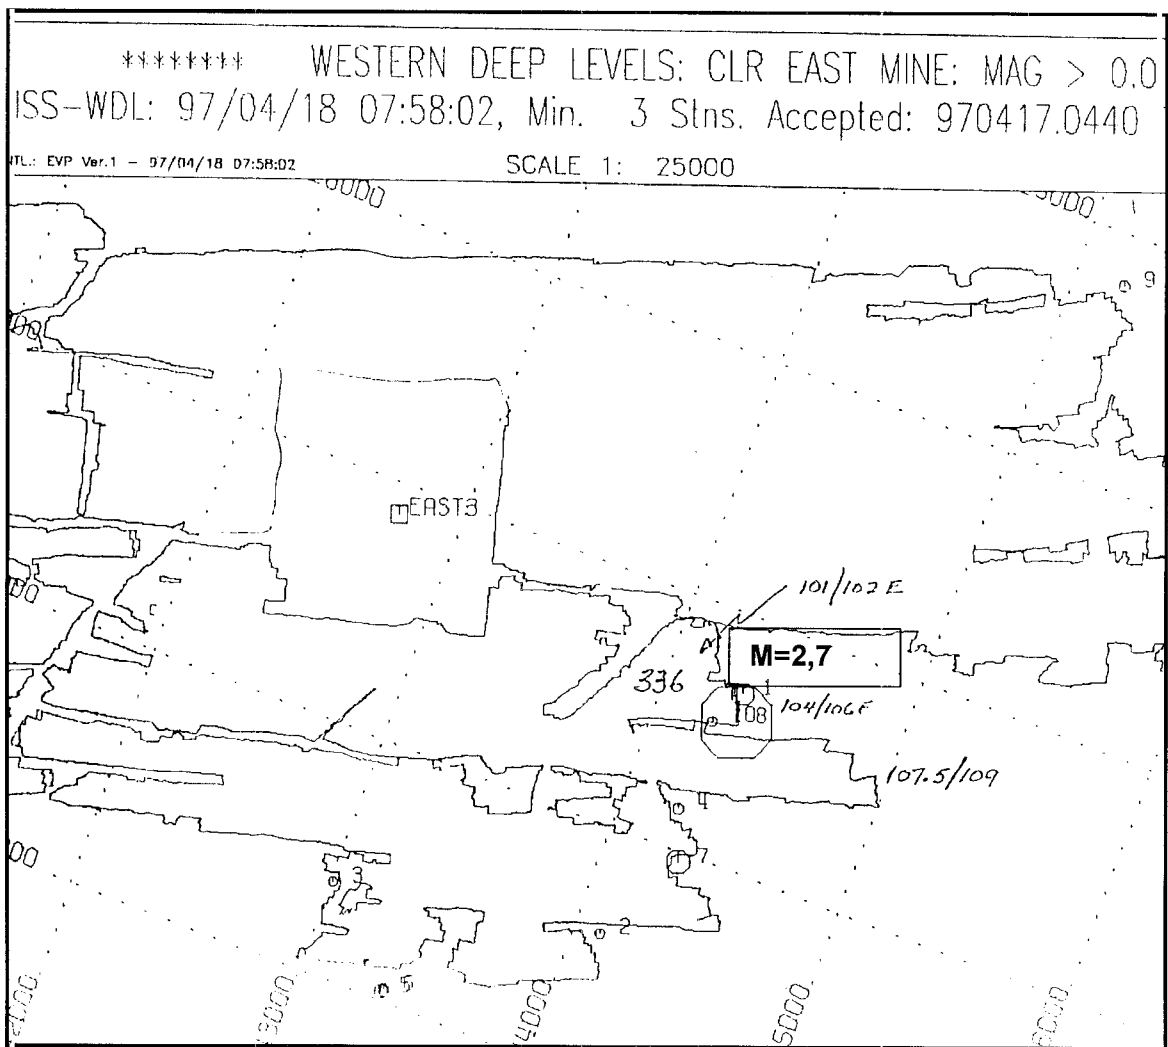
The two mini-longwalls (101/102E and 104/106E) making up Section 336 are shown in Figure B.64. A fault zone known as the Break Fault is shown traversing both mini-longwalls (Figure B.65). This fault zone made for difficult mining in the upper reaches of

Figure B.64 Plan showing the location of the $M_L=2,7$ seismic event which occurred at 22:32 on 17 April 1997, Section 336 Western Deep Levels East Mine.

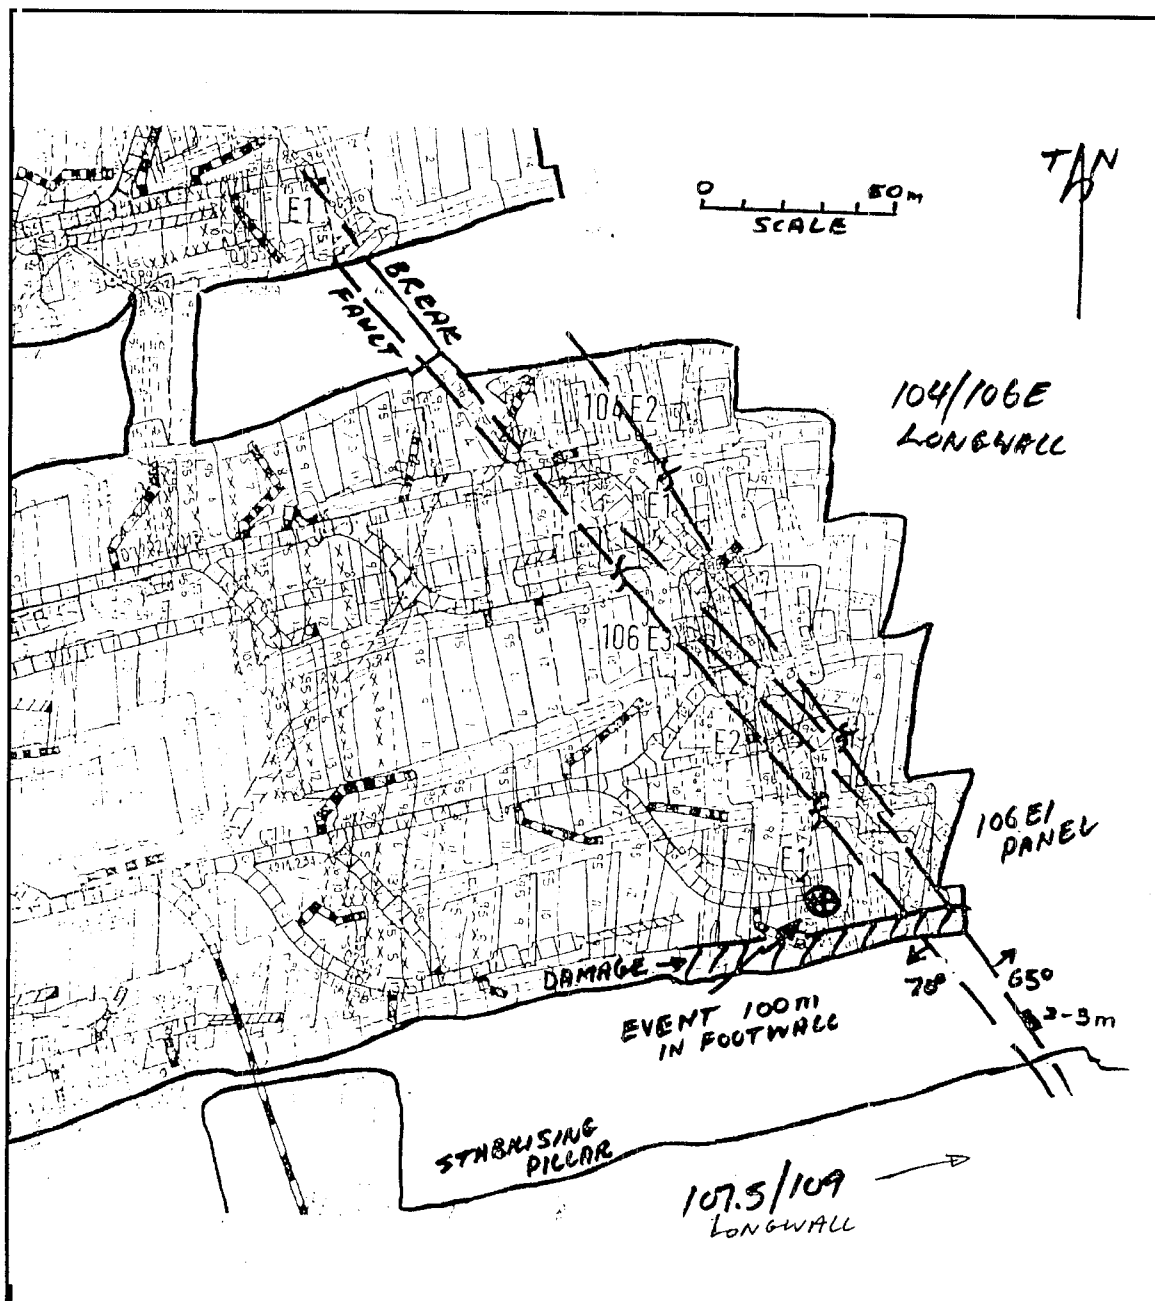
the section. Subsequent speeding up of mining in the lower reaches of the section resulted in both longwalls breasting on to the fault at the same time. It is likely that a magnitude $M_L=4,0$ seismic event, which occurred on 5 May 1996, was initiated as a result. Since then, strict face control measures have resulted in the successful negotiation of the Break Fault in both mini-longwalls, with the exception of the 106E1 panel. It was in the strike gully, leading to the bottom of this panel, that the damage associated with the rockburst of 17 April 1997 occurred (see Figure B.65).

Figure B.65 Plan showing the location of the $M_L=2.7$ seismic event which caused damage to the 106/E1 gully along a stabilising pillar, Section 336 Western Deep Levels East Mine.

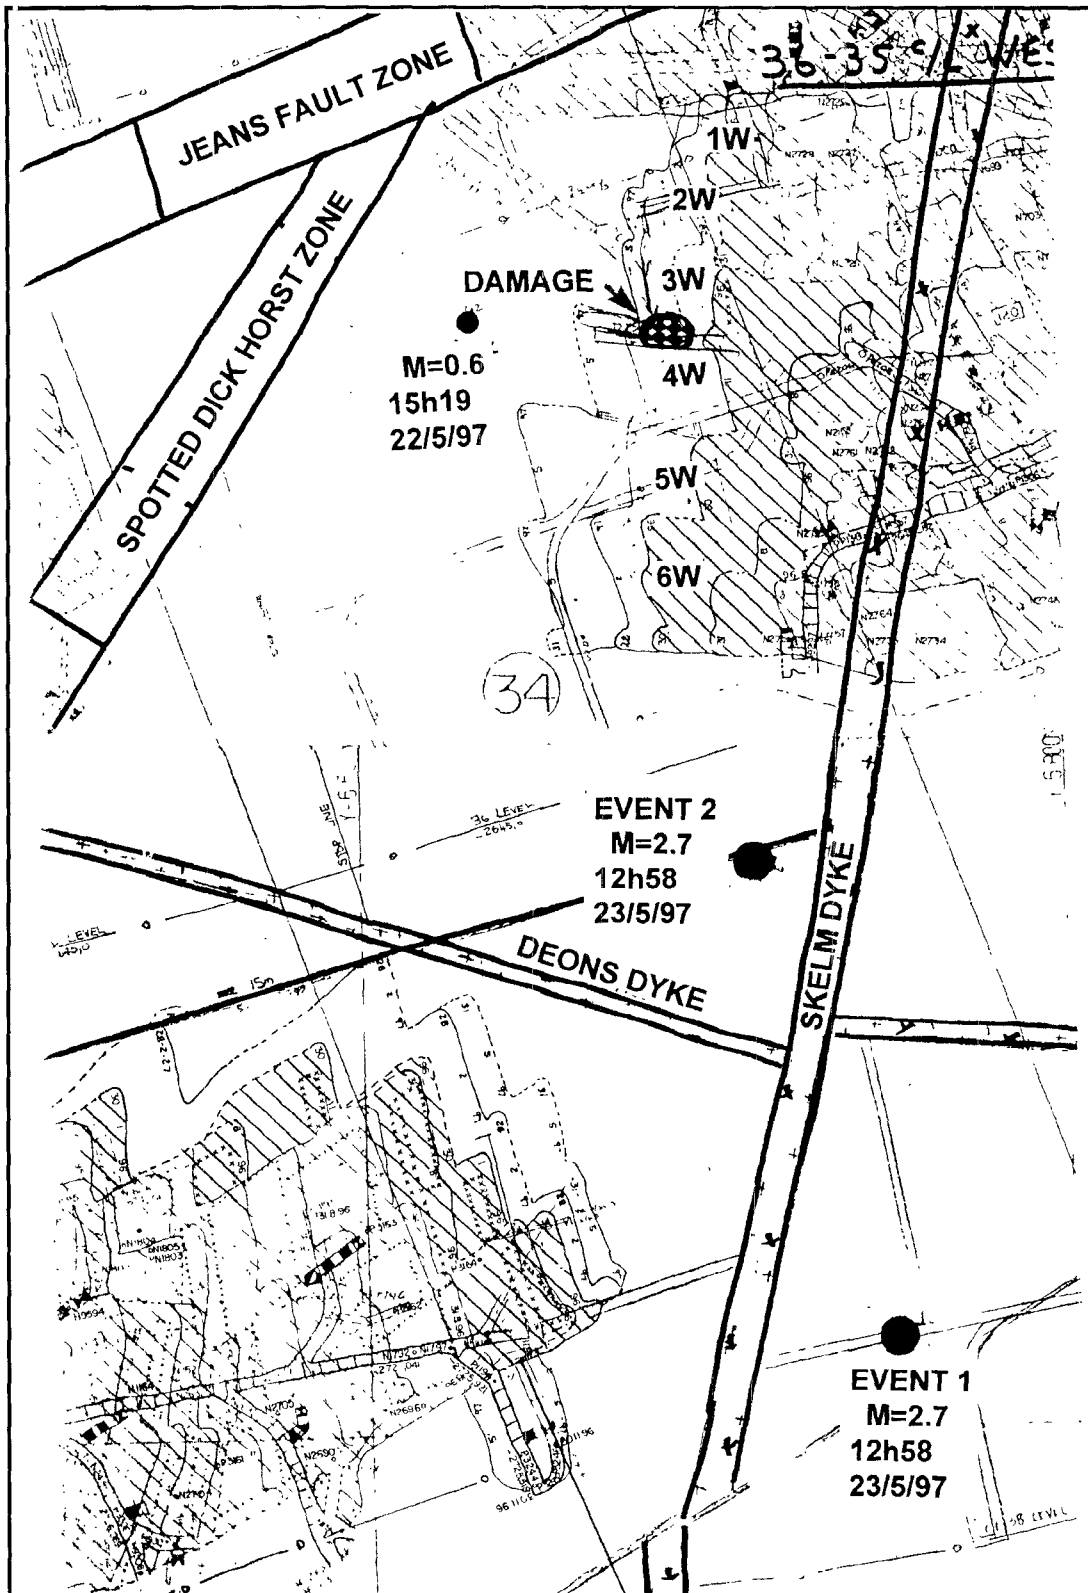
There are several significant geological structures in the environs of the 35-36 C/L West mini-longwall (see Figure B.67). The mini-longwall lies within a trapezoid, approximately 200 m x 200 m in area, bounded by the Jean's Fault Zone to the north-west, the Skelm Dyke to the east, Deon's Dyke to the south, and the Spotted Dick Horst Zone to the west. Several smaller structures are also present, for example a fault with a 2 m downthrow to the west was being negotiated by the (lagging) 1W panel at the time of the rockburst. The (leading) 2W and 3W panels had already mined through this fault.

Figure B.67 Plan showing the stoping layout and epicentre of the $M_L=2,7$ seismic events which occurred on 23 May 1997 damaging the 36-35 C/L West mini-longwall, West Driefontein Gold Mine.

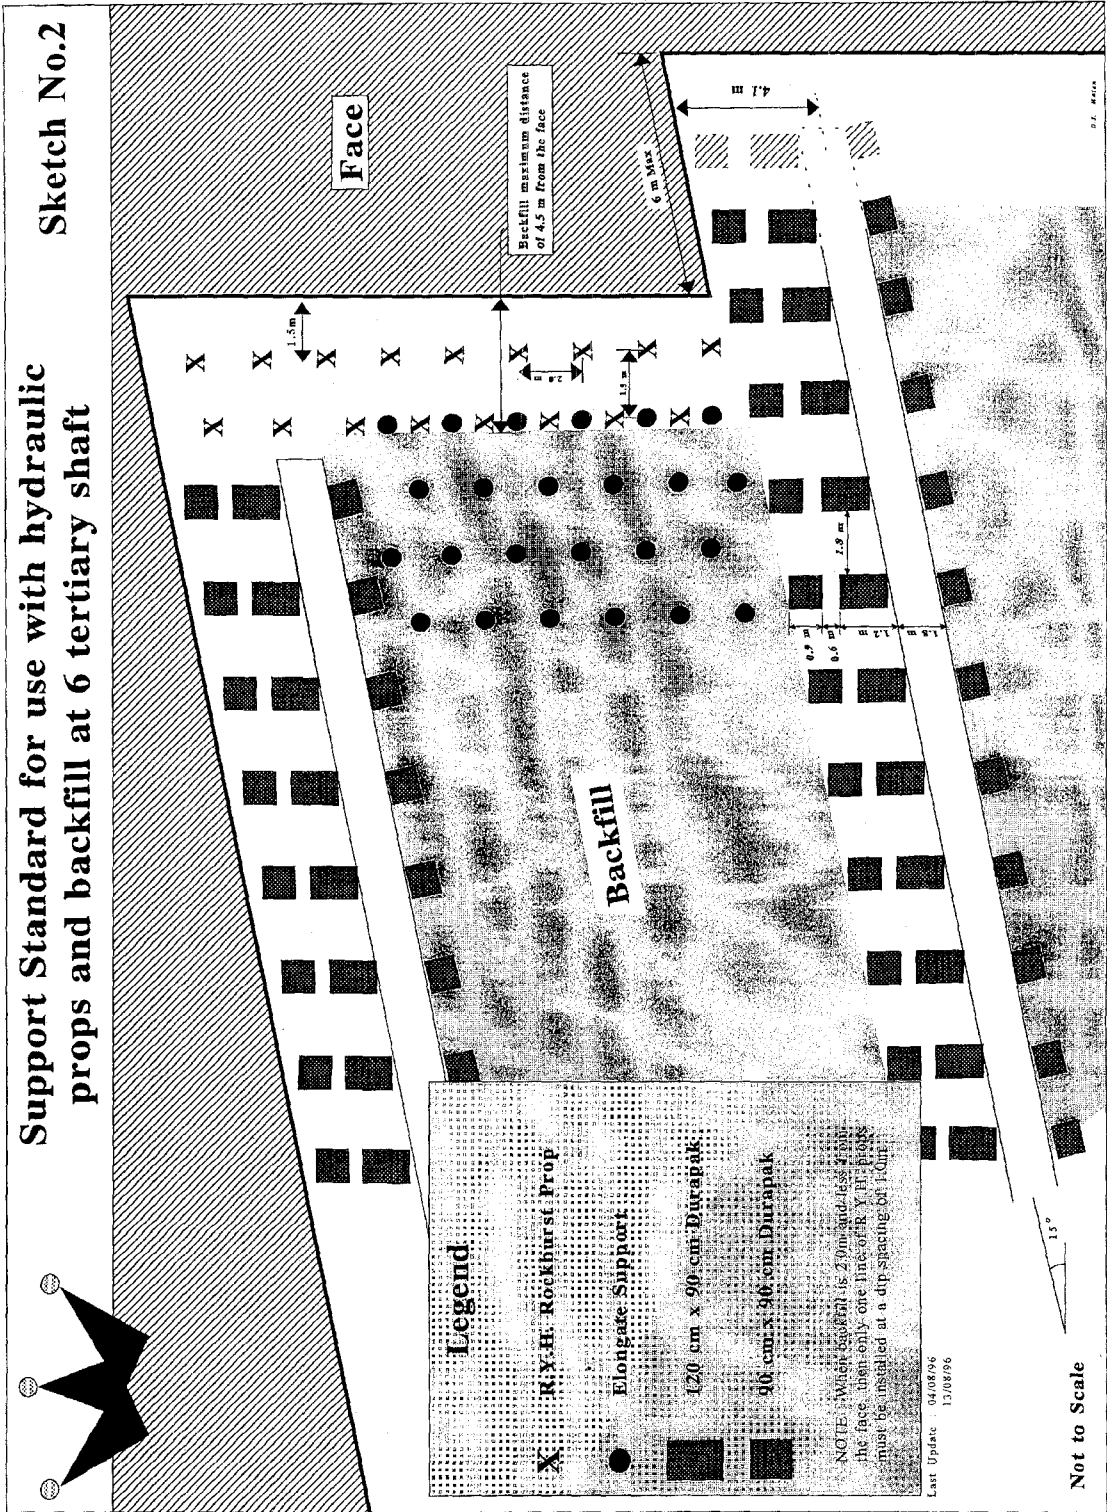
Figure B.68 Stope and gully support standard for West Driefontein No. 6 Shaft.

Gullies were lined with 1,2 m x 0,9 m Durapaks, with a yield load of 1400 kN. The gullies were oriented at 15° up-dip of strike. The lack of tendons to reinforce the hangingwall in the gully was a point of concern. Furthermore, experience gained from this investigation indicates that benefit might be gained by bringing the backfill closer to the gully.

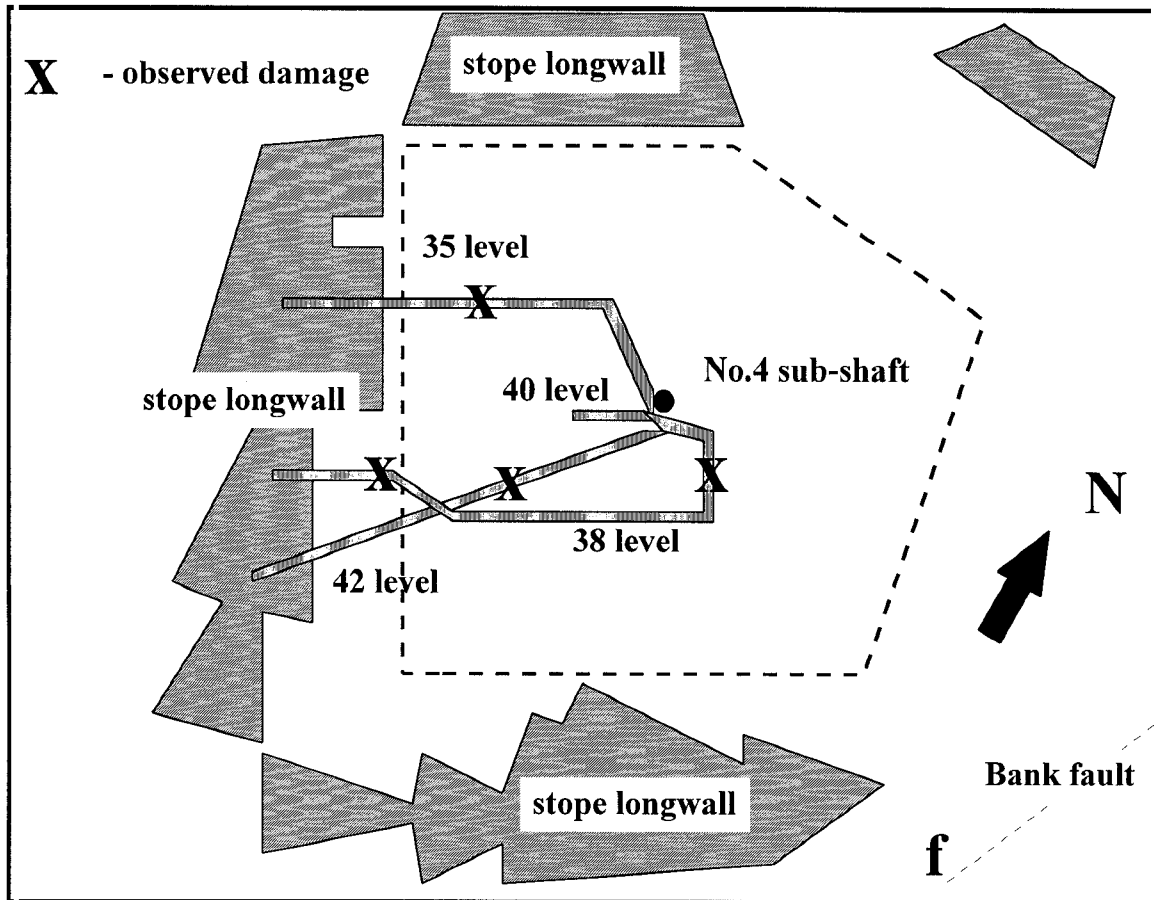
Damage on 35 level was inspected approximately two months after the main event, after completion of rehabilitation work in the main haulage west. Rockburst damage consisted primarily of the failure of the south sidewall of the tunnel to a depth of approximately 1,5 m. The failure of the support system was due to the bulking of the sidewall, and the failure of the mesh and lacing fabric support, with the subsequent unravelling of the rock mass from around the rock bolt reinforcement. At a breakaway position adjacent to peg D3492 in the 35 level footwall drive, observations were made of rock bolt failure under shear deformation, failure of mesh and lacing, and significant closure of the cross-cut excavation. The rock mass in the immediate periphery of the excavation was highly

Figure B.70 Schematic plan of tunnel and stoping layout, East Driefontein No. 4 Sub-vertical Shaft, and the distribution of damage caused by the $M_L=4,4$ event on 25 September 1997 and inspected during the investigation.

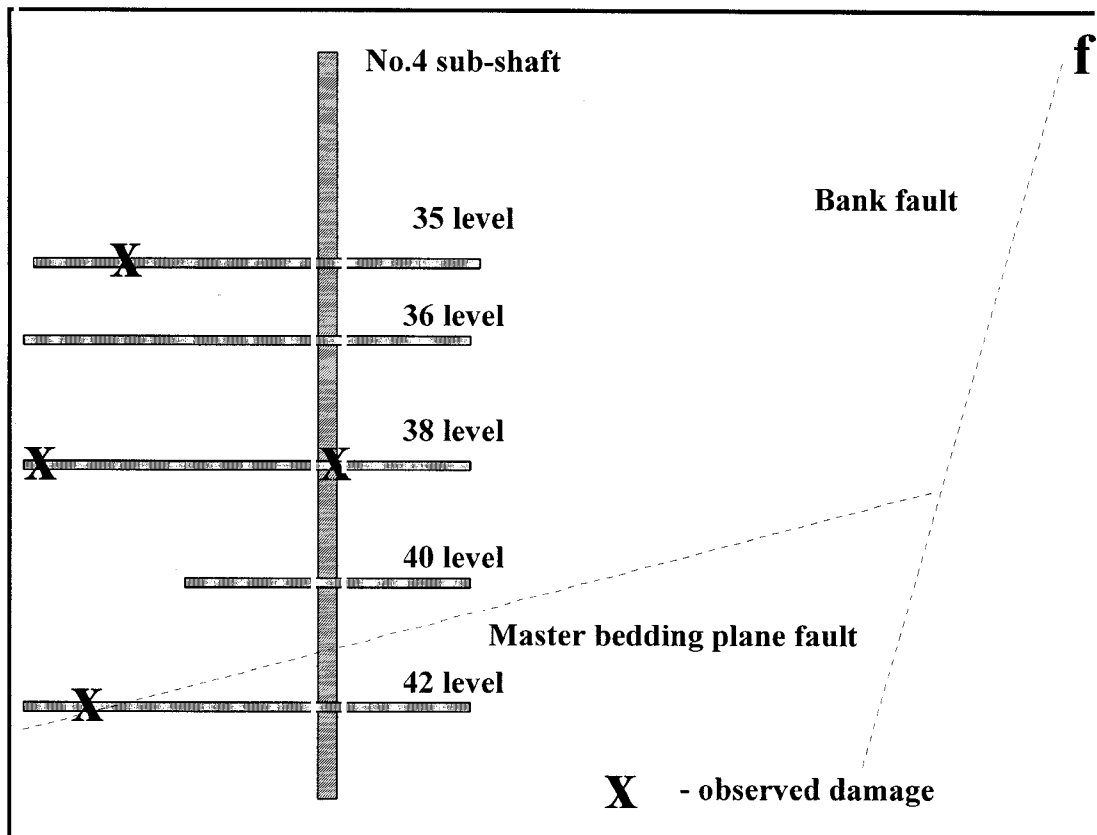
Figure B.71 Schematic section of shaft layout and major fault planes with distribution of damage.

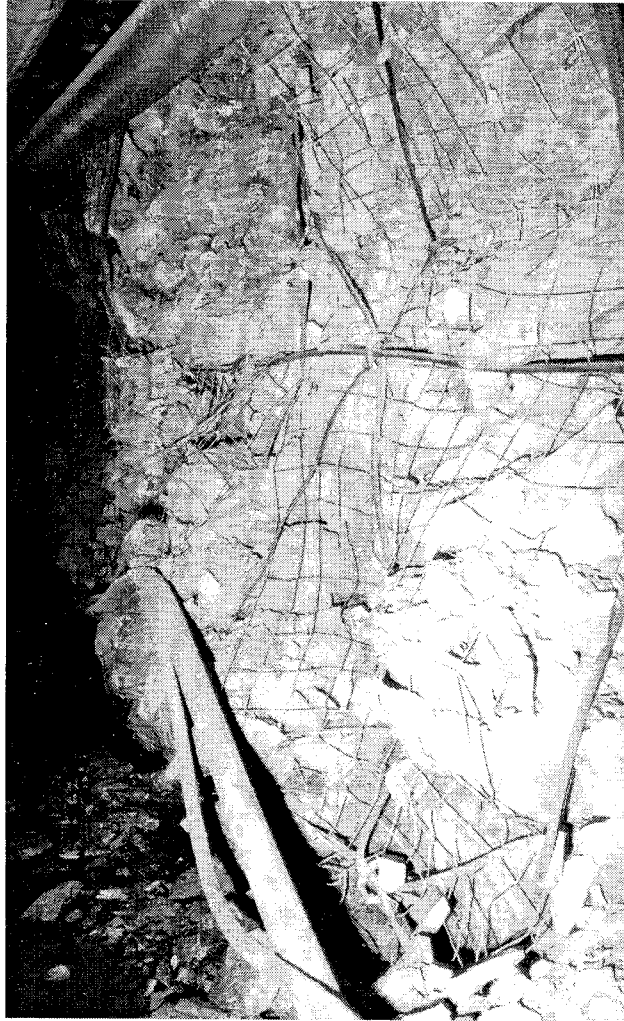
Figure B.74 View east along 38 level deep footwall drive of south sidewall showing more uniform containment and deformation of the sidewall rock mass with isolated areas of mesh failure.

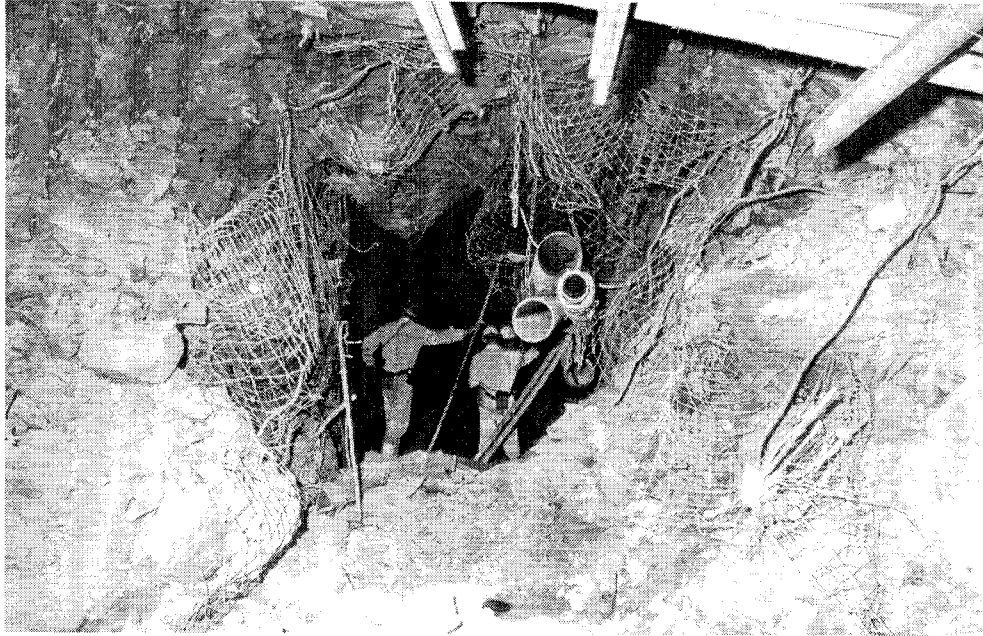
Immediately to the south-west of this collapse, direct observations of damage to the support system could be made (Figure B.75). This damage consisted of a combination of mechanisms of bulk sidewall deformation, with failure or loss of anchorage of the rock bolts and cables, and containment of the unstable rock mass by mesh and lace anchored to stable rock bolts. The large scale deformations of the overall sidewall were generally associated with the lower portion of the excavation and perhaps in association with the observed footwall heave. The extent of differential deformation within the rock mass, particularly where rock bolt anchorage was maintained, resulted in significant damage to the mesh and lacing fabric support system. This again illustrates the low interaction between the rock bolt reinforcement and the rock mass in this highly fractured immediate skin of the excavation, and thus, the large loading of the fabric support.

Figure B.75 View south-west along 42 level haulage showing highly fractured nature of the rock mass, footwall heave of approximately 1,5 m, bulk sidewall deformation (bottom right) and failure of mesh and lacing in upper portions of excavation.

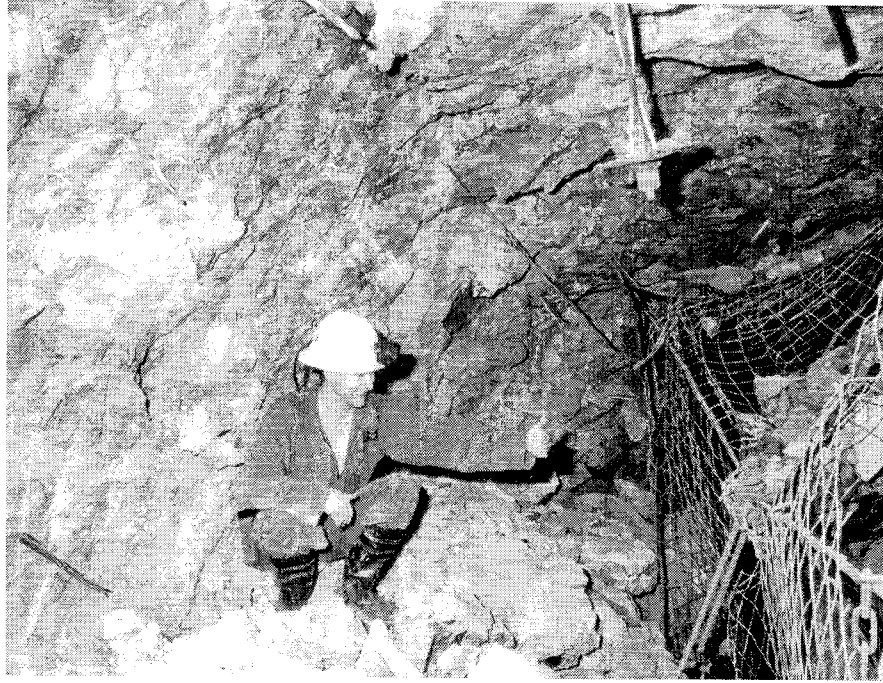
Further observations in this area indicated mechanisms of failure of the rock bolt reinforcement and thus subsequent collapse of the mesh and lacing system (Figure B.76). In this area tensile failure of the rock bolts and cable anchors had occurred because of localised corrosion of these reinforcement units within the rock mass. The subsequent collapse of the rock mass was to a depth of approximately 1,5 m. The rock mass in this area appeared highly weathered in nature which is indicative of the occurrence of ground water and a highly corrosive environment.

Figure B.76 View north east along 42 level haulage showing failure of rock bolt reinforcement (left) and thus loss of fabric anchorage (right) and collapse of approximately 1,5 m of fractured sidewall rock mass.

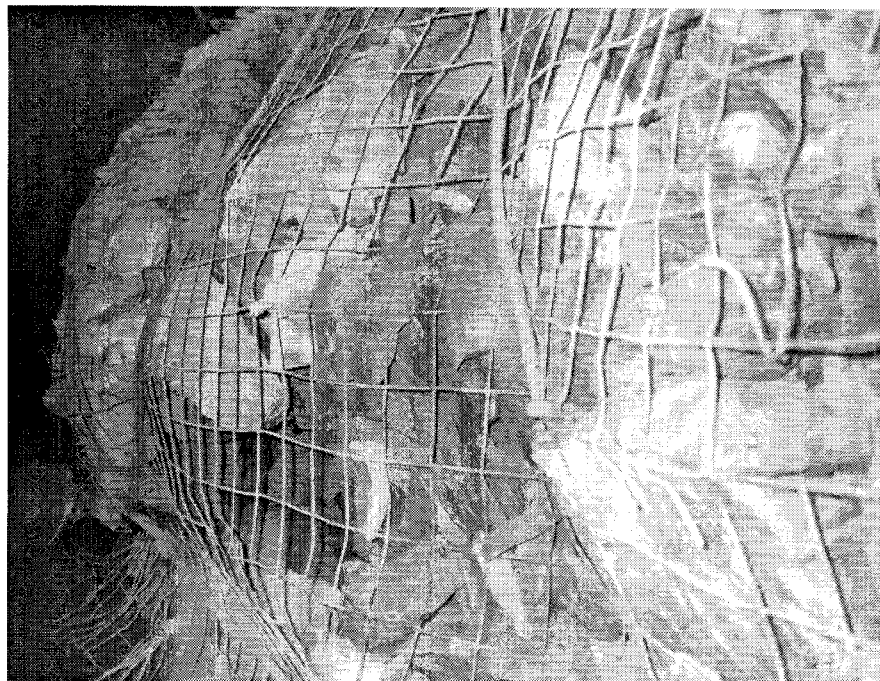
Stability of sections of the tunnel were maintained, but again characteristic bulking of the rock mass between the rock bolts and the lacing is evident with associated loading of the mesh panels (Figure B.77). This again clearly illustrates the limited extent of interaction of the rock bolt reinforcement within the immediate peripheral rock mass of the sidewall of the excavation in this environment.

Figure B.77 Bulking of fractured sidewall rock mass between rock bolt reinforcement and lacing within 42 level haulage.
