Identifying structural damage with ground penetrating radar

by Michael van Schoor and Stoffel Fourie, CSIR

Ground penetrating radar (GPR) and electrical resistance tomography (ERT) surveys were conducted in an urban environment in an attempt to identify the cause of severe structural damage to a historically significant residential property in Johannesburg, South Africa.

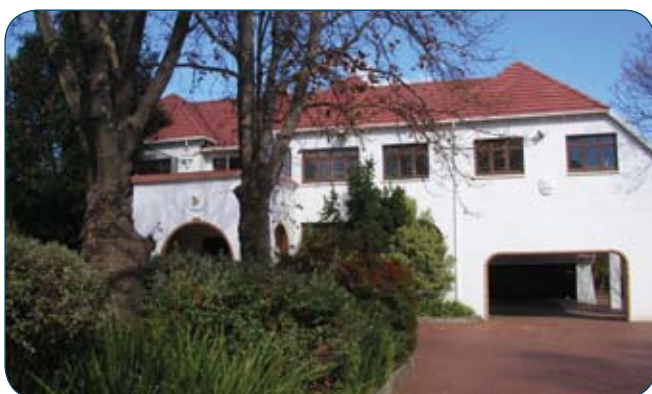
Fig. 1: Front view of the house in 13th Avenue, Houghton, former home to Nelson Mandela.

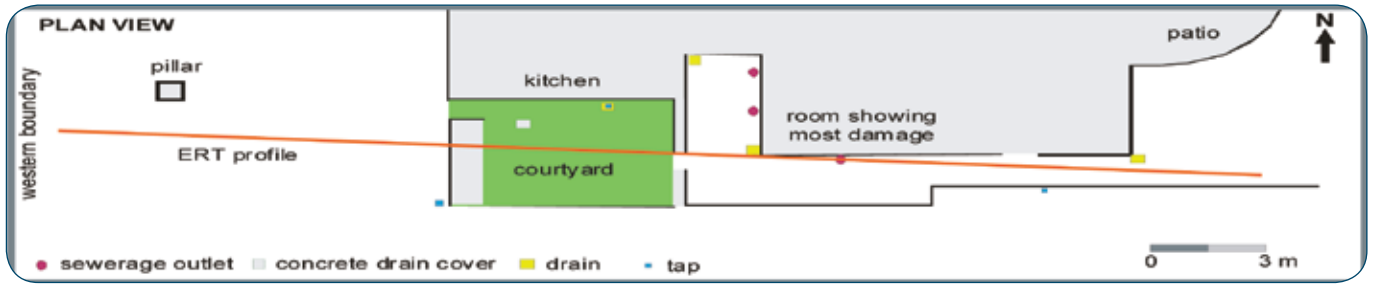
Access was limited to a paved pathway that extends from the south east (SE) corner of the house towards a courtyard outside the kitchen and then leading onto the paved section in front of the double garage that can be seen in the background of Fig 1. A schematic plan view of the site is also shown in Fig. 3. The position of the ERT profile is also shown in Fig. 3. GPR profiles were acquired along the same line, with a few additional, shorter profiles acquired at selected locations in a direction perpendicular to the main profile.

Fig. 3: Schematic view of the test site depicting the southern side (back) of the house, the surface positions of known utilities and the position of the main ERT and GPR profile.
