# FORENSIC INVESTIGATION INTO THE PERFORMANCE OF HOT-MIX ASPHALT

E. DENNEMAN<sup>1</sup> and E.S. SADZIK<sup>2</sup>

<sup>1</sup>CSIR, Built Environment, PO Box 395, Pretoria, 0001, SOUTH AFRICA

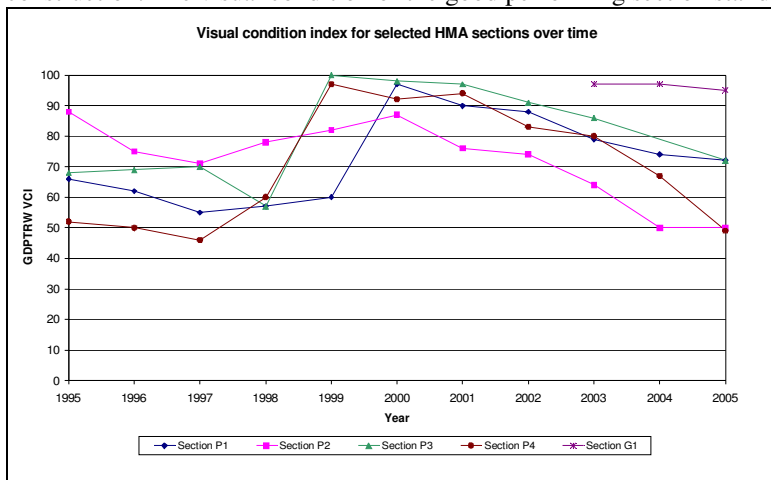
The HMA overlays on the poor performing sections formed part of rehabilitation projects conducted in 1999. The construction of the good performing section, which is the only newly constructed road section included in this study, also took place in 1999. Figure 1 shows the Visual Condition Index (VCI) of the road sections over time. The VCI parameter used by the Gauteng Department of Public Transport Roads and Works (GDPTRW) is calculated by assigning weight factors to the different distress types. In this weighted score system, the occurrence of rutting and cracking are assigned relatively high weights compared to other forms of distress. For the forensic study, it was assumed that when the VCI for a road section drops to below 70, the road has reached the end of its optimal pavement functionality and may be due for rehabilitation. As can be seen from Figure 1, the VCI for sections P1 to P4 was restored to almost a perfect score of 100 directly after rehabilitation in 1999. From this level, the VCI of the sections decreased with time. The condition of section P2 became worse than its pre-rehabilitation condition within four years. The condition of section P4 broke through the 70 level after five years. Both section P2 and P4 continued to deteriorate rapidly. The VCI scores of sections P1 and P3 reached 70 in 2005, after six years of service. For the good performing section G1, only three years of VCI data are available as the visual inspections were started three years after construction. The visual condition of the good performing section stands at 95 after six years of service.

Figure 1: Visual condition of selected sections over time
