The environmental effect of SO₂-bearing atmosphere on the creep fatigue failure of aluminide-coated MM-002 nickel-base superalloy at 870 °C

High-temperature low-cycle fatigue (HTLCF) failure mechanisms of aluminide-coated MAR-M002 nickel-base superalloy in air, argon and Ar + 5% SO₂ atmospheres were investigated at 870 °C. The loading conditions were constant and consisted of creep tension and plastic compression according to the creep plasticity mode of the strain-range partitioning method. The resultant failure mechanisms were investigated using scanning electron microscopy, energy dispersive spectroscopy and X-ray diffraction analysis. The results obtained indicated that the combination of environmental effect and cyclic loading resulted in an early failure of the coating. This failure acted as the incubation and initiation stages for the HTLCF failure of the coated alloy. However, it was found that under an SO₂-containing environment, an accelerated and premature failure was obtained compared to that obtained in argon and air environments. Hence, it is evident that although the aluminide coating provides relatively adequate resistance towards oxidation environment, this protec

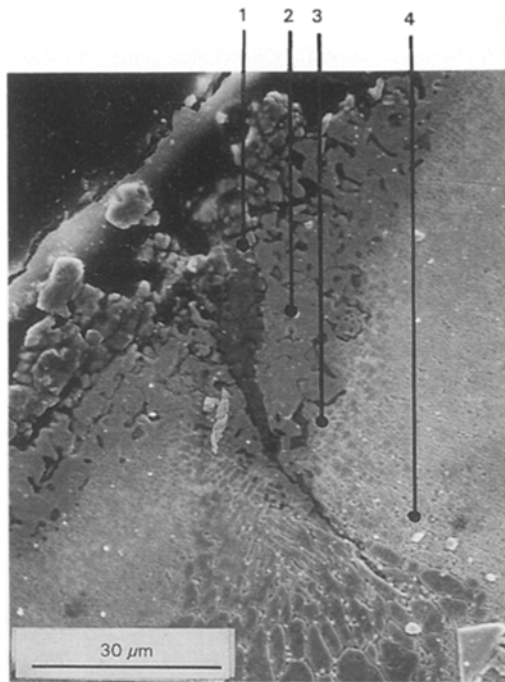
A general view of the longitudinal cross-section of the fracture surface (Fig. 10) showed that the fatigue crack was initiated where the coating was damaged and peeling off. The crack propagation was perpendicular to plane of loading and direction of solidification. The secondary cracks tended to nucleate at the interdendritic segregation zone suggesting that the mode of crack propagation was a mixed trans-interdendritic one. Coalescence and coarsening of the γ' phase was observed adjacent to the fracture surface and secondary crack edges. In order to evaluate the nature of the layers along the crack edge, EDS analysis was performed in the different regions (Fig. 11). A sulphur content of 8.25 wt % was found in the crack manifesting the presence of sulphide phases. There was rich presence of reactive elements aluminium, chromium, and hafnium in the crack indicating the presence of the sulphide phases of these elements and also the oxide phases as a result of the SO_2 breakdown. The presence of sulphur in the second and third layers analysed indicate the penetration of the sulphidation attack.

Elements	Layer (Wt %)			
	1	2	3	4
Al	24.35	3.12	3.46	5.89
S	8.25	0.29	0.29	-
Ti	1.17	-	0.91	1.93
Cr	13.27	0.82	3.87	3.49
Co	4.73	12.83	10.70	7.77
Ni	27.86	69.12	71.32	70.81
Zr	-	-	0.77	-
Hf	16.72	-	-	-
Ta	3.66	-	-	1.42
W	-	13.83	8.68	8.69

Figure 11 Spot chemical analysis of the different regions along the crack edge.

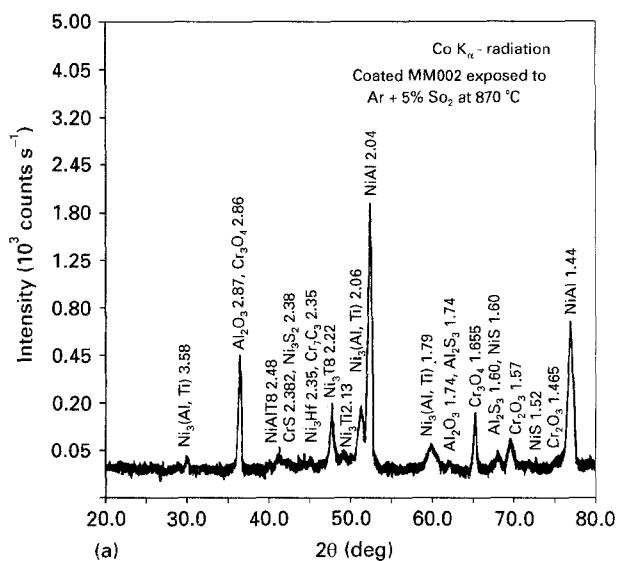
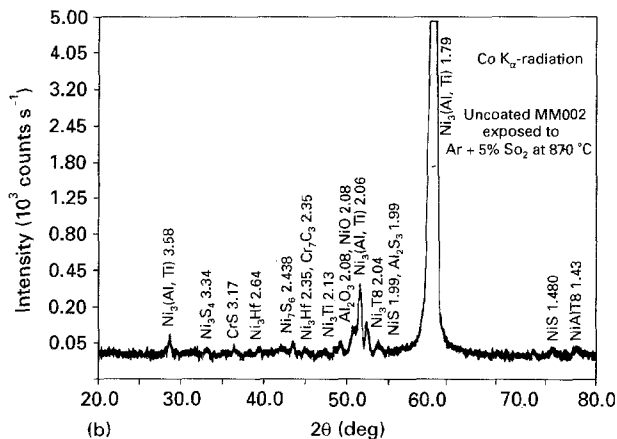
The X-ray analysis of coated and uncoated transverse cross-sectional disc sample exposed to Ar + 5% SO_2 at 870 °C disclose the following results (Fig. 12). For the coated samples (Fig. 12a), there was indication of several sulphide phases present, namely CrS, Ni_3S_2 , Al_2S_3 and NiS. The X-ray diffraction spectrum for uncoated MAR-M002 (Fig. 12b) revealed the typical corrosion product that was present along the crack edge, once the coating was penetrated. The sulphide phases present were Ni_3S_4 , CrS, Ni_7S_6 , NiS and Al_2S_3 as well as Al_2O_3 and NiO phases.

Figure 12 (a) X-ray diffraction of an aluminide-coated disc sample after exposure to Ar + 5% SO₂ at 870 °C. (b) X-ray diffraction analysis of an uncoated disc sample exposed to Ar + 5% SO₂ at 870 °C.
