FORENSIC STUDY INTO THE CAUSES OF PREMATURE FAILURES IN ASPHALT PAVEMENTS IN TANZANIA

ABSTRACT

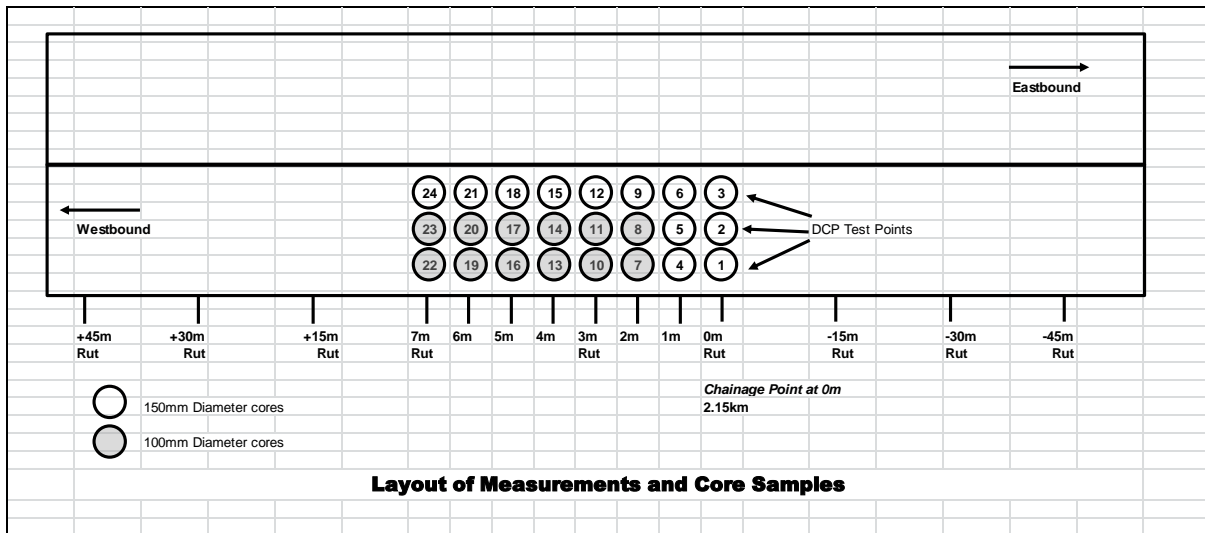
Figure 6: Typical Layout of Road Section used during this Investigation.

Figure 6 shows the layout of typical coring positions and locations for each road section. At each section, a total of 24 asphalt cores were extracted in the areas exhibiting moderate rutting, out of which eight cores from each site were taken in the outer left wheel tracks, between wheel tracks and in the right wheel tracks. A total of eight cores were retained for replacement of damage cores and repeats of laboratory tests which provide doubtful results. All sampling/coring positions were maintained at the specified intervals of 1m.

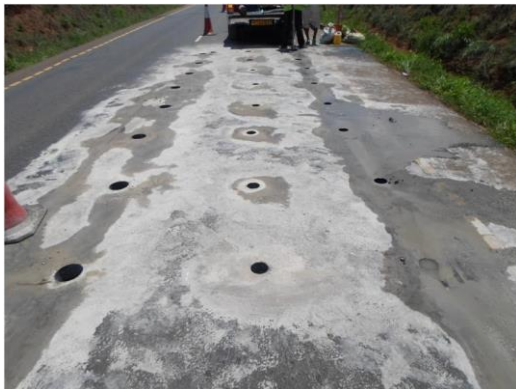
Coring at the rehabilitated road sections showed that during rehabilitation, the old asphalt layers were not milled out before new overlays were placed. Thus, the core samples extracted consist of the new and old surfacing layers.

(a) Core position and holes for a road section

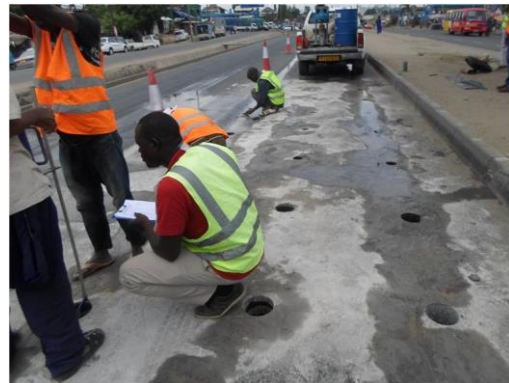
(b) DCP tests at core positions
