Laser induced damage threshold on metallic surfaces during laser cleaning

K. Labuschagne^{1,2}, S. Pityana²

Keywords: Laser induced damage, AISI 316L, Q-switched Nd:YAG, Scanning Electron Microscopy

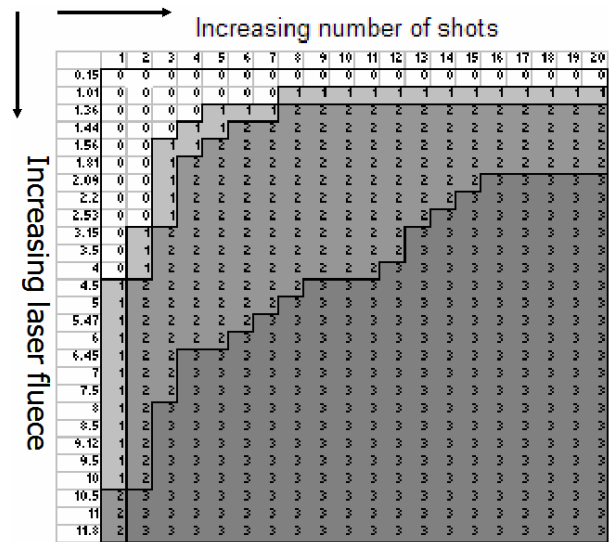
A diagram shown in **Fig.6** was constructed using the damage criteria as categorized in **Tab.1** to indicate the onset of the damage on the specimens as a function of the number of shots versus the laser fluence

Fig.6. Damage diagram showing the onset of laser damage as a function of the number of shots versus the laser fluence.

A diagram was constructed to show the onset of damage on the substrate when using various laser parameters for the removal of a 20 μm thick paint layer. The threshold range for substrate damage at low fluence i.e. 2.09 J.cm⁻², is less than 16 pulses and at higher fluence i.e. 11.80 J.cm⁻², is less than 2 pulses.

The degree of paint removal is highly dependant on the type of paint used as well as the thickness of the paint layer. A safe working window for paint removal without substantial damage caused to the substrate can be derived from the damage diagram in **Fig.6** for the current experimental parameters. Similar diagrams can be constructed for various other paint qualities, layer thicknesses and substrates for the determination of safe paint stripping regimes.
