The non-technical factors that affect sustainability of borehole systems in rural communities – A study on selected villages for the ASWSD project in Limpopo province

E. Mamakoa*, G. Maponya* and M. Mothetha*

* CSIR Built Environment, Meiring Naude Road, Brummeria, Pretoria, 0001
(E-mail: EMamakoa@csir.co.za, GMaponya@csir.co.za, MMothetha@csir.co.za)

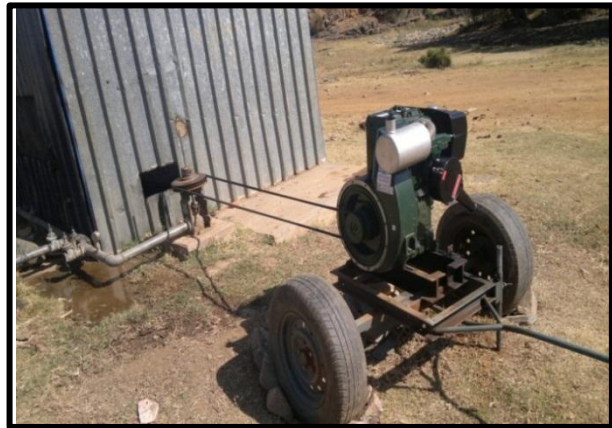
A total of nine boreholes were identified and assessed, of which only one was operational at the time of assessment and was used by the local primary school. It was also established that a diesel engine had been stolen from a borehole that was supplying the community. After eight months the municipality then replaced the engine with a movable motor that was mounted on a trailer that could be towed by hands (see figure 1). To counter the risk of theft, the community came with an idea of wheeling the engine to and from the local chief's house on a daily basis. This posed further challenges to the community as the borehole operator (who was paid by the municipality) could not tow the motor and therefore needed assistance from the community. Since community members were not being paid to operate boreholes, they became reluctant to assist the operator. This resulted in water not being pumped during some days. Other challenges that the community of Kgotlopong faced with the municipality were related to communication – the municipality taking long to attend to breakdowns and also failing to address the issues of theft.

Figure 1: A wheeled borehole diesel motor in Kgotlopong

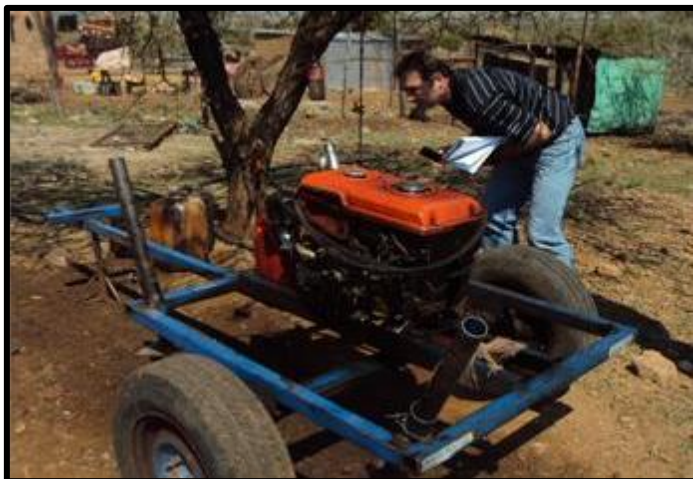
Ten boreholes were identified and assessed in Dresden, of which only three were functional. Of the three functional, two were operated using wheeled diesel motors (see figure 2) while

Figure 2: A wheeled borehole diesel motor in Dresden

the one was a hand pump. The hand pump is only serving about five households that are located in a part of the village that is divided from the rest of the village by a working railway line and therefore difficult to access. The two boreholes with diesel motors both had an operator each, one male and one female. The female operator had challenges with wheeling the motor to the borehole as the motor was heavy and had to be pulled through an uneven terrain using bare hands. As a result, she relied on the help that some of the community members gave her. When

no one was available or willing to help her to wheel the motor to the borehole, it meant that she would not pump water on that particular day. The male operator did not have any challenges with wheeling his diesel motor, and this was also partly so because his homestead was located very close to the borehole.

Other challenges that were faced by the operators were skills related. For example, the diesel motor operated by the female operator had reportedly a lot of breakdowns compared to that of the male operator. According to the technical services officials responsible for maintenance from the municipality, some of the breakdowns that were reported by the female operator were unknowingly of her own wrong doing – such as not aligning the motor with the borehole pump correctly and thus increasing the wear on the fan belt and the pulley of the borehole. It was also reported that she did not perform minor checks such as checking and cleaning the air filters when necessary, and as a result the diesel motor would clog the air filter with dust and not start properly. The municipality would have then had to send technicians to site only to make such discoveries. On the other end, the female operator was adamant that such routine checks did not form part of her training as the operator.

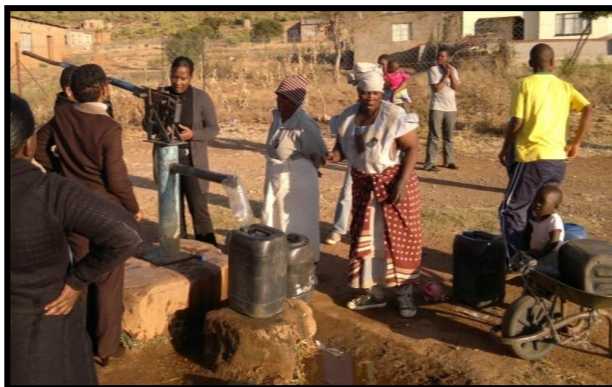
In Ga-MailaMapitsane there was only one hand pumped borehole (out of 13) that was functional (see figure 3). This is also in a village that has a population of over 1000 households. The first observation that was made in the entire community, which was undoubtedly a response by the community to address this challenge, is the presence of a community-based water supply initiative which uses a mountain water source to get water to the community through trenching and water channelling (see figure 4). A large proportion (unknown) gets water from the community-based initiative than from the single borehole.

Figure 3: The only operational hand pumped borehole in Mailamapitsane

Challenges that have been reported by the municipality with regard to maintenance and repairs of the borehole systems in Mailamapitsane was the fact that the municipality is struggling to get spares for the type of borehole hand pumps that are in the area; they are very old technologies for which spares are no longer made and therefore they struggle getting spares from the suppliers. However, the municipality also indicated that they did not have any plans to replace the current broken boreholes with newer technologies for which they can get spares. The municipality also did not have any signed agreements with suppliers from which they procured the old borehole technologies. For newer technologies that they currently implement elsewhere, agreements that they have with suppliers are short term; only lasting less than two years and regulated by the Public Finance Management Act (PFMA).

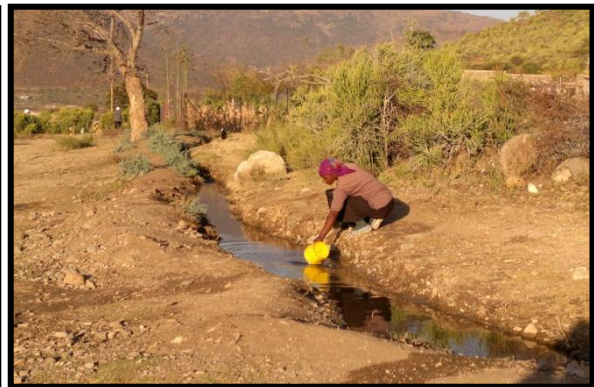
Figure 4: A community-based mountain water harvesting initiative in Mailamapitsane
