ADDRESSING THE TECHNICAL CAPACITY CONSTRAINTS ON COMMUNITY-BASED LABOUR INTENSIVE ROAD PROJECTS – A CASE STUDY OF THE AMADIBA ROAD PROJECT

A LACHMAN¹ and S THEVADASAN²

¹ Vela VKE Consulting Engineers PO Box 37067, Overport, Durban, 4067 ² CSIR Built Environment PO Box 17001, Congella, 4013

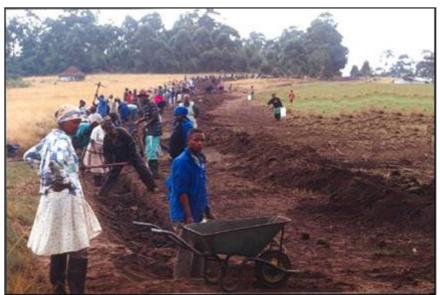
Formation building was the main activity of the labour force (Figure 1). Labourers were divided into teams of five people and were given the task of building 11.25 metres of formation per team. This included the simultaneous digging and shaping of the side drain(s) and the achievement of a camber of 11%. This task was controlled by the use of templates. The earth was not compacted by machine but the local drivers were encouraged to assist by varying their wheel tracks.

Figure 1. Labour Force Constructing the Road Formation

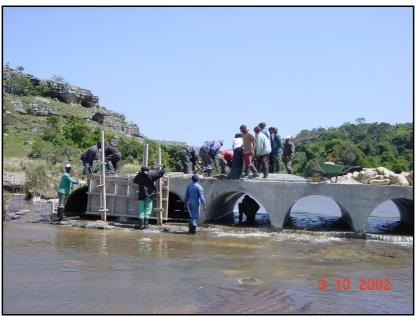
The project called for 1 major and 2 minor river crossings. The limited budget suggested vented, low-level causeways suitable for construction by labour intensive means. A reinforced concrete arch causeway design was chosen and was built entirely by semi-skilled local labour (Figure 2). The causeway was anchored down by means of dowel bars set in holes drilled into the rock base. The causeway was 5.25 m wide and it was cast in sections 2.3 m long, each containing an arch. The arch diameter was 1.9 m. The arch was formed on purpose made steel moulds.

Figure 2. Construction of Causeway by Local Semi-skilled Labourers
